From: John Locklear <john@locklearconsulting.com>
Sent: Friday, April 15, 2022 2:34 PM
To: Tafuni, Steven <Steven.Tafuni@FloridaDEP.gov>; Madden, Melissa <Melissa.Madden@FloridaDEP.gov>
Cc: John Arnold <john.phillip.arnold@gmail.com>; Pradeep Jain <pjain@innovativetec.com>; ljbaker23@outlook.com <lisa@locklearconsulting.com>; Walker Wrenn <walker@locklearconsulting.com>
Subject: Enterprise Road Class III Recycling and Disposal Facility - Response to inspection comment

April 15, 2022

RE: Angelo's Recycled Materials
Enterprise Road Landfill & Recycling Facility
Facility ID No.: 87895
FDEP Inspection Letter Dated February 24, 2022: Response to Comment 1.6

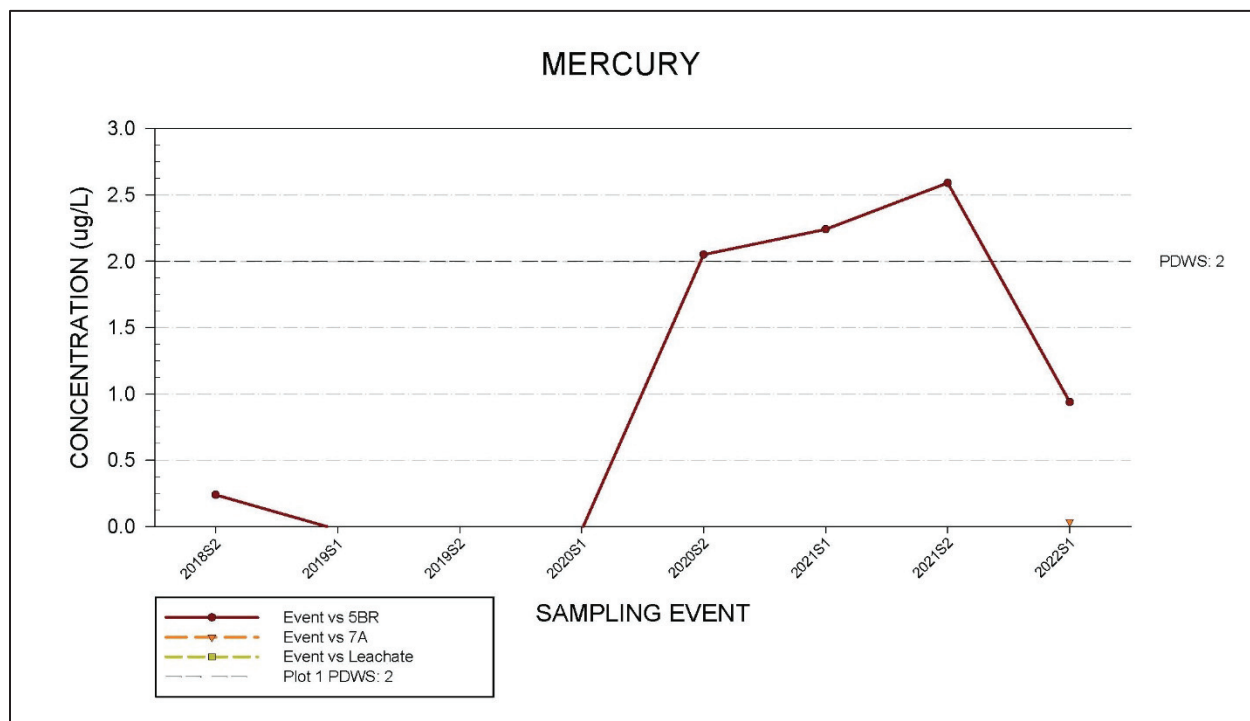
FIGURE 1

Mercury was reported above the Method Detection Limit (MDL) in samples collected from MW-5BR in four of the eight monitoring events. Three of the detections were slightly above the Primary Drinking Water Standard (PDWS) of 2 µg/L as shown in Figure 1. The most recent data shows Mercury below the PDWS in the MW-5BR sample. Mercury has not been detected in any of the leachate samples collected from the leachate wet well during the entire period. This suggests that the landfill leachate is not the source of exceedances observed at MW-5BR.

Mercury. Mercury has been reported at concentrations at or slightly above the PDWS in three of the last four semiannual samples collected from monitoring well MW-5BR. The most recent measurement was below the PDWS. Mercury has not been detected in any leachate samples collected from the leachate wet well during the reporting period. This suggests that leachate is not likely the source of mercury exceedance at MW-5BR. Mercury is documented to be present in Florida soils (Chen et al. 1999²). Variations in groundwater chemistry can cause naturally-occurring mercury to mobilize.

- Mercury concentrations should continue to be monitored in both monitoring well MW-5BR and the leachate wet well. The time-series plot provided herein should be updated in the semiannual monitoring reports to further evaluate potential trends.
- Benzene concentrations should continue to be monitored in both monitoring well MW-7A and the leachate wet well. The time-series plot provided herein should be updated in the semiannual monitoring reports to further evaluate potential trends.

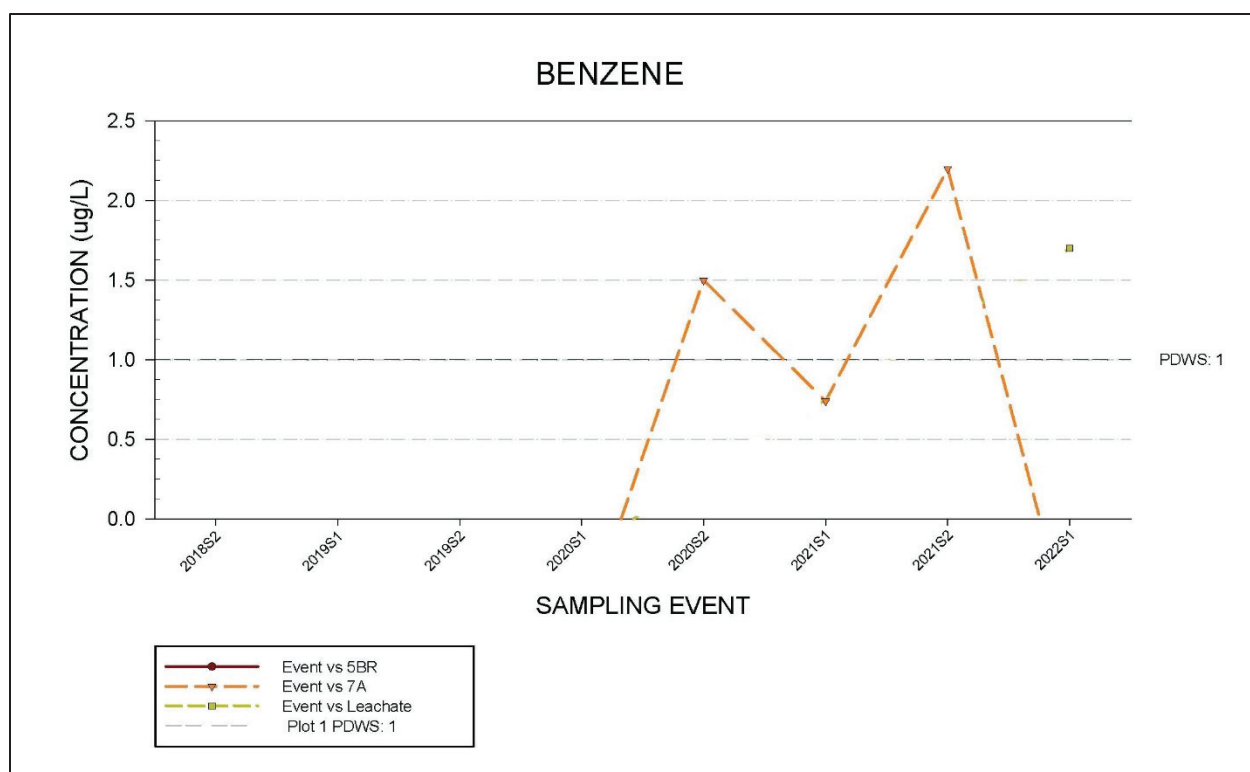
FIGURE 2

Benzene was reported above the MDL in samples collected from MW-7A in three of the eight monitoring events. Two of the detections were slightly above the PDWS of 1 µg/L as shown in Figure 2. Benzene was not detected in the most recent sample collected from MW-7A. A Sample collected from the leachate wet well during the first semiannual 2022 sampling event was analyzed for benzene. Benzene was not detected in the leachate sample collected from the leachate wet well. Since benzene monitoring is not required for leachate, the leachate wet well samples historically have not been analyzed for benzene.

Benzene. Benzene has been reported at concentrations at or slightly above the PDWS in two of the last four semiannual samples collected from monitoring well MW-7A. Benzene was not detected in the first semiannual 2022 sample collected

from the leachate wet well. Benzene monitoring is not required for leachate. Therefore, historically, benzene has not been measured in leachate samples.

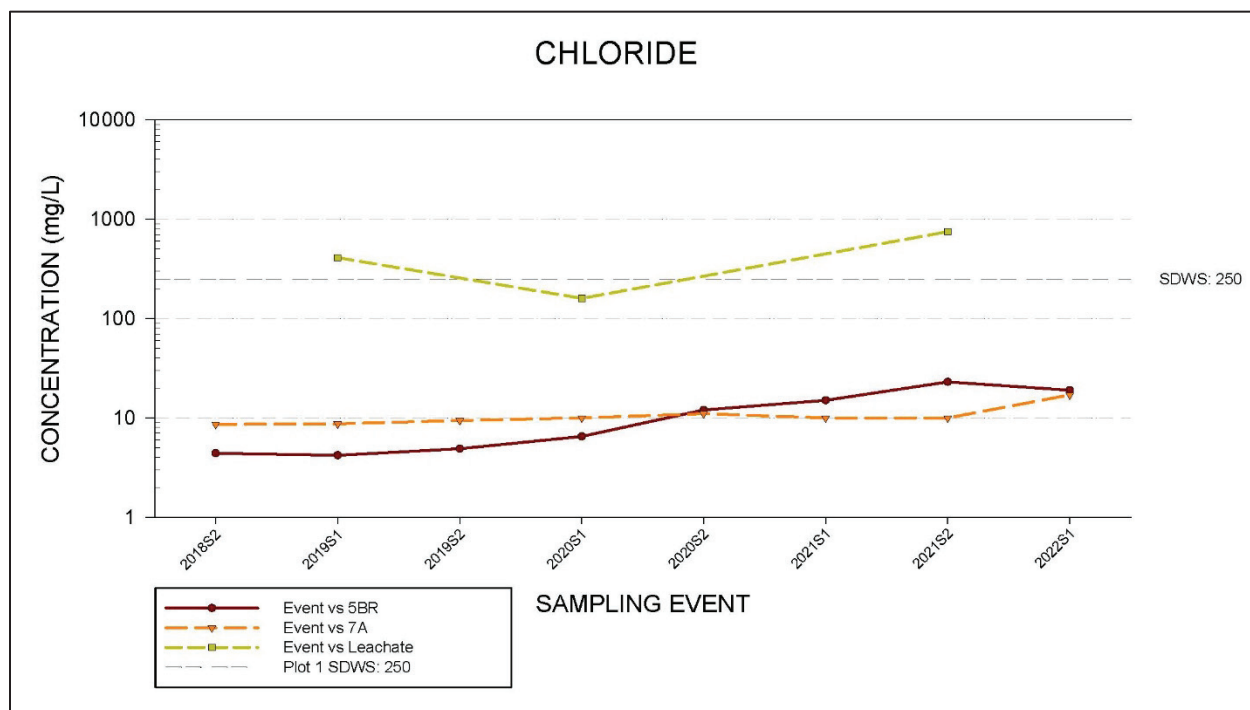
FIGURE 3

Chloride is widely known and used as an indicator parameter for monitoring leachate migration into groundwater (US EPA, 2020¹). Leachate typically has significantly higher chloride concentrations than that groundwater. As shown in Figure 3, chloride concentrations reported for the leachate wet well samples have been two orders of magnitude higher than those reported for samples collected from monitoring wells MW-5BR and MW-7A. Chloride concentrations in all samples collected from monitoring wells MW-5BR and MW-7A have been significantly below the Secondary Drinking Water Standard (SDWS) and have been relatively consistent over time.

Leachate Indicator Parameters. No elevated concentrations or significant increases of leachate indicator parameters (sodium, chloride, specific conductance, and total dissolved solids) were observed in any of the samples collected from monitoring wells MW-5BR and MW-7A during the reporting period.

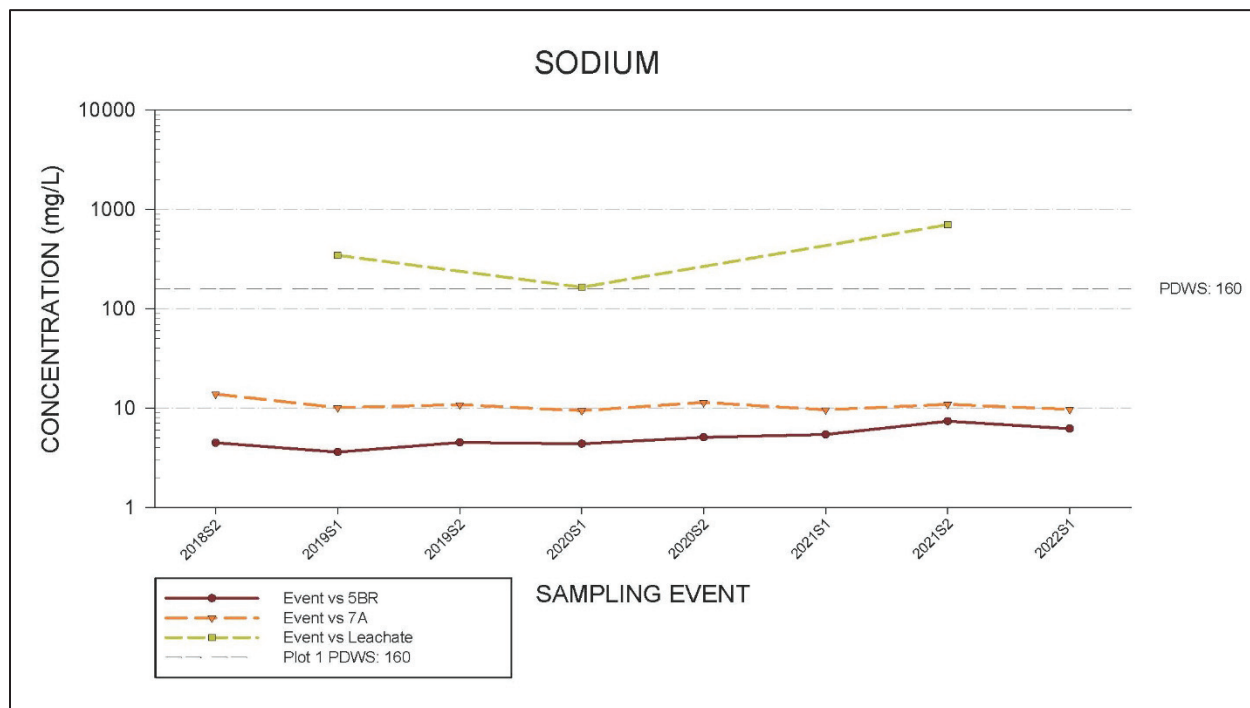
FIGURE 4

Sodium is also widely known as an indicator of leachate in groundwater. Leachate typically has significantly higher sodium concentrations than that of groundwater. As shown in Figure 4, chloride concentrations reported for the leachate wet well samples have been two orders of magnitude higher than those reported for samples collected

from monitoring wells MW-5BR and MW-7A. Sodium concentrations in all samples collected from monitoring wells MW-5BR and MW-7A have been significantly below the SDWS and have been relatively consistent over time.

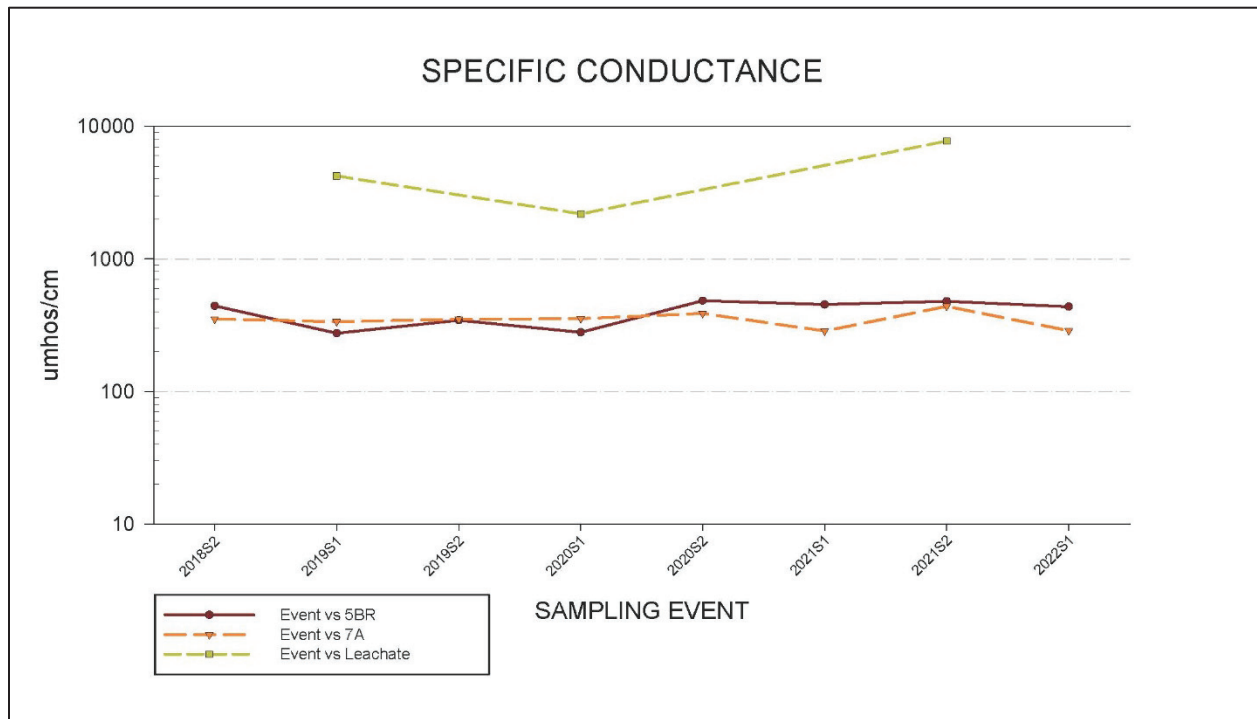
FIGURE 5

Specific conductance is another widely accepted indicator of leachate in groundwater. Leachate typically has significantly higher specific conductance values than that of groundwater. As shown in Figure 5, specific conductance values reported for the leachate wet well samples have been over two orders of magnitude higher than those reported for samples collected from monitoring wells MW-5BR and MW-7A. Specific conductance values in all samples collected from monitoring wells MW-5BR and MW-7A have been consistent over time.

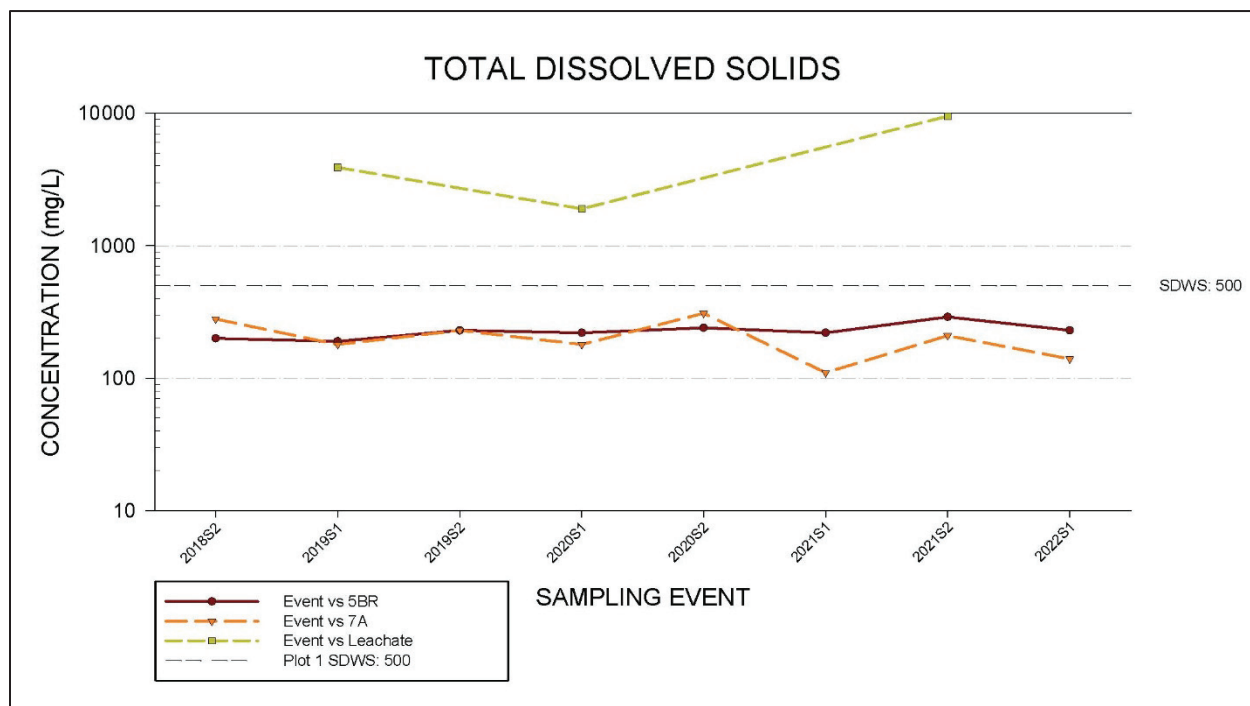
FIGURE 6

Total dissolved solids (TDS) are another indicator of leachate in groundwater. Leachate typically has significantly higher TDS than that of groundwater. As shown in Figure 6, TDS concentrations reported for the leachate wet well samples were over two orders of magnitude higher than those reported for samples collected from monitoring wells MW-5BR and MW-7A. TDS concentrations in all samples collected from monitoring wells MW-5BR and MW-7A have been significantly below the SDWS and have been consistent over time.
