Hillsborough County
Florida

RE: December 15, 2008 Inspection – Southeast County Landfill

On December 15, 2009, the Florida Department of Environmental Protection (FDEP) conducted an inspection of the Southeast County Landfill (Permit No. 34535-014-SO/01)

RE: FDEP Inspection of Southeast County Landfill – 12/15/08
Question Number 2.24
Southeast County Landfill, Hillsborough County, Florida
Jones Edmunds Project No.: 08449-030-03 Task 1110

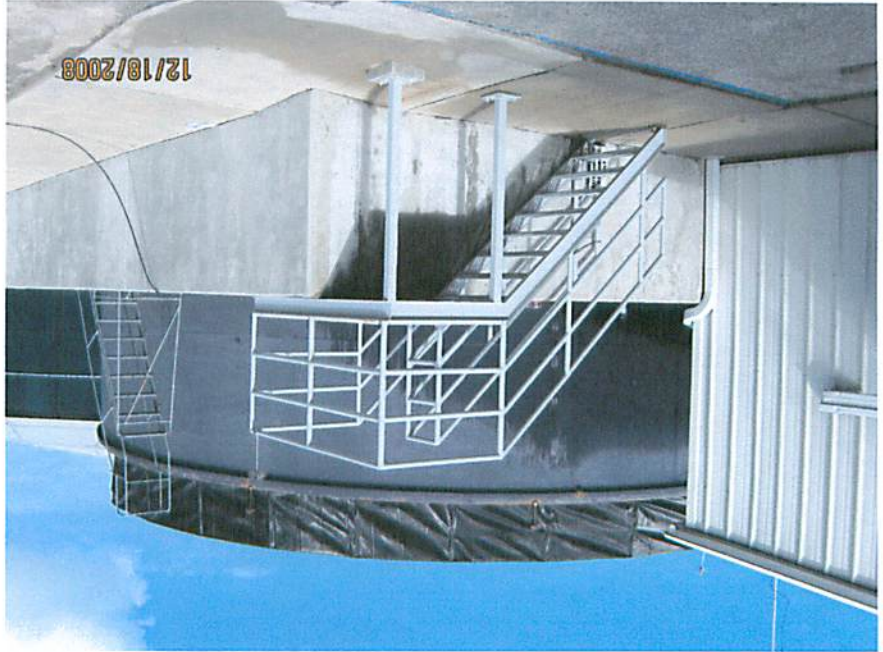
Photograph Number 1

FDEP Explanation: During the inspection DEP staff observed that wind had blown foam from the process tank at the leachate treatment plant onto the building and outside of the containment. Facility staff indicated that the dried solids would be swept up from the ground and placed into the landfill dumpster. The process for cleaning the sides of the building should be carefully evaluated to prevent contact water from running off into stormwater.

Date: December 18, 2008
Site: Southeast County Landfill, Hillsborough County, FL
Description: Exterior of containment area and process tank. View of new filter fabric rim skirt.
Looking northwest.

As requested, Jones Edmunds evaluated Question No. 2.24 of the subject Inspection Report conducted by the Florida Department of Environmental Protection (FDEP). In the FDEP Inspection Report dated December 15, 2008, a potential violation is documented regarding wind blown foam from the activated sludge tank at the Leachate Treatment and Reclamation Facility (LTRF). Blown foam residuals were observed outside of the containment area as well as on the adjacent building. The FDEP report requested corrective actions and stated that any liquids or liquids generated during clean-up should be treated as leachate unless it can be proven otherwise. It is our opinion that the foam from the activated sludge tank, and thus the residuals documented on the side of the tank and the adjacent building, at the LTRF, is not leachate, but is a product of wind blown foam produced by microorganisms within the activated sludge tank of the LTRF and/or the existence of surfactants within the activated sludge tank.

Foaming from an activated sludge process is commonly associated with the presence of a microorganism known as Nocardia. Foam that is caused by Nocardia typically has a brownish color and can reproduce so quickly that it could easily overflow from a holding tank. In high-wind conditions it will blow from the tank to surrounding facilities. Assessing the pictures provided by the FDEP Inspection, we can see that the walls of the activated sludge tank, facility building, and the concrete sidewalk all have a brownish residual from dried, wind-blown foam. This is likely Nocardia foam that was blown from the process tank during high winds. This is a common occurrence at many wastewater treatment plants.

In conclusion, the foam is formed by one or a combination of microbiological activity or surfactants in the activated sludge tank. The resulting foam is not a hazardous substance or leachate.

Response: The SWMD operates the Southeast County Landfill (SCLF) in substantial compliance with the Operation Plan. The foam from the activated sludge tank at the leachate treatment plant (LTP) that had blown onto the side of the tank, LTP building, and adjacent sidewalk were pressure washed on December 17, 2008. The wash water generated during the washing activities was collected and placed in the activated sludge tank at the LTP. Additionally, a skirt was added to the southeast rim of the tank to minimize re-occurrence (See Attachment A).

The foam that forms within the activated sludge of a biological treatment process is a byproduct of bacterial activity. Please see attached response from Jones Edmunds addressing this issue. In the future, if any foam is blown outside of the process tank, the following cleanup procedure will be used:

1. Pressure wash the affected areas.
2. The wash water will be collected and placed back in the activated sludge tank.
