CERTIFICATION REPORT

PHASE 1 PARTIAL CLOSURE

J.E.D. SOLID WASTE MANAGEMENT FACILITY
Osceola County, Florida

Project Number FQ1672
December 2009

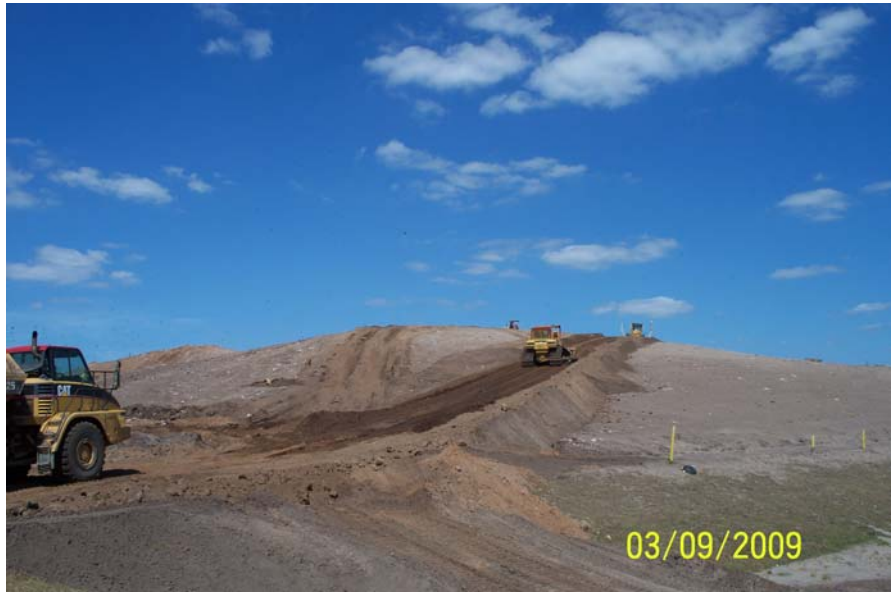
Comments: Construction of access road at SW corner of the Phase 1 Area (Cell 4).

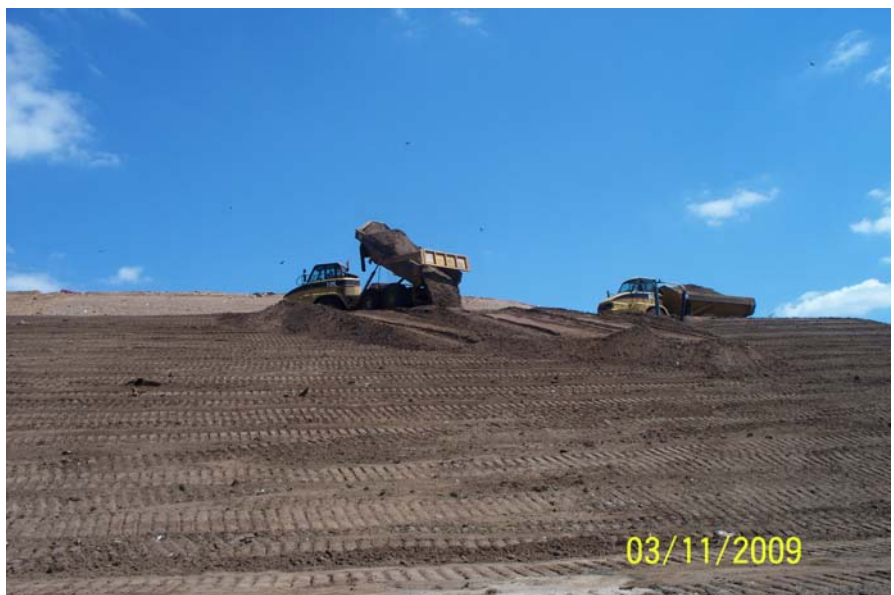
Photograph No.: 2

Comments: Dumping of general fill (intermediate cover) on landfill side slope.

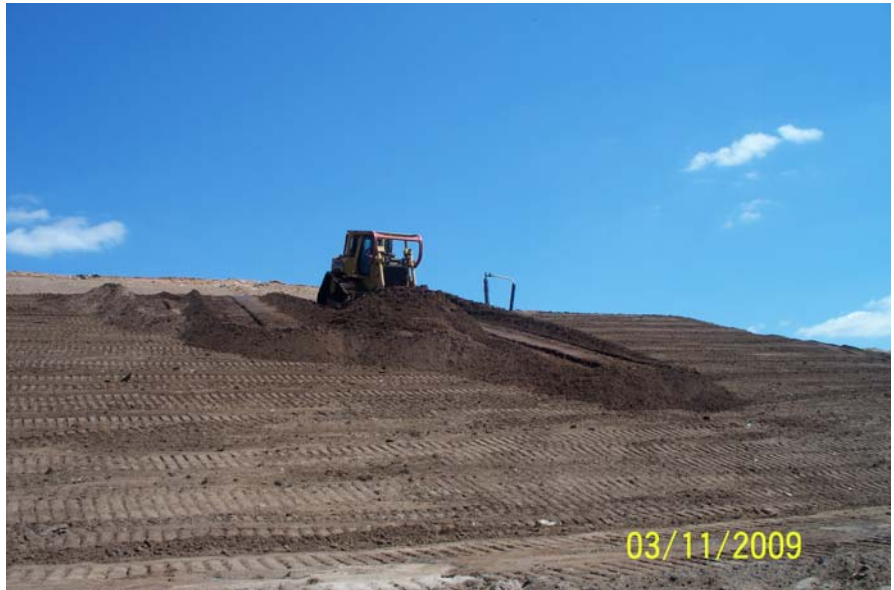
Comments: Spreading general fill (intermediate cover) on landfill side slope.

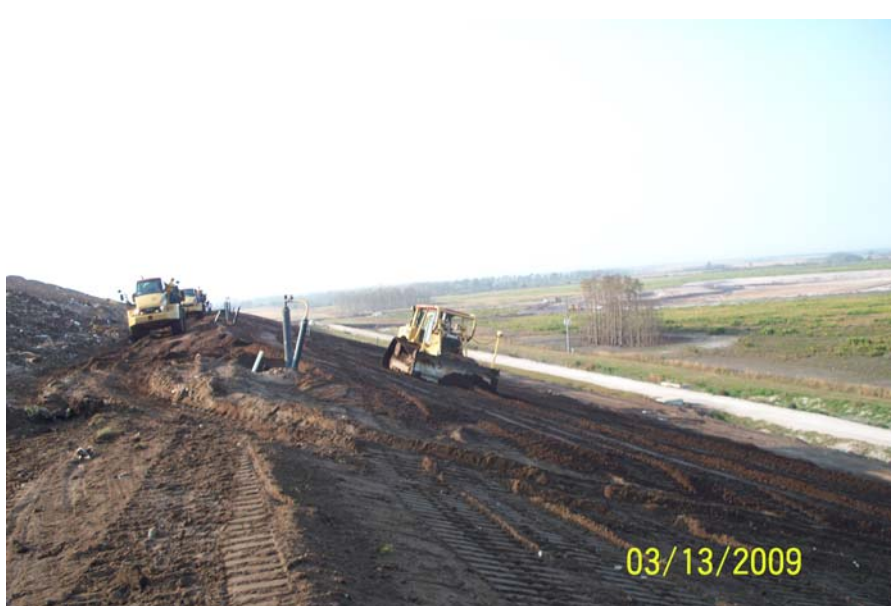
Photograph No.: 4

Comments: Grading of intermediate cover layer w/GPS equipped bulldozer.

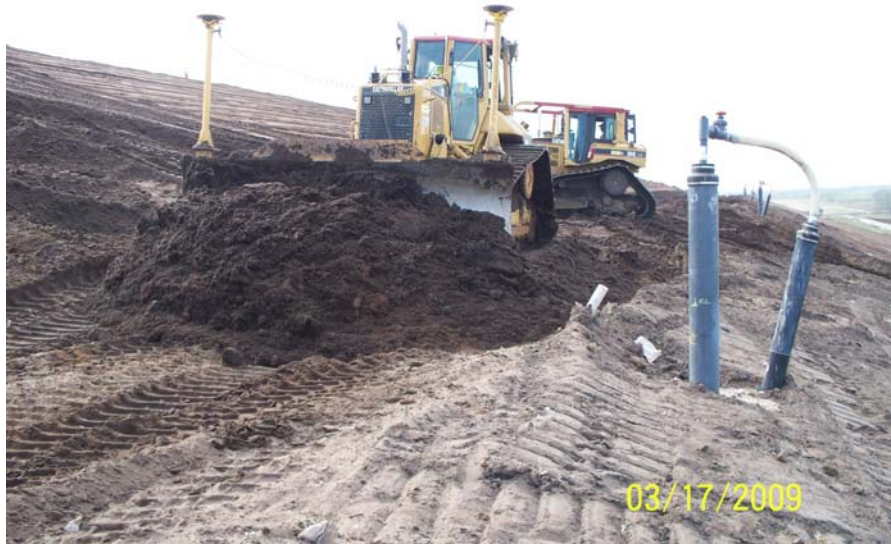
Comments: Grading of intermediate cover layer using GPS equipped bulldozers.

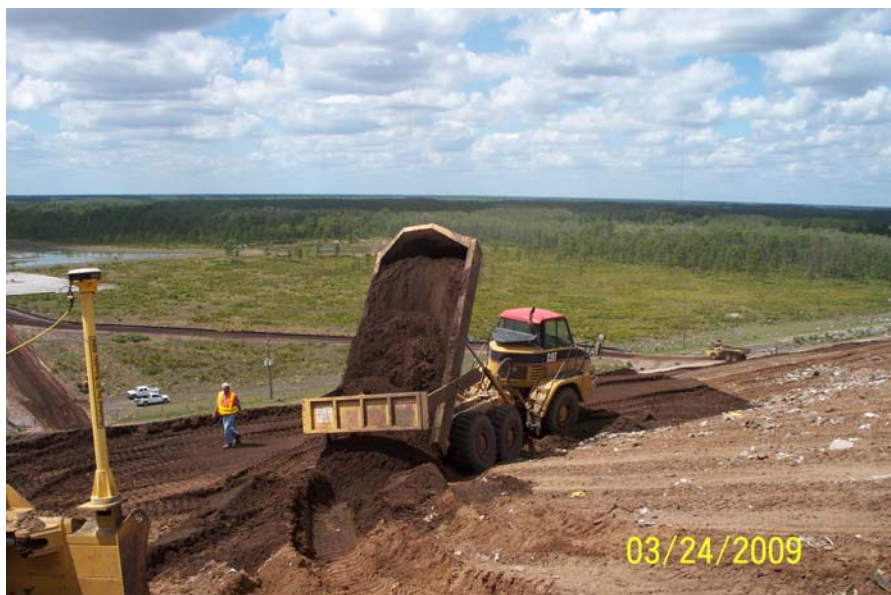
Photograph No.: 6

Comments: Dumping of general fill (intermediate cover) on landfill side slope.

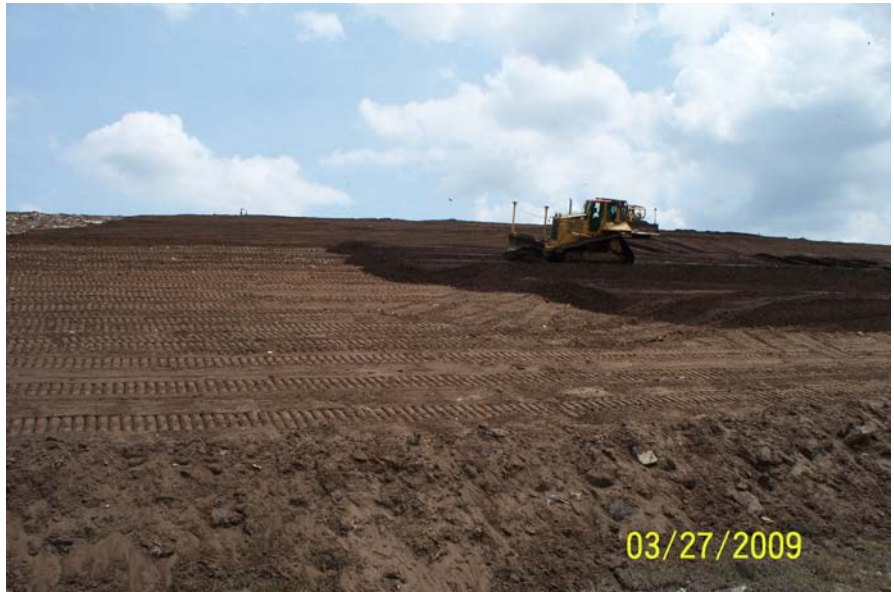
Comments: Grading of intermediate cover layer using GPS equipped bulldozer.

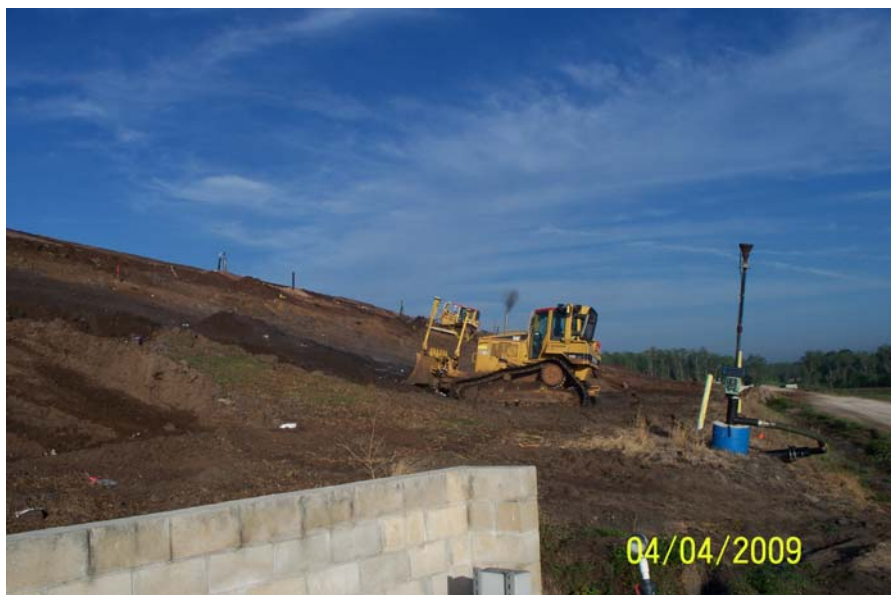
Photograph No.: 8

Comments: Grading of existing landfill surface (daily cover).

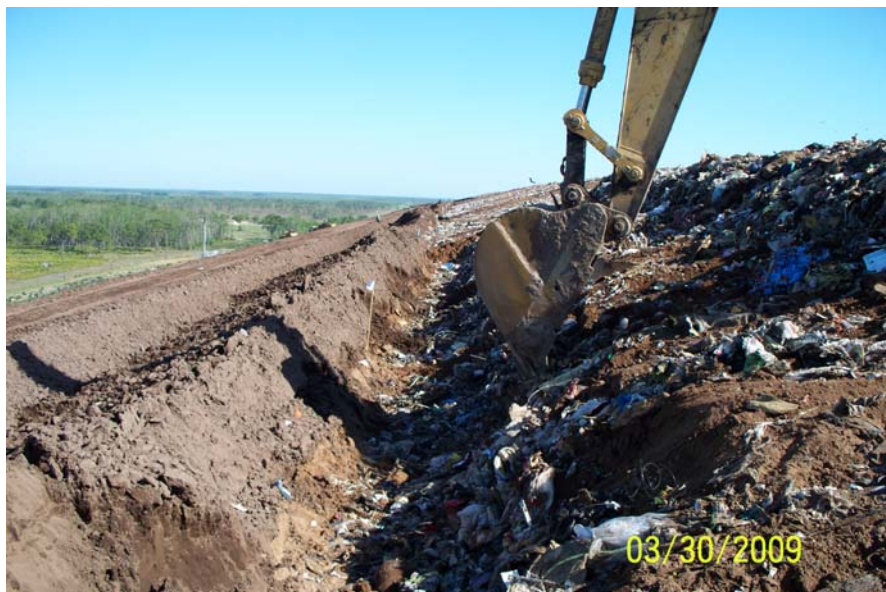
Comments: Excavation
of anchor trench on upper
bench (i.e., elevation
180-ft).

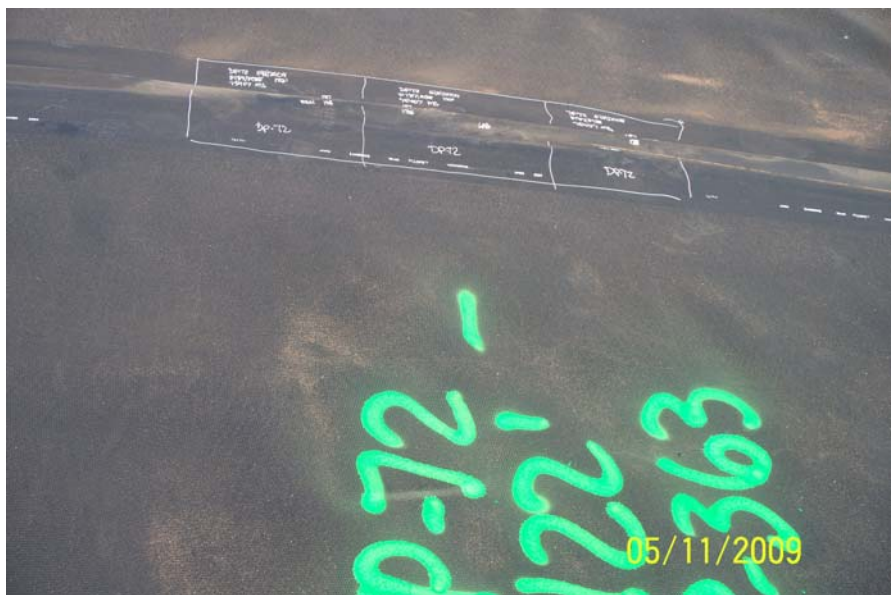
Photograph No.: 20

Comments: Destructive
seam test location
marked on welded seam.

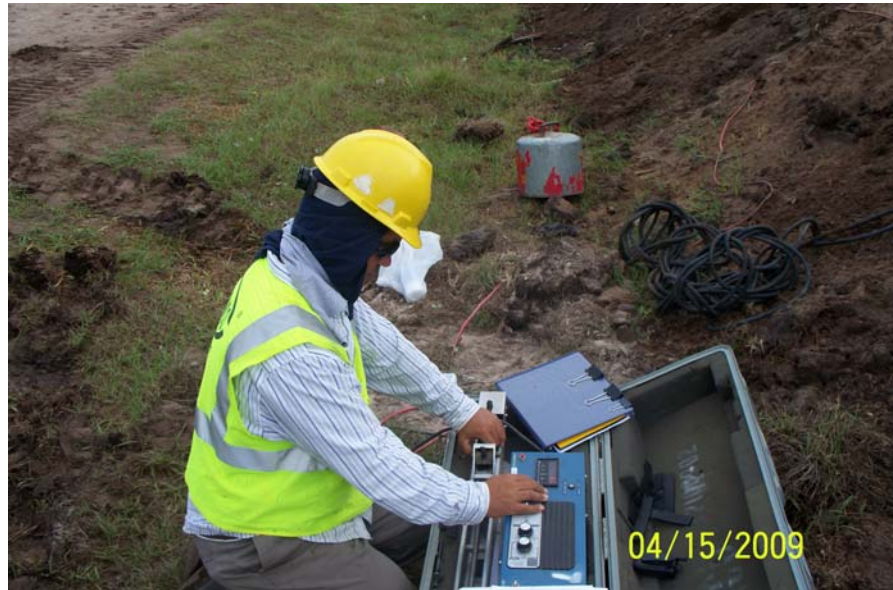
Comments: Field testing
of destructive test
sample.

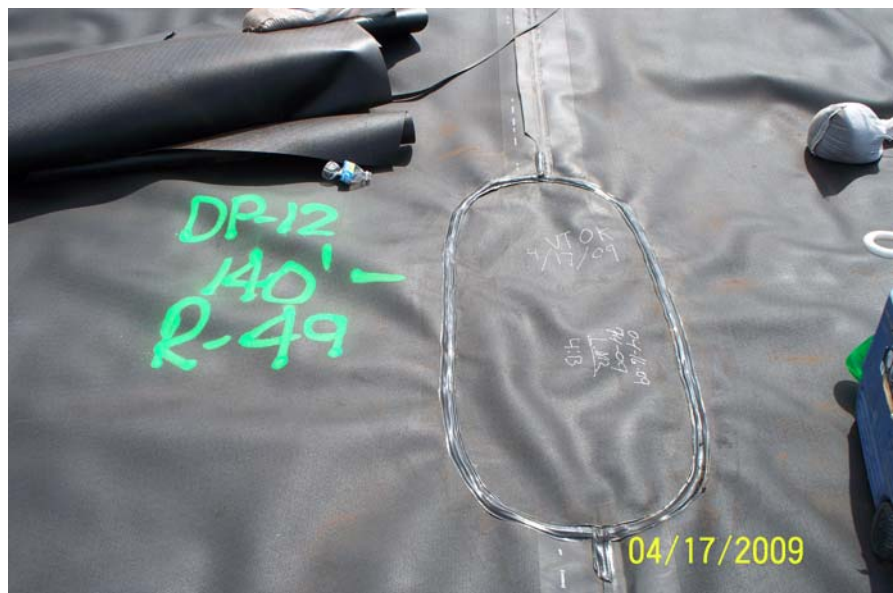
Photograph No.: 22

Comments: Repair of
liner where destructive
test sample was removed.

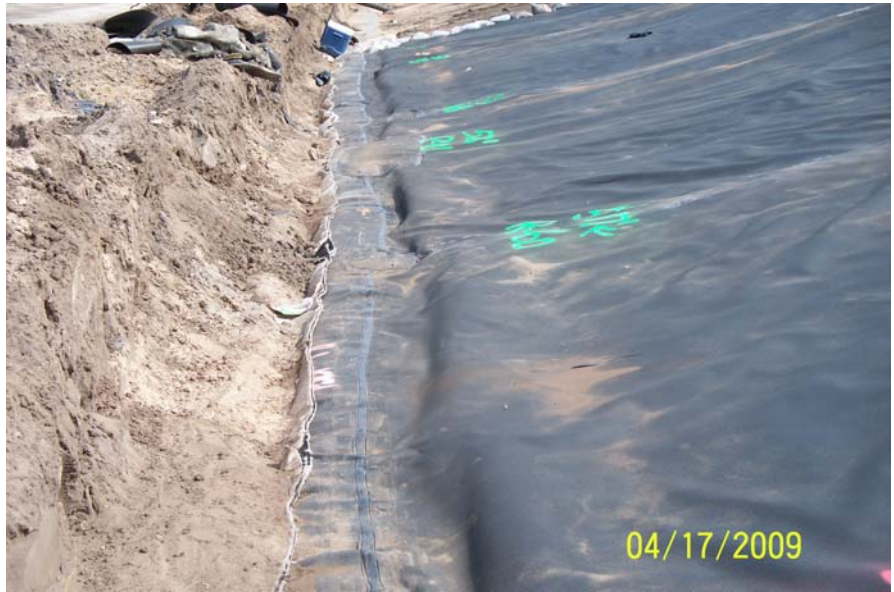
Comments: Extrusion welded tie-in connecting the cover system liner with the base liner.

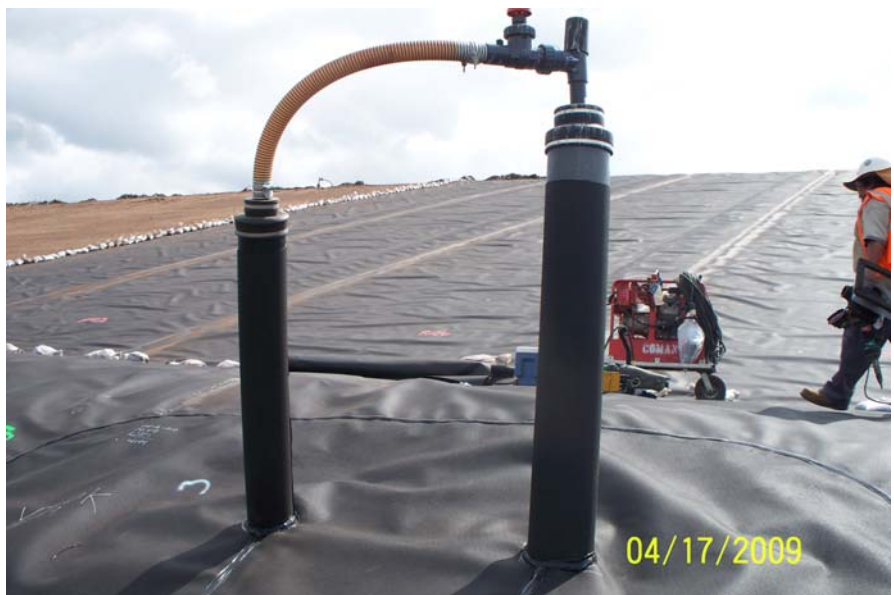
Photograph No.: 26

Comments: Gas system penetrations in cover system geomembrane.

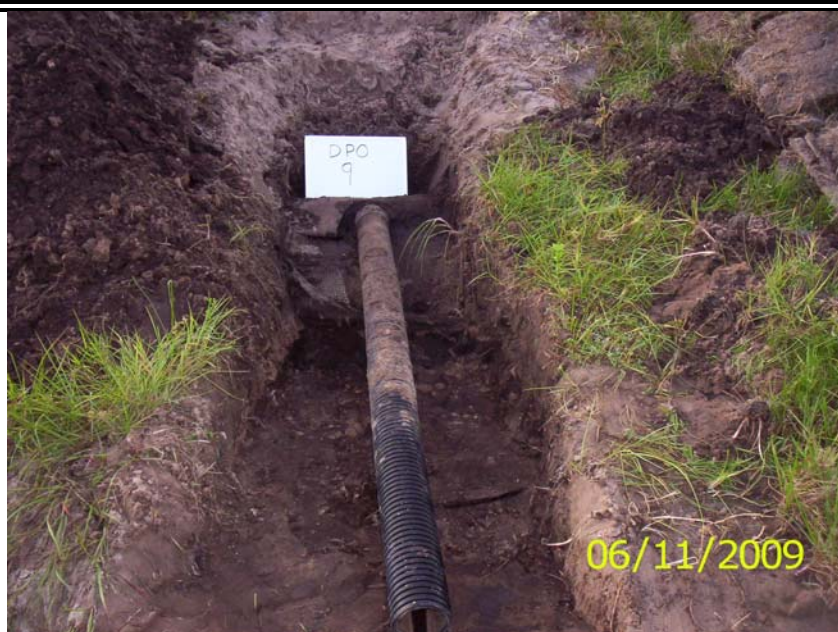
Comments: Excavated
drain pipe outlet pipe.

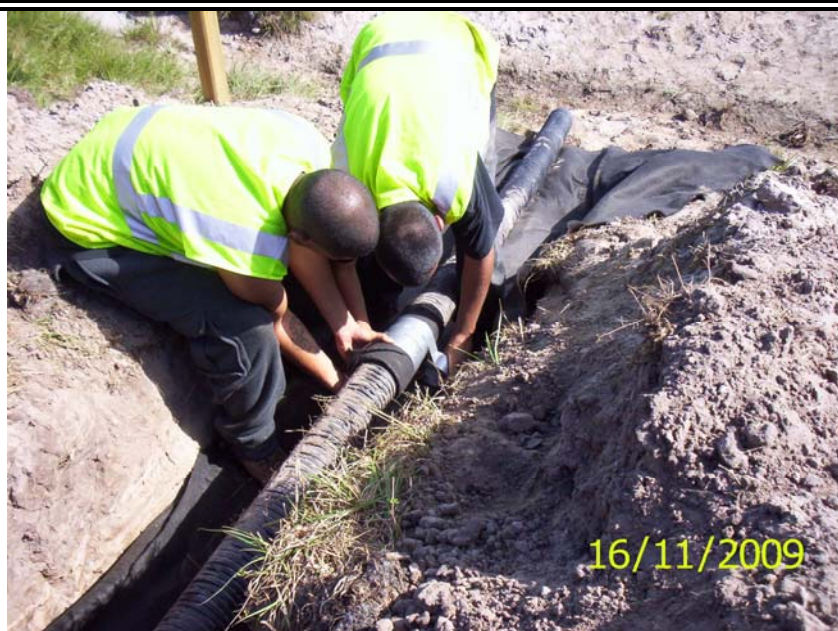
Photograph: 62

Comments: Sealing of
drain pipe with geotextile
and duct tape.

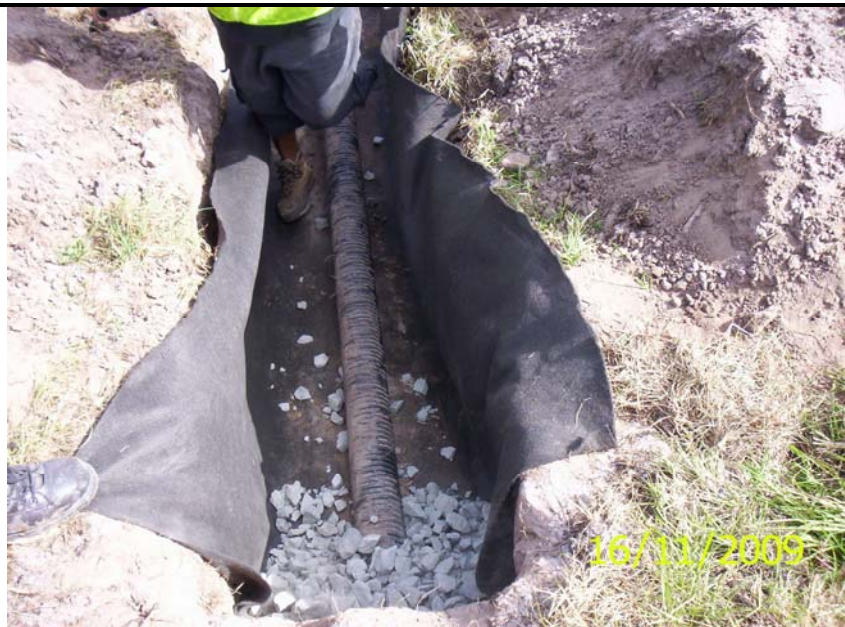
Photograph: 64

Comments: Geotextile Placed beneath drain pipe outlet. Drainage gravel placed over the geotextile.

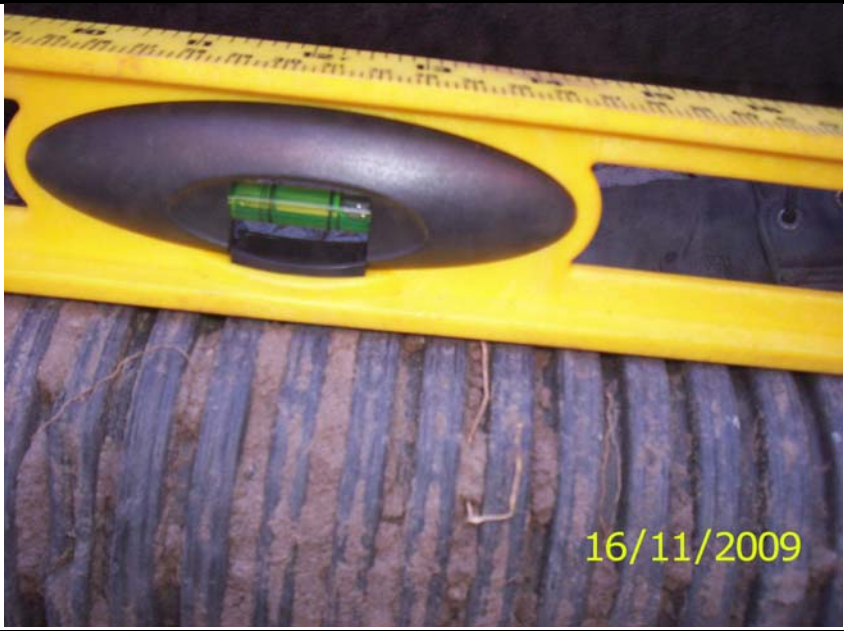
<p>Photograph: 65</p> <p>Date: 16 November 2009</p> <p>Direction: N/A</p> <p>Comments. Carpenter's level utilized to ensure positive slope on drain pipe.</p>

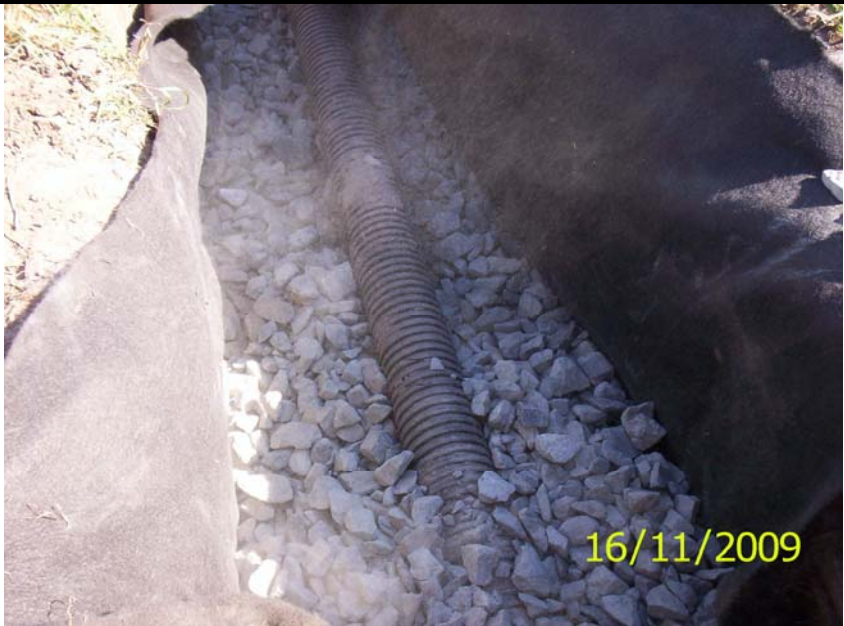
<p>Photograph: 66</p> <p>Date: 16 November 2009</p> <p>Direction : N/A</p> <p>Comments: Drainage gravel placed around drain pipe outlet.</p>

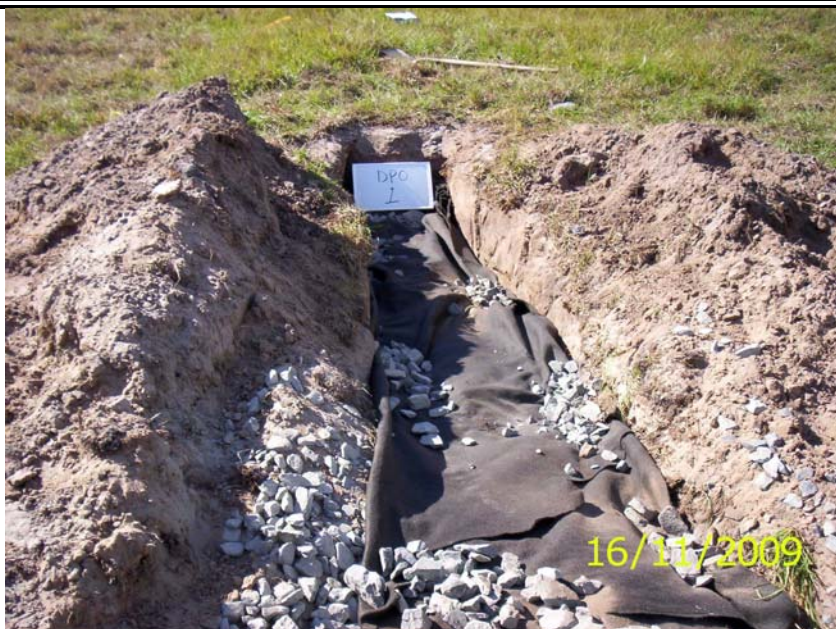
Photograph:68

Comments: Geotextile wrapped around drainage gravel and pipe prior to backfilling.

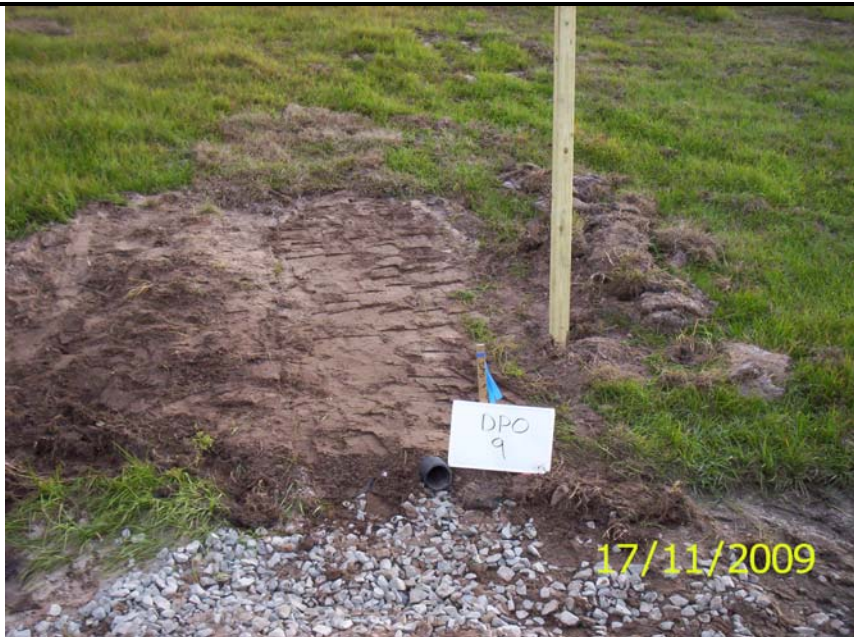
Photograph:70

Comments: Drain pipe outlet after completion of backfilling.
