Florida Department of
Environmental Protection
Inspection Checklist

Facility Name: J.E.D LANDFILL (F/K/A OAK HAMMOCK DISPOSAL)

On-Site Inspection Start Date: 10/20/2010

Construction Completion Certification Inspection for Landfill - Class I facility

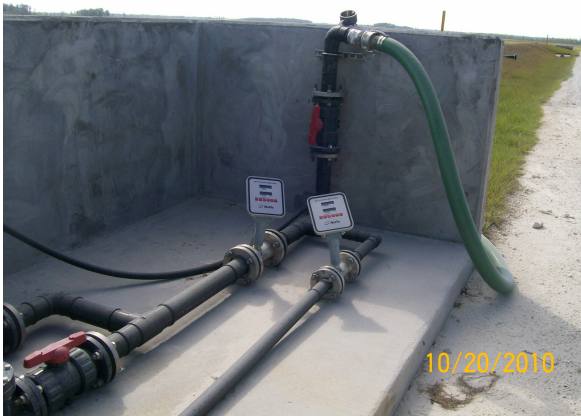
Leachate Pumpout System

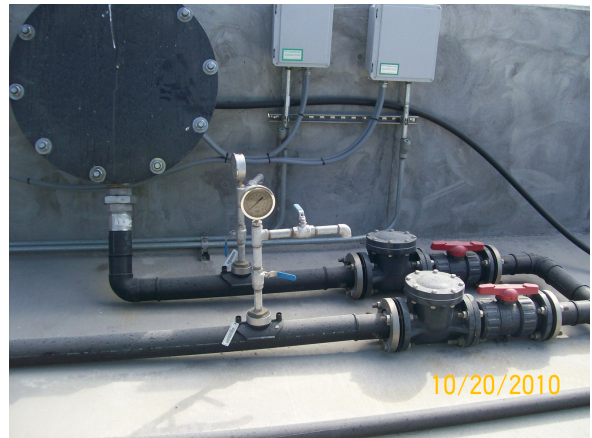
Leachate Pumpout System

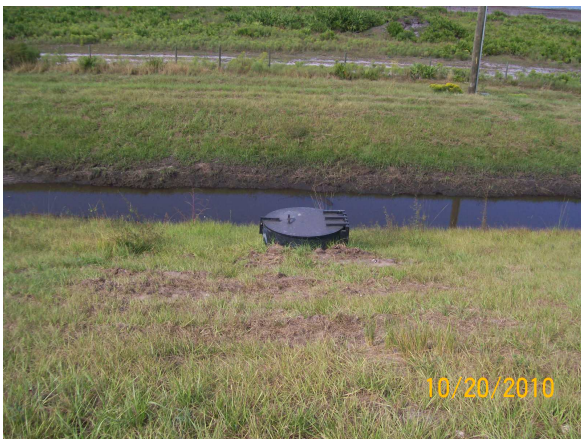
Leachate TransmissionLine Manhole

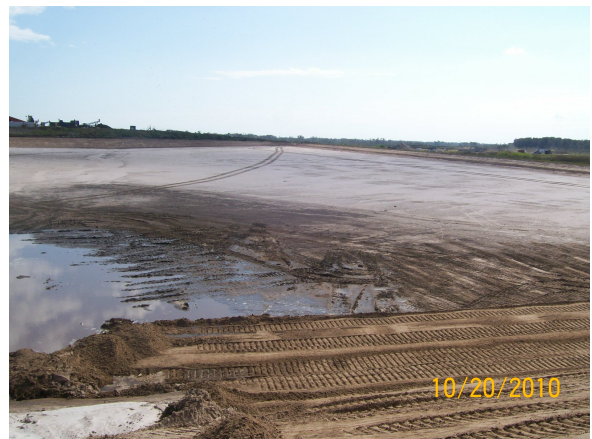
Cell 7 looking in SE Direction

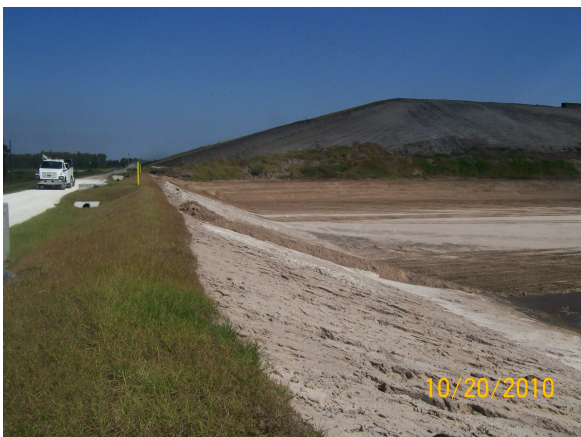
Cell 7 w/ Limits of Liner Marker

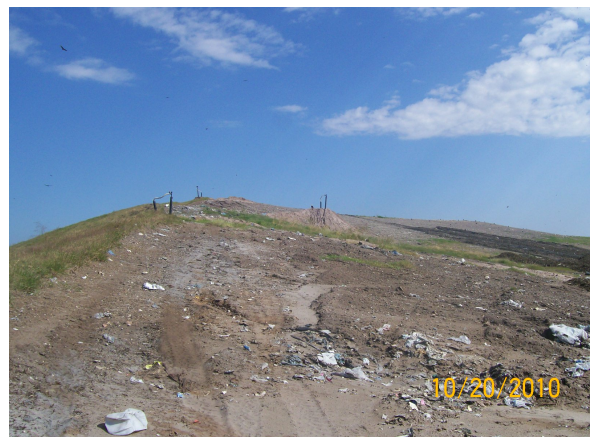
Gas Wells - Sequence 3A

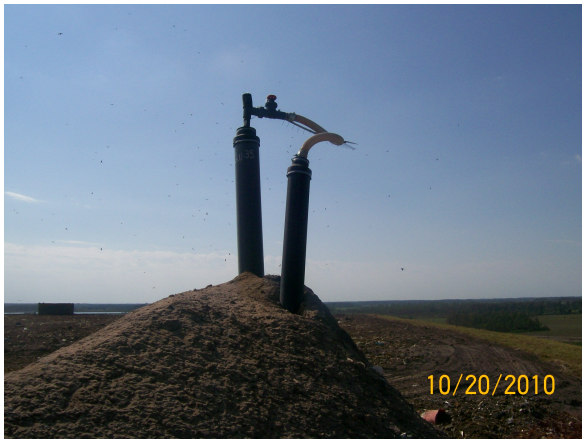
GW-35 Installed - Sequence 3A
