December 2010 Landfill Fire Mitigation Summary Report Trail Ridge Landfill

December 22, 2010
File No. 09209058.02

**December 2010 Landfill Fire Mitigation Summary Report
Trail Ridge Landfill**

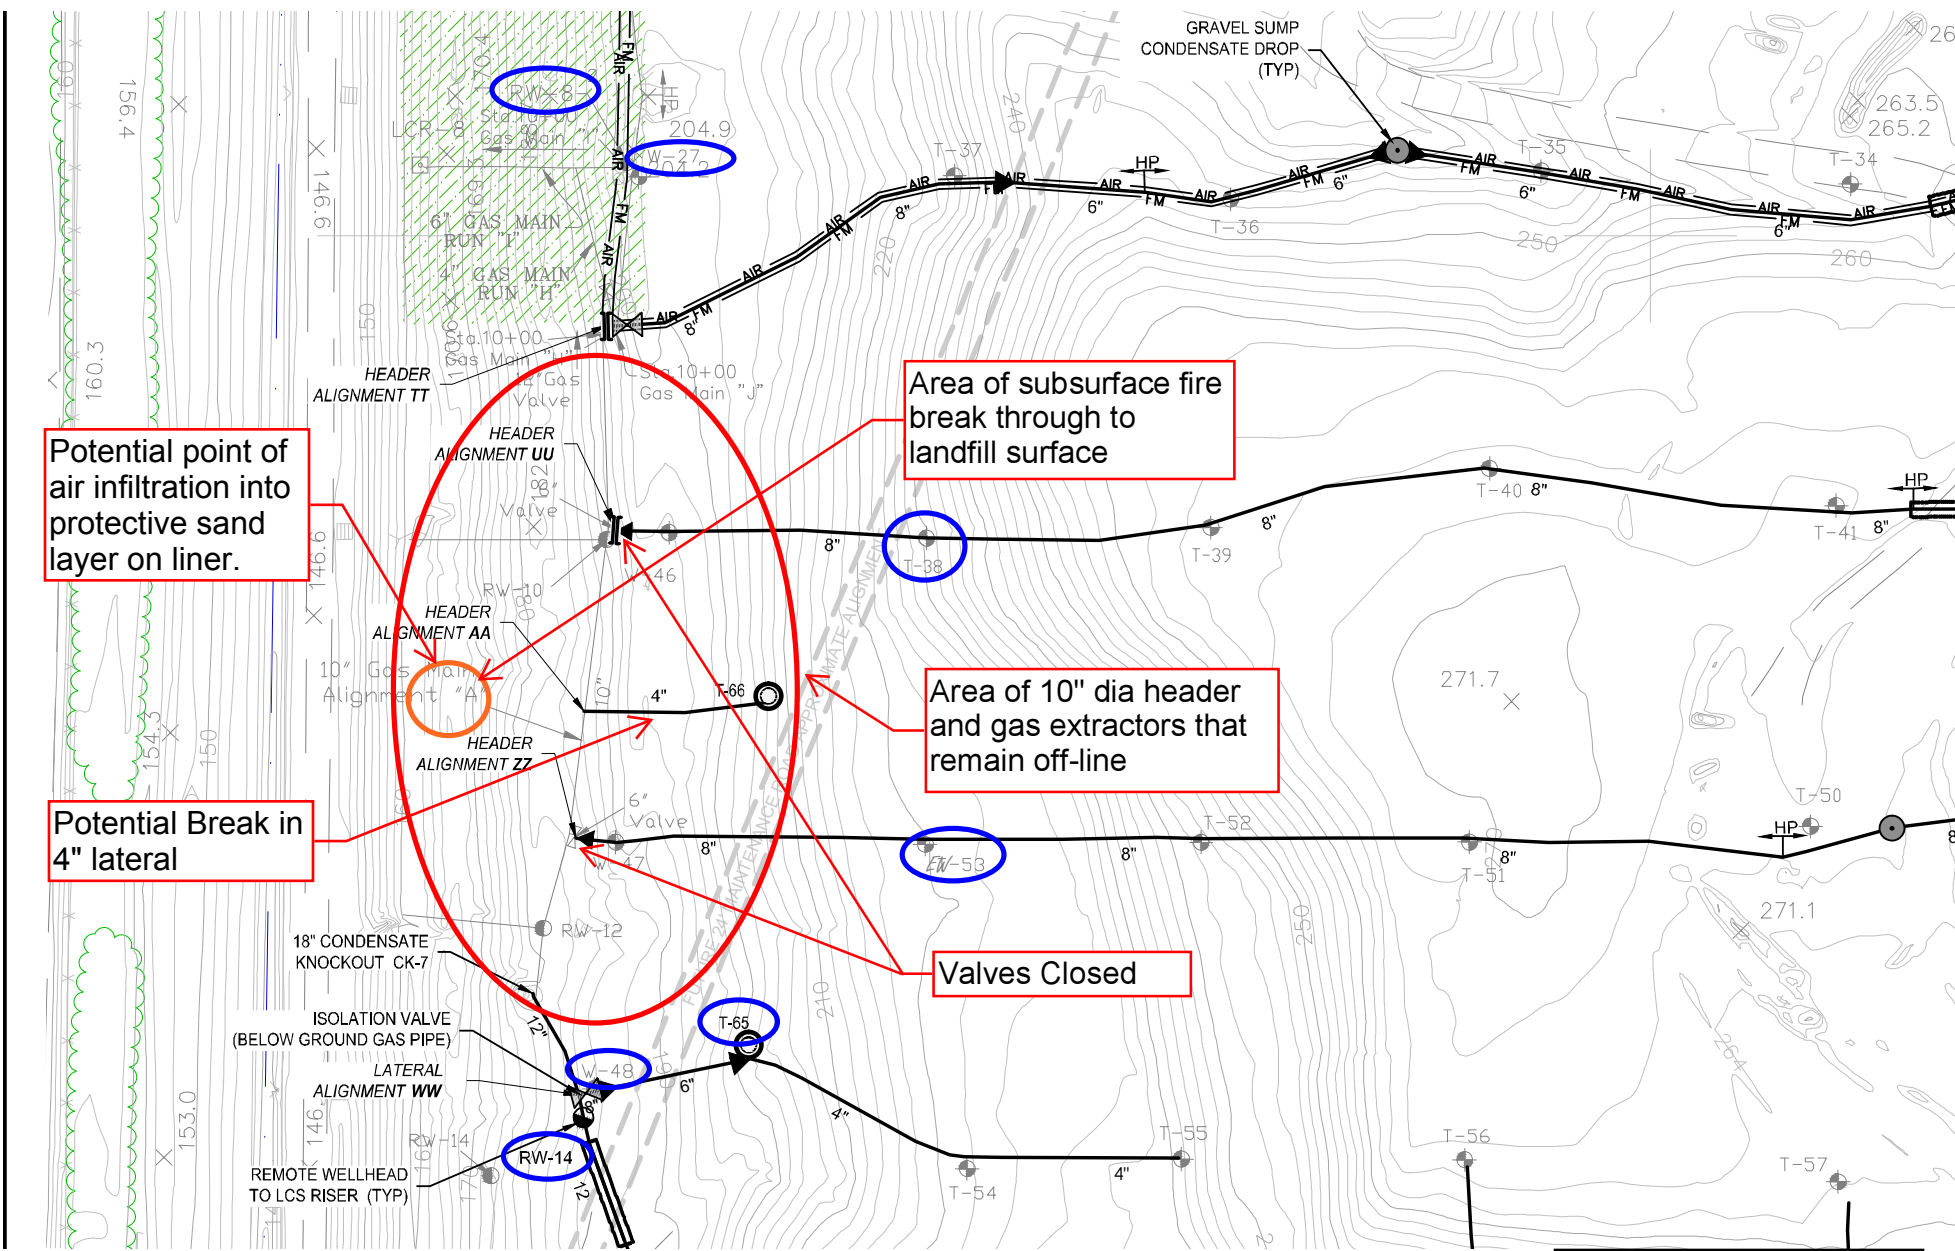
Potential point of air infiltration into protective sand layer on liner.

Area of subsurface fire break through to landfill surface

Area of 10" dia header and gas extractors that remain off-line

Potential Break in 4" lateral

Valves Closed

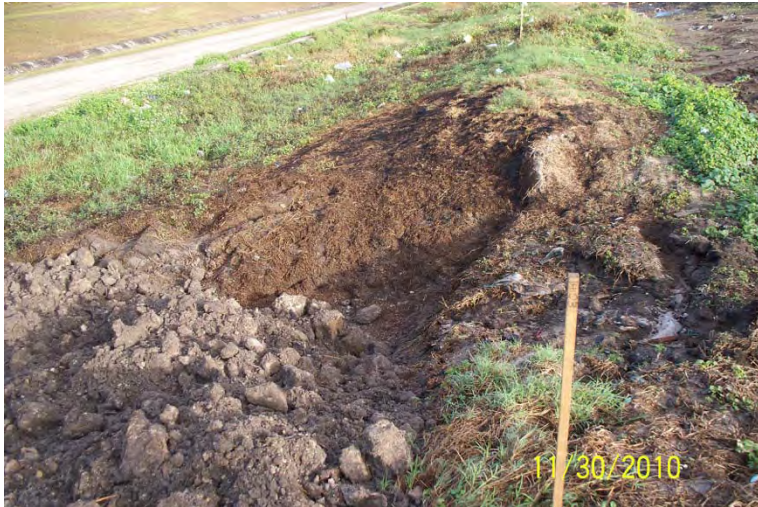
11/30/2010
Location of subsurface fire
100_0567.JPG

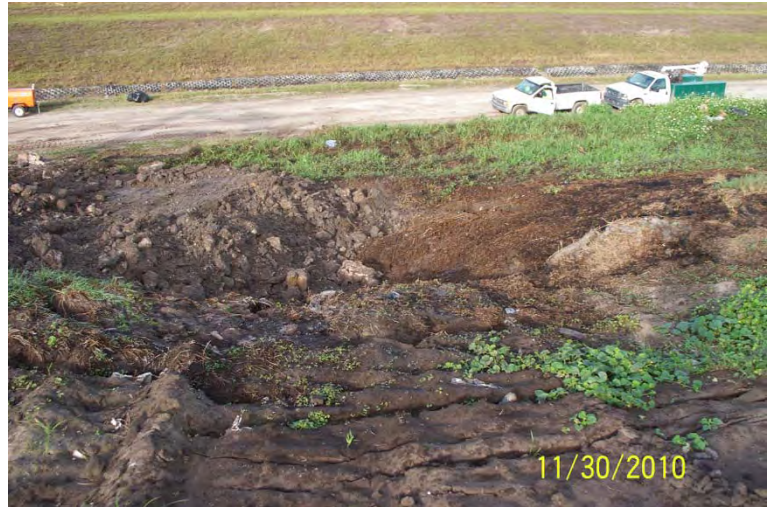
11/30/2010
Subsidence @ location of subsurface fire
100_0568.JPG

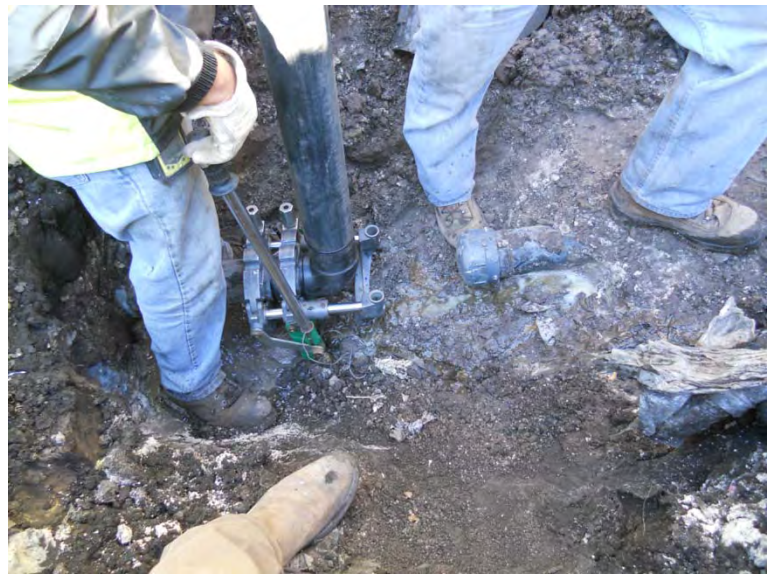
The source of the fire has been determined to be a compromised lateral gas collection pipe. The damaged lateral provided a short-circuit path for air to be drawn through the cover soil and into the waste mass. The short-circuiting air resulted in the waste over-heating and combusting.

12/7/2010
Cutting, capping the lateral
DSCN0001.JPG

- The lateral was then identified as compromised and was therefore cut and abandoned with a butt cap fused to lateral segment that will remain active.

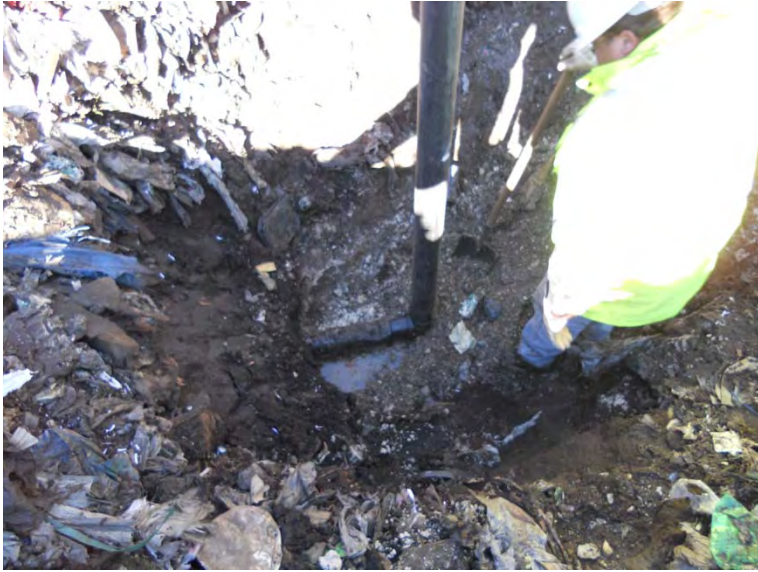
12/7/2010
Installing the 90' replacement lateral and abandoning the compromised lateral
DSCN0002.JPG

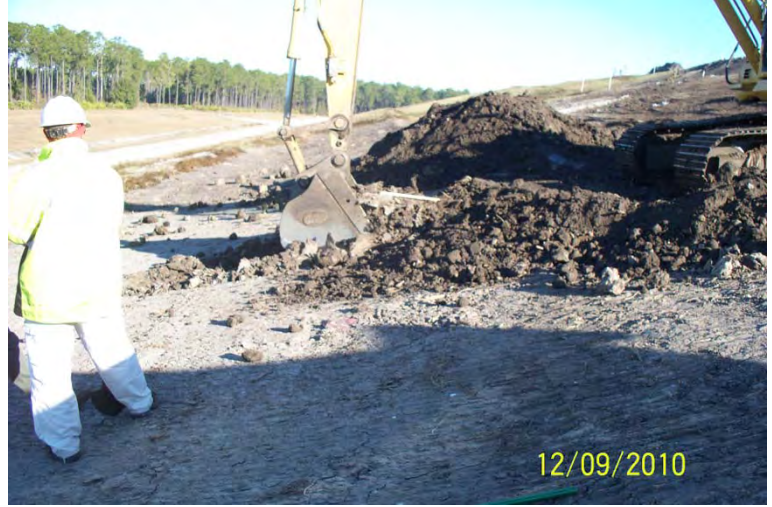
12/9/2010
Excavating to determine the condition of the bottom liner
100_0570.JPG

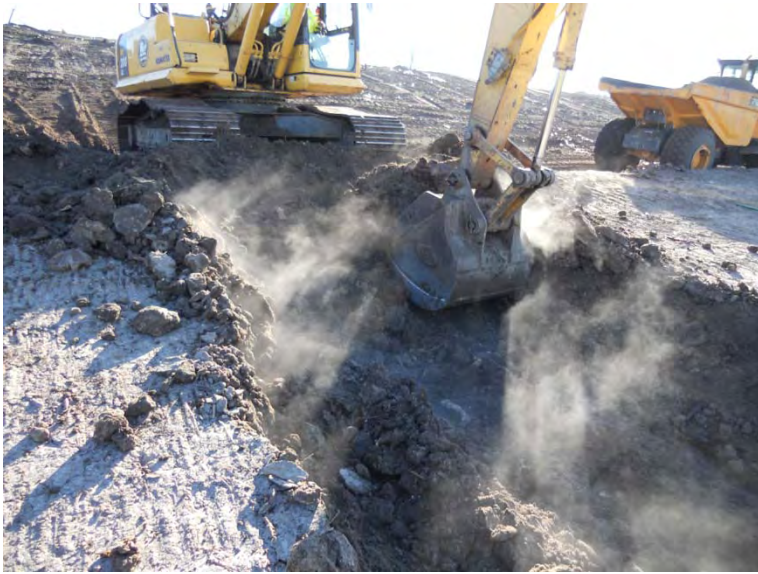
12/9/2010
Excavation to determine the condition of bottom liner being performed
DSCN0004.JPG

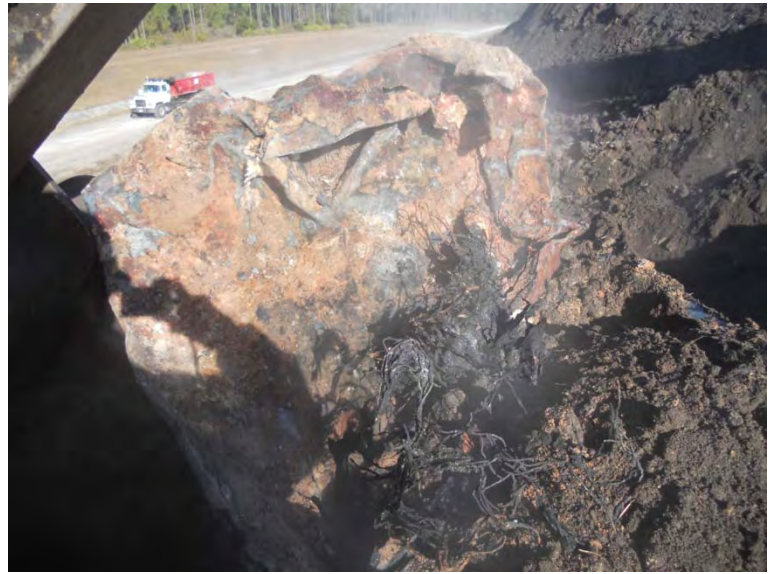
12/9/2010
Charred, burnt waste excavated from location of subsurface fire
DSCN0010.JPG

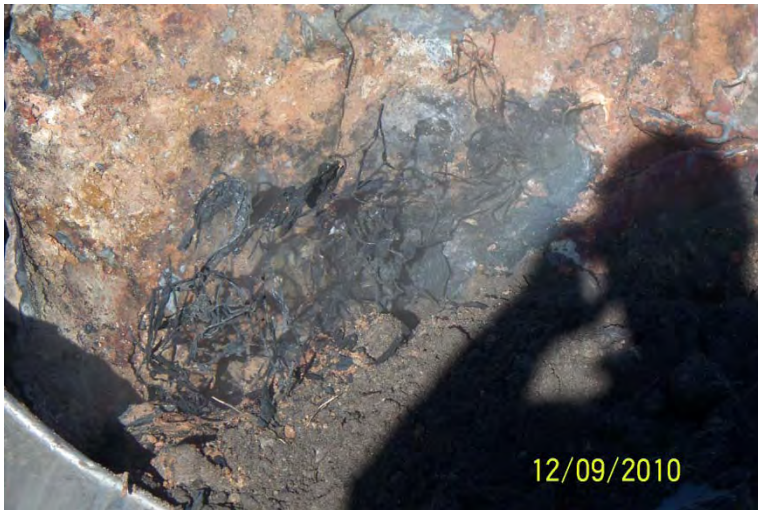
12/9/2010
Charred waste excavated at location of subsurface fire
100_0578.JPG

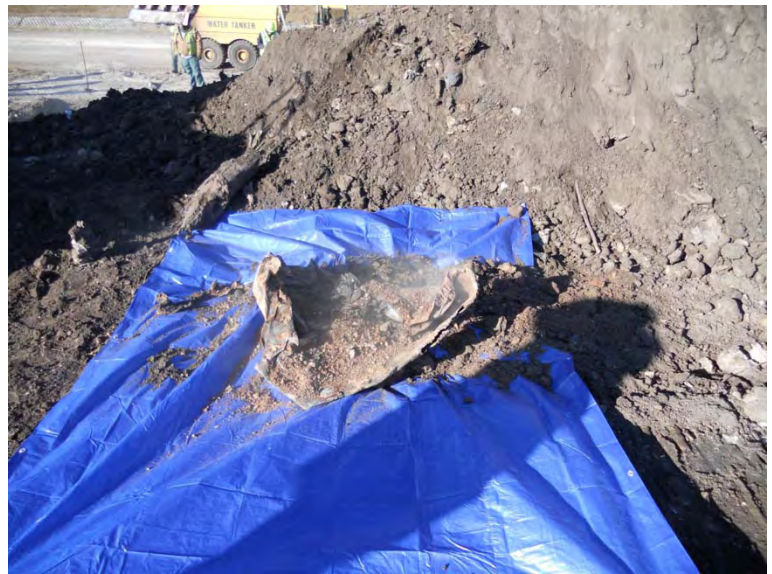
12/9/2010
Excavated waste placed on tarpaulin for identification
DSCN0011.JPG

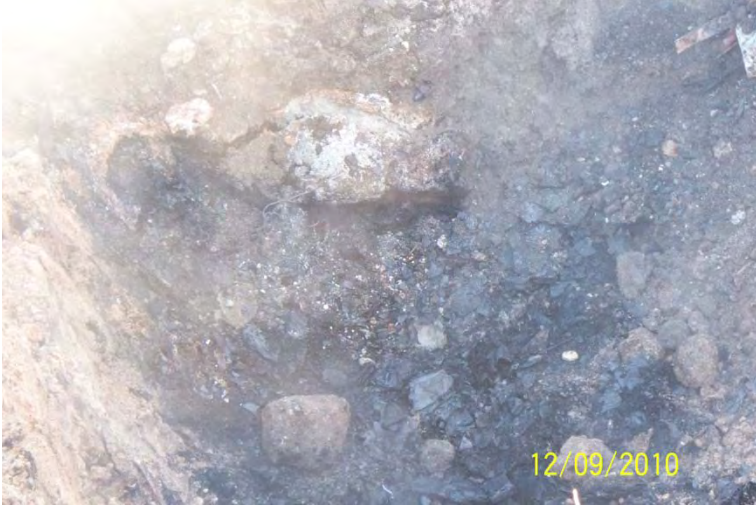
12/9/2010
Charred and burnt waste and ash in excavation
100_0579.JPG

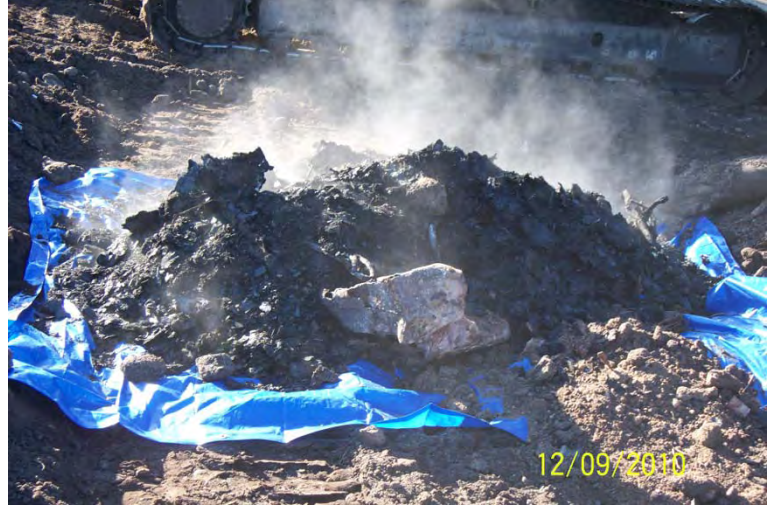
12/9/2010
Burnt waste placed on tarpaulin for identification
100_0580.JPG

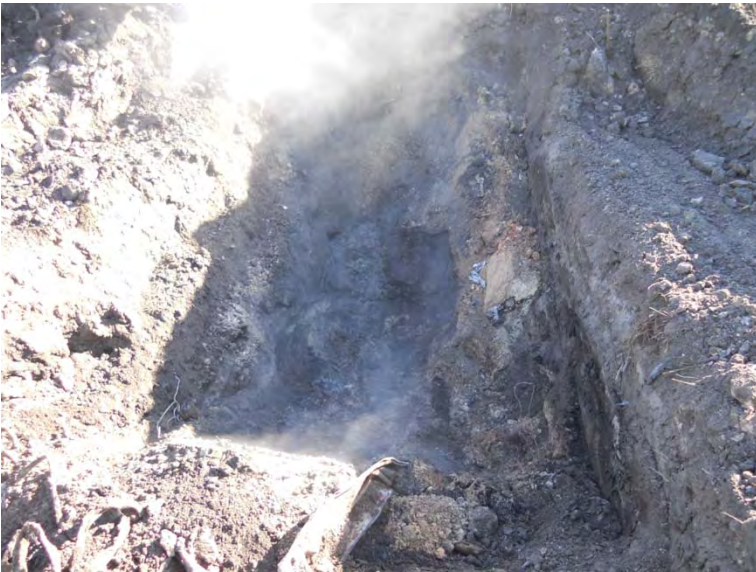
12/9/2010
Protective sand layer exposed
DSCN0017.JPG

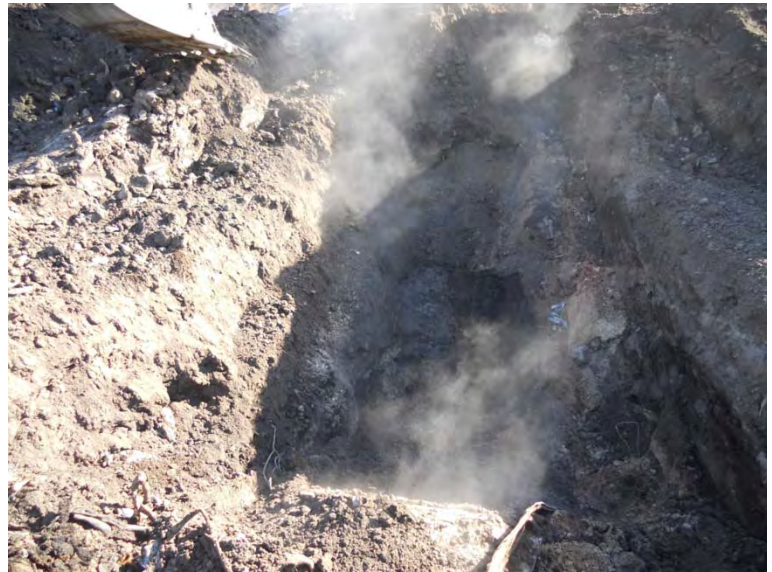
- Visual inspection of the excavated materials yielded approximately 7 feet of clayey soils with charred materials ranging from 8 to 10 feet below ground surface. The subsequent 6 inches of unburned solid waste, and finally the top of the 2 feet of protective sand layer displayed no signs of charring, melting, or other signs of exposure to high temperatures associated with a subsurface fire. Therefore, it was determined that the liner below was unlikely damaged by the fire.

12/9/2010
Exposed sand layer; little sign of being affected by high combustion temps
DSCN0018.JPG

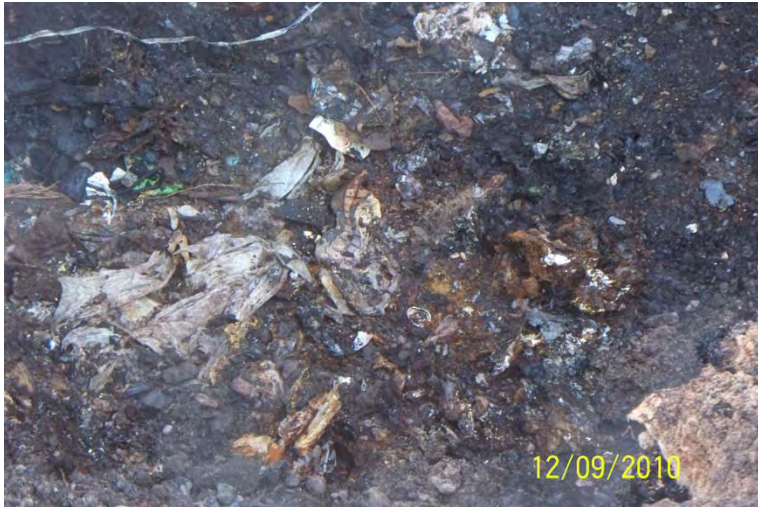
12/9/2010
Unburned waste in the area of the subsurface fire
100_0582.JPG

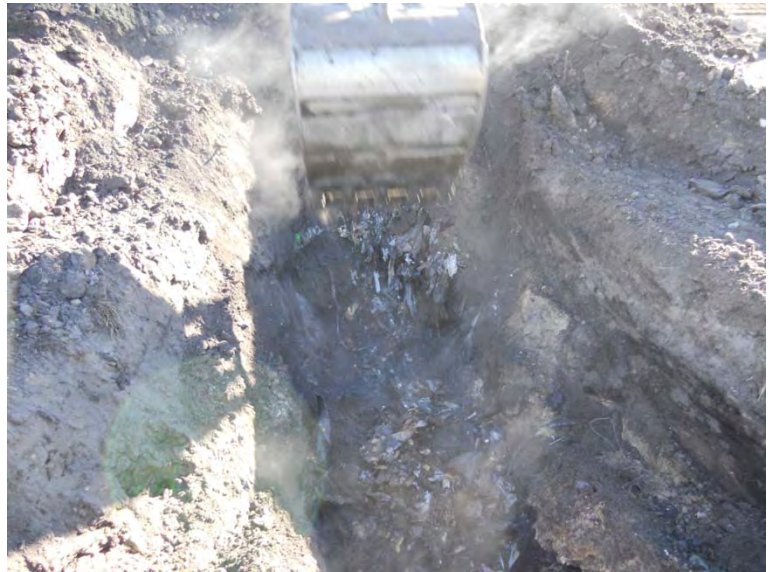
12/9/2010
Unburned / unaffected waste being excavated
DSCN0023.JPG

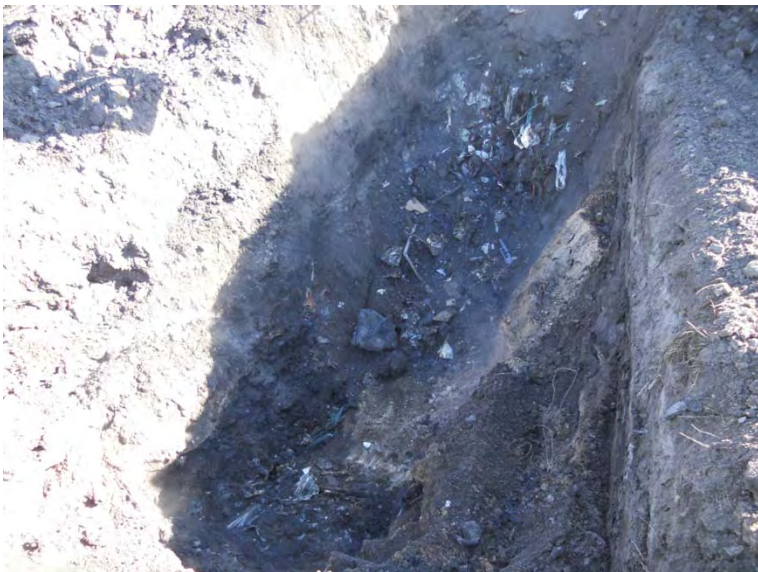
12/9/2010
Unburned waste below
DSCN0024.JPG

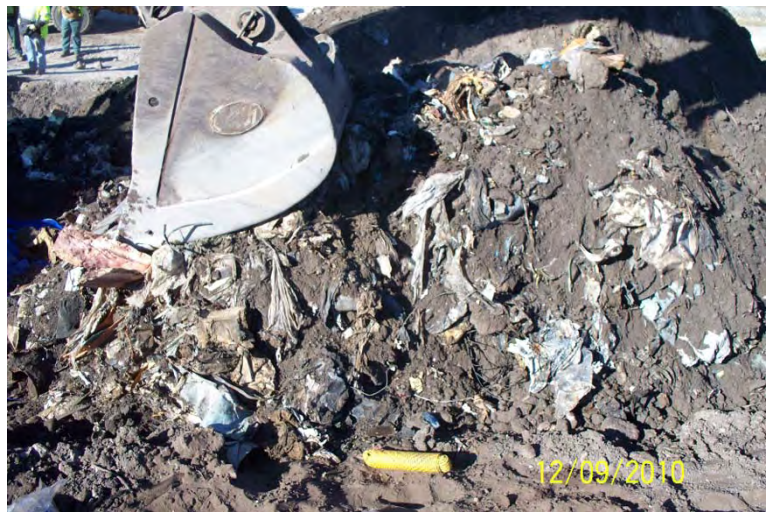
12/9/2010
Unburned waste removed from excavation
100_0585.JPG

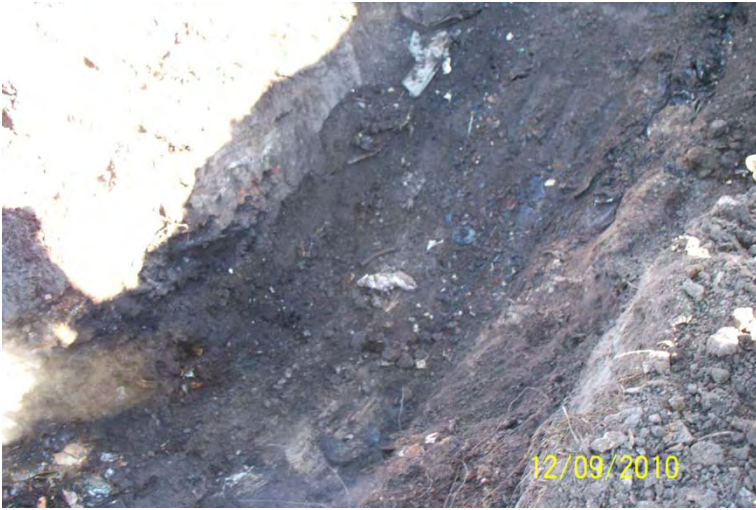
12/9/2010
Protective san layer exposed; no sign of damage apparent.
100_0586.JPG
