RE: Response to FDEP September 18, 2015 - Request for Additional Information Water Recovery, LLC Used Oil Operating Permit Renewal EPA ID No. FLR 000 069 062; Used Oil Permit No. 79677-HO-12

#### Item #1. Copies of tank inspection reports are attached in files named:

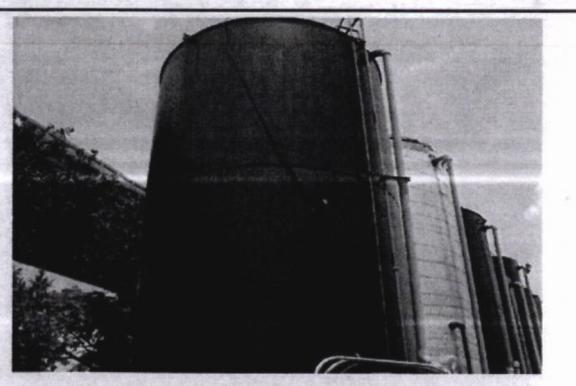
External Examination		
No issues.		
Internal Examination		
Shell has early stages of corrosion with mi	nimal metal loss.	
Floor has random areas of corrosion conce	entrated near floor to shell area. Cor	rosion is approximately 1" to 3"
in diameter with a maximum measured de	epth of 0.100"	• •

1P Tank - External Shell Photo

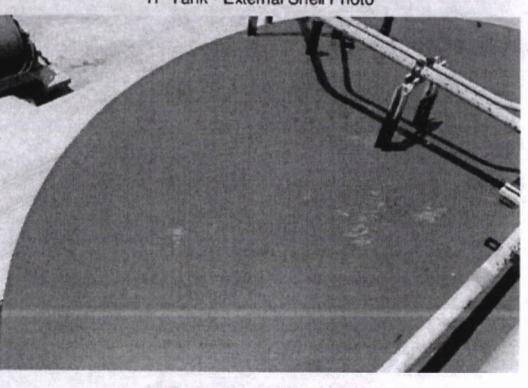
1P Tank - External Roof Photo

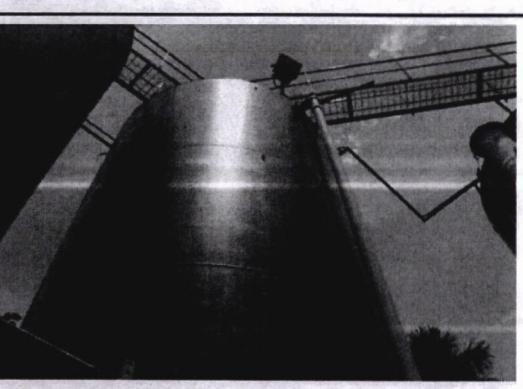
9P Tank - External Shell Photo

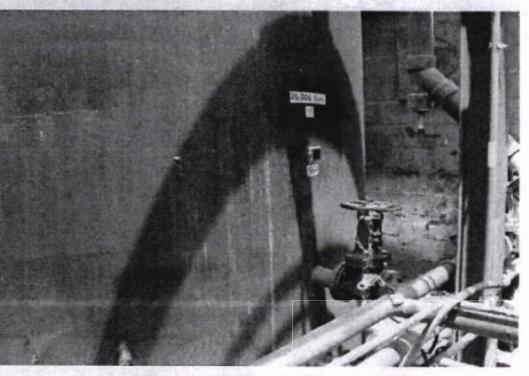
9P Tank - Additional External Shell Photo

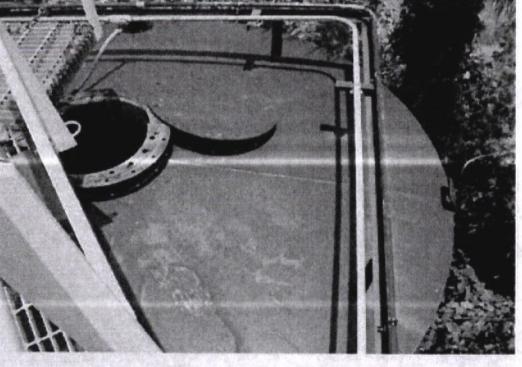
9P Tank - External Roof Photo

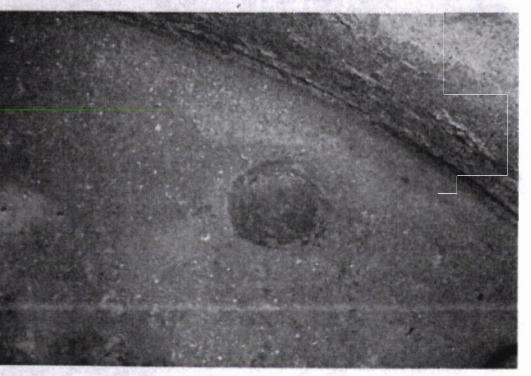
9P Tank - Internal Floor Patch Plate Photo

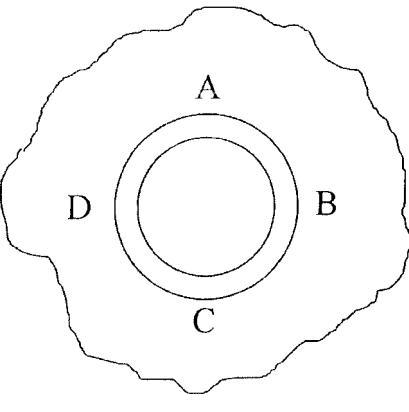
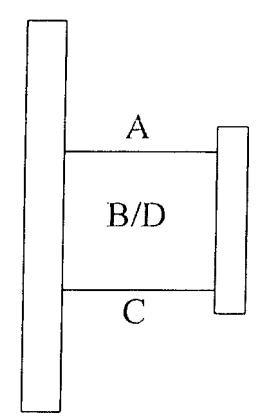
#### TANK 3P MANWAY/NOZZLE UT READINGS WATER RECOVERY, INC.

#### SHELL VIEW

#### NECK VIEW
