## HAZARDOUS WASTE INSPECTION REPORT

**FACILITY NAME:** Veolia Environmental Services Technical Solutions LLC (Veolia)

**ADDRESS:** 342 Marpan Lane, Tallahassee, Florida, 32305

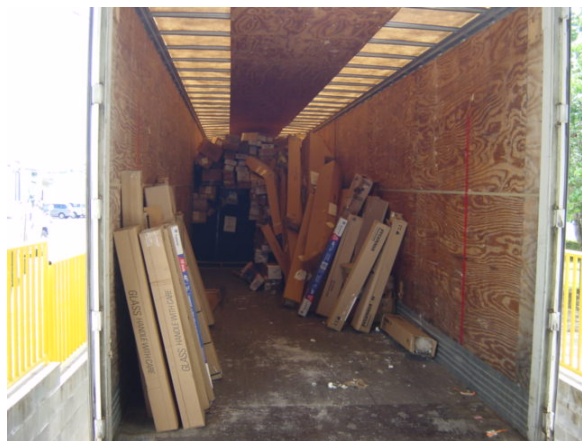
Picture A

Trailers are backed up to one of two loading docks (Picture A and B). Hazardous waste is unloaded first and universal waste is moved to the transfer area to wait in line behind shipments received earlier. Compliance with storage limits is maintained by scheduling. All incoming material is profiled and arrival dates are scheduled to prevent exceeding Transfer Area storage limits.

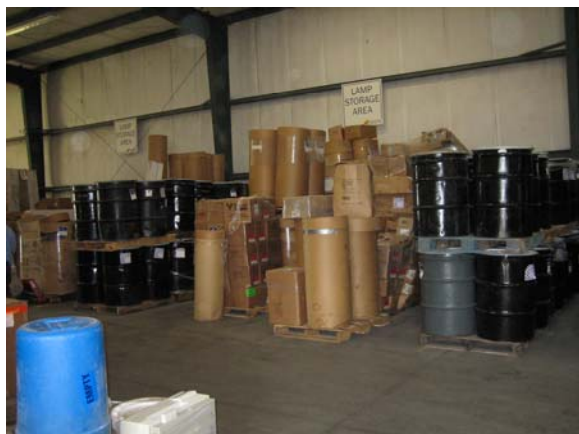
Picture C

At the time of this inspection, 38 pallets of fluorescent lamps and 4 pallets of HID lamps were staged at the south end of the building (Number of lamps per pallet vary significantly). Ongoing activities at the south end of the building included HID and fluorescent lamp processing. HID lamps were being processed by removal of the inner tubes and fluorescent lamps were being processed by removal of plastic jackets in preparation for crushing (Pictures C - F). Two mechanized devices designed to process HID lamps and included in the permit application currently under review were on site. Veolia intends to use one and keep the other as a backup pending permit approval.

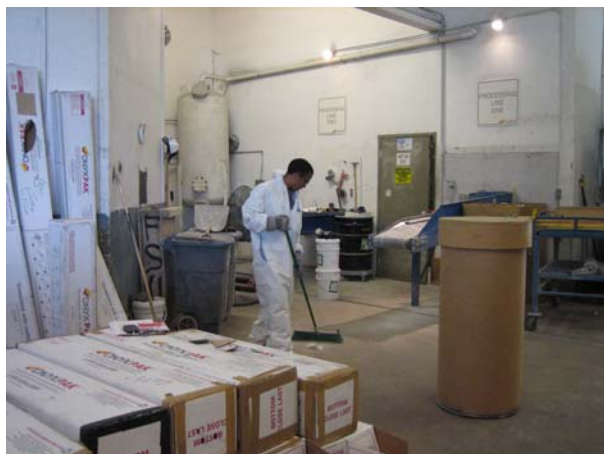
Picture G

Fluorescent lamps were staged for crushing to separate glass and metal end caps from phosphor powder near the center of the building. One of the two lines (conveyor belts) which feed the processing equipment, contained within a separate room, was operating at the time of this inspection. The operator swept up lamp components that spilled onto the floor and returned them to the conveyor belt as we watched (see Pictures G and H).

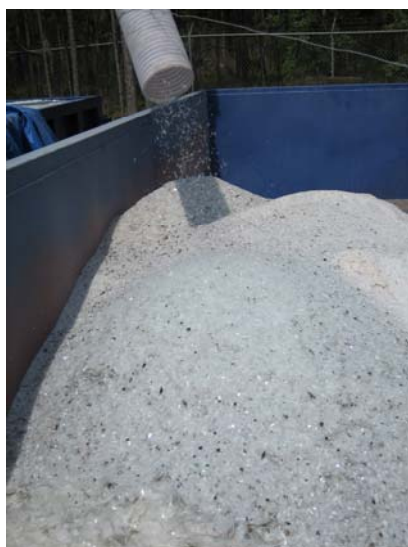
Picture I

The area to the north of the building is paved and used for storage of scrap metal, glass, wooden pallets, and maintenance equipment (see Pictures I and J). There is a utility building to the south of the building used for storage of empty containers.
