## HAZARDOUS WASTE INSPECTION REPORT

**FACILITY NAME:** Safety-Kleen Systems, Inc. **DEP/EPA ID #:** FLD 982 133 159

**STREET ADDRESS:** 4426 Entrepot Boulevard, Tallahassee, Florida 32310

**COUNTY:** Leon **PHONE:** (850) 576-9764 **DATE:** December 7, 2006 **TIME:** 1:00 P.M.

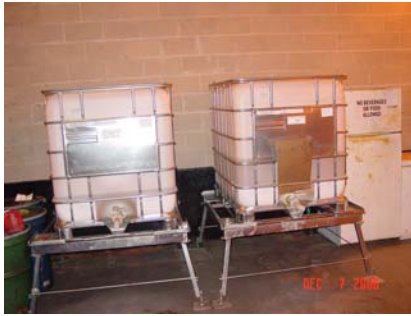
Also in this area were two 250-gallon totes that held product. Mr. Hinsey informed me that the aqueous parts washing solvents are now being mixed in the receiving area. A further inspection revealed (16) 30-gallon drums of aqueous parts washing solvent that were waiting to be vacuumed out. Mr. Hinsey indicated that they were just pulled off the truck and have not been processed. The drums were in good condition, labeled and closed. These drums were non-regulated aqueous parts washer solvent.

Aqueous parts washer totes   Aqueous parts washer drums   Load and unload area

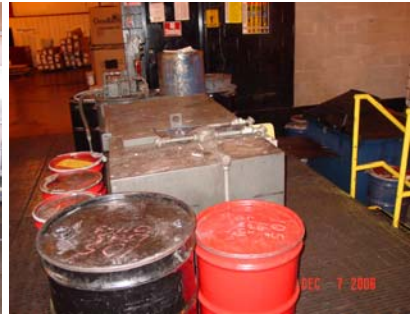
The area was inspected mid-afternoon when no loading/unloading activity was underway. The loading and unloading area was well maintained, located with easy access to the emergency and safety equipment installed in this area. In this area were twelve 30-gallon empty drums that were waiting to be filled with solvent.

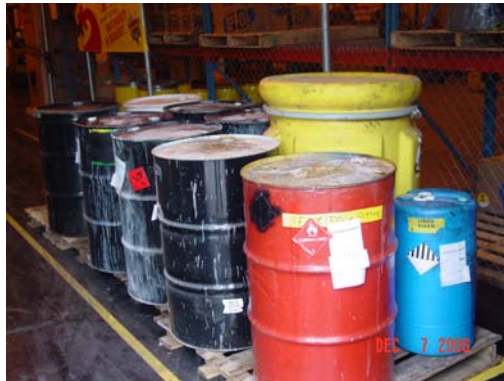
This area contained nine 55-gallon drums of various waste streams which includes paint waste, acetone, waste fixer solution. The oldest date noted on any container was December 5, 2006. This area was well kept with no discrepancies noted. All containers were in good physical condition, closed, and labeled. The daily inspection record for the 10-Day Transfer Station was reviewed and appropriate documentation was available during the inspection. Adequate aisle space was available to inspect each container.

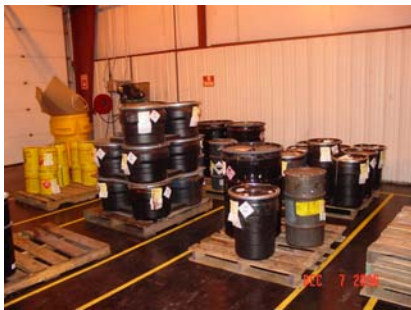
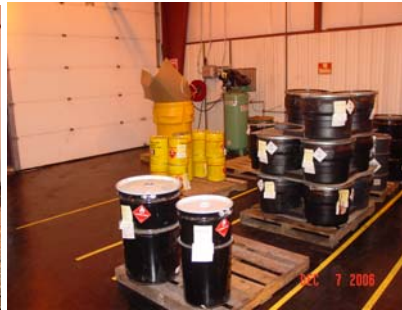
The TSD Storage Area was well organized and aisle space maintained to allow inspection of each container. All containers were in good physical condition, closed, and labeled. Three random containers were selected (Container #'s 125, 826 & 030) and

a computer and hardcopy records check conducted to verify its origin, transport history and storage inventory. No discrepancies were noted. The containers identified above when referenced against manifest revealed that these containers were identified on manifest #'s 170534, 253522 & 230049 respectively. A visual inventory of drums versus computer record inventory for the TSD Storage Area was conducted by Mr. Hinsey and Terry Wells with no discrepancies noted. Also located in this area was Universal Waste that was being managed properly with no discrepancies identified.

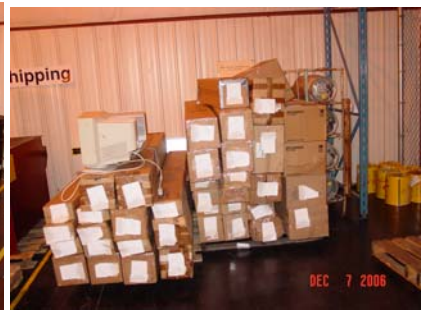
Universal Waste Storage

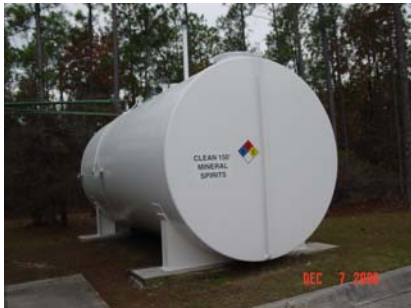
The area was well maintained with no evidence of tank leakage noted. The load/unload pipe manifold area showed no evidence of leakage or spillage from the piping and equipage in this area. The accumulation drum located in this area was closed, labeled and in good condition.

150 Premium product

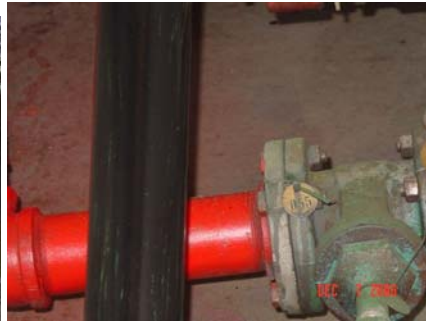
Waste solvent tank valve

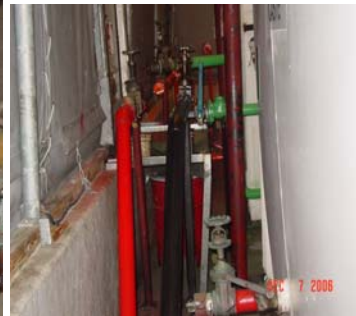
The facility's 40 CFR 264 Subpart BB compliance procedures for the waste mineral spirits solvent management system were in place and being implemented during this inspection. The waste mineral spirits solvent management system equipage (piping, valves, flanges, pumps, etc) was color coated to distinguish it readily from the other equipage in the facility. Red piping is for dirty solvent, orange piping represents Safety Kleen's 105° solvent and green piping represents 150° solvent. This coloring scheme allows the daily inspector of the system to track the equipage and inspect for liquid leaks. The tank system consists of two 15,000-gallon tanks and one 11,400-gallon tank. All tanks are double-walled. Brass numbering tags are used to identify valves and flanges associated with the waste solvent tank system. The daily inspection logs were reviewed for the previous year with no discrepancies noted. The tanks are in the process of being repainted.

Waste solvent equipage

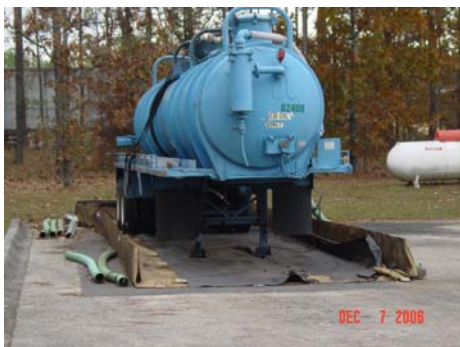
The outside storage/laydown area, driveways, vehicle parking lot, solid waste dumpsters and the perimeter fence/lawn areas were inspected with no discrepancies noted. All other security and safety equipment was installed in accordance with the permit and operational. A tanker trailer had been parked within a temporary secondary containment at the southwest corner of the rear asphalt parking area. This tanker will be used for on-site consolidation of wastes collected daily in the vacuum truck and then transfer and stored on-site in the tank trailer until a full 5,000-gallon load makes it necessary for transport to the follow-on processor. Also in this area were four "Used Oil Filter" dumpsters that were properly labeled and closed. Mr. Hinsey indicated that all collected used oil filters are sent to a processing facility called Oil Filter Recyclers located in Illinois. There were also several empty containers that Safety Kleen utilizes during its daily operations located outside the facility. Mr. Hinsey then informed me that the budget included money for the repaving of the parking and storage area for the upcoming year.

5,000-gallon tank trailer

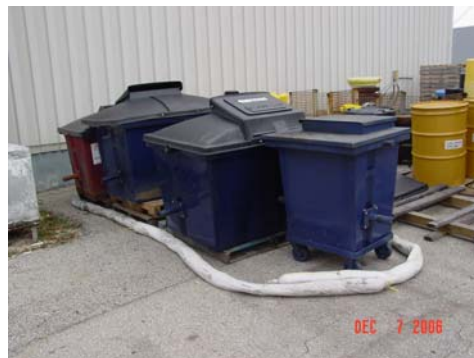
"Used Oil Filter" dumpsters
