Florida Department of
Environmental Protection
Hazardous Waste Inspection Report

Facility Name: Veolia ES Technical Solutions LLC
On-Site Inspection Start Date: 03/16/2009 **On-Site Inspection End Date:** 03/16/2009
ME ID#: 6716 **EPA ID#:** FL0000207449
Facility Street Address: 342 Marpan Ln, Tallahassee, Florida 32305-0904
Contact Mailing Address: 342 Marpan Ln, Tallahassee, Florida 32305-0904
County Name: Leon **Contact Phone:** (850) 877-8299

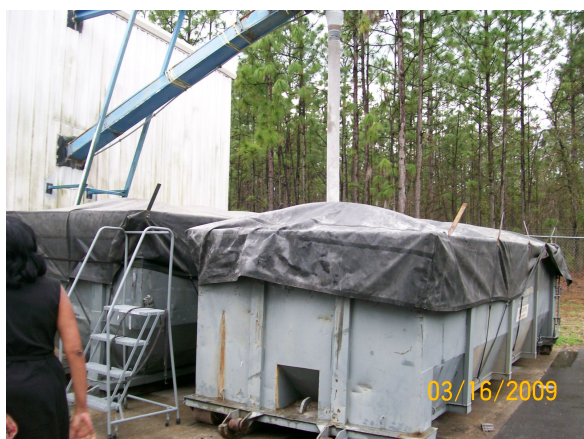
An outside, asphalt paved area is used for collection and storage of processed glass in two 20 yard roll-offs, paper-product and wood pallet recycling, UW Transporter bulk delivery drop off (FEDEX) and various empty container storage. At the north end of this paved area, there are two container trailers for storage of equipment, replacement parts and empty non-hazardous containers.

Glass Roll-offs

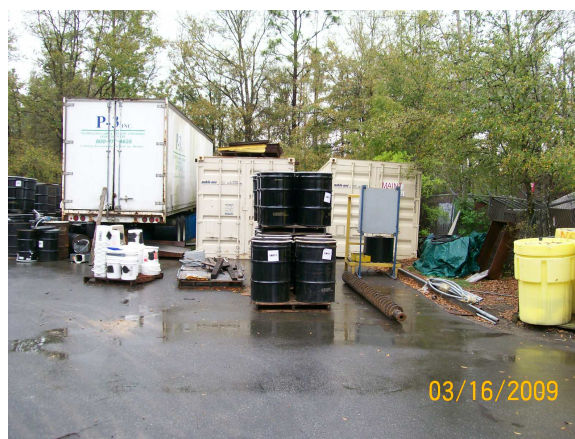
Equip. Storage & Empty Containers

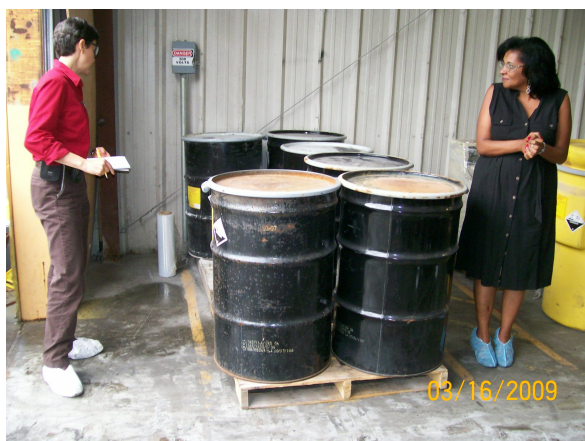
Mercury containing phosphor powder is collected in 55-gallon drums and staged in the northeast end of the building prior to processing in the facility's vacuum distiller. The area is permitted for storage of 15 pallets (60 drums) maximum; double stacked is OK. Inbound manifested hazardous waste, prior to processing, and outbound hazardous waste, is accumulated in the 90 Day storage area located in the northwest portion of the building. This area is permitted for a maximum storage capacity of 24 drums.

Drums of Phospor Powder

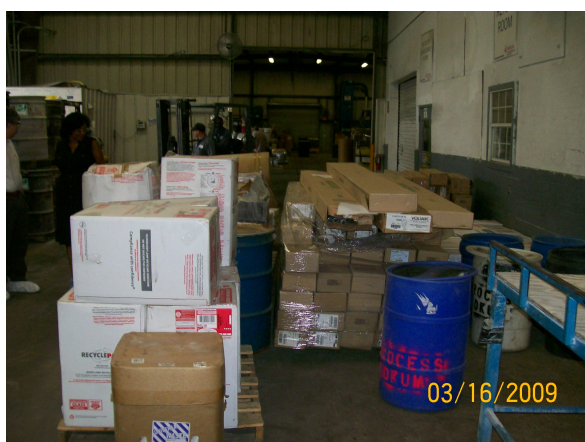
Fluorescent lamps are staged immediately adjacent to the lamp processing feed belts. Fluorescent lamps are hand fed into the lamp processing room via a conveyor belt. This room, located in the northwest corner of the facility, is designed to process approximately 200,000 feet of lamp equivalents per 8 hour shift. Lamps are crushed with a drum crusher and dry separated into glass, aluminum and phosphor powder. Phosphor powder is collected by a bag tower and accumulated in 55 gallon drums.

Fluorescent Lamps

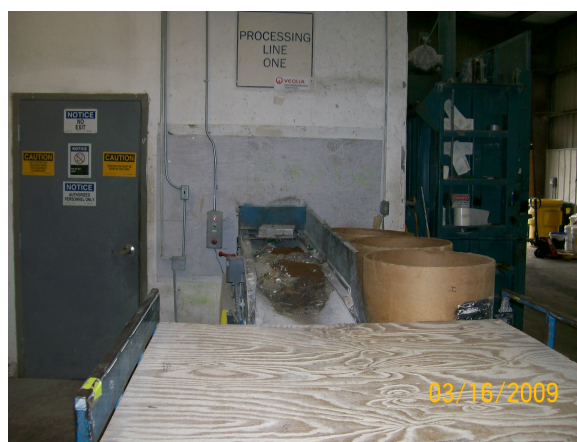
Conveyor Belt

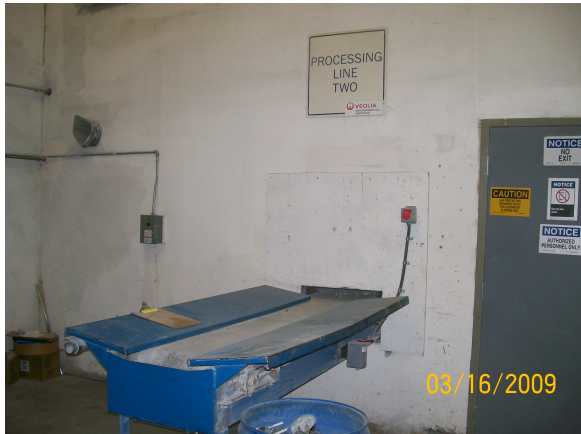
Type: Area Of Concern

Rule: 62-737.800(10)

Explanation: Veolia TSD is considering modifications to "Processing Line Two" for the lamp processing room.

Processing Line Two

Corrective Action: Veolia needs to ensure compliance with Rule 62-730.290, F.A.C.

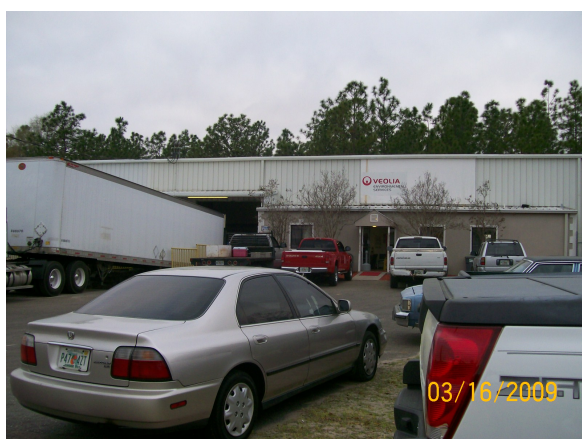
The loading and unloading area consists of two trailer dock areas for forklift transfer of materials to/from transport vehicles. Retort process residues in 55 gallon drums are accumulated in this area along the east wall prior to shipment off-site for disposal in a Class D landfill. Retorted process residuals in this area are/have been sampled to ensure effective retort processing. The Facility maintenance area is also located in this area.

Loading/Unloading Dock

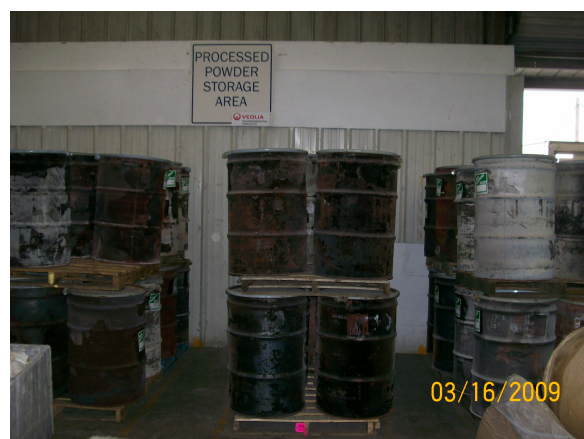
Post Retort Drums

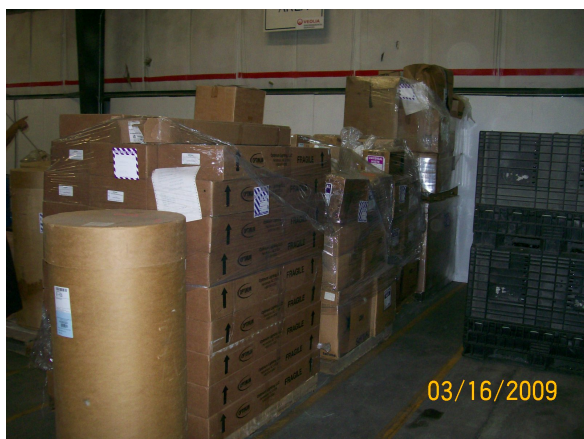
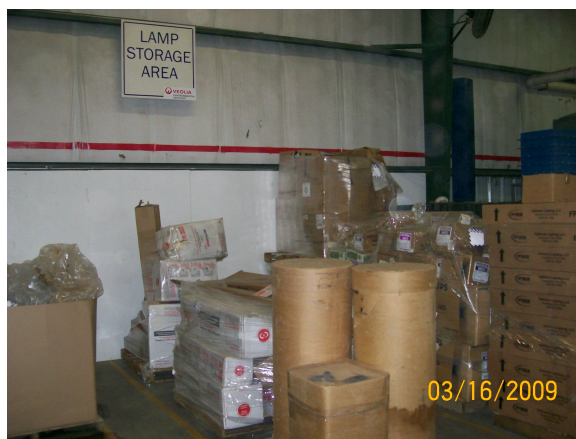
This area located on the west side in the southern portion of the building is the lamp storage area. The permitted storage dimensions are 64.5 feet long, 20 feet deep and 8 feet high for a maximum of 6,400 cubic feet of mixed fluorescent and HID lamps. This area is used for temporary storage of universal waste lamps that cannot be immediately processed. These lamps normally consist of HID lamps, U-shaped lamps and other specialty lamps that require manual processing prior to recycling/reclamation.

Inbound UW Lamps

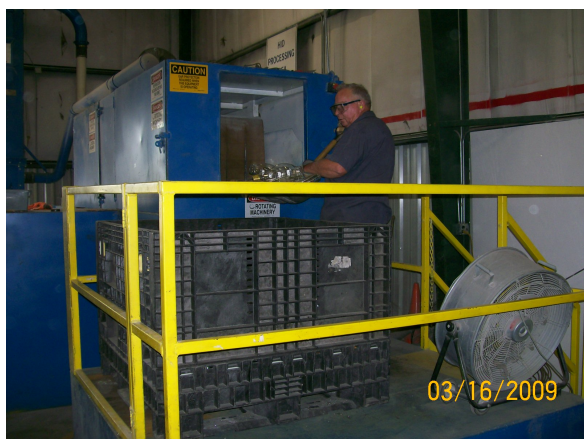
HID can be processed either by manual or automated process located at the southwestern end of the building. The automated process uses a custom built, dry separation, enclosed, negative pressure process. The system is comprised of conveyor belts, crushers, dry separation and an air emissions control system. Outer glass, metal bases and support wires are removed from the arc tubes and dropped into collection containers for recycling. Arc tubes are crushed and accumulated in 55-gallon drums for further processing in the retort room. The drums of crushed arc tubes are managed as satellite accumulation area containers and moved to the Hazardous Waste Storage Area at the north end of the building within three days.

HID Automated Process

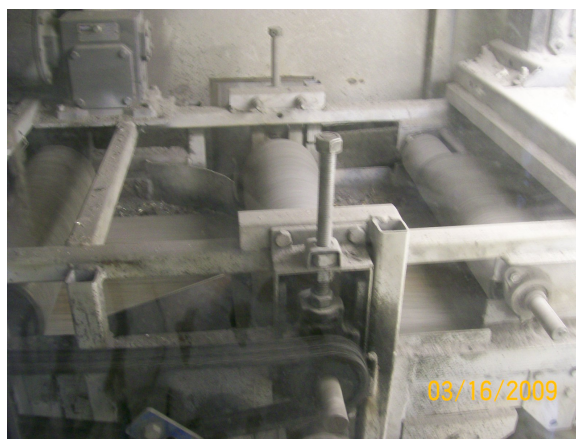
HID Arc Tubes Being Crushed

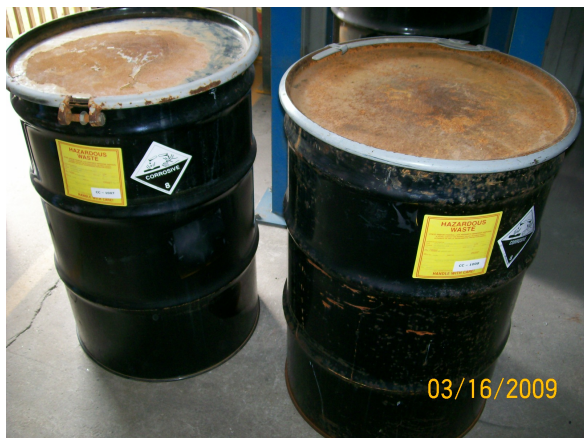
Drums of Crushed Arc Tubes

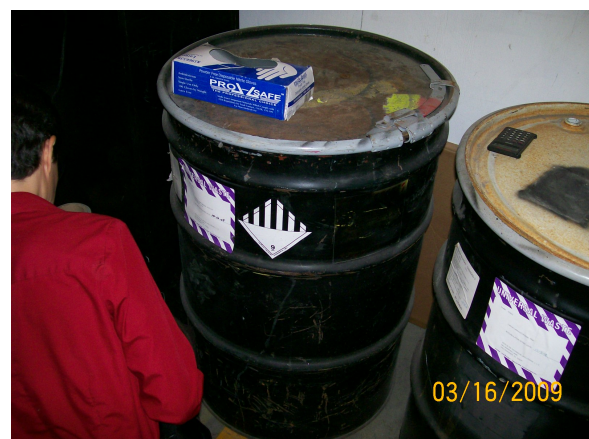
Type: Area Of Concern
 Rule: 273.35(a)
 Question Number: 30.50
 Question: Are universal wastes stored for less than one year?
 Explanation: There was one 55-gallon drum in this area labeled Universal Waste Batteries with a start accumulation date of 10-10-05.
 Corrective Action: Veolia TSD reviewed receiving records and discovered that the date was an error. The actual received date was 2008. In response to this issue, Veolia implemented a new HOUSE inspection that requires the inspector to document the oldest date in the storage areas of the plant and cannot be done by the same person two consecutive days.

Batteries Dated 2005

Close-Up of Battery Label

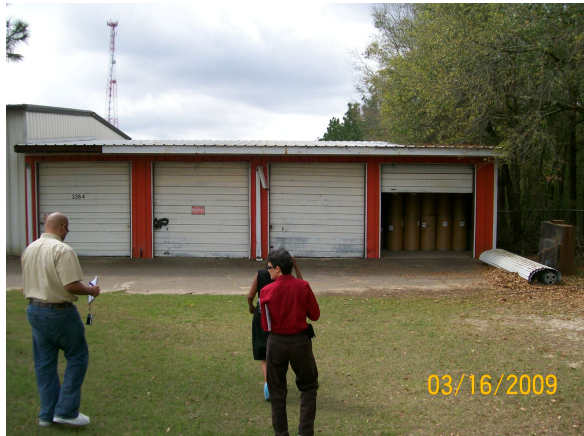
This building is immediately south of the main building and is divided into two large storage areas. The Container Storage Area is used to hold empty fiber drums and cardboard boxes. No universal or hazardous wastes are stored in this area. The second room in this building is used for additional storage of electronic recycling wastes up to a maximum of 86 Pallets (in combination with storage within the main building storage).

South Bldg / Empty Containers

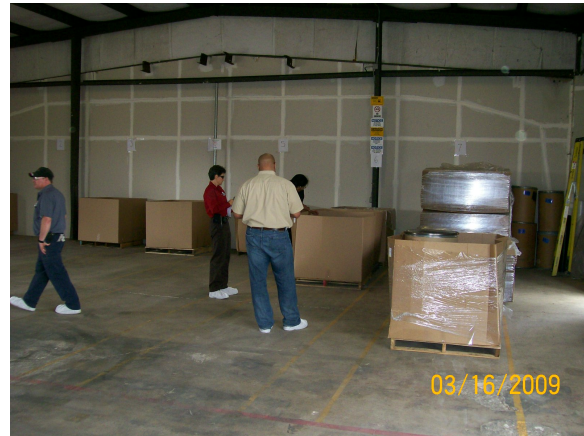
South Bldg / E-Waste
