FLORIDA DEPARTMENT OF Environmental Protection

Re: Compliance Assistance Offer
315 Newfound Harbor Dr, Merritt Island, FL 32952
ERP Site ID: 228041
Brevard County

ERP Program Inspection Report

Project Name: [Shepard Wetland Fill]

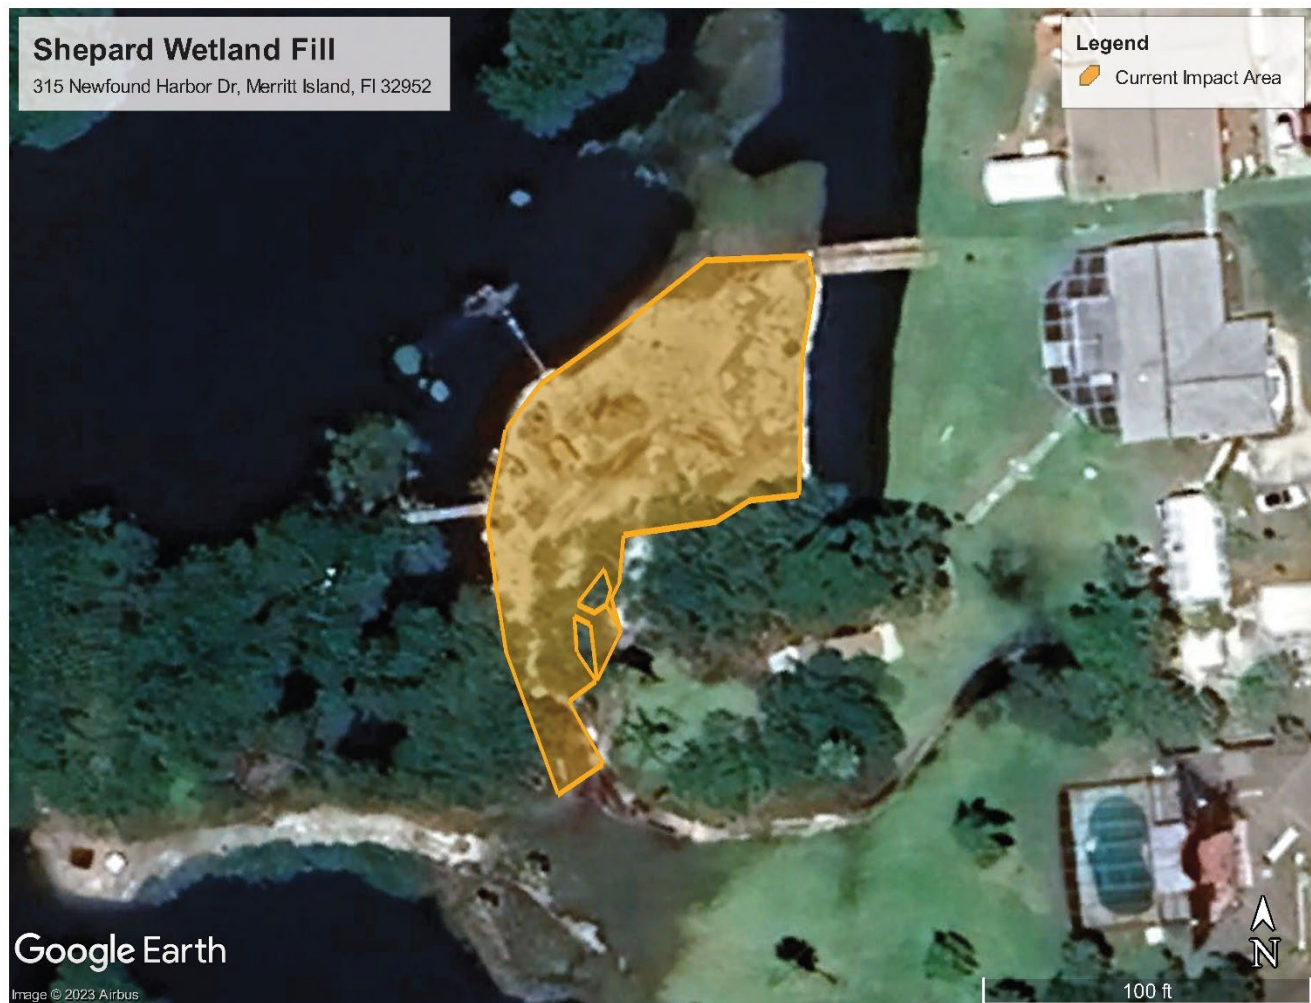
Figure One. Shown (orange polygon) is the area of fill material that was placed by the current property owners (0.18 acre). Aerial imagery is from January 2023. Area was determined using GPS points taken in the field.

- 1) Within 180 days**, Obtain an Individual Environmental Resource Permit (ERP) for the coquina rock serving as a riprap seawall along the shoreline of the peninsula, or
- 2) If permitting is denied or otherwise not obtained, within 60 days** of denial, the coquina boulders serving as riprap along the peninsula shoreline must be removed from the wetland/surface water.

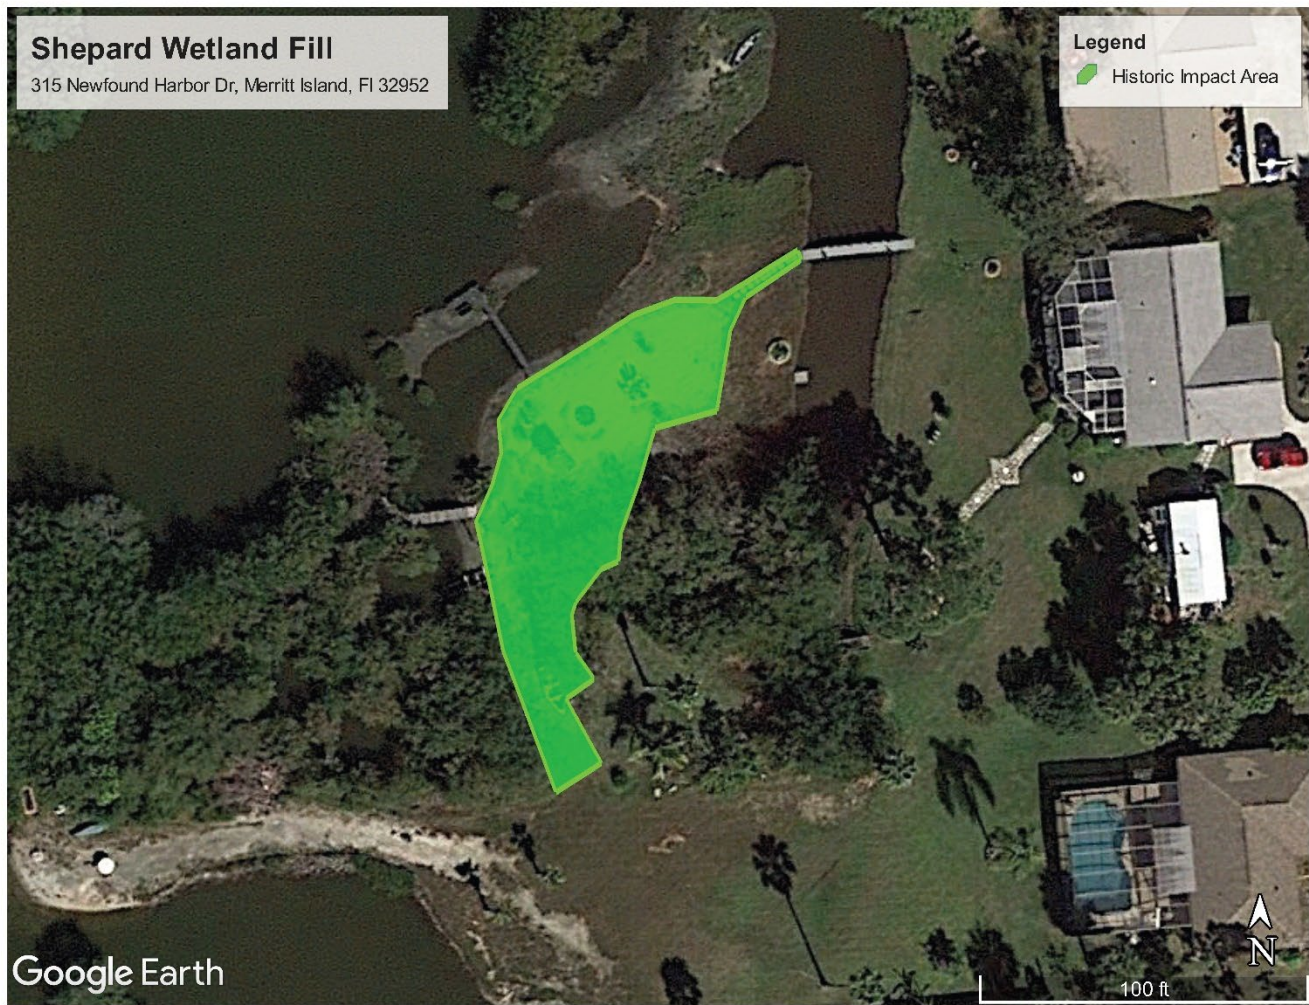
Figure Two. Shown (green polygon) is the area of fill material that was placed by the previous property owner(s) (0.12 acre). Aerial imagery is from February 2020. Wetland alteration has been maintained in similar configuration since 1994 (earliest available aerals). Area was determined using available historic aerial imagery.

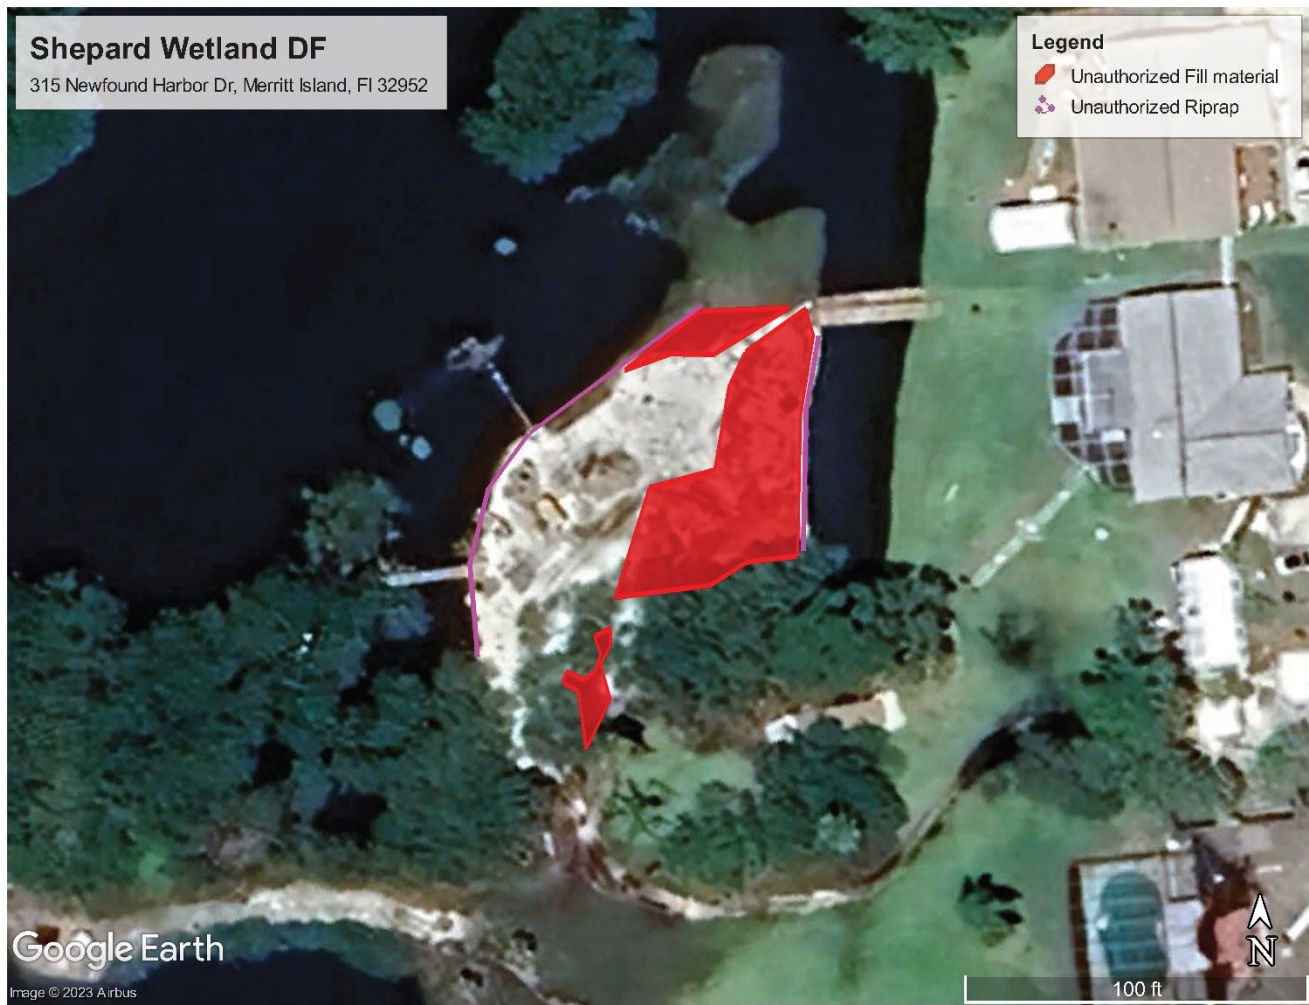
They have also placed coquina boulders along the shoreline of the peninsula, in the form of riprap, totaling approximately 195 linear feet, without proper authorization. Historic aerals and available photos of the property do not indicate that riprap has been installed on this peninsula in the past, thus the coquina riprap would be considered a non-compliance activity.

Figure Three. Shown (red polygon) is the area of fill material (crushed coquina, sand, gravel) placed by the current property owner that does not overlap with the historic wetland alterations (0.06 acre). The purple lines show where the coquina boulders were placed as riprap, along the East and West shorelines of the peninsula.

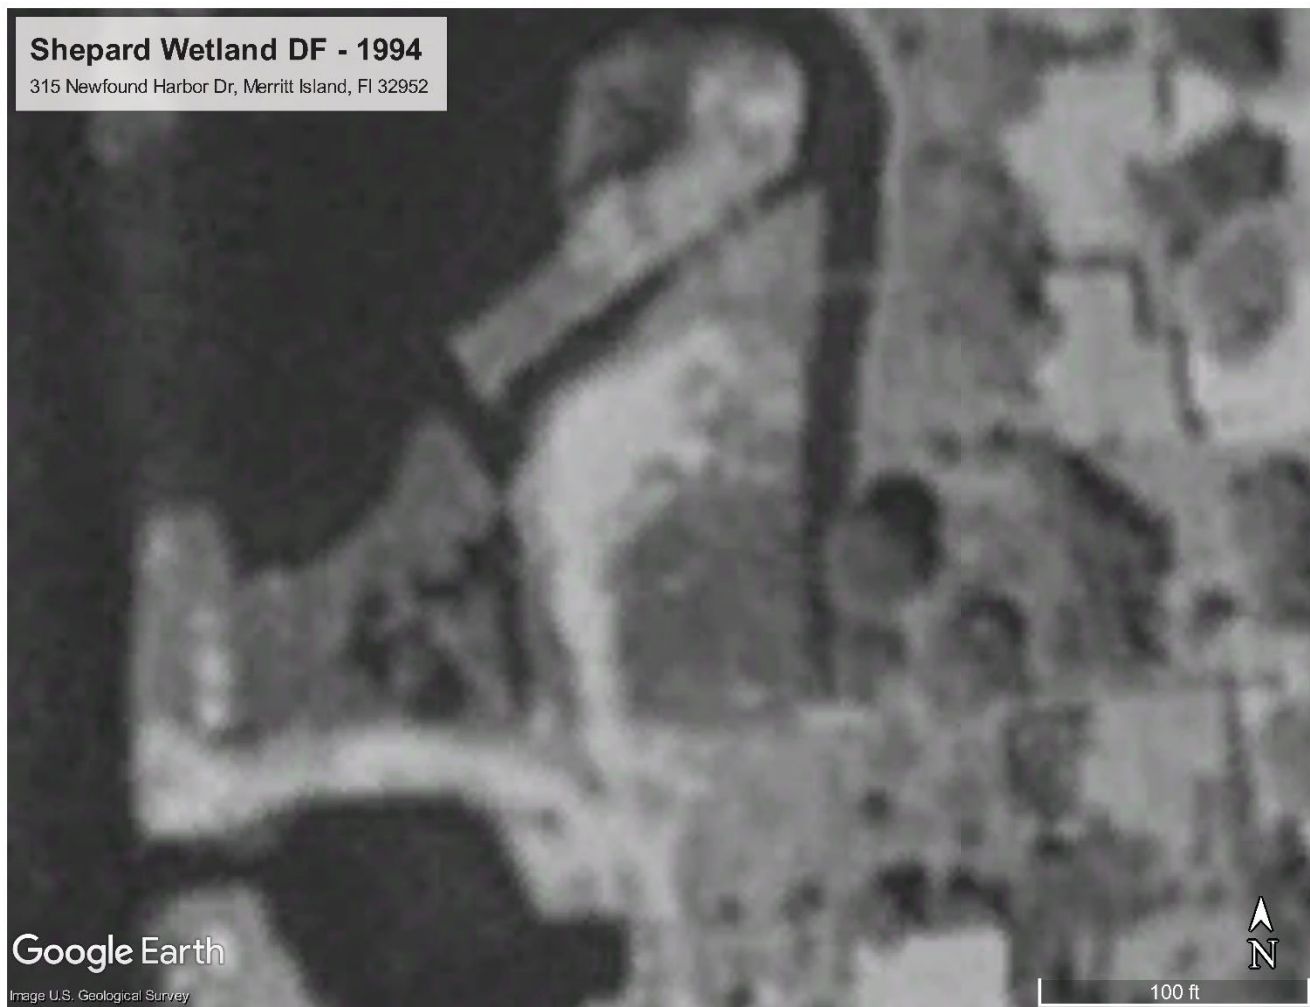
Available historic aerials beginning in 1994 show extensive alteration to the wetland system on this property, prior to the current property owners' activity (Figure four). Aerial images from 1994 through 2023 show fill material present on the peninsula, with continual replacement to maintain the alteration; no relevant aerials were available prior to 1994.

Figure Four. Shown is the area of fill material that was placed by the previous property owner(s). Aerial imagery is from February 1994, prior to the effective date of Chapter 62-330 Florida Administrative Code (F.A.C.). Alterations to the peninsula can be seen.

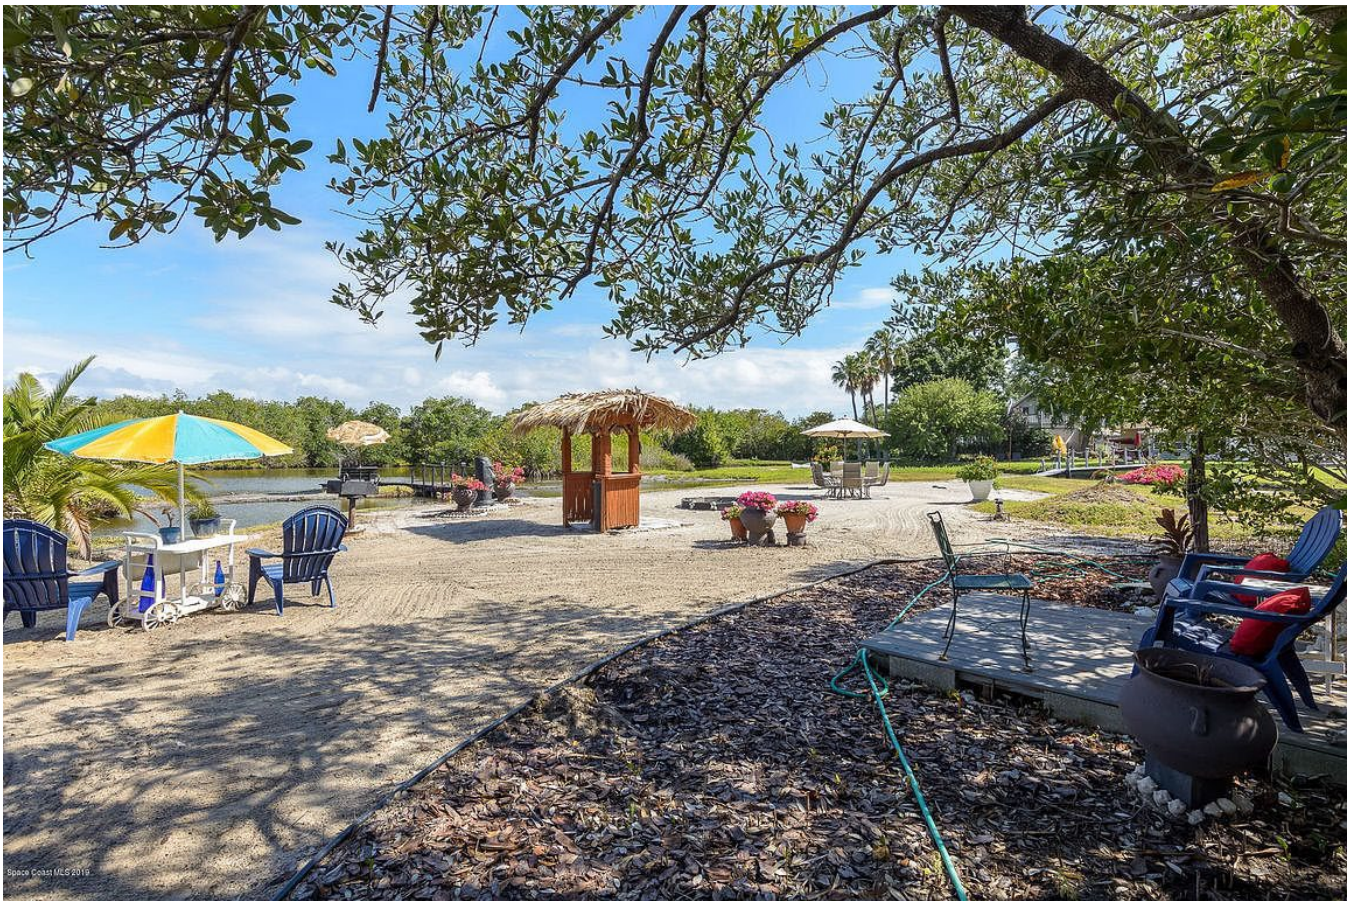
Figure Five: Photo available from public website, Zillow. Fill material is present in image from prior property owners and appears to be consistent with historic aerials.

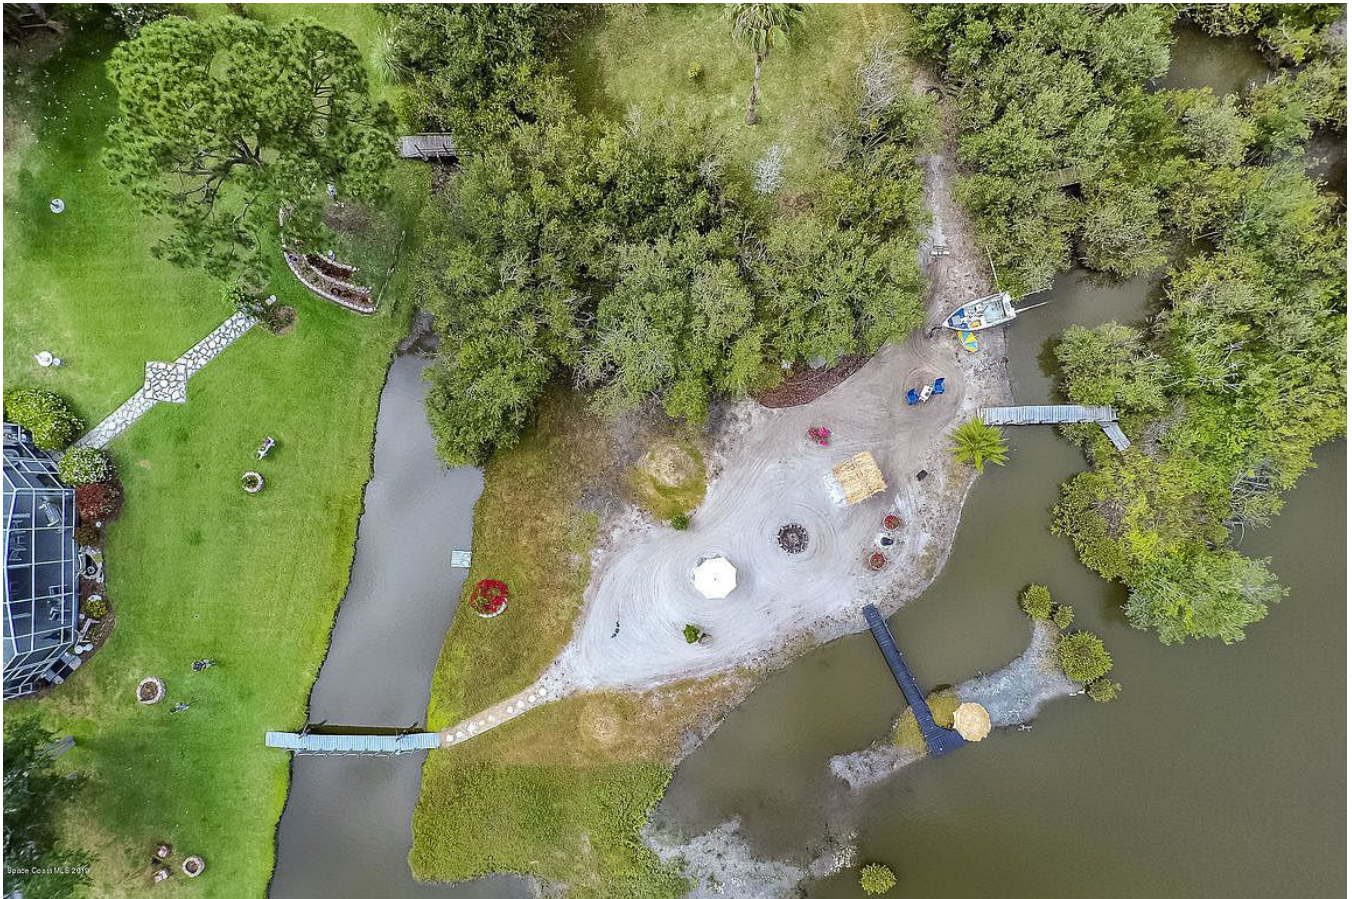
Figure Six: Photo available from public website, Zillow. Fill material is present in image from prior property owners in the same configuration as historic aerials.

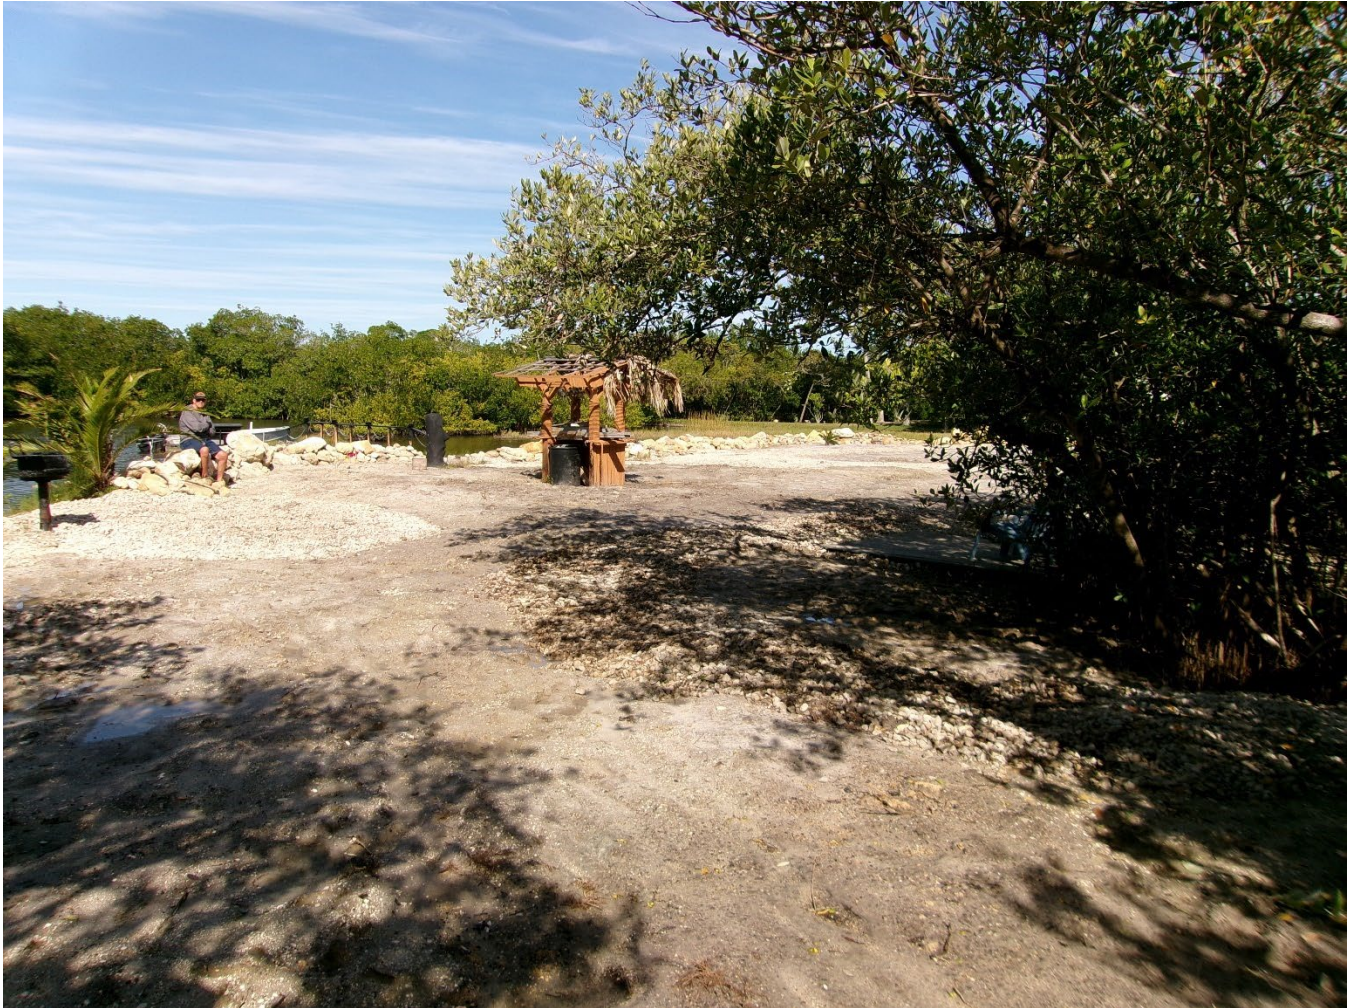
Photo One: Facing North, previously wetland area where current property owners have placed crushed coquina rock and sand fill.

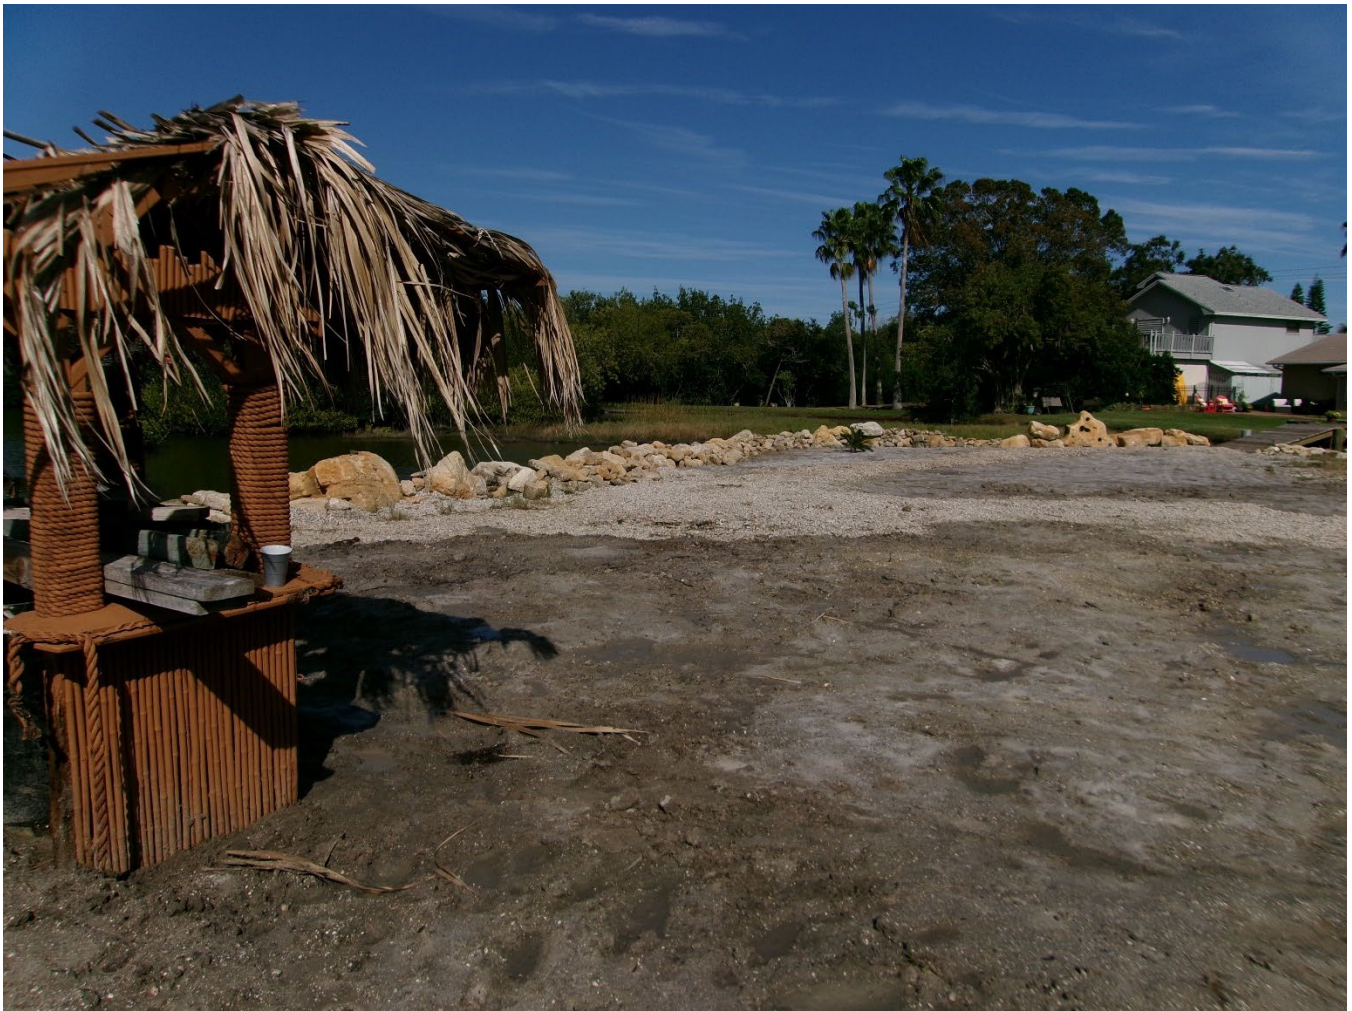
Photo Two: Facing North, previously wetland area where current property owners have placed crushed coquina rock and sand fill. Coquina boulders have been placed along the perimeter of the recent fill, and along the shoreline of the peninsula.

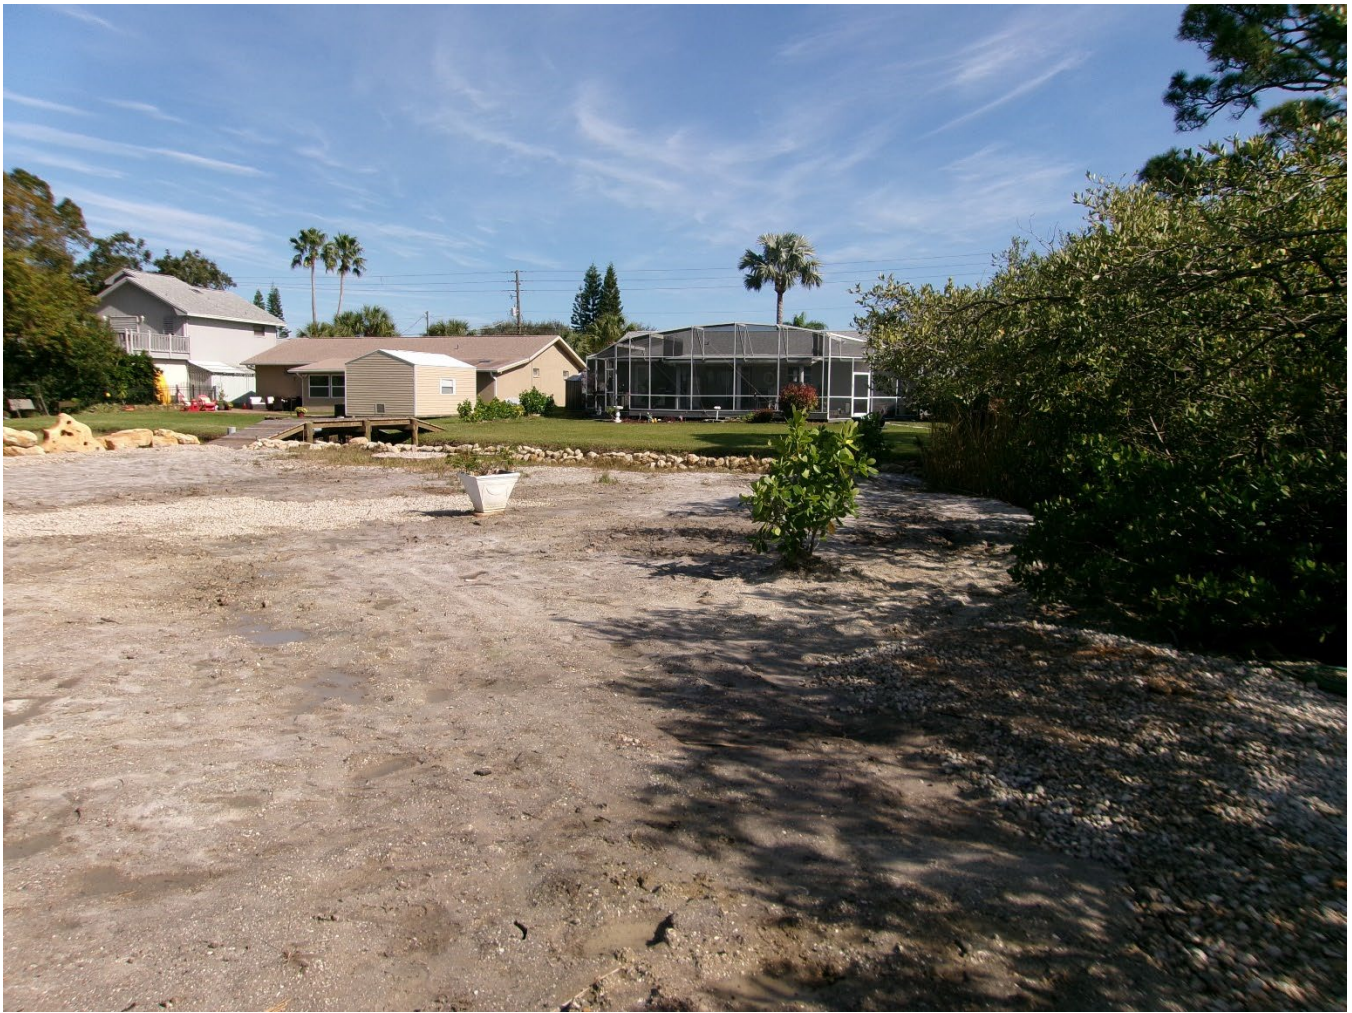
Photo Three: Facing Northeast, previously wetland area where current property owners have placed crushed coquina rock and sand fill. Coquina boulders have been placed along the perimeter of the recent fill, and along the shoreline of the peninsula.

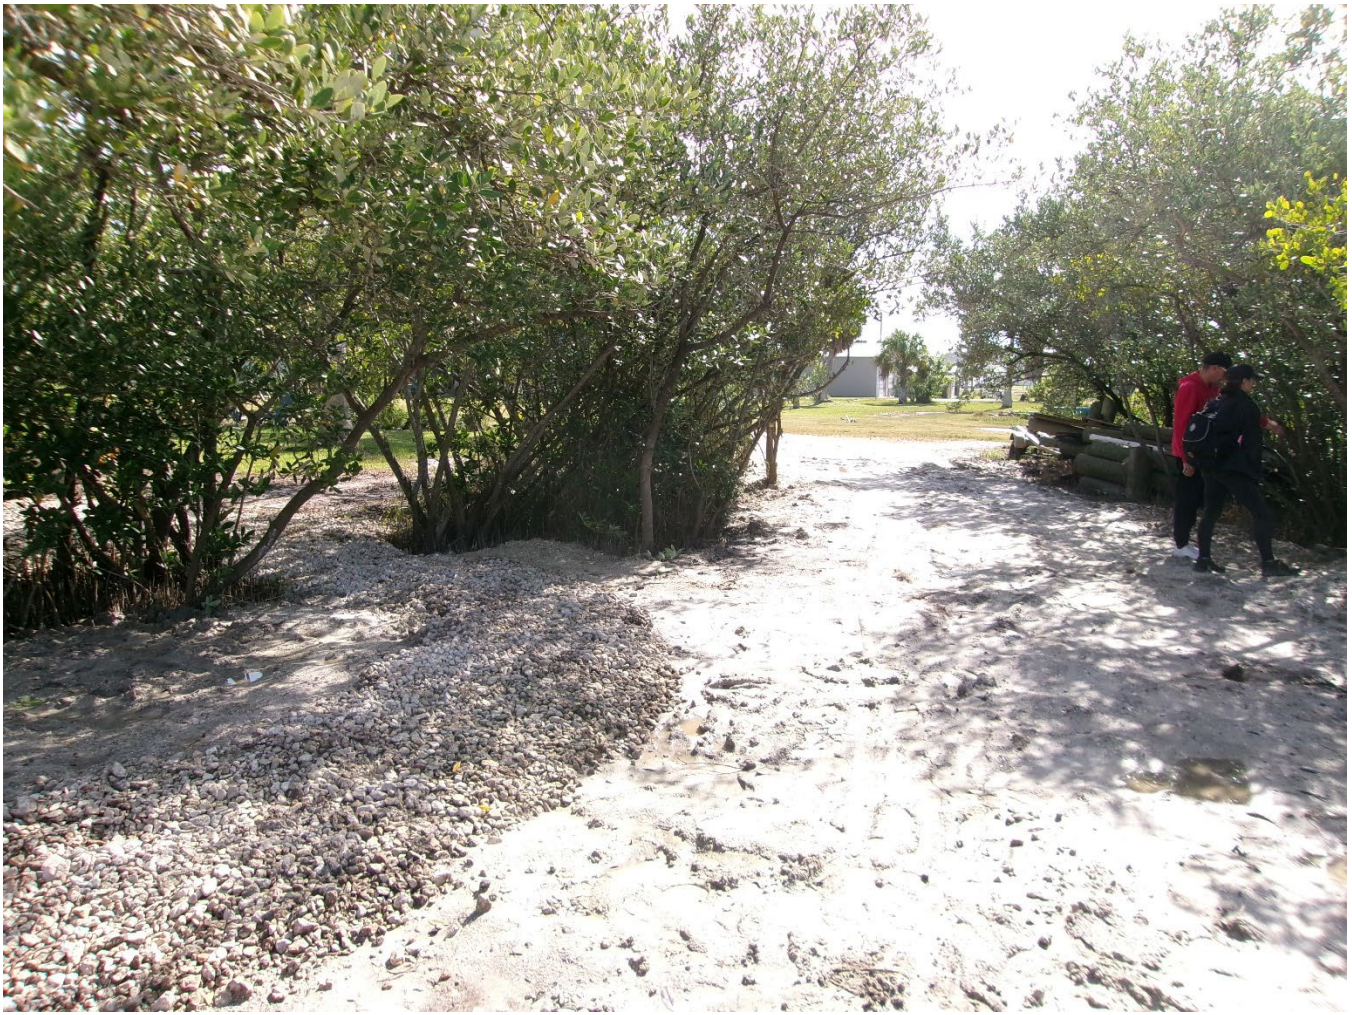
Photo Four: Facing South, previously wetland area where current property owners have placed crushed coquina rock, sand and gravel fill.

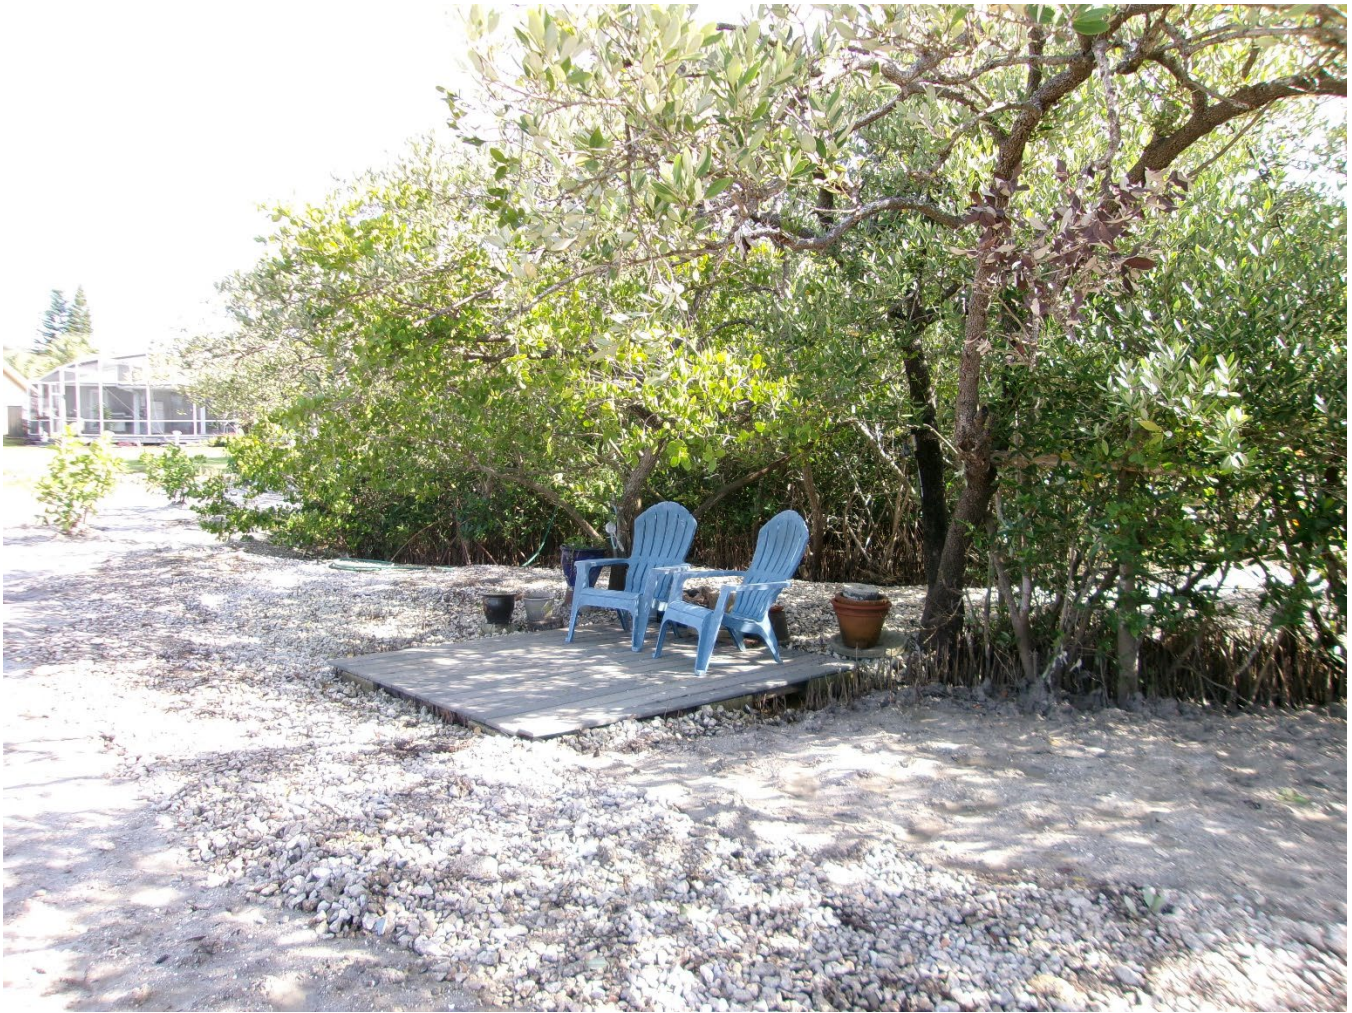
Photo Five: Facing East, Facing South, previously wetland area where current property owners have placed crushed coquina rock, sand and gravel fill. The platform is in the same location/configuration as documented in the previous owners photos.

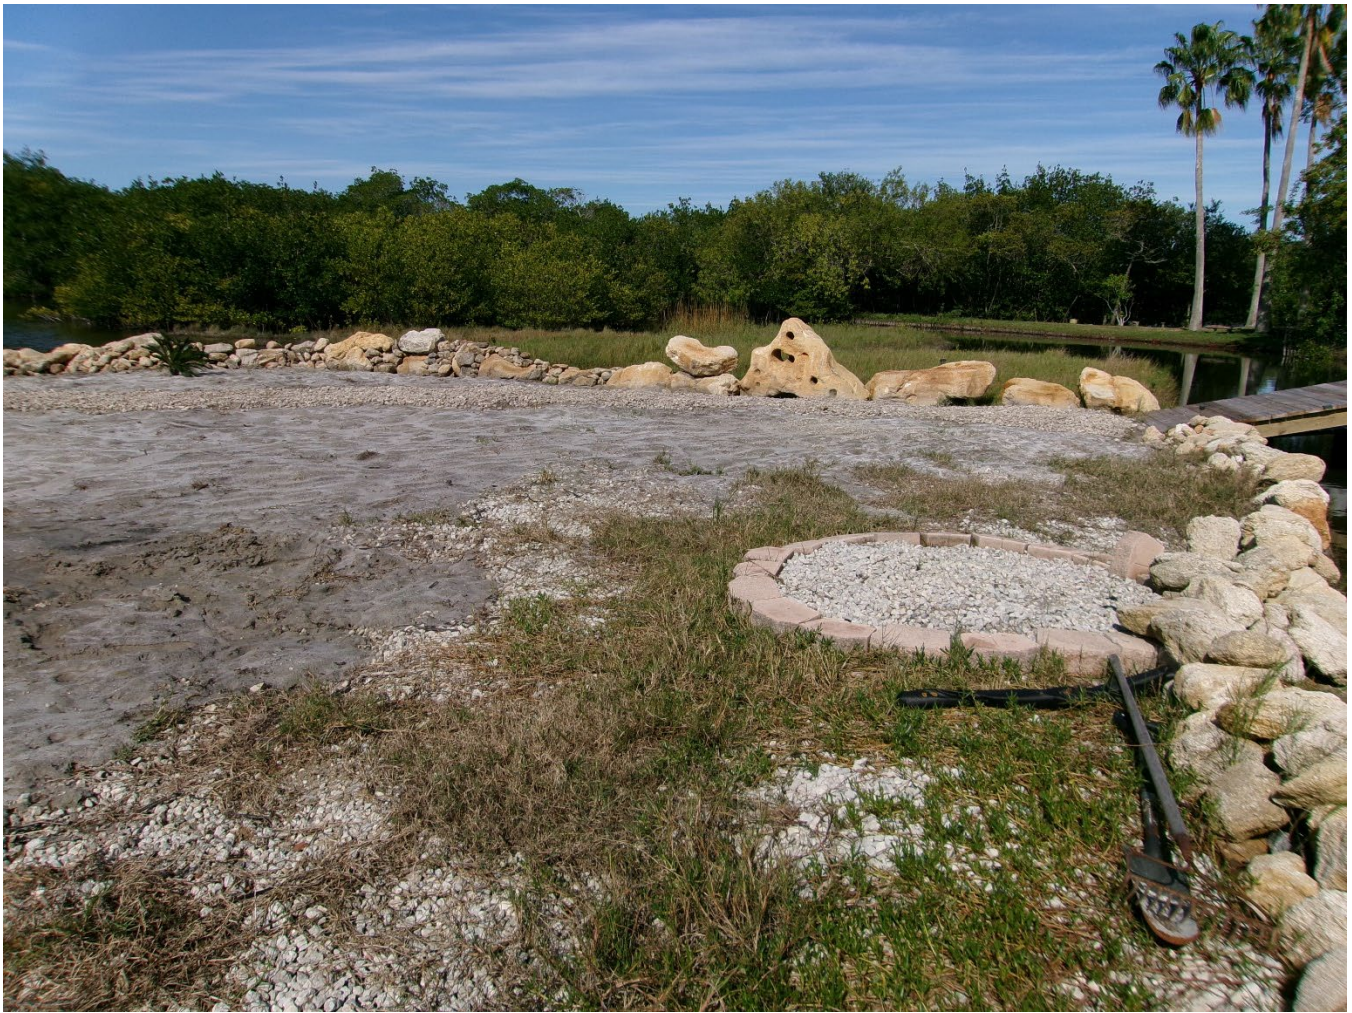
Photo Six: Facing West, previously wetland area where current property owners have placed crushed coquina rock, sand and gravel fill. Coquina boulders have been placed along the perimeter of the recent fill, and along the shoreline of the peninsula.

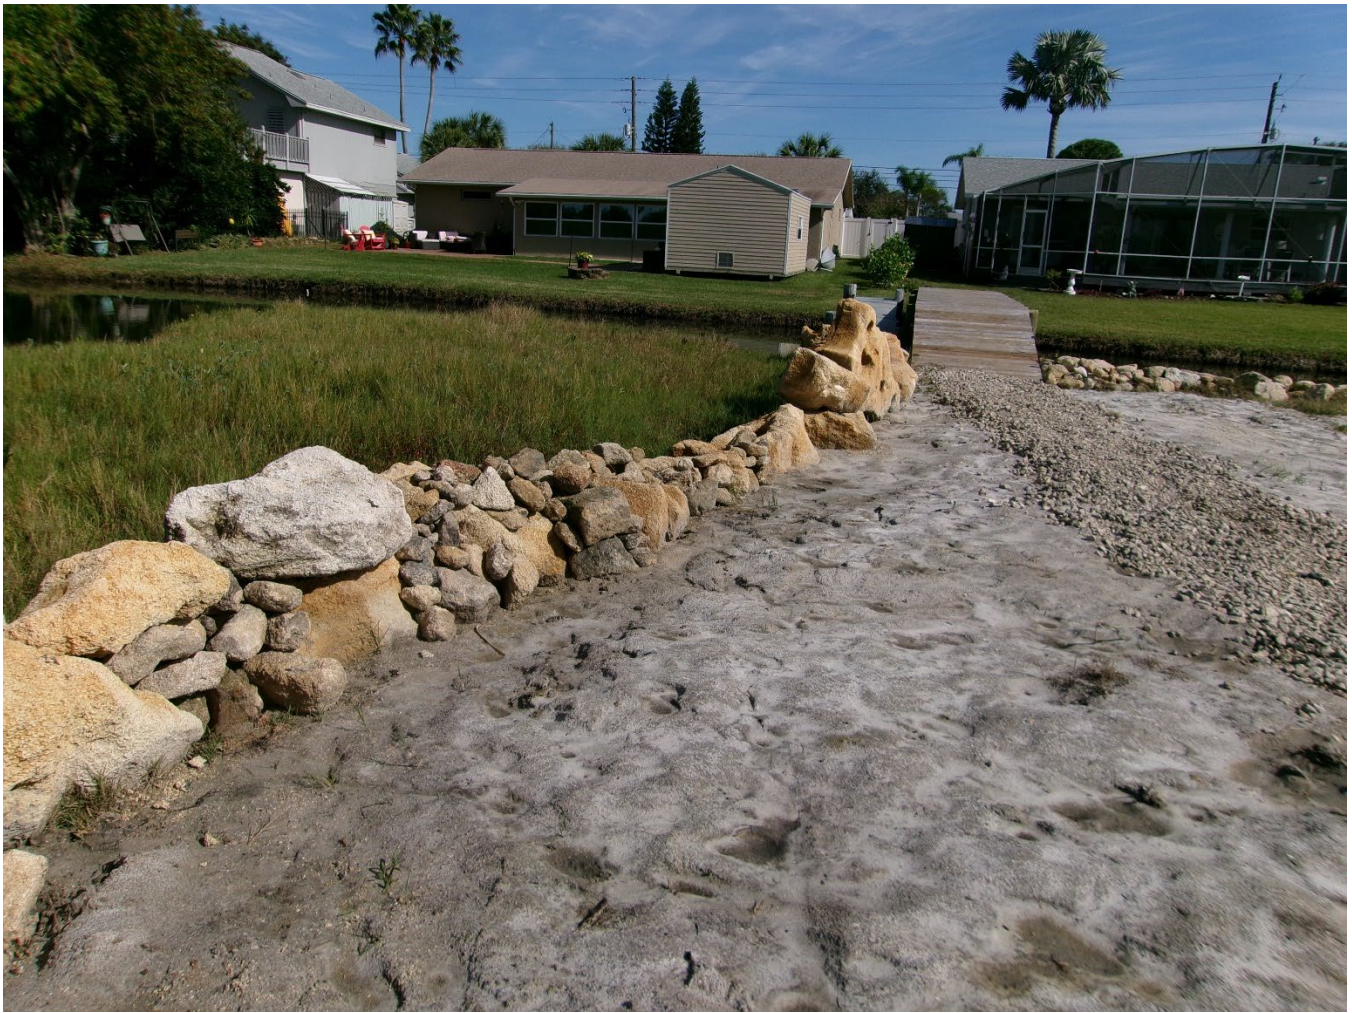
Photo Seven: Facing East, previously wetland area where current property owners have placed crushed coquina rock, sand and gravel fill. Coquina boulders have been placed along the perimeter of the recent fill.

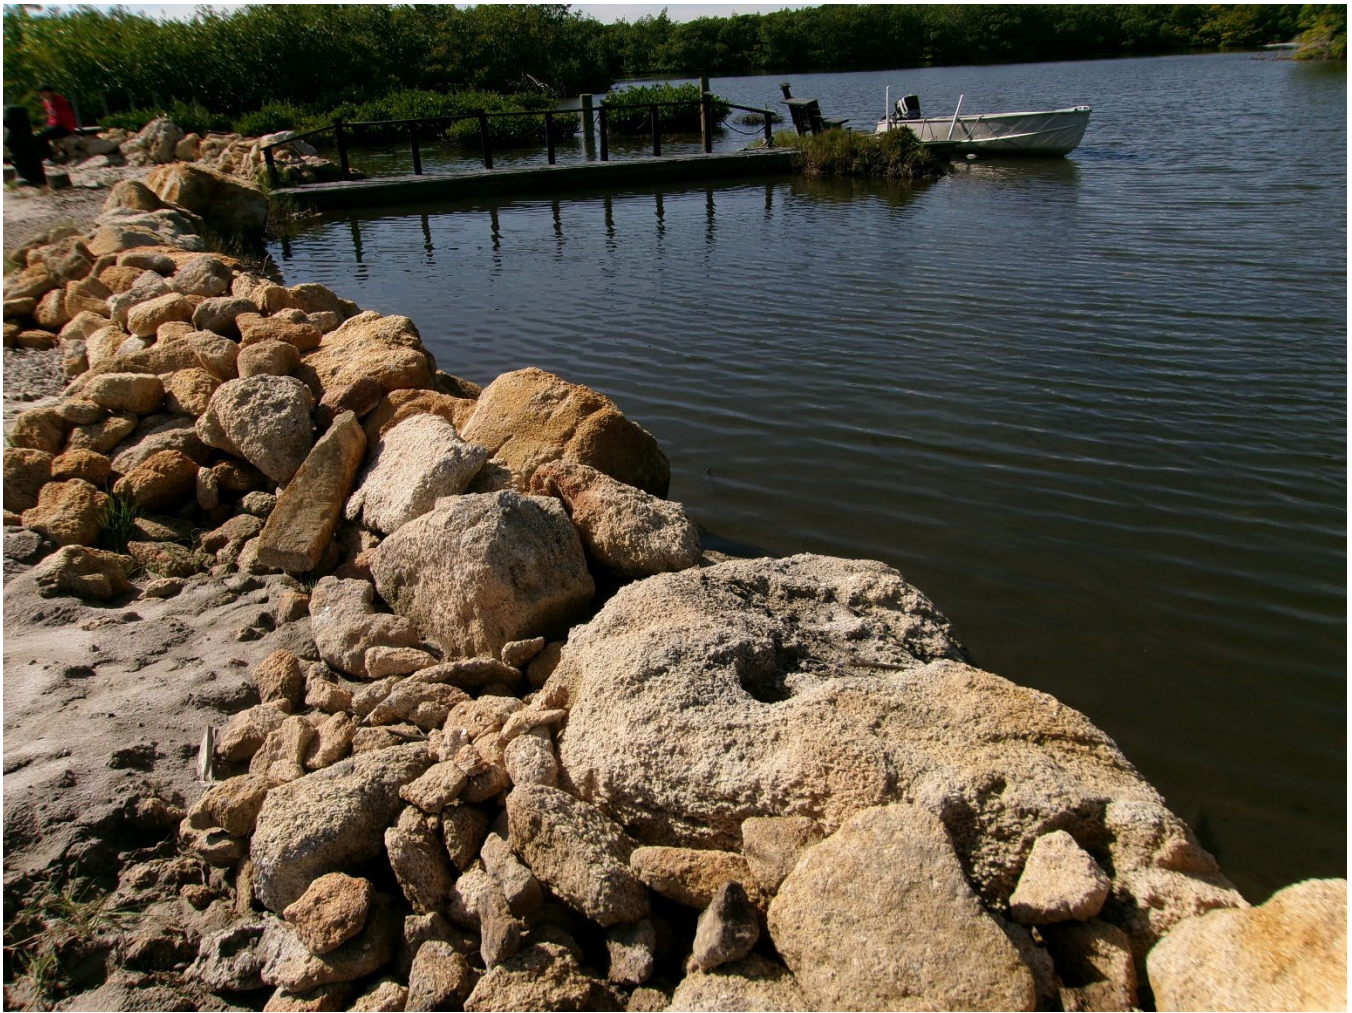
Photo Eight: Facing South, coquina boulders have been placed along the perimeter of the recent fill, and along the shoreline of the peninsula.

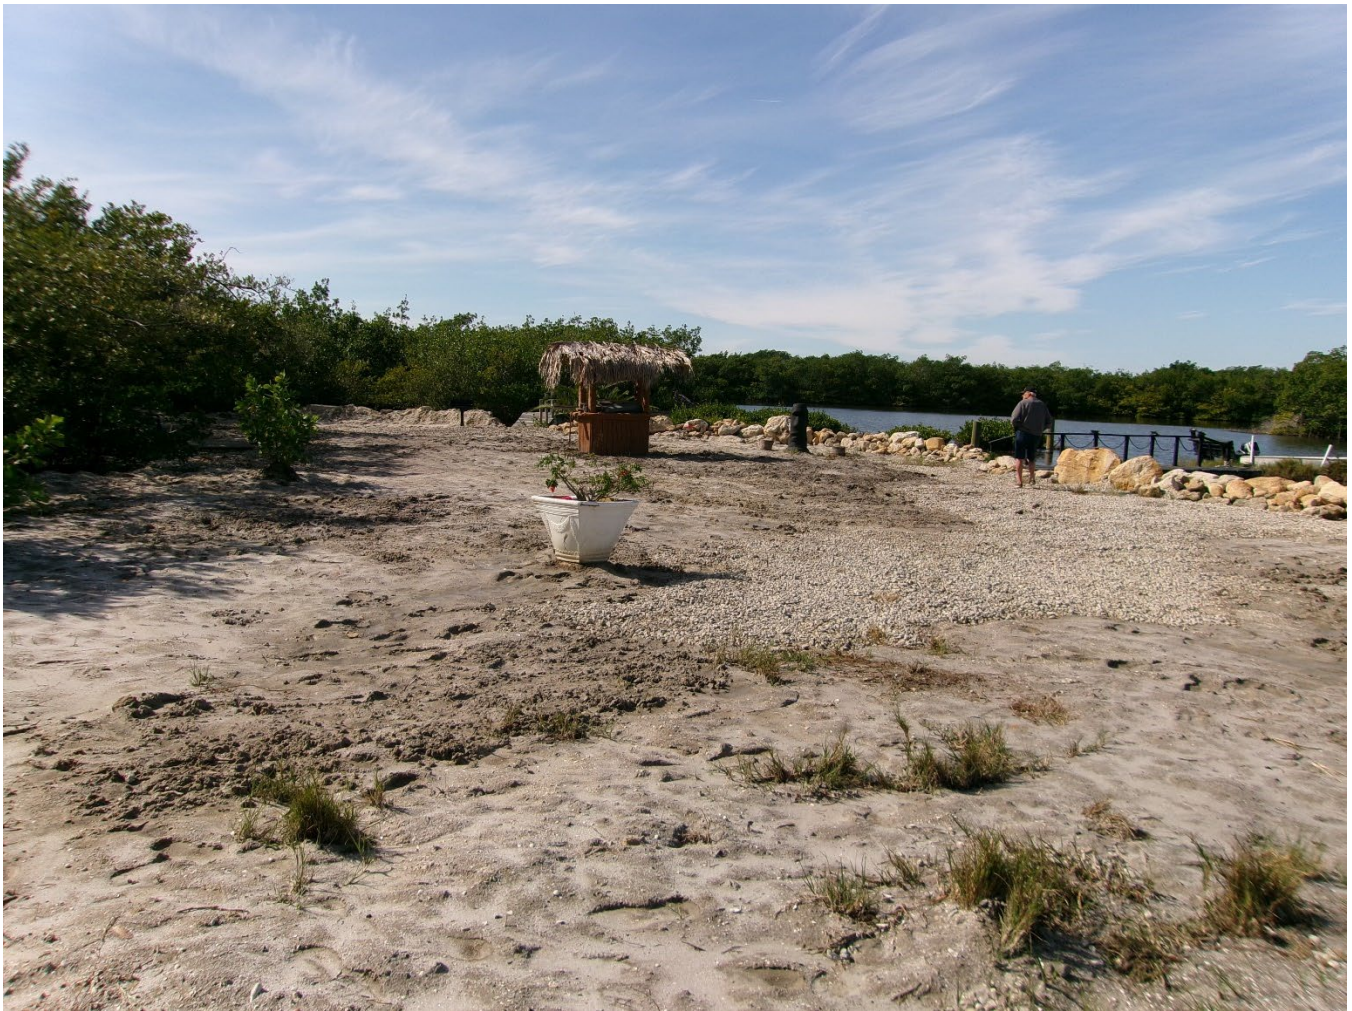
Photo Nine: Facing South, previously wetland area where current property owners have placed crushed coquina rock, sand and gravel fill. Coquina boulders have been placed along the perimeter of the recent fill, and along the shoreline of the peninsula.

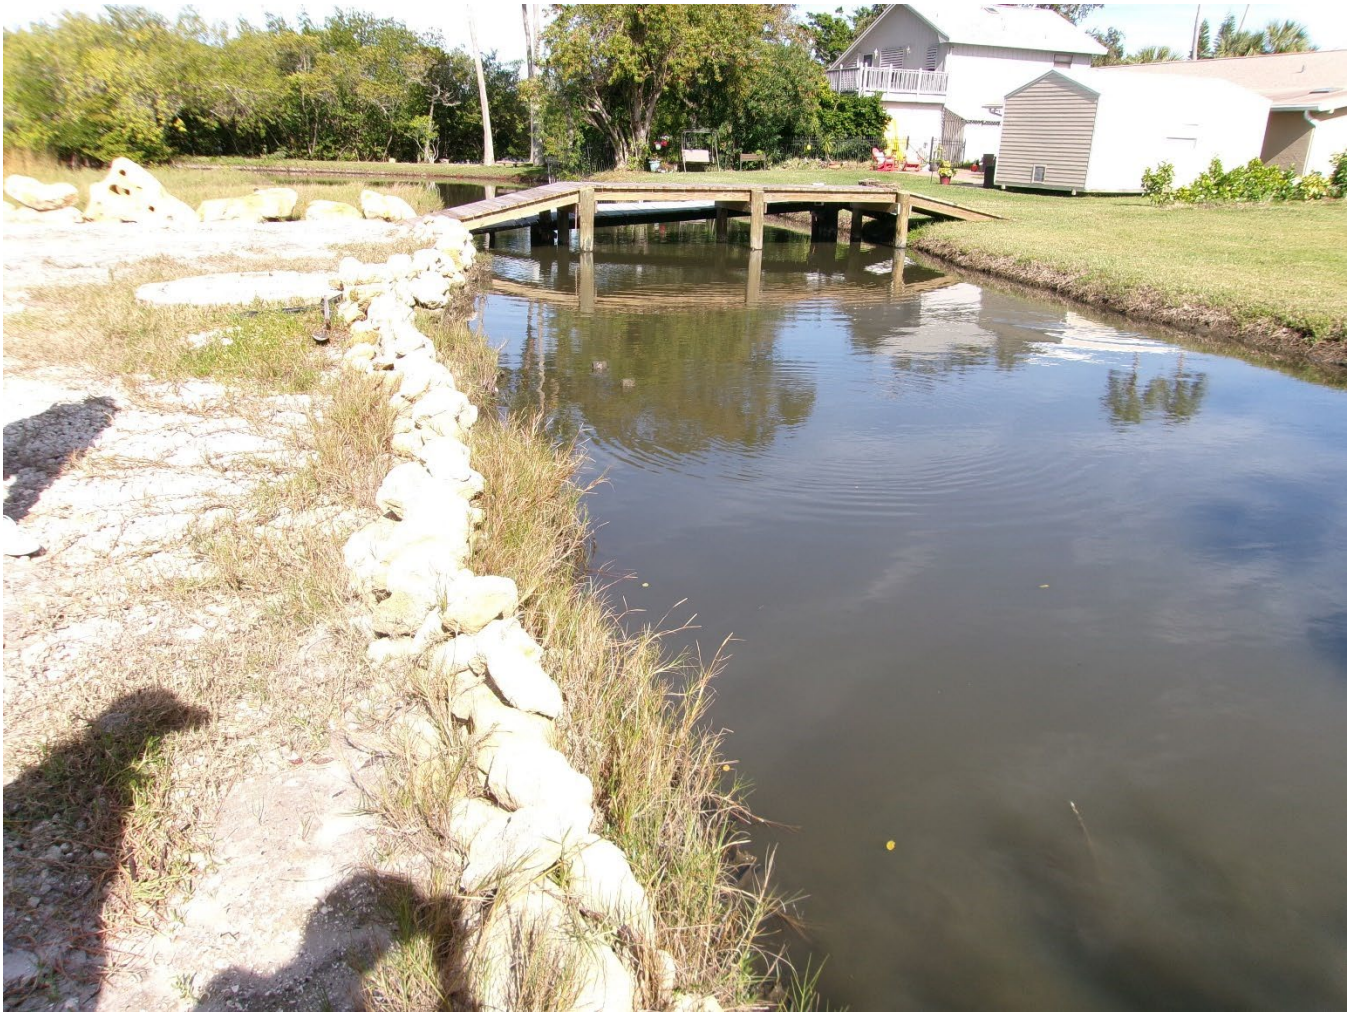
Photo Ten: Facing North, coquina boulders have been placed along the perimeter of the recent fill, and along the shoreline of the peninsula.
