FLORIDA DEPARTMENT OF Environmental Protection

Re: Compliance Assistance Offer
315 Newfound Harbor Dr, Merritt Island, FL 32952
ERP Site ID: 228041
Brevard County

ERP Program Inspection Report

Project Name: [Shepard Wetland Fill]

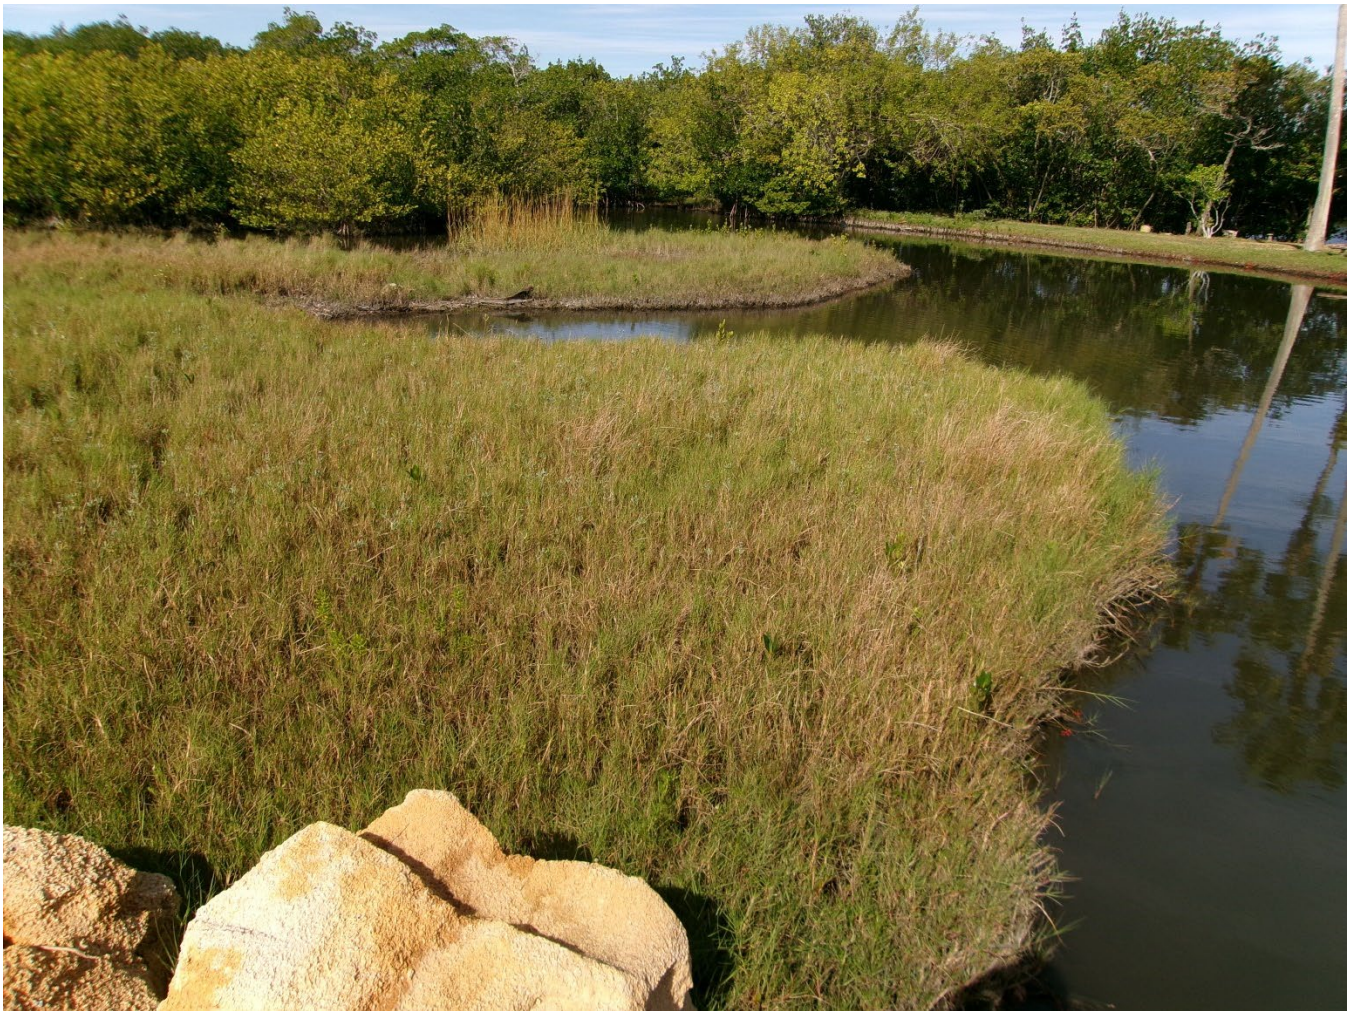
Photo Eleven: Facing North, unaltered wetland area adjacent to current impacts.

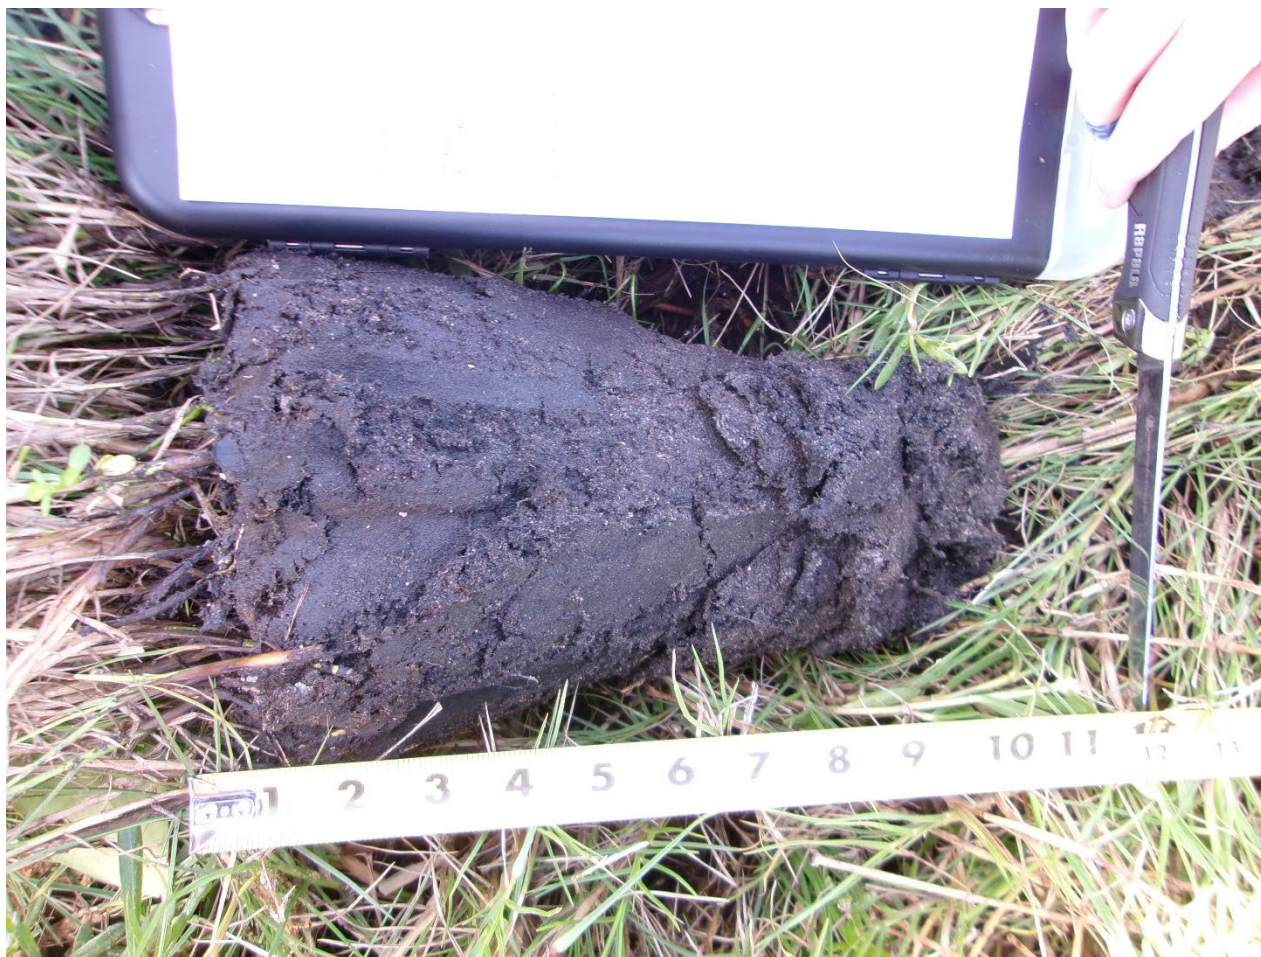
1	0-12	SMM	10YR 2/1	98%			
2							
3							
4							
5							
6

Photo #1. Soil profile at WRP1

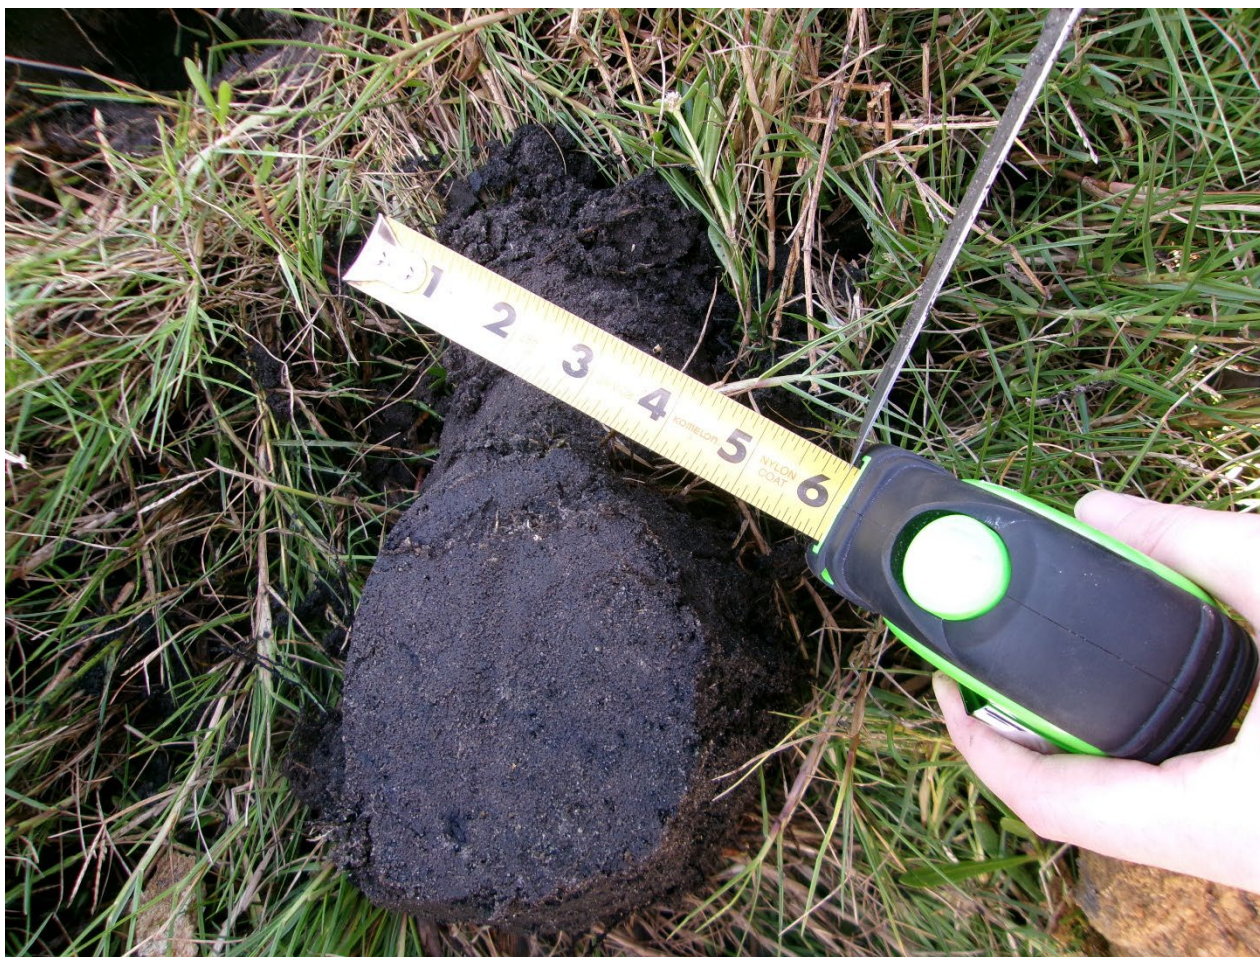
Photo #2. Cut at 6" on WRP1

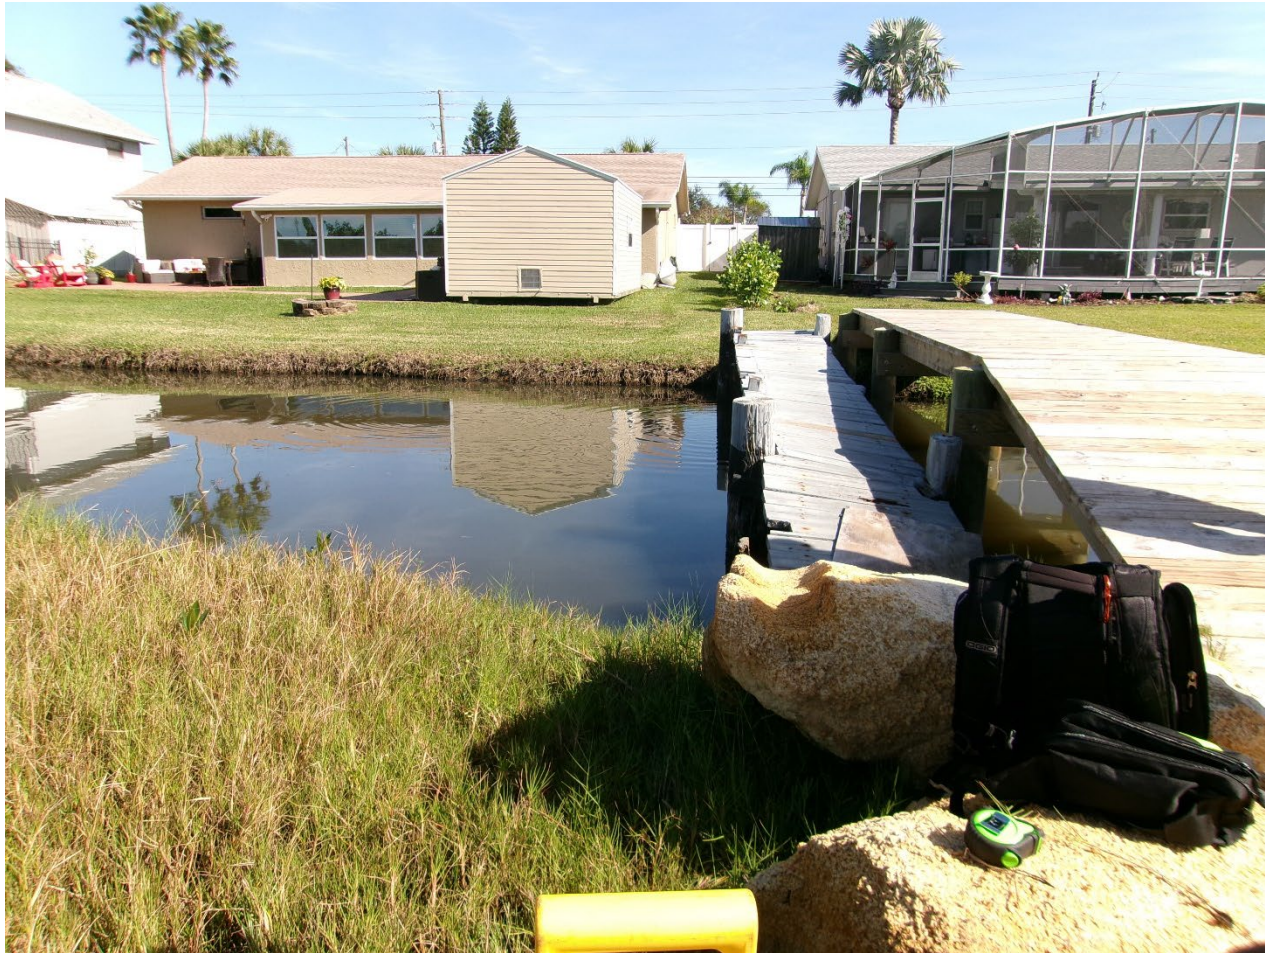
(7) Evidence of aquatic fauna				
(8) Hydrologic data*	✓			A7, S7 present. Surface water present 5 ft East.
(9) Morphological plant adaptations*				
(10) Secondary flow channels

Photo #3. Surface water present 5' East of WRP1
