**RE:** Riverview Chemical Complex  
Permit No. FL0000761  
PA No.: FL0000761-017-IW1S/NR  
Compliance Evaluation Inspection

**FLORIDA DEPARTMENT OF ENVIRONMENTAL PROTECTION**  
**WASTEWATER COMPLIANCE INSPECTION REPORT**

<b>Facility Name and Physical Address</b> Mosaic Fertilizer, LLC- Riverview Chemical Complex 8813 U.S. HWY 41 Riverview, FL 33547-3953	<b>WAFR ID</b> FL0000761	<b>County</b> Hillsborough	<b>Entry Date</b> 3/5/2024	<b>Entry Time</b> 09:45 AM
<b>Facility Phone #</b> 813-767-5105		<b>Exit Date</b> 3/5/2024		<b>Exit Time</b> 12:15 PM

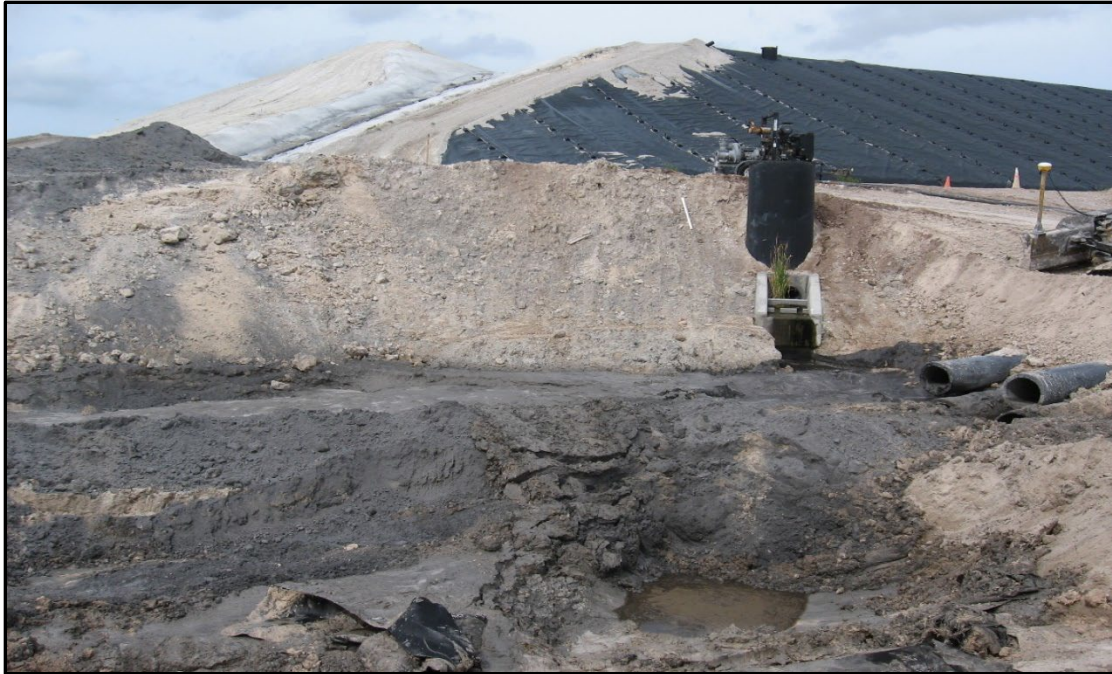
Photograph 1. The overall critical condition area.

- 14.1 Additional Comments: On March 4, 2024, at 15:30, a critical condition occurred on the Active Stack. During construction activities at the 160-Acre Cooling Pond, an excavator tore a section of the liner while grading the slope for fabiform installation. The facility notified the Department within 24 hours, per Rule 62-620.610(20), F.A.C.

- a. Photographs of the torn liner taken by the Department are provided, below:
- i. ***Photograph 1:*** Standing West, facing the overall critical condition area.
  - ii. ***Photograph 2:*** Standing West, facing the area of the torn liner.
  - iii. ***Photograph 3:*** Standing SW, facing the coffer dam that was installed around the critical condition area.
  - iv. ***Photograph 4:*** Standing SW, facing dry gypsum that was used as a barrier to segregate the wet muddy central area where the critical condition occurred.
  - v. ***Photograph 5:*** Standing North, facing excavator used for cleanup of the area and mud to expose the area where the torn liner was found.

During the inspection, facility representatives provided the Department with a status report of the active repairs that were being taken to fix the torn liner and took Department representatives to the location of the torn liner. The area was covered, and a coffer dam was constructed to isolate the tear from the process water. Per facility representatives, a repair completion report will be submitted to the Department upon receipt of third-party engineers from Ardaman and Associates, Inc.; with an estimated timeline for repair completion of two weeks from date the critical condition was reported.
