**Florida Department of
Environmental Protection
Hazardous Waste Inspection Report**

Facility Name: Veolia ES Technical Solutions LLC

On-Site Inspection Start Date: 01/27/2010

Routine Inspection for Transporter facility

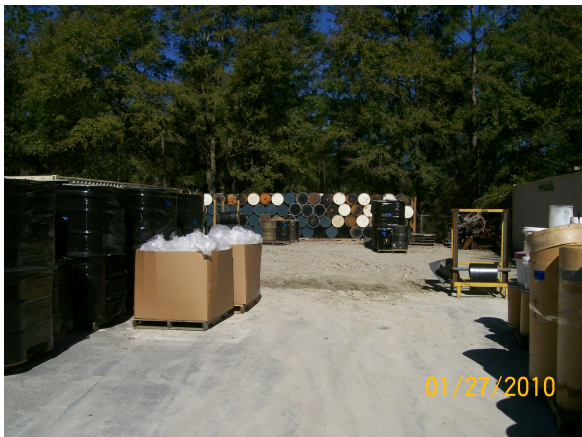
Attachments:**Equip. Storage & Empty Containers**

Two 20-yard roll-offs for collection of processed glass are staged in this area on a concrete pad. An adjacent asphalt paved area is used for collection of paper-products, wood pallet recycling, UW Transporter bulk delivery drop off (FEDEX), and various empty container storage. At the north end of this paved area, there are two container trailers for storage of equipment, replacement parts and empty non-hazardous containers. This area is also used for overnight holding of transport trucks in the event of an arrival after business hours. The trucks are immediately unloaded during the next business day.

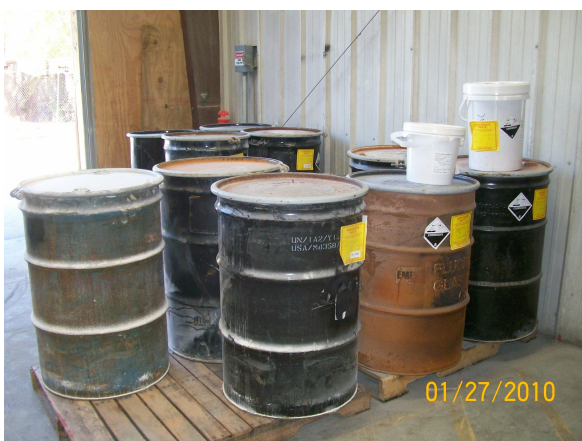
Attachments:**Phosphor Powder & Neon Drums**

At the time of this inspection, waste stored in the HWS Area included eight 55-gallon drums of pre-retort phosphor powder, two 55-gallon drums of pre-retort neon, and two small containers of MCMA. The former 90-Day area was located directly across from the HWS area and is now used for storage of aluminum end caps from lamp processing.

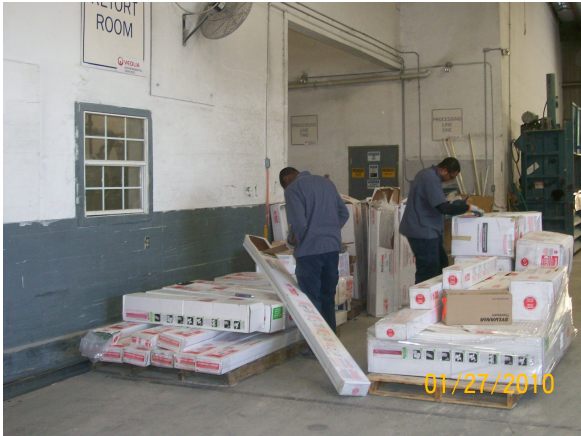
Attachments:**Flourescent Lamps Staging Area**

Fluorescent lamps are staged immediately adjacent to the lamp processing feed belts. Fluorescent lamps are hand fed into the lamp processing room via a conveyor belt. This room, located in the northwest corner of the facility, is designed to process approximately 200,000 feet of lamp equivalents per 8-hour shift. Lamps are crushed with a drum crusher and dry separated into glass, aluminum and phosphor powder. Phosphor powder is collected by a bag tower and accumulated in 55-gallon drums. Veolia-TSD has a second processing line that is used when there is a need to process more materials.

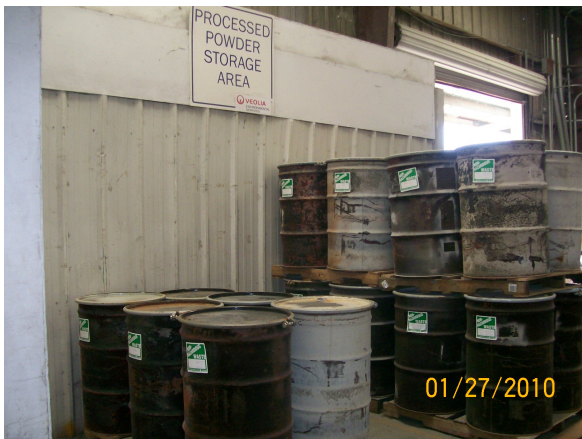
Attachments:**Post Retort Drums**

The loading and unloading area consists of two trailer docking areas for forklift transfer of materials to/from transport vehicles. Post-retort phosphor powder in 55-gallon drums is accumulated in this area along the east wall prior to shipment off-site for disposal in a Class D landfill. The post-retort phosphor powder has been sampled to ensure effective retort processing. The facility maintenance area is also located in this area.

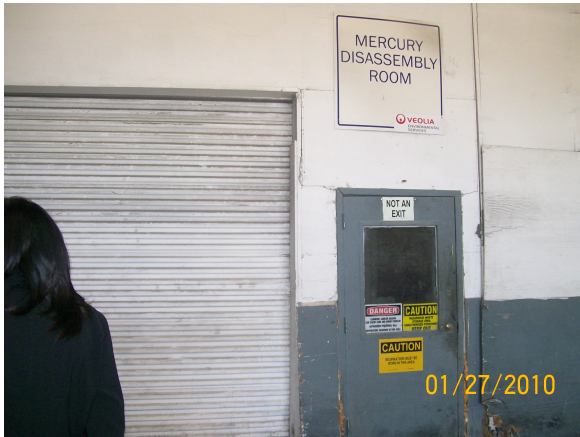
Attachments:**Mercury Disassembly Room**

The retort room, located immediately south of the fluorescent lamp conveyor belts, is an enclosed negative pressure room. The prep area is separated from the retort oven by a roll-up door. The phosphor powder, crushed HID arc tubes, and MCMA's are prepared for the retort oven in the prep area. Drums of crushed HID arc tubes and phosphor powder from the lamp recycling operation have their lids removed in the prep area and are then placed in the retort oven. MCMA are manually disassembled and the liquid mercury is drained and accumulated for sale in the prep area. MCMA components are placed in the retort oven or segregated for off-site recycle/disposal.

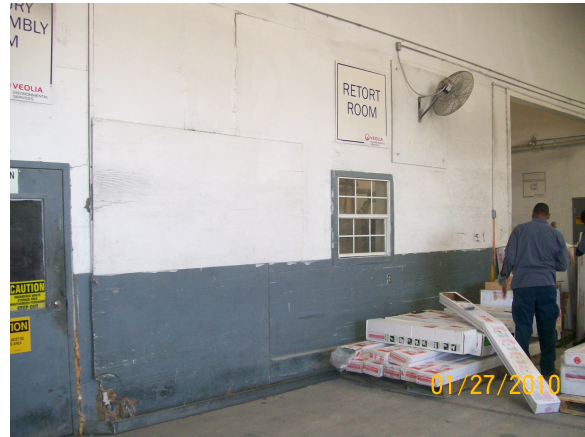
**Retort Room**

The retort operation is comprised of an oven which is used to heat the Hg containing waste, liberating the Hg vapors which are drawn off the oven with a vacuum pump. The vapors are drawn through a series of heat exchangers in order to condense the vapors back into a liquid Hg state. The liquid Hg is decanted into accumulation containers for sale. This process varies depending on the materials that are going through the retort process. Lamps are on a 24-hr retorting time frame in which the oven bakes the lamp materials at high temperatures (1120F max) then cools down. This process is repeated several times during the 24-hour time period.

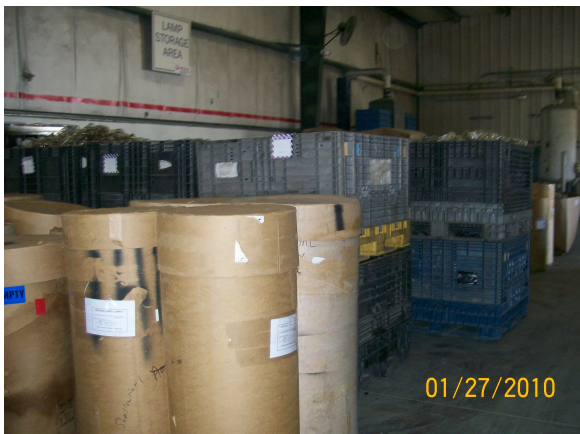
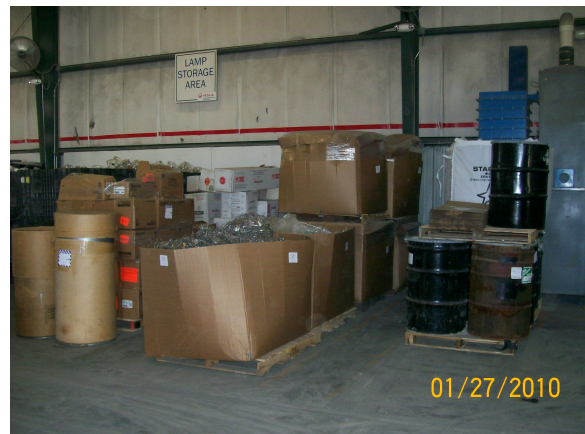
Attachments:**Pre-Process UW Lamp Storage**

This area, located on the west side in the southern portion of the building, is the lamp storage area. The permitted storage dimensions are 64.5 feet long, 20 feet deep and 8 feet high for a maximum of 6,400 cubic feet of mixed fluorescent and HID lamps. This area is used for temporary storage of universal waste lamps that cannot be immediately processed. These lamps normally consist of HID lamps, U-shaped lamps and other specialty lamps that require manual processing prior to recycling/reclamation.

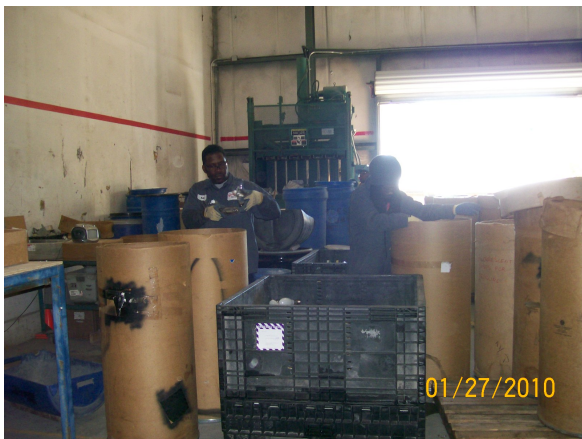
Manual Processing of HID Lamps

HID lamps are processed manually or through a custom built HID machine in the southern end of the building. The HID lamp machine is comprised of conveyor belts, crushers, magnets, and air pollution control equipment. It is enclosed and under negative pressure. It uses an automated process to dry-separate outer glass, metal bases and support wires from the arc tubes. The arc tubes are crushed and dropped into 55-gallon drums for further processing in the retort room. The remaining components are dropped into collection containers for recycle/disposal. The drums of crushed arc tubes are managed as satellite accumulation area containers and moved to the HWS Area at the north end of the building within three days. In the manual process, individuals carry out the separation and sorting procedures by hand. The separated arc tubes are fed into the HID machine for crushing prior to retort.

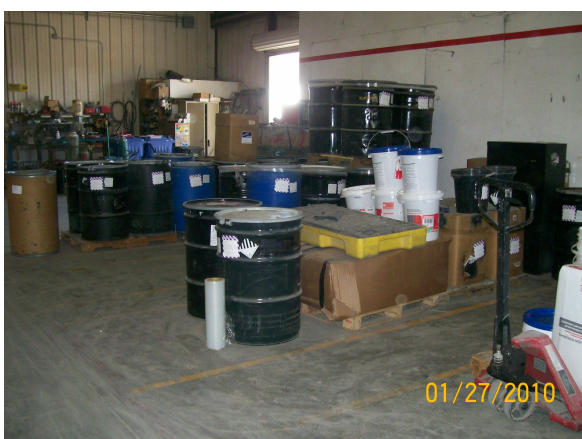
Battery Storage

This area is in the southeast corner of the main building which is used for storage and sorting of batteries and electronic recycling wastes (e-waste). The maximum quantity of battery storage is 36 pallets. Batteries are repackaged in 55-gallon drums before being further processed.

The oldest date observed was June 29, 2009 , which was within the regulatory storage limit of one year.

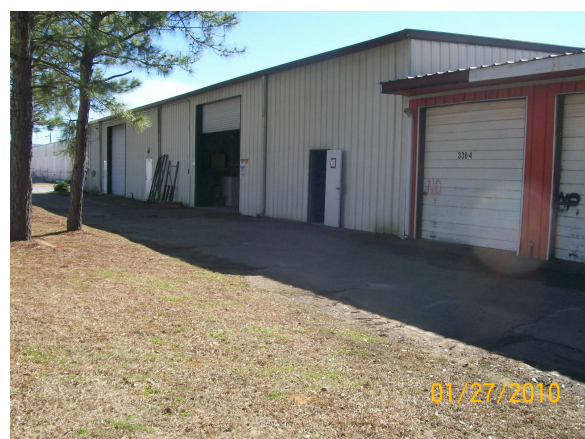
South Building

This building is immediately south of the main building and is divided into two large storage areas. The Container Storage Area is used to hold empty fiber drums and cardboard boxes. No universal or hazardous wastes are stored in this area. The second room in this building is used for storage of e-waste up to a maximum of 86 Pallets.
