SUBJ: RCRA Compliance Evaluation Inspection
Safety-Kleen Systems, Inc.
EPA ID Number: FLD 980 847 214

RCRA Inspection Report

Safety-Kleen Systems, Inc.
161 Industrial Loop South
Orange Park, Florida 32073
Clay County

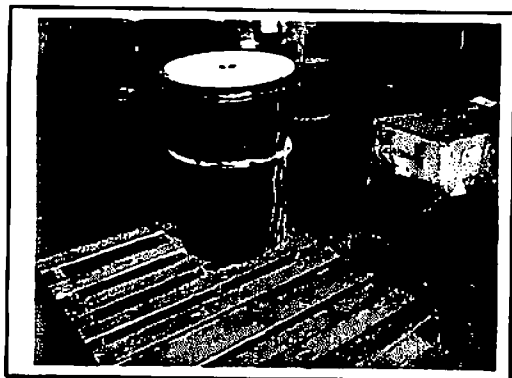
Safety Kleen Systems Inc. (Safety Kleen) 5/14/10. 8:30 am. Southern Area of Warehouse - 10-Day Transfer Facility. One 55-gallon container of hazardous waste. Photograph 1. WK.

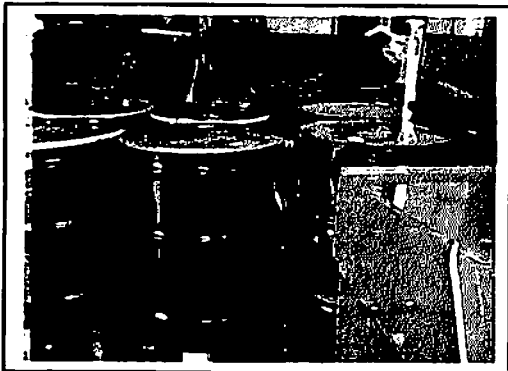
Safety Kleen. 5/14/10. 8:30 am.
Warehouse Container Storage Area.
Containers stored in the permitted area
against secondary containment.
Equipment located outside of
containment system. One container
blocked from access and did not have
sufficient aisle space. Facility corrected
and provided aisle space.
Photograph 7. WK.

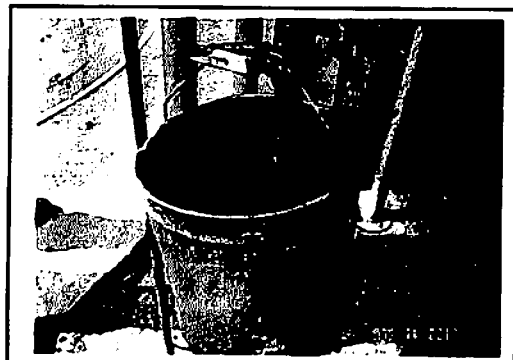
Inspectors also observed a one gallon container in the covered secondary containment area, half full of used oil from drips from the used oil tank's pipe and valve system.

Florida Administrative Code (F.A.C.) 62-710.401(6) states in part, "the facility should only store used oil in containers that are clearly labeled with the words "Used Oil." The containers must be in good condition (no severe rusting, apparent structural defects, or deterioration) with no visible oil leakage. All used oil containers and tanks stored outside of a structure, regardless of size, must be closed or covered or otherwise protected from the weather and must either be double-walled or stored on an oil-impermeable surface with engineered secondary containment that has the capacity to hold 110% of the volume of the largest container within the containment area."

Safety Kleen. 5/14/10. 8:30 am.
Covered Secondary Containment Area.
Container accumulating used oil.
Photograph 11. WK.

Inspectors advised the facility to either empty the container after each use or label the container with the words "Used Oil" and to keep it closed if storing used oil.
