Re: Safety Kleen Systems, Inc. FLD 984 171 694, Operating Permit 56019/HO/006, draft
RCRA Facility Assessment (RFA) Addendum

Safety Kleen Systems, Inc.
FLD 984 171 694
Operating Permit 56019/HO/006

*RCRA Facility Assessment (RFA)
Addendum*

November 17, 2010

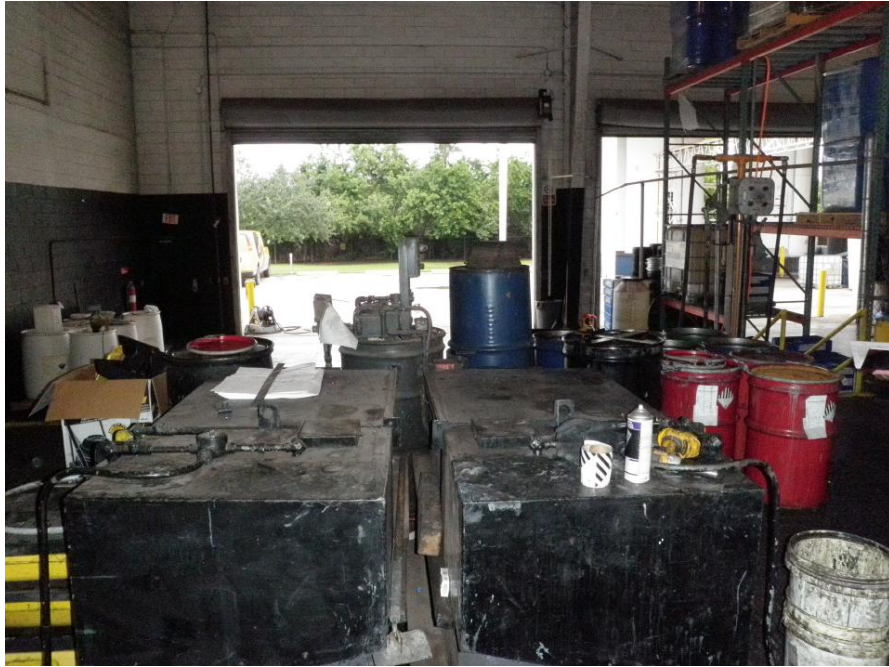
Photos of SWMU-3

The black boxes in the front are the fill and return boxes. Wastes are poured into the boxes, the liquid passes through a filter and the waste is pumped to the above-ground storage tanks outside.

WASTE MANAGEMENT AREA/AREA OF CONCERN REFERENCE NUMBER	SWMU-3
NAME	Return/Fill Area
TYPE OF UNIT	Accumulation and storage
DESCRIPTION OF WASTE MANAGED	Used solvents, used oil and used oil filters
PHYSICAL DESCRIPTION AND CONDITION	Spent solvents enter the waste solvent storage tank through the two wet dumpsters located in the Solvent Return/Fill Station. The wet dumpsters can hold a maximum of 504 gallons each but are not intended for storage of liquid hazardous waste. This area also contains the used oil samples that are pending analysis. These bottles are staged in, or near, metal cabinets located against the wall of the Return/Fill Area. Used oil filters are also stored in 55-gallon drums.
HISTORY AND/OR EVIDENCE OF RELEASE(s)	Yes but within containment area.
RECOMMENDATION	No Further Action at this time.
COMMENTS

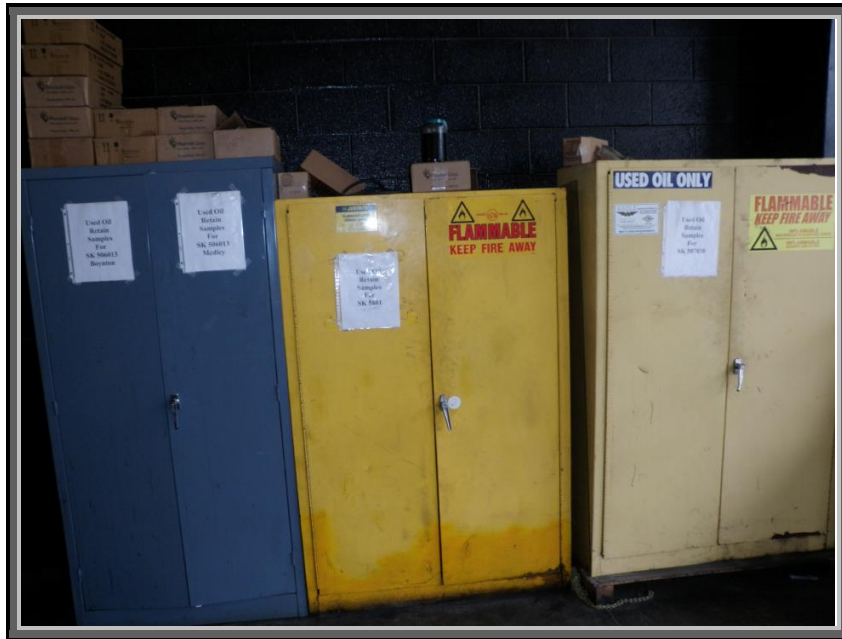
Photos of SWMU-3 (cont.)

Used oil samples awaiting analytical testing results are stored in lockers labeled “Flammable”. The lockers are located along the east wall on the south side of walkway.

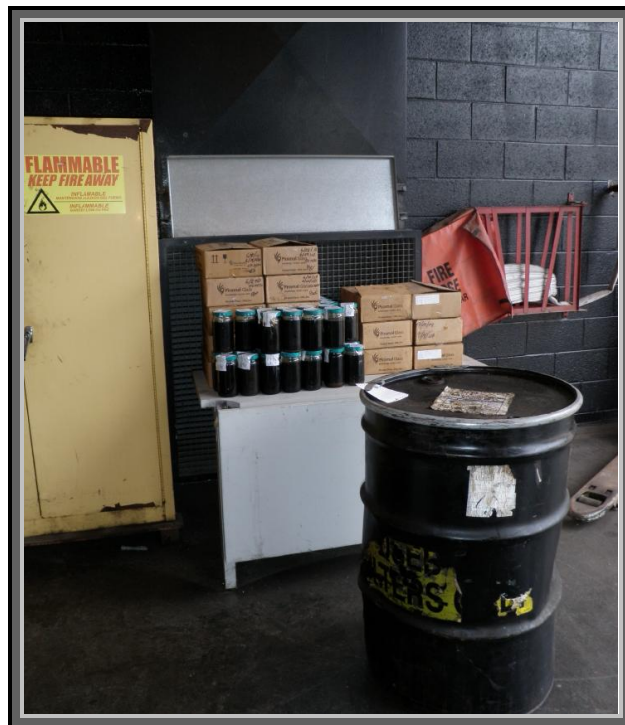
This photo shows a number of the oil samples. Used oil filters were in the 55-gallon drum in the foreground. Photographs taken October 14, 2010 by Ben Fisch.

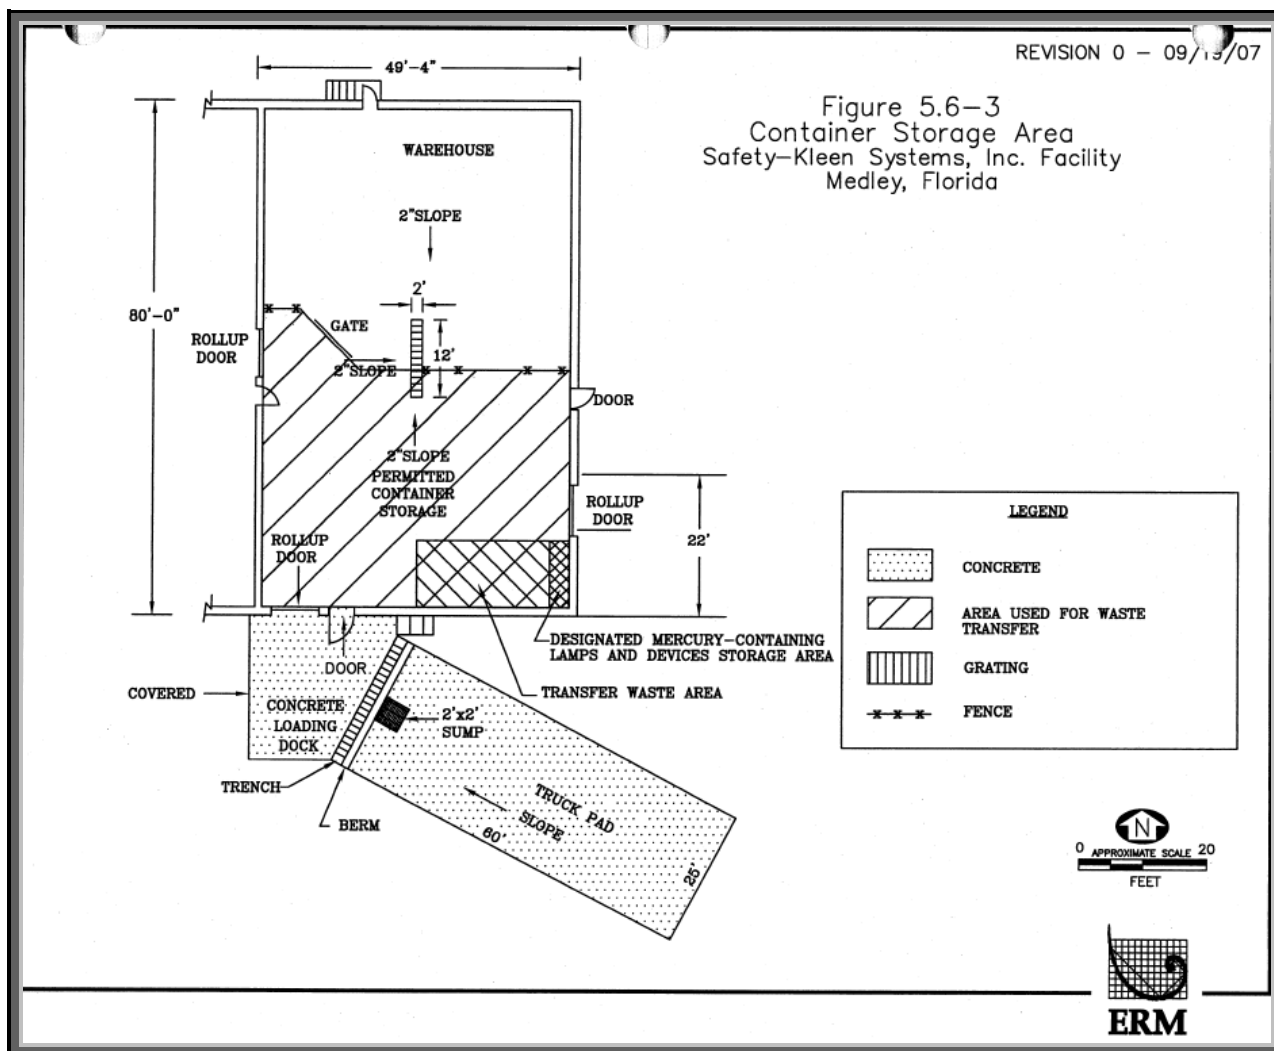
Figure 5.6-3 from Safety Kleen's September 19, 2007 Part B. This map identifies the locations of SWMU-1 (Container Storage/Waste Transfer Area), and SWMU-4 (Mercury Lamps Storage Area).

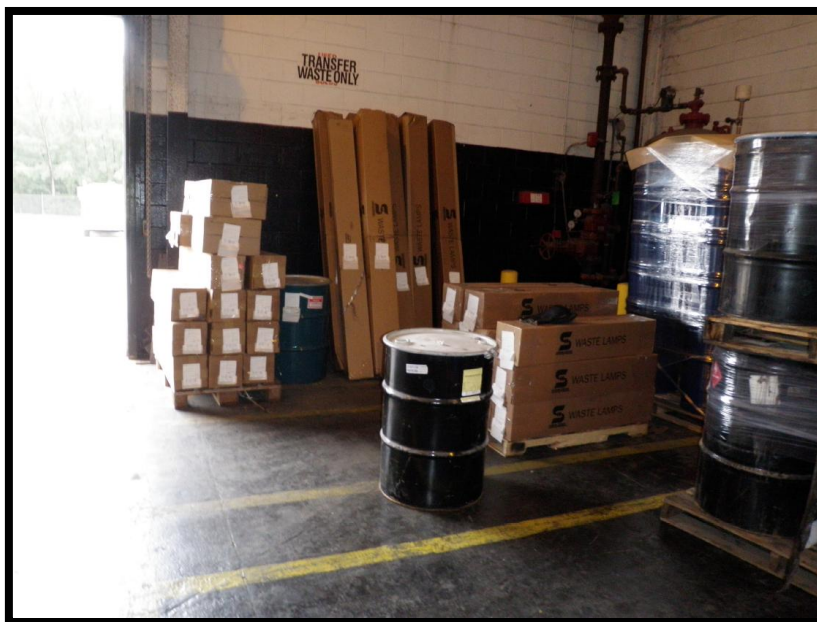
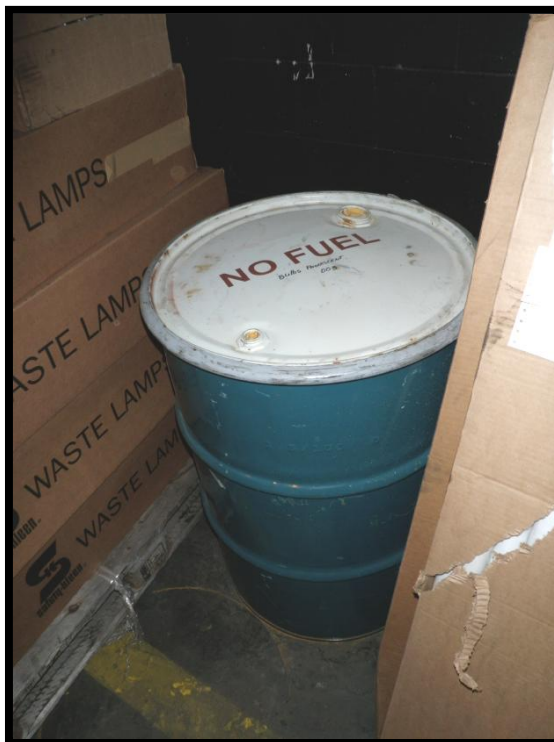
Photo of SWMU-4

Photographs showing the location of the Mercury Lamps Storage Area. The area is located within the Transfer Waste Area. The bulbs are stored in boxes and one drum along the northern wall of the building. The photograph below shows a closeup of a 55-gallon drum containing fluorescent bulbs. Photographs taken October 14, 2010 by Ben Fisch.

WASTE MANAGEMENT AREA/AREA OF CONCERN REFERENCE NUMBER	SWMU-4
NAME	Mercury Lamps Storage Area
TYPE OF UNIT	Accumulation and storage
DESCRIPTION OF WASTE MANAGED	Fluorescent lights & devices
PHYSICAL DESCRIPTION AND CONDITION	The accumulation and storage area for spent mercury lamps and devices is located inside the southeast corner of the warehouse. Lamps are stored in 4' and 8' length boxes. The area has an approximate capacity of 100 boxes.
HISTORY AND/OR EVIDENCE OF RELEASE(s)	None
RECOMMENDATION	No Further Action at this time.
COMMENTS	Safety-Kleen has registered as a transporter and storer of mercury containing lamps and devices that are regulated in accordance with Chapter 62-737, F.A.C. A maximum of 2,000 kilograms of mercury containing lamps and devices destined for recycling may be stored and managed in compliance with Rule 62-737.400, F.A.C.

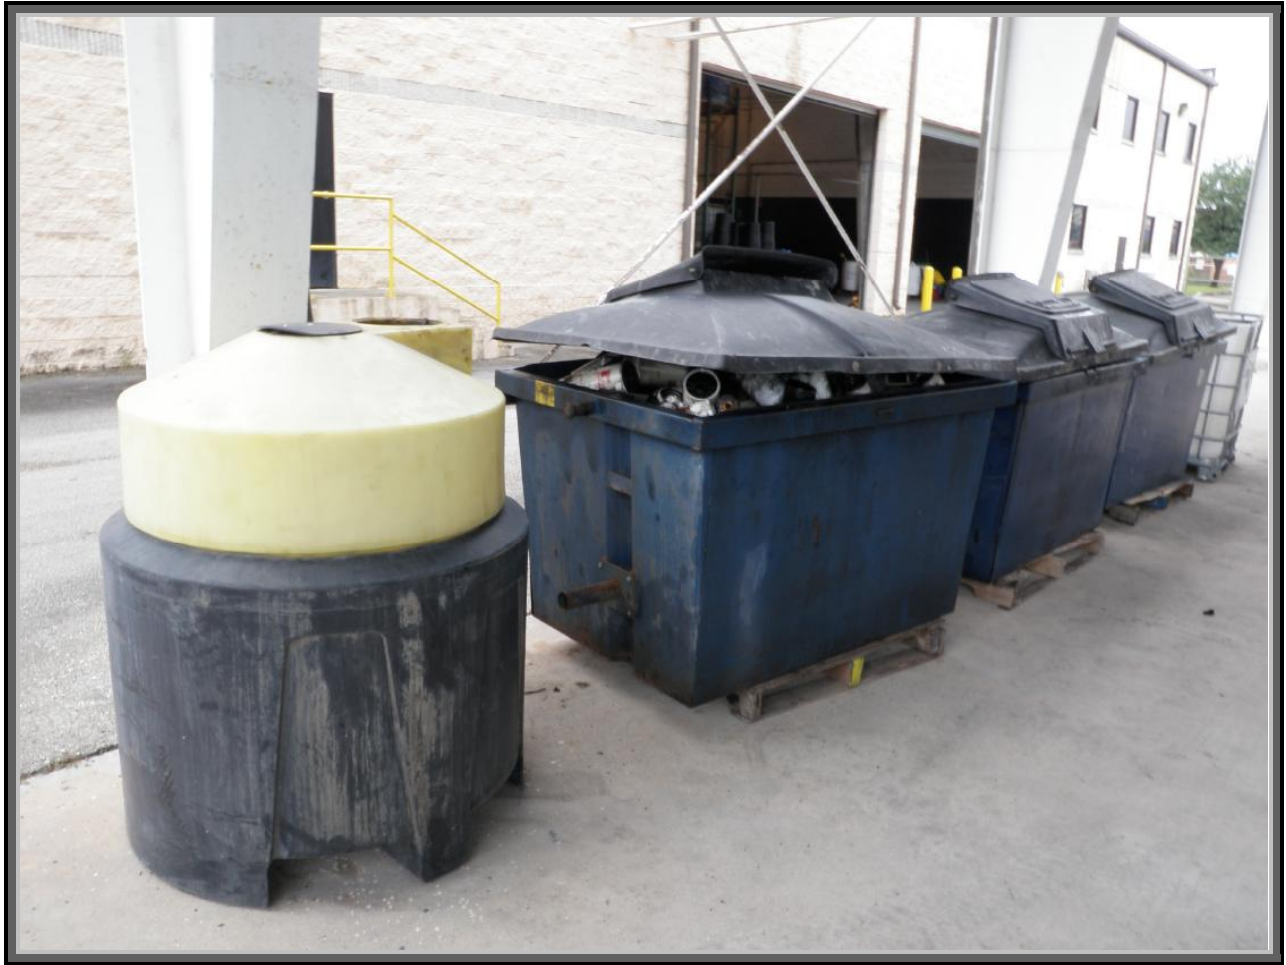
Photo of SWMU 6

Photograph showing antifreeze storage tote (front left) and bins containing used oil filters. Containers are staged on the concrete pad of the above-ground storage tank area (SWMU-2). Photograph is facing southwest. Open doors in the background are the northern side of the return/fill station. Photograph taken October 14, 2010 by Ben Fisch.

WASTE MANAGEMENT AREA/AREA OF CONCERN REFERENCE NUMBER	SWMU-6
NAME	Used Oil Filter/Antifreeze Storage
TYPE OF UNIT	Accumulation and storage
DESCRIPTION OF WASTE MANAGED	Used oil filters
PHYSICAL DESCRIPTION AND CONDITION	Used oil filters are stored on the secondary containment for the aboveground storage tanks (SWMU-2)
HISTORY AND/OR EVIDENCE OF RELEASE(s)	Yes but within containment area.
RECOMMENDATION	No Further Action at this time.
COMMENTS	Oil filter storage on the secondary containment for the aboveground storage tanks (SWMU-2) consists of three bins with approximately 400 gallons of capacity each. Antifreeze storage in this area includes three 350 gallon totes.

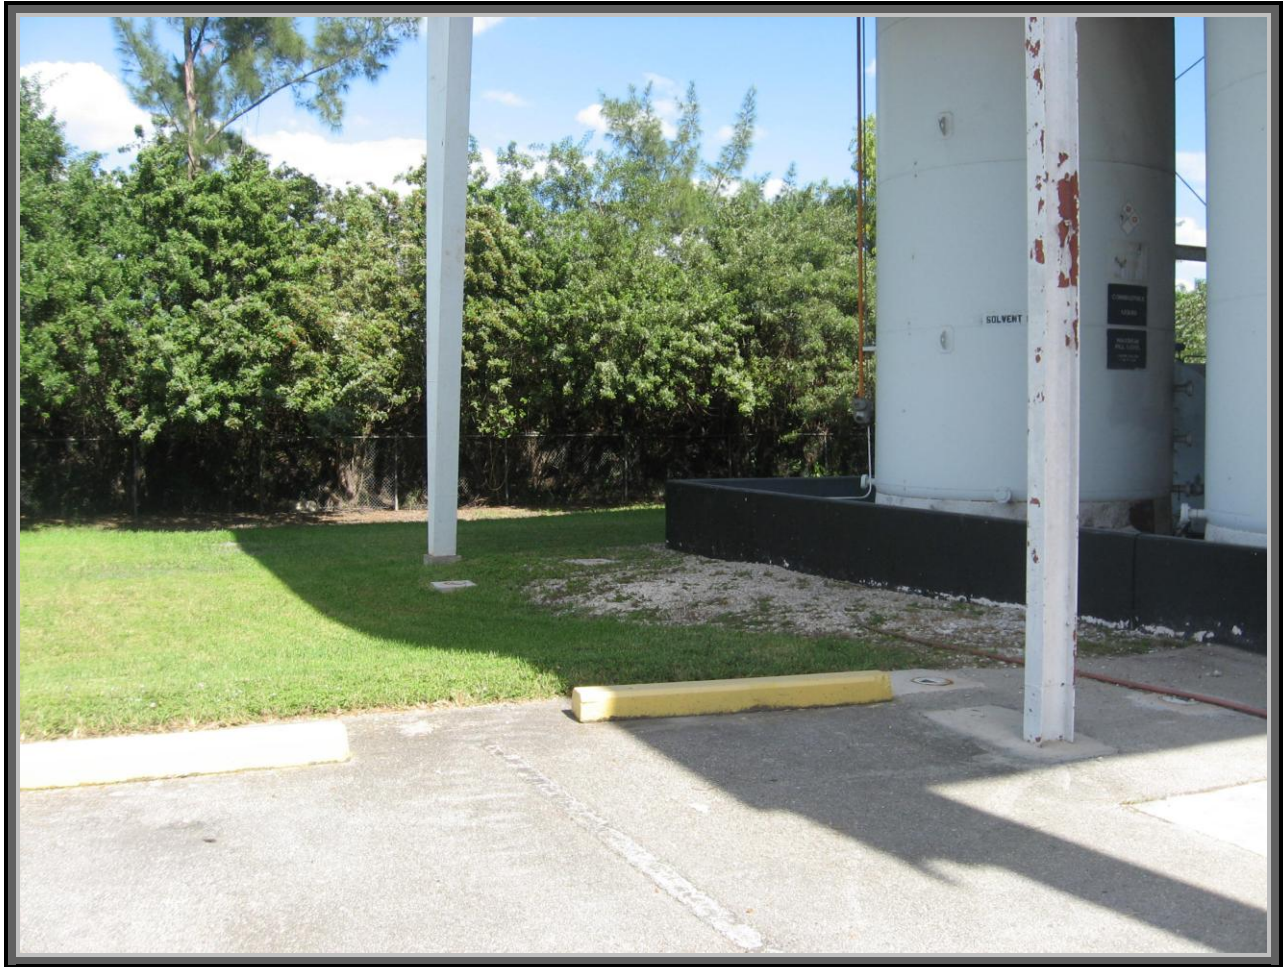
Photo of AOC A

Photograph showing Alph Area (AOC A) facing north/northeast. Photograph taken November 15, 2010 by Jeff Curtis. Note monitoring wells: MW-4 in front of rear roof support; MW-4D in the grassy area between MW-4 and the corner of the black secondary containment wall; MW-5 just right of the yellow curb on the parking lot, and MW-5D at the far right under the red hose.

WASTE MANAGEMENT AREA/AREA OF CONCERN REFERENCE NUMBER	AOC-A
NAME	Alpha Area
TYPE OF UNIT	Grassy area not used to manage wastes
DESCRIPTION OF WASTE MANAGED	Wastes were not managed at the unit
PHYSICAL DESCRIPTION AND CONDITION	This AOC is a grassy area located in the vicinity of monitoring well MW-1, adjacent to the western side of the aboveground storage tank area. The area impacted by arsenic-contaminated soils is an area less than 150 ft ² . Groundwater impacts were initially estimated to be limited to an area of approximately 470 ft ² and limited to the shallow monitoring wells.
HISTORY AND/OR EVIDENCE OF RELEASE(s)	Soil samples indicate the presence of tetrachloroethylene and arsenic above cleanup target levels. Groundwater samples indicated the presence of chlorinated solvents. Detailed information can be found in the site assessment report dated April 8, 2010.
RECOMMENDATION	Remedial Action Required
