Re: Ring Power Corp
4900 N Main St, Gainesville, Florida 32609
EPA/DEP ID: FLD 982 150 237
Alachua County - Hazardous Waste

**Florida Department of
Environmental Protection
Hazardous Waste Inspection Report**

Facility Name: Ring Power Corp.

Ring Power Corp was inspected on December 16, 2010, as a hazardous waste compliance evaluation inspection. The facility was last inspected by the DEP on 1/25/1995, when it was operating as a Conditionally Exempt Small Quantity Generator (CESQG). The facility last notified the DEP in March of 2010 as a CESQG and a used oil transporter, and is currently operating as such.

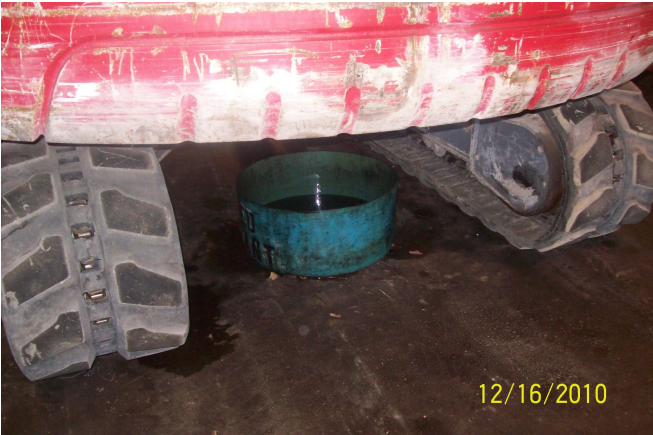
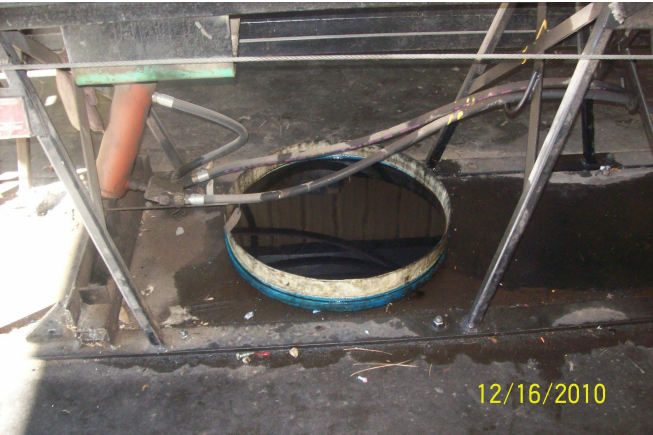
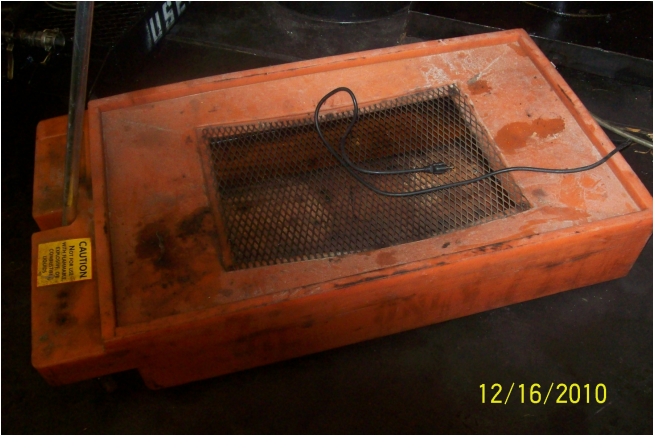
General maintenance on a variety of vehicles is performed in this area. Several used oil containers were not properly labeled with the words "Used Oil" (Photos 1 - 3) [[40 CFR 279.22\(c\)\(1\)](#)]. A 55-gallon drum of used oil within the shop was placed in a small metal containment. There was a small amount of used oil within the metal containment (Photo 4). [This is an area of concern.](#)

Type: Violation 1
Rule: 40 CFR 279.22(c)(1)
Explanation: Several used oil containers within the Service Shop were not properly labeled.
Corrective Action: No further action is required. The facility returned to compliance on 1/10/11.

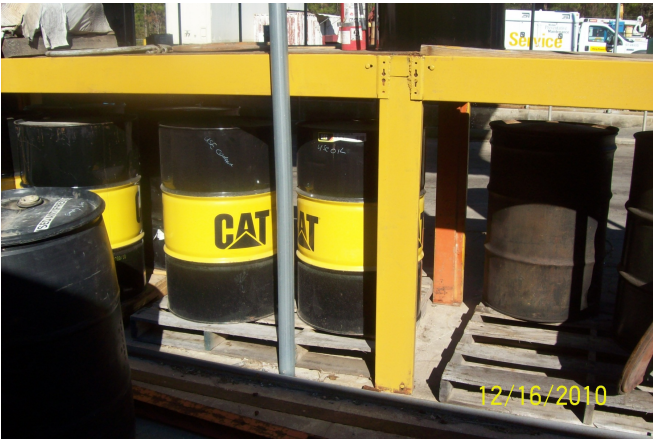
Photo 5

There was one 55-gallon drum in the area for the collection of waste aerosols. Mr. Jones stated that aerosol cans are collected in this drum once the shop has used them. Mr. Jones also stated that the waste aerosol cans are taken as needed by the facility to another Ring Power located in Tampa, where they are punctured and disposed of. None of the waste aerosol cans within the drum appeared to contain any residual liquids. The drum was dated 11/17/10. [This is an area of concern.](#)

2. Mr. Jones stated that aerosol cans are collected in a 55-gallon drum once the shop has used them. Mr. Jones also stated that the waste aerosol cans are taken as needed by the facility to another Ring Power located in Tampa, where they are punctured and disposed of. The facility is reminded that non-empty aerosol cans are, at a minimum, a D001 hazardous waste. Although CESQGs are allowed to transport hazardous waste in Florida without registering as a hazardous waste transporter, the receiving facility must have permission from the FDEP to receive hazardous waste from CESQGs. The DEP recommends one of the following disposal options for waste aerosol cans: the facility may throw away or recycle these cans as scrap metal if they are empty; the facility may collect the waste aerosols and have them disposed of with a treatment, storage, or disposal facility; or Ring Power may puncture the cans with a drum-top aerosol can puncturer on-site.

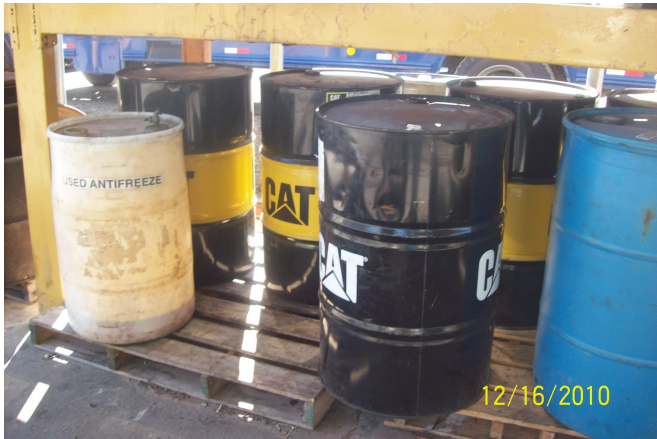
Photo 6

Equipment is washed down in this area with a closed-loop wash system. The facility also uses this area for storage of used oil drums that have been transported back to the facility after field technicians have serviced generators. At the time of the inspection, there were four 55-gallon drums of used oil in this area (Photos 5 - 7). All of the drums were labeled and closed; however, they were not within adequate secondary containment because they were stored at the edge of the concrete pad [[Rule 62-710.401\(6\), FAC](#)].

Type: Violation 3
Rule: Rule 62-710.401(6), FAC
Explanation: The facility failed to provide adequate secondary containment for four 55-gallon drums of used oil in the Wash Rack area.
Corrective Action: No further action is required. The facility returned to compliance on 1/24/2011.
