Re: Ring Power Corp
EPA/DEP ID: FLD 984 209 346
Duval County - Hazardous Waste

**Florida Department of
Environmental Protection
Hazardous Waste Inspection Report**

Facility Name: Ring Power Corp

On-Site Inspection Start Date: 02/21/2012

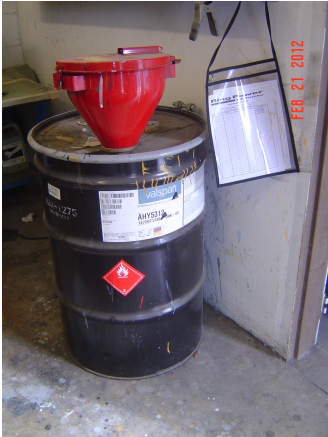
Photo 2

black and CAT yellow paints. Spray guns are cleaned by DT-5 Virgin lacquer thinner (35-45% methanol, 25-35 toluene, 15-20% acetone, 2 degrees Fahrenheit flashpoint), and the D001/F003/F005 hazardous waste is accumulated in a 55-gallon drum. This drum was properly labeled and closed (Photo 2). Its rags used for cleanup are laundered by Aramark.

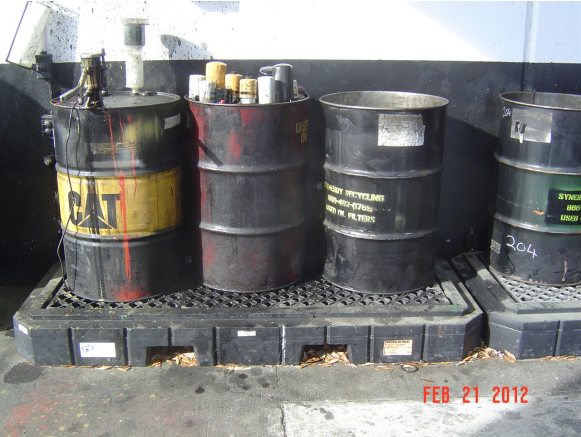
Photo 3

On the outside of the paint shop, and underneath cover, is where the facility stores its used oil filters (Photo 3). The facility drains its used oil filters into a 55-gallon drum labeled "used oil." The filters are then accumulated in two used oil filter drums, which were properly labeled. The facility operates an aerosol puncture system in this area. According to Mr. Meyer, the facility has not had to dispose of this aerosol waste to date. All of these drums were on secondary containment pallets.
