SUBJ: RCRA Compliance Evaluation Inspection (CEI)
AERC.com, Inc.
EPA I.D. Number: FLD984262782

**United States Environmental Protection Agency (USEPA)
Region 4, Atlanta, Georgia
Compliance Evaluation Inspection Report**

AERC.com, Inc.
4317-J Fortune Place
Brevard County
West Melbourne, FL 32904
EPA ID No.: FLD984262782
NAICS No.: 562111

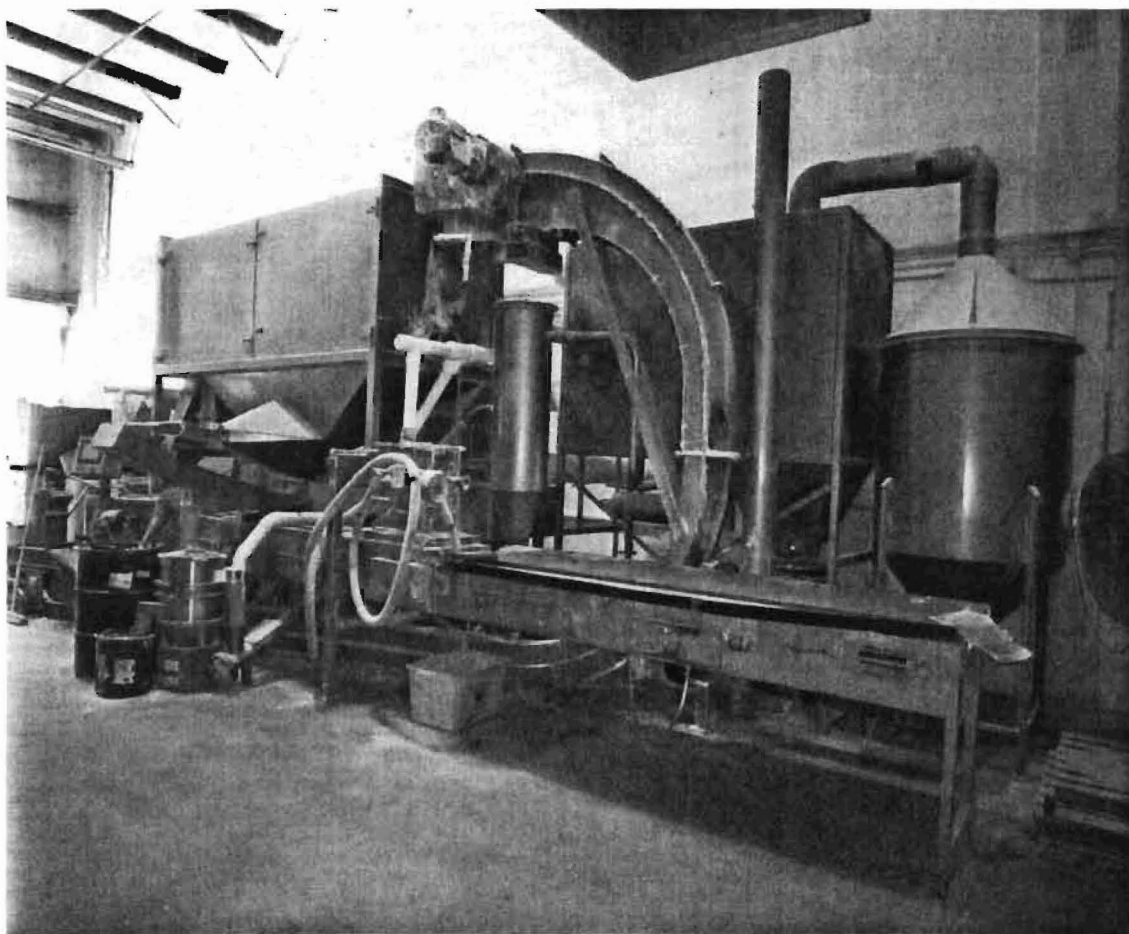
The lamp recycling machine (LSS-1) was not in operation at the time of the inspection (Photograph 1). Phosphor powder generated from lamp crushing in the LSS-1 is collected in a satellite accumulation container prior to transport to the 90 day hazardous waste storage area (Photograph 2). Glass, end caps, and HID bases (not ampoules) are sampled daily and sent to an outside laboratory for mercury analysis (5 day composite is analyzed). End caps generated from LSS-1 are sent to metal recyclers, Fortune Metals & Plastic Inc., located in Tampa, Florida (Photograph 3). Glass generated from LSS-1 is collected in a bin by LSS-1 prior to going to the roll-off container by the shipping/receiving dock area. The roll-off glass container destined for Brevard landfill, was full and covered (Photograph 4). Phosphor powder is transported as hazardous waste to the AERC facility in Pennsylvania.

Photograph 1 – Lamp recycling machine (LSS-1)

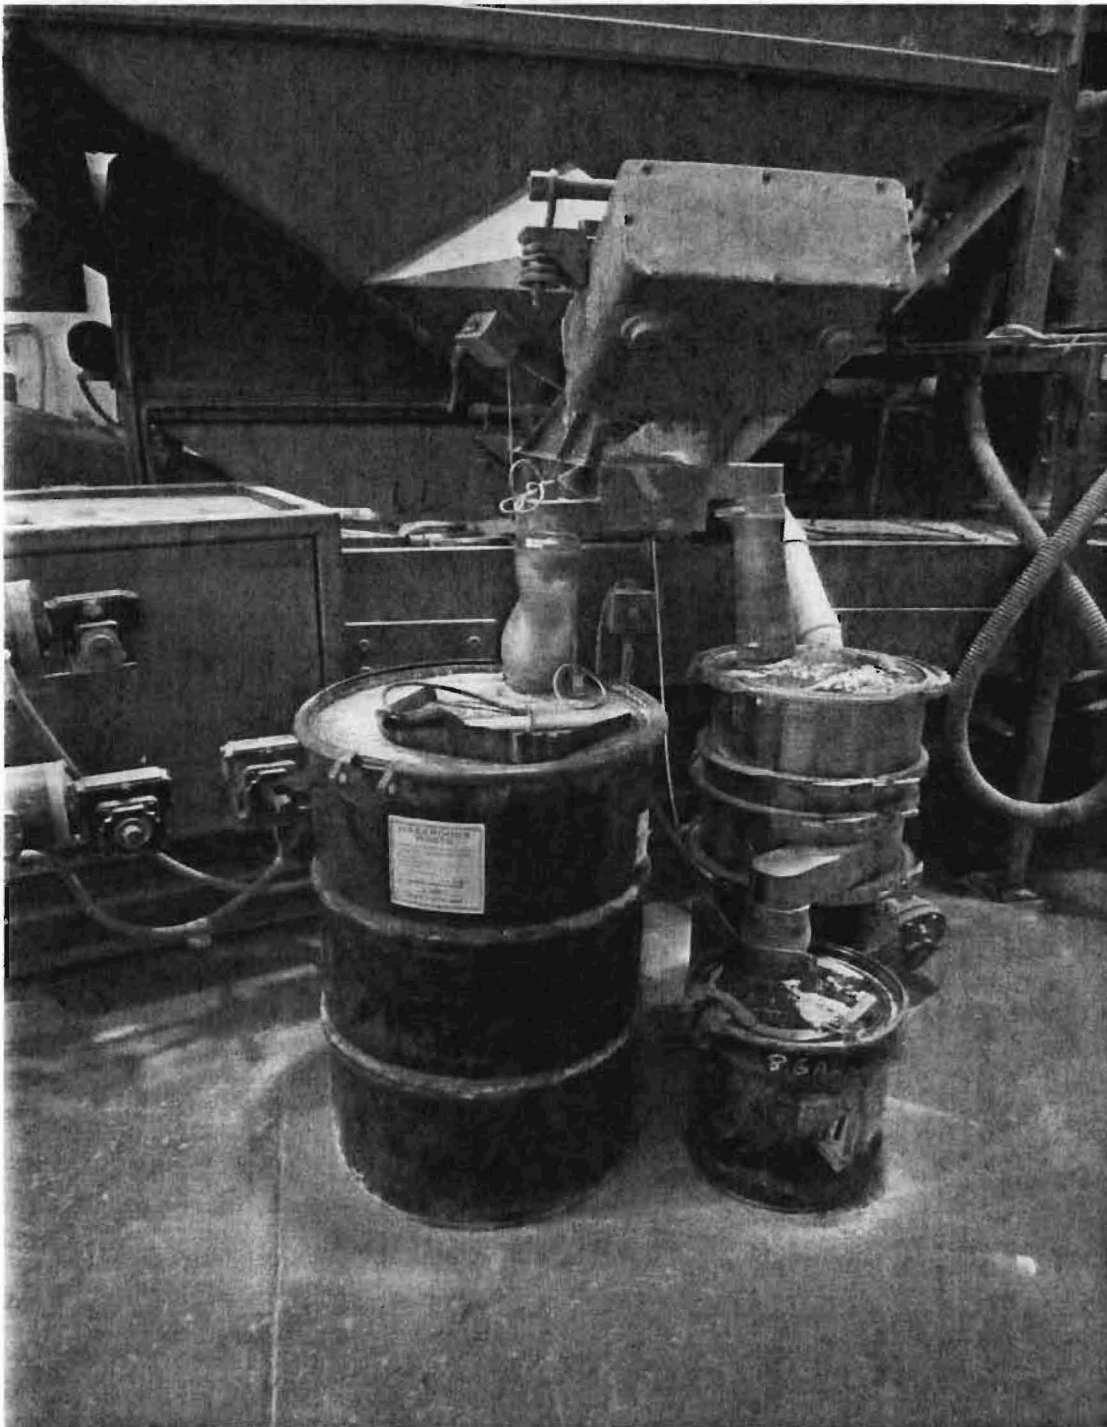
Photograph 2 – Satellite accumulation container of phosphor powder.

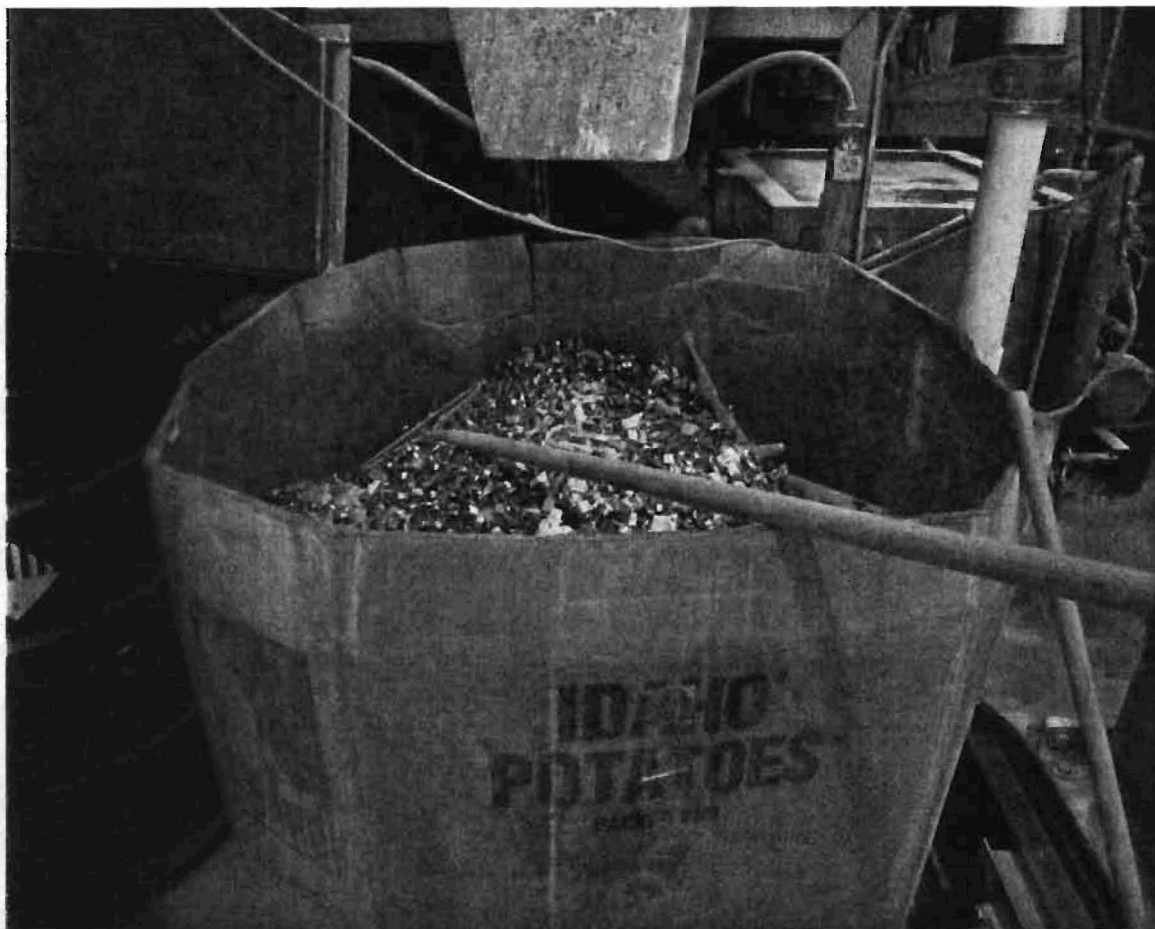
Photograph 3 – End caps generated from LSS-1

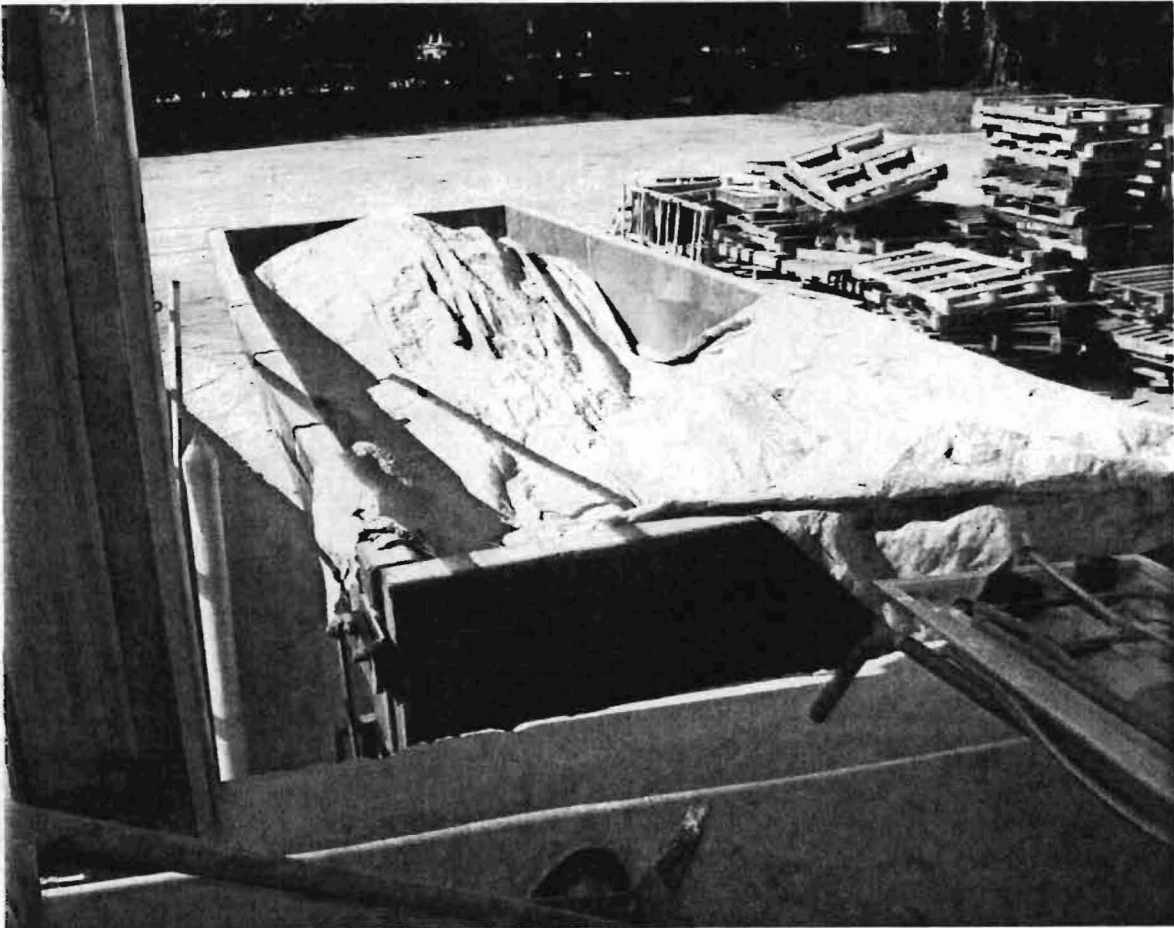
Photograph 4 – Covered roll-off container of clean glass

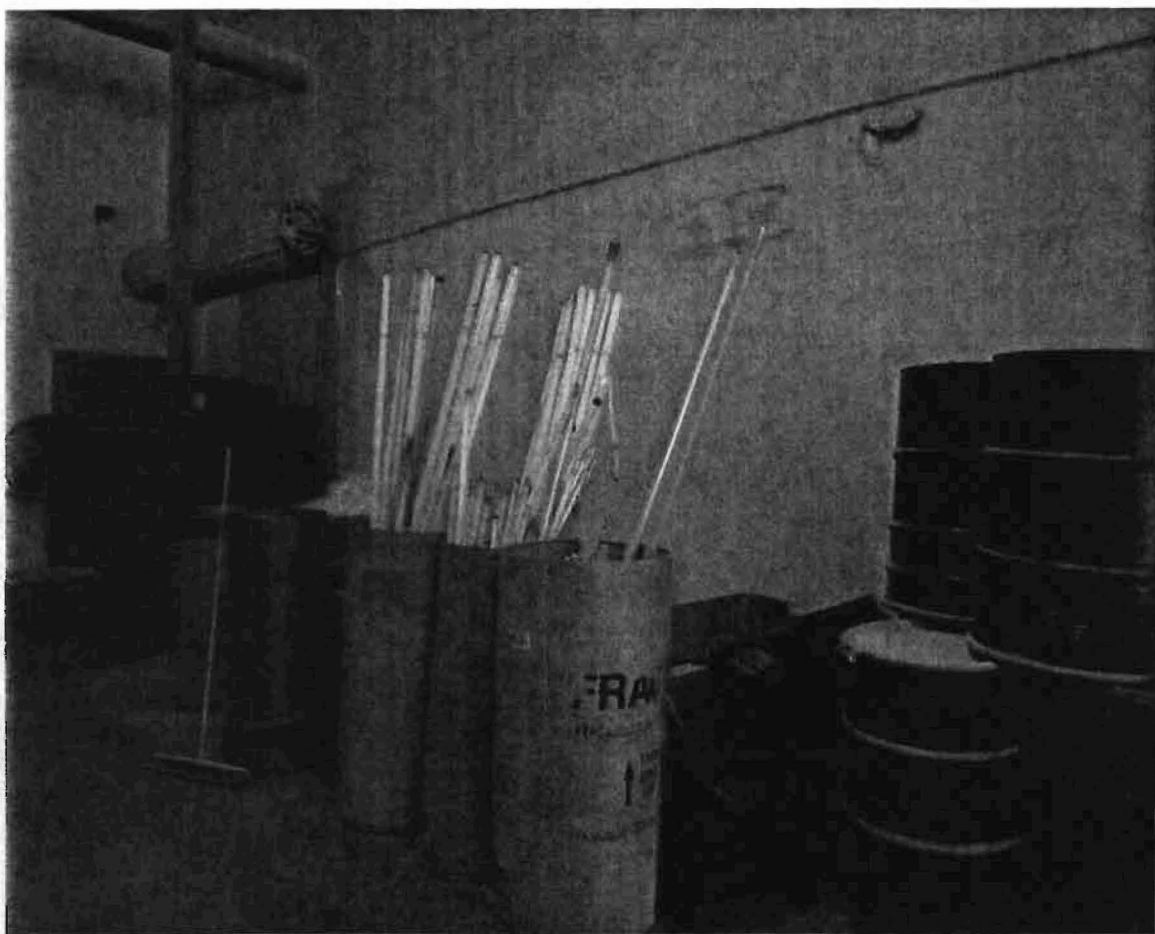
During the inspection, there were three open containers of lamps near the LSS-1 (Photograph 5). **AERC appears to be in violation of F.A.C. Chapter 62-730.185(1) (40 C.F.R. § 273.33(d)(1)), which states that containers or packages of lamps must remain closed. The inspectors informed AERC to keep all boxes/containers closed prior to processing.**

Photograph 5 – Open containers of lamps

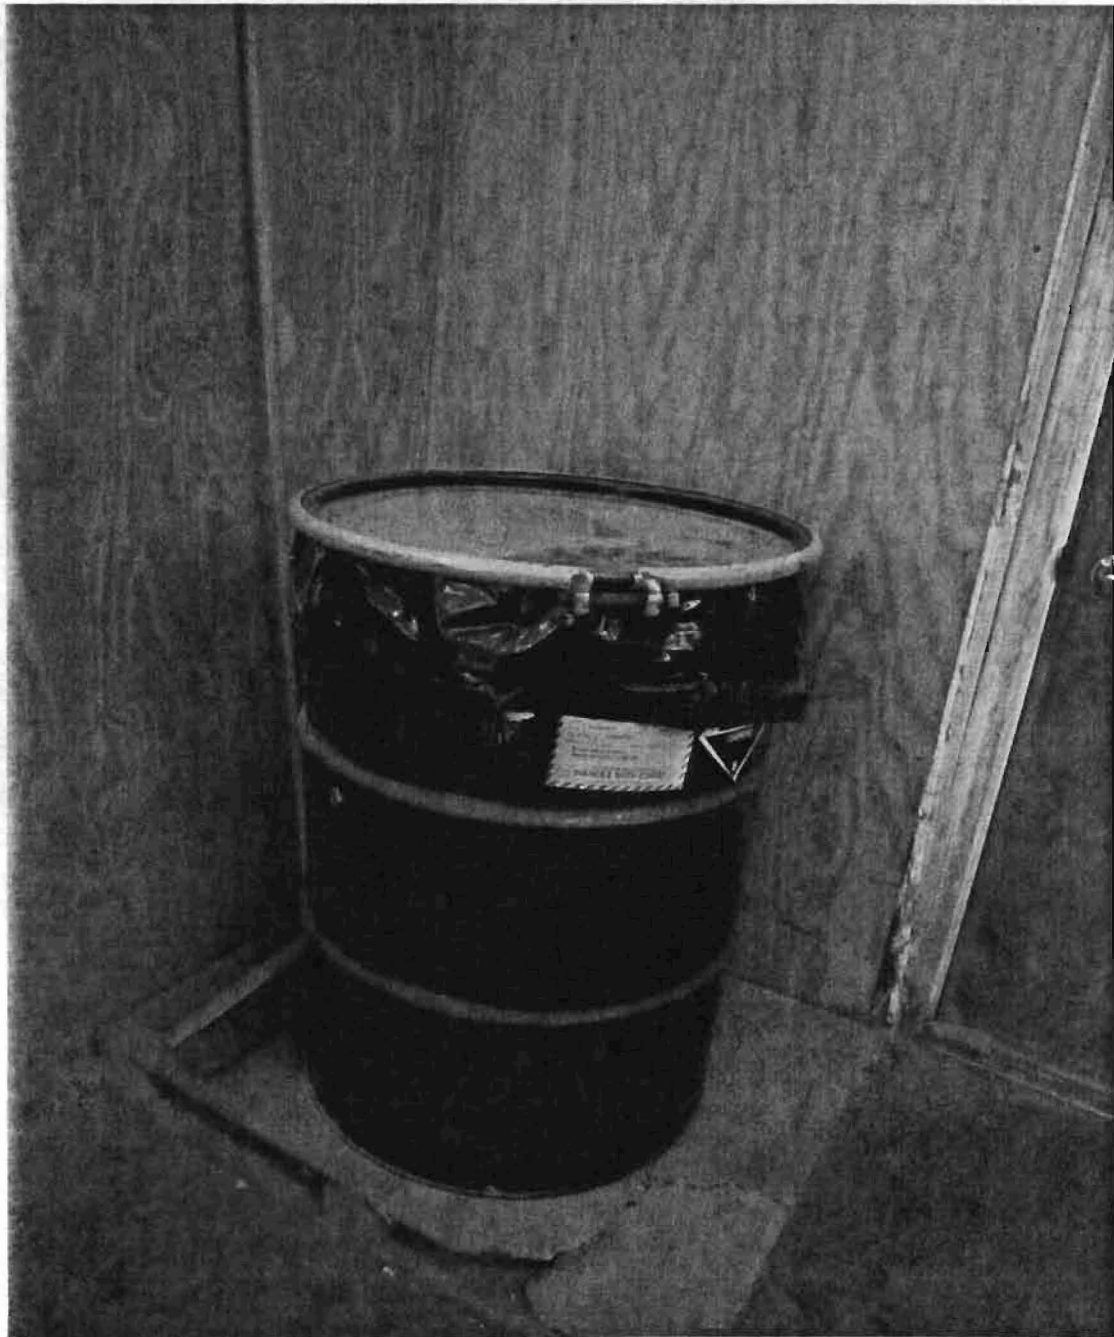
Ampoules are removed from the H.I.D. lamp bases in this area. The ampoules contain liquid mercury. One 55-gallon container of ampoules closed and labeled "Hazardous Waste", dated (4/13/11), was located in this area (Photograph 6). AERC was informed that a satellite accumulation container for the collection of mercury containing ampoules at the point of generation does not require dating, until the satellite container becomes full (and greater than 55 gallons of hazardous waste begins accumulating in the satellite area) and is moved (within 3 days of accumulating greater than 55 gallons of hazardous in the satellite area) to the 90 day area.

Photograph 6 – Satellite area with 55-gallon container of ampoules

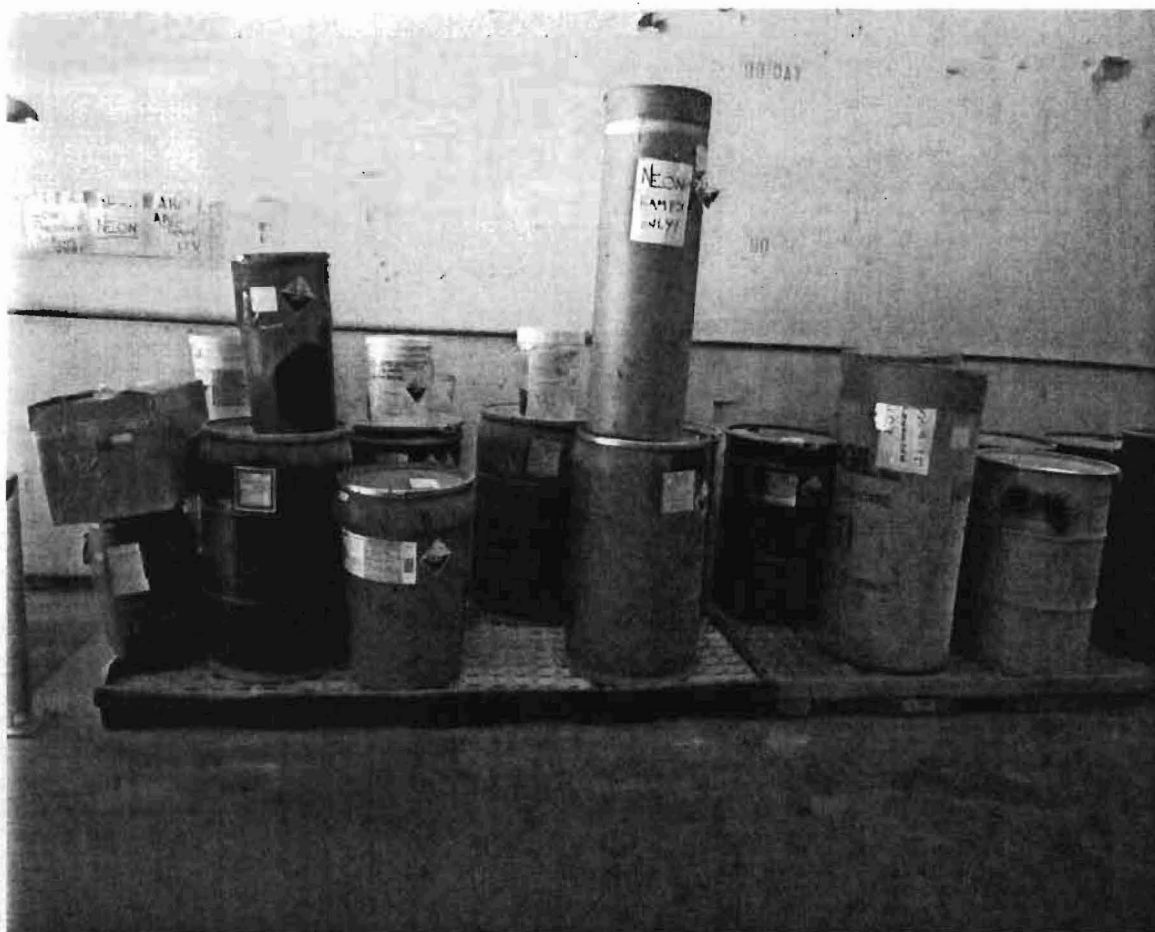
The 90 day area contained mercury containing devices/debris (D009 hazardous waste). According to AERC, material in the 90 day storage area goes to the AERC Pennsylvania facility for disposal and/or to be disassembled and treated by thermal retort. Approximately, fifteen 55-gallon containers and twelve smaller containers of hazardous waste were located in the 90 day area (Photograph 7). The 10 day transfer area contains wastes received with the mercury containing waste plus additional hazardous waste. Approximately, sixteen 55-gallon containers of hazardous waste were stored in this area. These containers are transferred to the Pennsylvania facility within ten days of receipt (Photograph 8).

Photograph 7 – 90-Day Storage Area

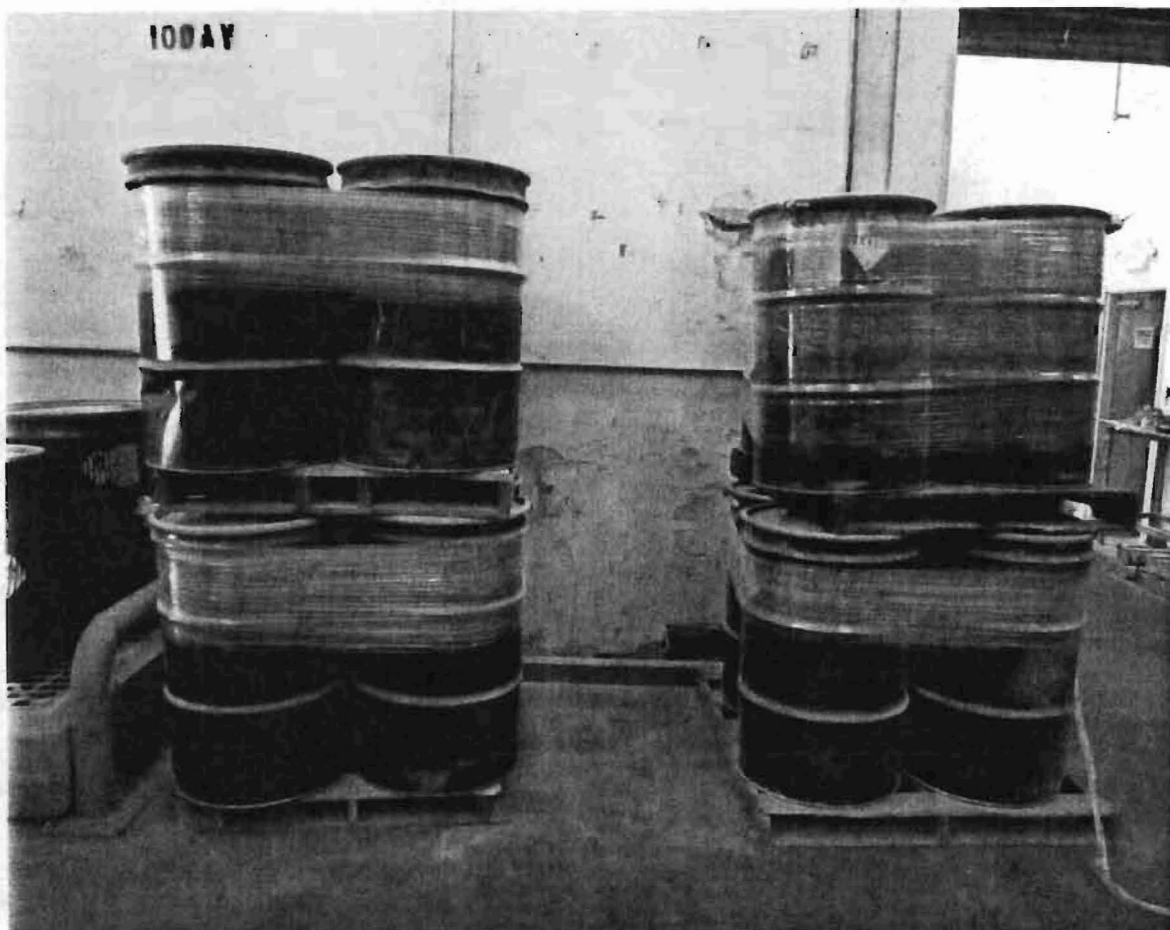
Photograph 8 – 10-Day Transfer Area

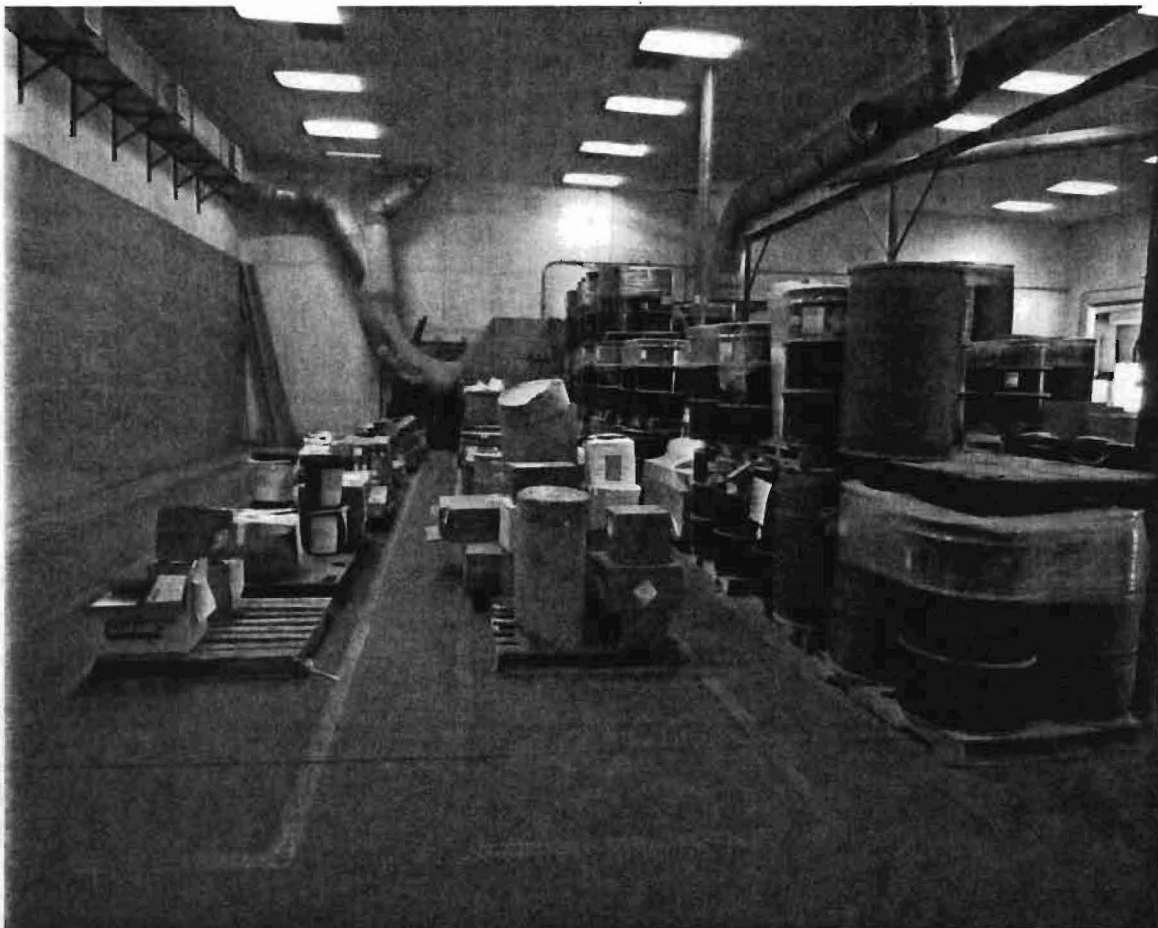
The staging area takes up the majority of the warehouse area and consists of multiple rows of materials in storage. During the inspection, Row 1 consisted of HID lamps and compact bulbs (Photograph 9). Rows 2 and 3 consisted of fluorescent lamps for processing in LSS-1. Row 4 contained PCB ballasts, crushed lamps, and batteries. Row 5 contained compact lamps and batteries. Row 6-8 contained batteries.

Photograph 9 – Staging area row 1-3

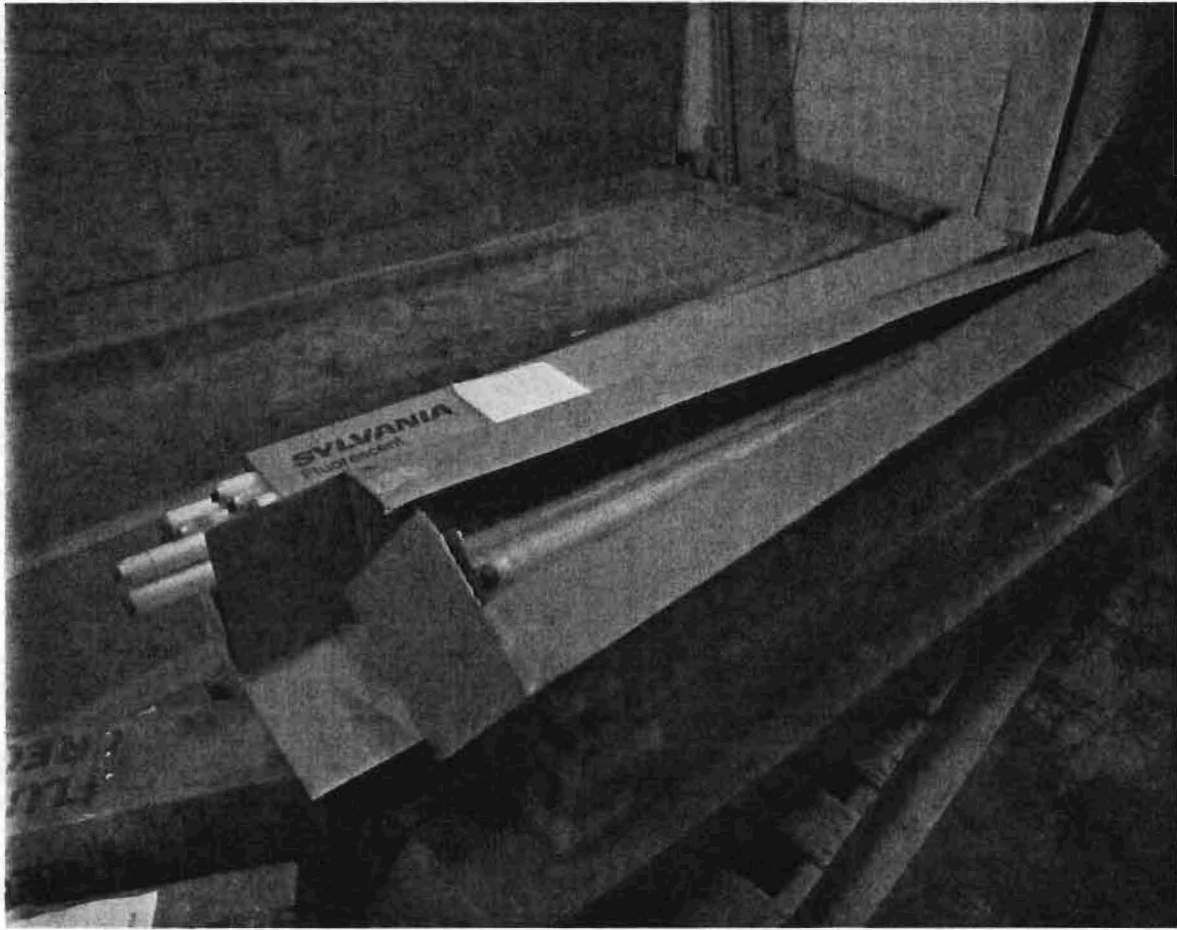
During the inspection, the inspectors observed several boxes of lamps were not closed in row 1 and 2 (Photograph 10). **AERC appears to be in violation of F.A.C. Chapter 62-730.185(1) (40 C.F.R. § 273.33(d)(1)), which states that containers or packages of lamps must remain closed. The inspectors informed AERC to keep all boxes/containers closed prior to processing.**

Photograph 10 – Open boxes of lamps

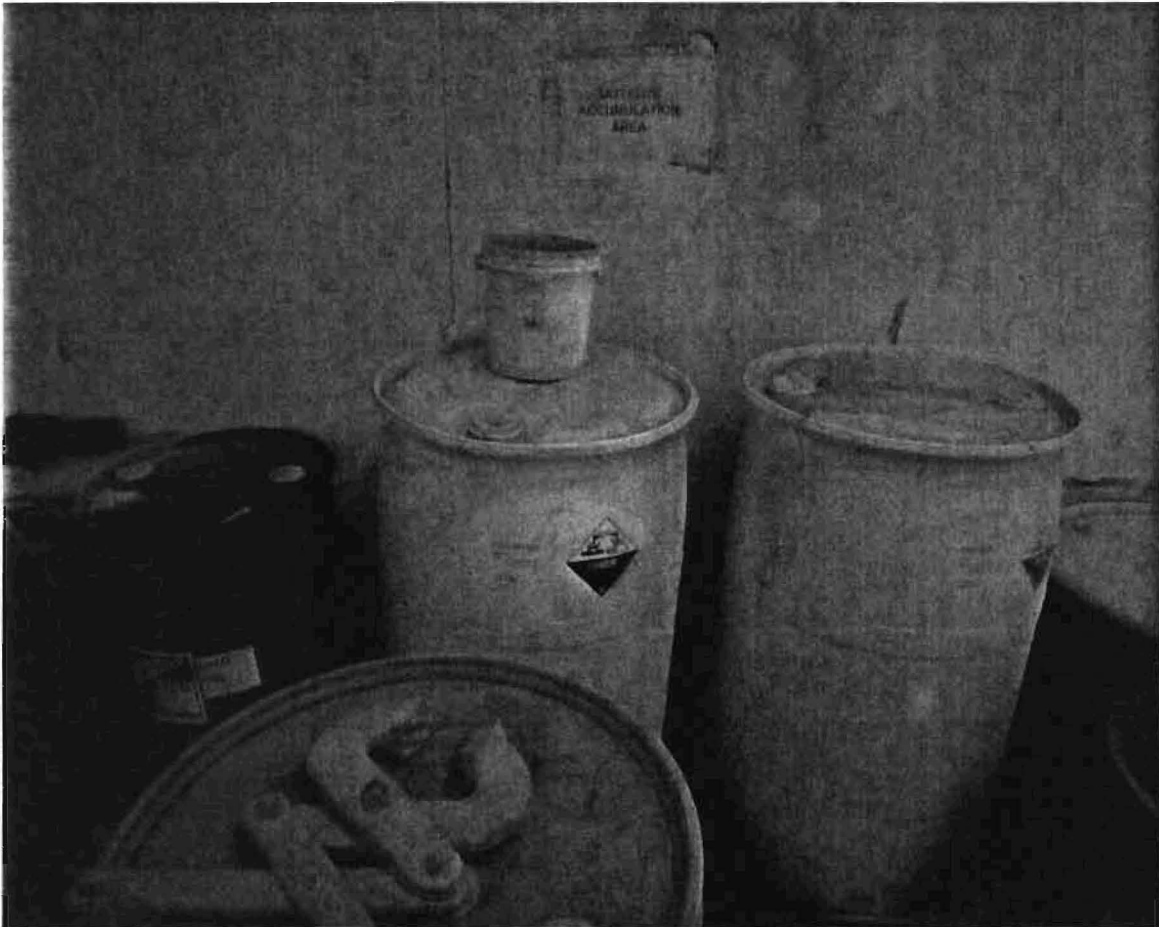
Waste batteries managed as universal waste are sorted and consolidated by type. On the east side of the warehouse, between the battery processing area and universal waste battery storage area, were two satellite accumulation containers for corrosive hazardous wastes (Photograph 11). One 55-gallon satellite accumulation container was used to collect caustic (sodium hydroxide) waste, one 55-gallon satellite accumulation container was used to collect acid (sulfuric acid) waste, and one 30-gallon container was used to collect used oil. All containers were closed and labeled.

Photograph 11 – Satellite accumulation area for battery electrolytes.
