Florida Department of
Environmental Protection
Hazardous Waste Inspection Report

Facility Name: Veolia ES Technical Solutions LLC

On-Site Inspection Start Date: 06/11/2012

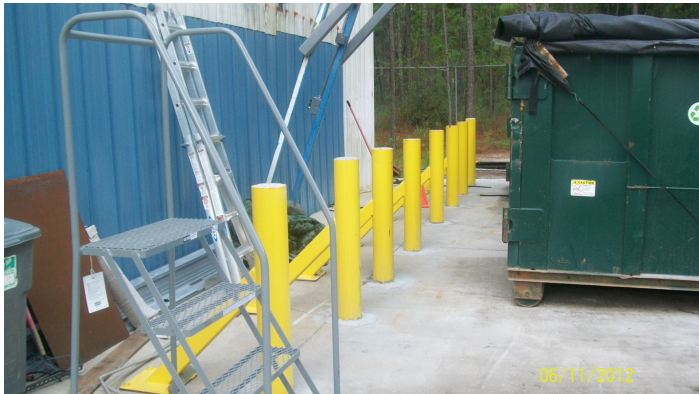
Outside North Storage

Four 20-yard roll-offs for collection of processed glass are staged in this area on a concrete pad. An adjacent asphalt paved area is used for collection of paper-products, wood pallet recycling, UW bulk delivery drop off (FEDEX), and various empty container storage. At the north end of this paved area are two container trailers for storage of equipment, replacement parts and empty non-hazardous containers. This area is also used for overnight holding of transport trucks in the event of an arrival after business hours. The trucks are immediately unloaded during the next business day.

The concrete pad as been expanded to accomodate the two additional roll-offs that have been added to the facility. The two new roll-offs were added to ensure that all processed glass is below the permitted levels of mercury. If a sample is found to exceed permitted levels the additonal roll-offs allows for the glass to be resampled and reprocessed if needed. Located behind the four roll-offs are new concrete/metal bracers to ensure that the building is protected from a roll-off loading incident. The area had previously been used as an offloading area for FEDEX trucks that could not backup to the loading bays near the eastern side of the building. The trucks now pull up to the docks for off-loading. There were no trucks in the 10-day hazardous waste transfer area at the time of this inspection.

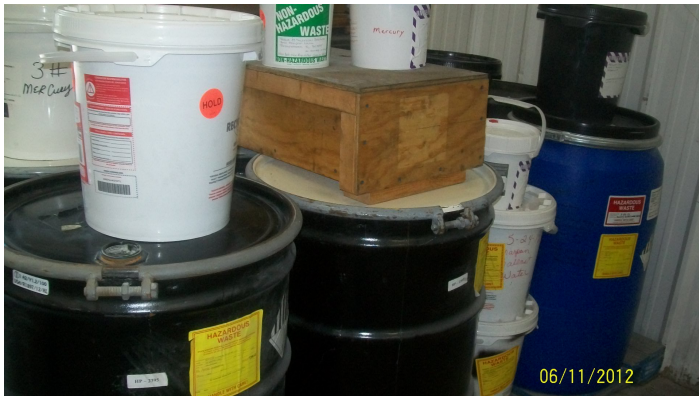
Container Storage

Veolia previously had two separate hazardous waste staging areas, "Hazardous Waste Storage Area" (HWS Area) and "90-Day Accumulation Area" (90-Day Area), both located inside the north end of the main building. In the new operating permit these areas are now designated as "Container Storage Areas One and Two" (CSAs). The CSAs are permitted for up to 27 pallets (108 55-gallon drums) of MCMA, dental amalgam and traps, pre-retort phosphor powder, HID arc tubes, and site-generated hazardous waste (prep room debris and PPE, condensate water, and spent carbon). At the time of this inspection, hazardous waste stored in the CSA One included 24 55-gallon drums, nine five-gallon buckets, two one-gallon buckets and three coardboard boxes of spill pads and belting from the HID machine.

CSA Two contained three containers of aluminum end caps and a 55-gallon drum of mop water that was being accumulated. The oldest date observed in the storage areas was March 07, 2012. No violations were observed during the time of the inspection.

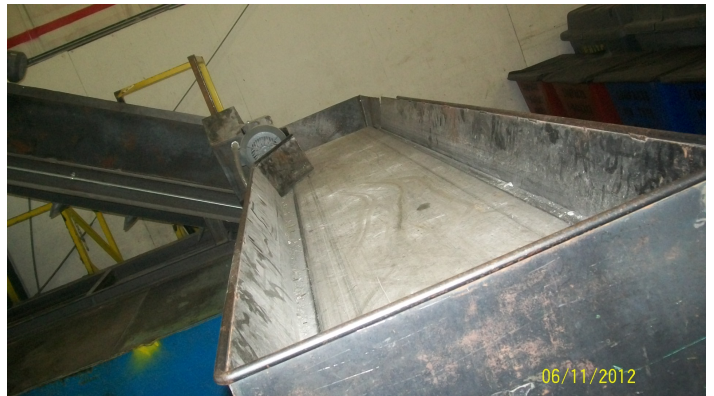
Conveyor/Feeder on HID Machine

HID lamps are processed manually or through a custom built HID machine in the southern end of the building. The HID lamp machine is comprised of conveyor belts, crushers, magnets, and air pollution control equipment. It is enclosed and under negative pressure. It uses an automated process to dry-separate outer glass, metal bases and support wires from the arc tubes. The arc tubes are crushed and dropped into 55-gallon drums for further processing in the retort room. The remaining components are dropped into collection containers for recycle/disposal. The drums of crushed arc tubes are managed as satellite accumulation area containers and moved to the HWS Area at the north end of the building within three days. In the manual process, individuals carry out the separation and sorting procedures by hand. The separated arc tubes are fed into the HID machine for crushing prior to retort. A new automatic feeder/conveyor belt has been added to the HID processing machine. The new conveyor belt allows for in the increased processing of HID lamps to 37,000 lamps per 8-hour shift.

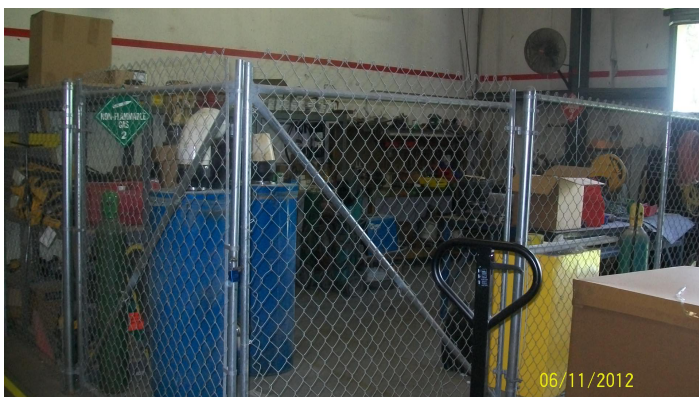
New Maintenance Area

The loading and unloading area consists of two trailer docking areas for forklift transfer of materials to/from transport vehicles. All FEDEX deliveries are now unloaded at this dock. Post-retort phosphor powder in 55-gallon drums is accumulated in this area along the east wall prior to off-site shipment for disposal in a Subtitle D landfill. The permit requires that post-retort phosphor powder be sampled to ensure effective retort processing prior to off-site shipment. The facility maintenance area has been moved to the southern end of the building closer to the HID processing machine. The area is enclosed by a cage that keeps all maintenance materials separated from processing equipment. During the inspection of the facility, approximately 10 drums total of post-retort phosphor powder and a box of used non-hazardous PPE were being stored in this area. No violations were observed at the time of the inspection.

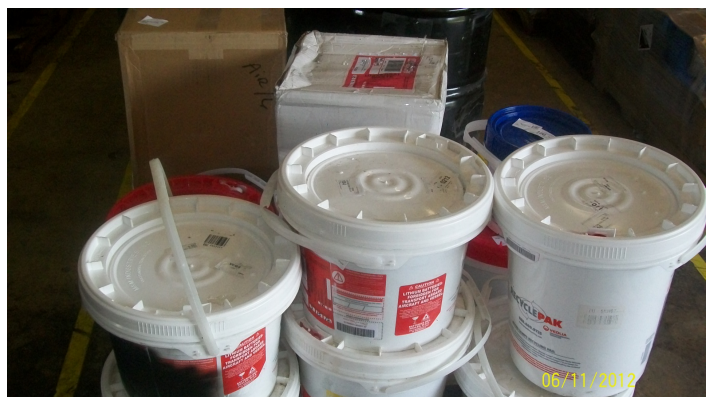
Battery Storage

This building is immediately south of the main building and is divided into two large storage areas. The Container Storage Area is used to hold empty fiber drums and cardboard boxes. No universal or hazardous wastes are stored in this area. The second room in this building is used for storage of e-waste and battery storage. The space is permitted to store up to 72 pallets. At the time of the inspection all pallets were properly labeled and protected from the environment. No violations were observed at the time of the inspections.
