**Florida Department of
Environmental Protection
Hazardous Waste Inspection Report**

Facility Name: International Paper Co Pensacola Mill
On-Site Inspection Start Date: 06/26/2012 **On-Site Inspection End Date:** 06/26/2012
ME ID#: 26581 **EPA ID#:** FLD008166639
Facility Street Address: 375 Muscogee Rd, Cantonment, Florida 32533-1422
Contact Mailing Address: 375 Muscogee Rd, Cantonment, Florida 32533-1422
County Name: Escambia **Contact Phone:** (850) 968-4258

Routine Inspection for SQG (100-1000 kg/month) facility
Routine Inspection for Used Oil Generator facility

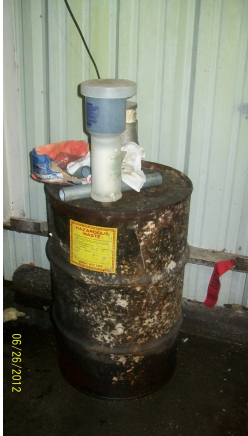
There are two paper machine lines in the Production Area, P4 (fluff pulp) and P5 (liner board). Aerosol cans are the only waste stream routinely managed as hazardous waste in this area. We visually inspected the aerosol can satellite accumulation area (SAA) for P4, located in the P4 basement. The SAA was a 30-gallon drum with a can puncturing device screwed into the bung hole and a carbon filter screwed into the vent hole. The drum was labeled and closed. The filter had instructions printed on it that said to replace every 90 to 120 days, but was not dated. Hydraulic oil had leaked from the machinery above and was pooled on the floor in this area (less than 25 gallons). The oil appeared to be contained within the building. IP employees put down absorbent pads during the inspection to soak up the oil.

P4 - Aerosol Can Puncturing SAA

Explanation: IP had six open HW drums (four aerosol can puncturing drums, one liquid paint waste drum and one waste air compressor oil drum).

Corrective Action: Four of the drums were closed during the on-site inspection. Documentation was submitted to demonstrate closure of the remaining drums the following day.

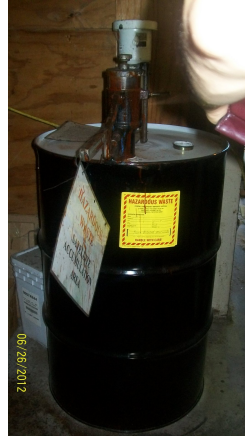
Aerosol cans are punctured in this area and residue is collected in a closed container labeled "Hazardous Waste". The puncturing device was in the open position rendering the drum open. Air compressor oil is accumulated in a 55-gallon drum labeled HW. The drum was open with a funnel resting in the open bung hole. Both drums were closed during the inspection.

E&I Shop - Aerosol Can Puncturing SAA

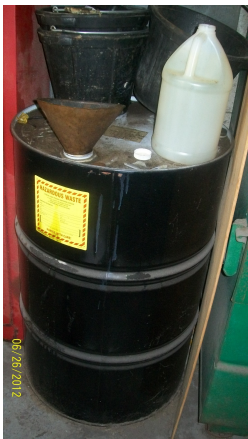
E&I Shop - Air Compressor Oil SAA

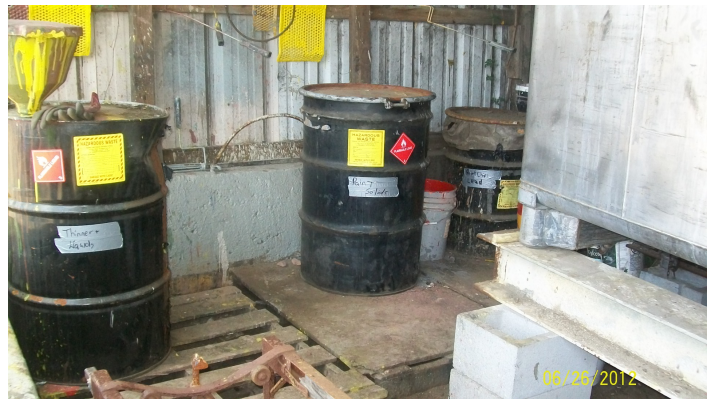
MIC is IP's paint contractor and has an on-site office, storage, and yard area (Paint Yard). Hazardous waste is satellite accumulated in a three sided shed with curbed concrete floor. Three SAA drums were observed: one 55-gallon drum marked "HW Thinners/ Liquids," one 55-gallon drum marked "HW Paint Solids," and one 30-gallon drum marked "HW Paint Chips Lead." The drum marked "Thinners/Liquids" was a closed top drum. A funnel was screwed into the bung hole, but did not adequately seal the drum. It also had a large dent in the side. The drum labeled "HW Paint Chips Lead" had an unsecured lid and significant rusting.

Paint Yard - Paint Waste SAAs

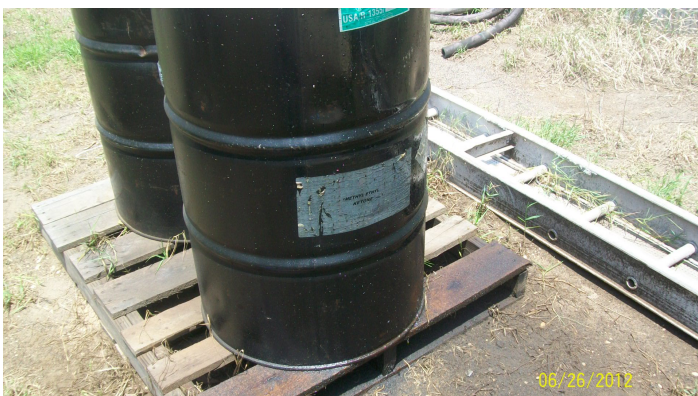
Two 55-gallon drums with MEK product labels were marked "30-Weight Oil" and had stained soil beneath them. They were on a wooden pallet between two trailers in the Paint Yard.

Explanation: In Reed's Maintenance Shop, one 110-gallon tank and one 55-gallon drum of used oil were being stored without secondary containment. In Mansfield's Paint Yard, two 55-gallon drums (MEK product drums) of used oil were being stored without secondary containment and had stained soils beneath them. Two tanks and two 55-gallon drums labeled "Wood Yard Used Oil" were staged outside the Wood Yard Maintenance Shop without secondary containment, see pictures.

Paint Yard - Used oil drums & stained soil

Corrective Action: IP and Reed agreed to move the used oil drum into the building and have it pumped by McPherson. It will not be used for storage of used oil after pumping. The used oil tank was put into a concrete containment unit. The containment appeared to meet the requirement to hold at least 110% of the largest container within the containment. IP moved the MEK drums to the 180-Day HW Storage Building to await pick-up by McPherson. The stained soils were removed and placed in closed 55-gallon drums. The stained soil was sampled and analysis by Test America for MEK was non-detect. IP has removed the single-walled (red) tank from service and placed the single-walled black tank into secondary containment along with the drums.

Recommend IP review Mill procedures to ensure that all "Used Oil" including "Wood Yard Used Oil" is stored within required secondary containment.

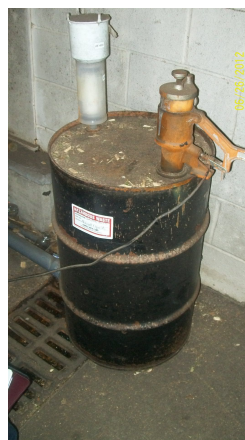
The aerosol can puncturing SAA for the Wood Yard Crane was observed to be open (puncturing device in open position). This was corrected during the inspection.

Wood Yard Crane Aerosol Can Puncturing SAA

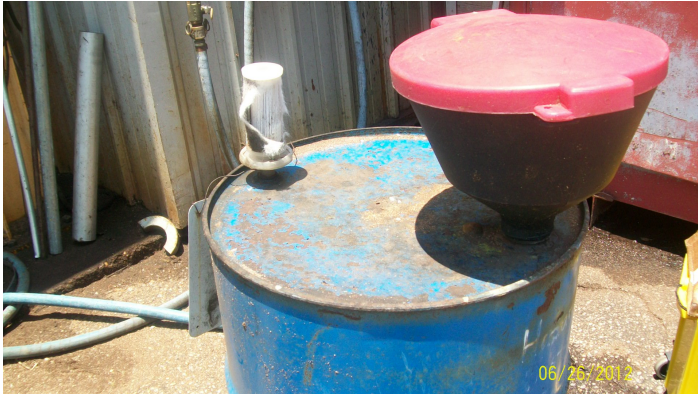
Two tanks and two 55-gallon drums labeled "Wood Yard Used Oil" were staged outside the Wood Yard Maintenance Shop without secondary containment. Aerosol cans are punctured in this area and residue is collected in a 30-gallon container labeled "Hazardous Waste." The drum had a funnel in the bung hole that did not seal the drum and the filter was broken. Mr. Taylor called maintenance to have the drum replaced.

Wood Yard Aerosol Can Puncturing SAA

Recommend IP consider centralizing aerosol can accumulation and puncturing to reduce the number of aerosol can puncturing SAAs and institute a system to routinely inspect SAAs for compliance.

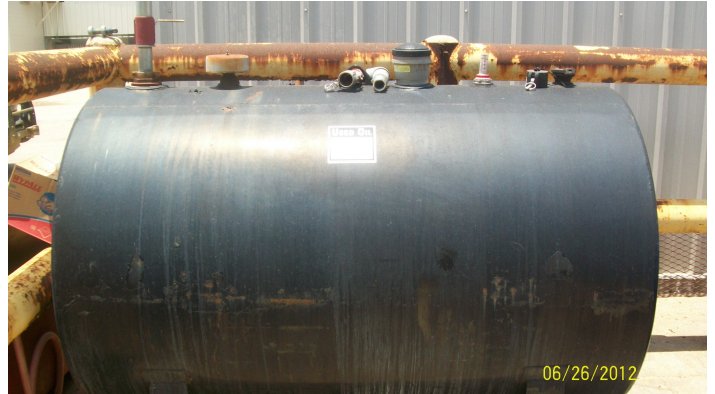
Wood Yard Used Oil Tank (black)

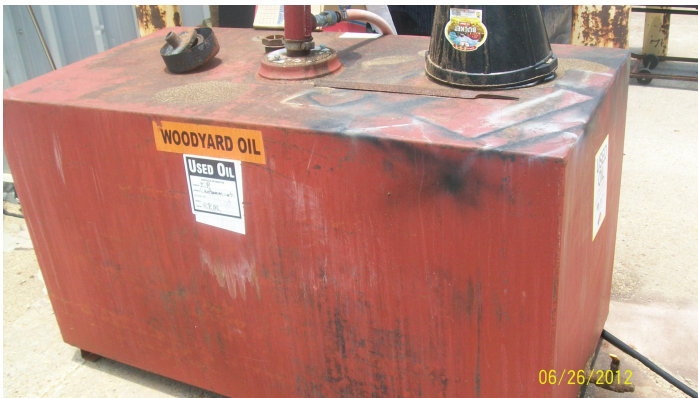
Wood Yard Used Oil Tank (red)

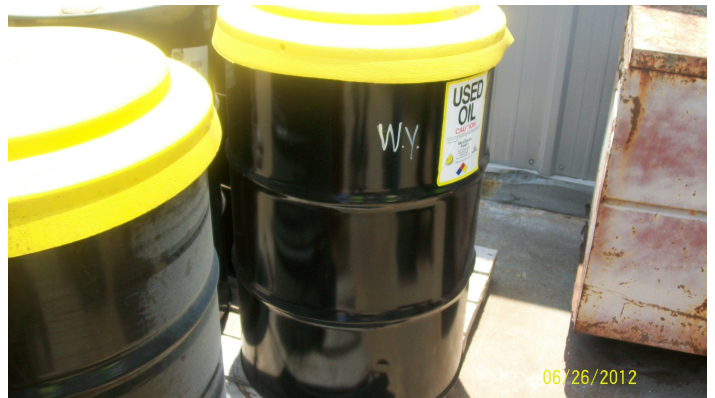
Wood Yard Used Oil 55-gallon drums
