**Florida Department of  
Environmental Protection  
Hazardous Waste Inspection Report**

**Facility Name:** Veolia ES Technical Solutions LLC

**On-Site Inspection Start Date:** 10/16/2012

Florida Department of  
Environmental Protection  
Hazardous Waste Inspection Report

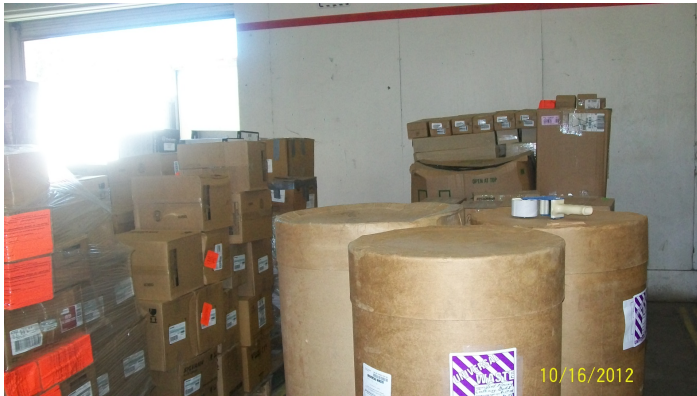
### Universal Waste Storage

This area, located on the west side in the southern portion of the building, is the lamp storage area. The area has a permitted maximum storage capacity of 7,424 cubic feet of mixed fluorescent and HID lamps. The area is used for temporary storage of universal waste lamps that cannot be immediately processed. These lamps normally consist of HID lamps, U-shaped lamps and other specialty lamps that require manual processing prior to recycling/reclamation. The area is also used for temporary storage of universal waste batteries and non-RCRA hazardous materials.

All of the inbound material was labeled, closed, and in good condition. All containers were within their permitted areas and no broken or exposed universal waste was observed. The area appeared to be in compliance at the time of the inspection.

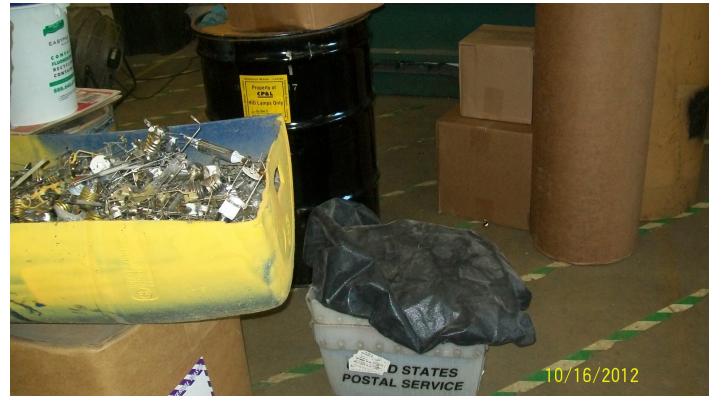
### Manual Processing Area

HID lamps are processed manually or through a custom built HID machine at the southern end of the building. The HID lamp machine is comprised of conveyor belts, crushers, magnets, and air pollution control equipment. It is enclosed and under negative pressure. It uses an automated process to dry-separate outer glass, metal bases and support wires from the arc tubes. The arc tubes are crushed and dropped into 55-gallon drums for further processing in the retort room. The remaining components are dropped into collection containers for recycle/disposal. The drums of crushed arc tubes are managed as satellite accumulation area containers and moved to the CSA at the north end of the building within three days. In the manual process, individuals carry out the separation and sorting procedures by hand. The separated arc tubes are fed into the HID machine for crushing prior to retort.

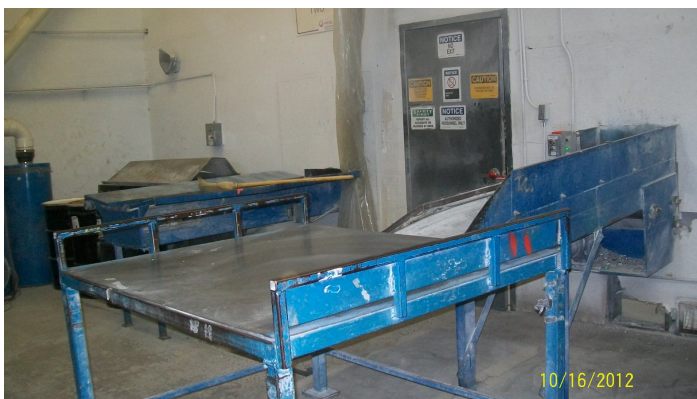
### Lamp Processing Lines

Fluorescent lamps are staged immediately adjacent to the lamp processing feed belts. Fluorescent lamps are hand fed into the lamp processing room via a conveyor belt.

The Fluorescent Lamp Processing room, located in the northwest corner of the facility, is designed to process approximately 200,000 feet of lamp equivalents per 8-hour shift. Lamps are crushed with a drum crusher and dry-separated into glass, aluminum and phosphor powder. Phosphor powder is collected by a bag tower and accumulated in 55-gallon drums. Veolia has a second processing line that is used when there is a need to process a larger volume of materials. No violations were observed at the time of the inspection.

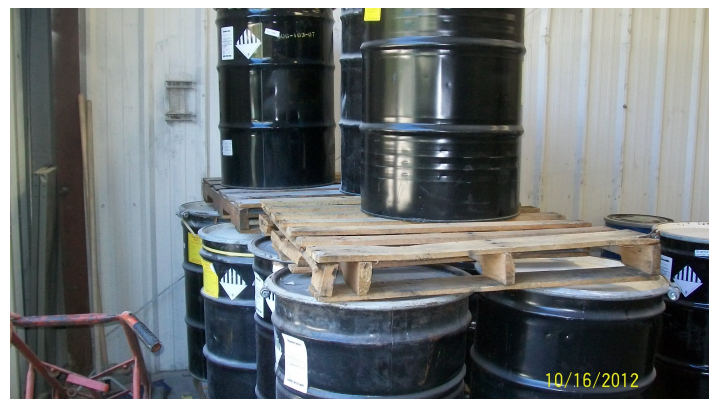
### Container Storage Area

Veolia previously had two separate hazardous waste staging areas, "Hazardous Waste Storage Area" (HWS Area) and "90-Day Accumulation Area" (90-Day Area), both located inside the north end of the main building. In accordance with the new operating permit, these areas are now designated as "Container Storage Areas One and Two" (CSAs). The CSAs are permitted for up to 27 pallets (108 55-gallon drums) of MCMA; dental amalgam and traps; pre-retort phosphor powder; HID arc tubes; and site-generated hazardous waste (prep room debris and PPE, condensate water, and spent carbon).

At the time of this inspection, hazardous waste stored in CSA One included 12 55-gallon drums (seven 55-gallon drums of capsules, five 55-gallon drum of phosphor powder), one 35-gallon drum of small capacitors, two gaylord boxes of belting, and one gaylord box of hazardous PPE. CSA Two contained four containers of aluminum end caps and two 55-gallon drums of mop water that were being accumulated. The oldest date observed in the storage areas was August 9, 2012. No violations were observed at the time of this inspection.

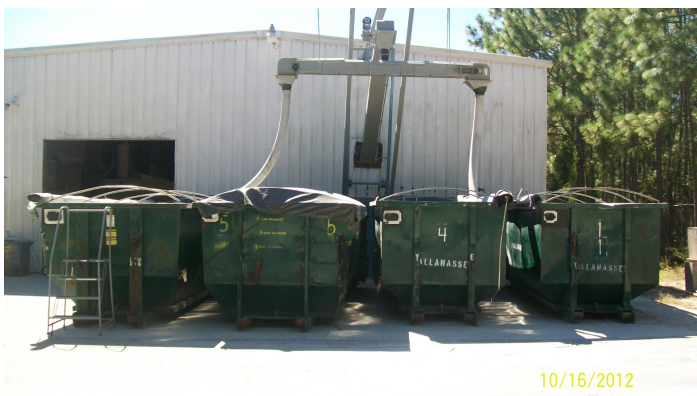
### Processed Glass Roll-offs

Four 20-yard roll-offs for collection of processed glass are staged in this area on a concrete pad. An adjacent asphalt paved area is used for collection of paper-products, wood pallet recycling, and various empty container storage. At the north end of this paved area are two container trailers for storage of equipment, replacement parts and empty non-hazardous containers. The area is no longer used for the delivery of UPS or Fed Ex deliveries. All deliveries are now conducted at the loading docks. There were no trucks in the 10-day hazardous waste transfer area at the time of this inspection.

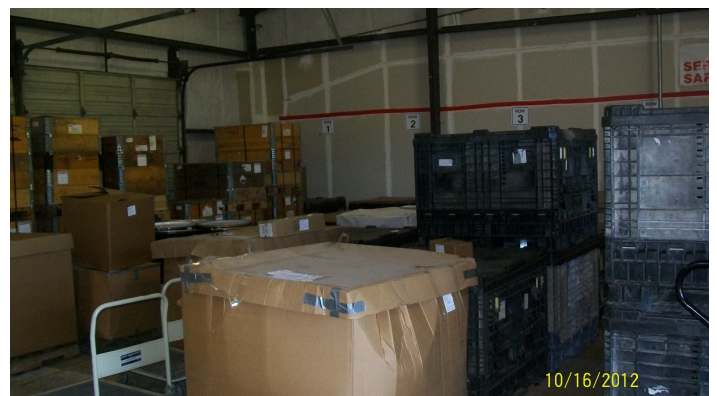
### Battery Storage and E-waste Storage

This building is immediately south of the main building and is divided into two large storage areas. The container storage area is used to hold empty fiber drums and cardboard boxes. No universal or hazardous wastes are stored in this area. The second room within this building is used for storage of e-waste and battery storage. The space is permitted to store up to 72 pallets. At the time of the inspection, all pallets were properly labeled and protected from the environment. No violations were observed at the time of the inspections.

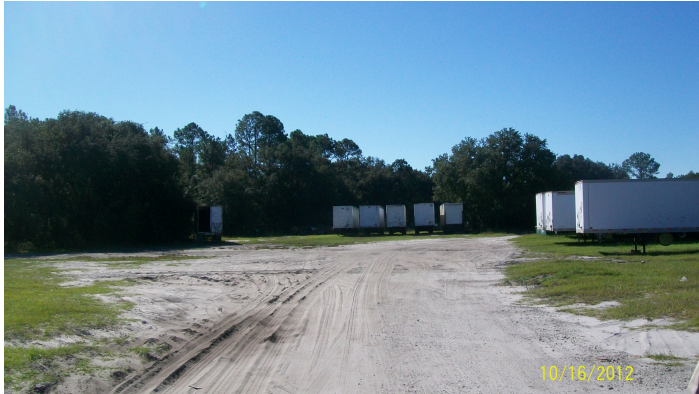
### Transfer Yard

The Veolia Transfer Yard (Veolia) is used for the storage of facility transport trailers and is a registered Universal Waste Transfer Area. Twelve trailers were inspected to ensure compliance with state and federal regulations. Four trailers were empty, one trailer was full of empty containers, and six others were full of universal and electronic waste. The storage times vary depending on the content of the trailers. Trailers that have universal waste stored on them are kept in the transfer yard for a maximum of ten days. On the tenth day or previous to that day, the universal waste is off-loaded at the main facility's docking area for processing. No trucks carrying universal waste was beyond its ten day storage time limit.
