SUBJ: RCRA Compliance Evaluation Inspection

Perma-Fix of Florida, Inc. Facility ID: FLD 980 711 071

On November 15, 2011, a Resource Conservation and Recovery Act (RCRA) Compliance Evaluation Inspection (CEI) was conducted by the EPA and the Florida Department of Environmental Protection at the Perma-Fix of Florida, located in Gainesville, Florida.

RCRA Inspection Report

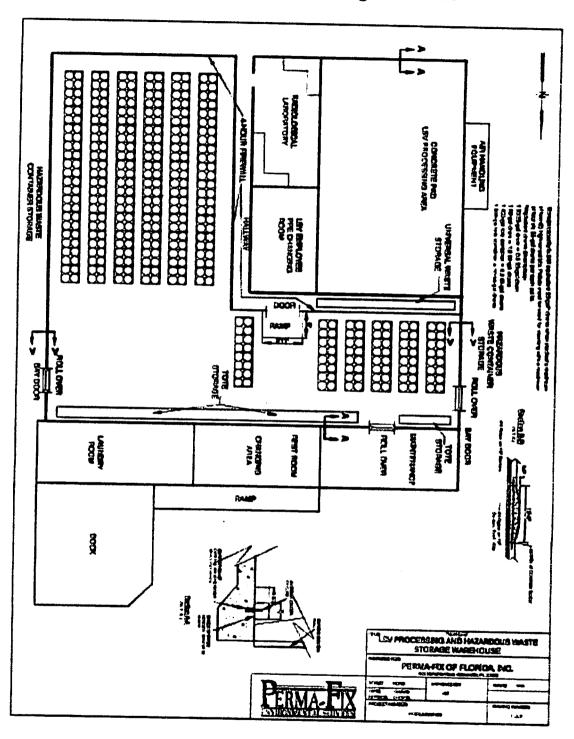
LSV Processing and Waste Storage Warehouse

The Waste Storage Warehouse (WSW) contains a permitted hazardous waste container storage area, Liquid Scintillation Fluid (LSF) processing area, Debris Treatment Unit, maintenance shop, and a separate storage area for used oil, oily wastewater, and other non-hazardous wastes. The facility may store a maximum of 54,340 gallons in containers in sizes up to 718 gallons (B-25 box) or less, in the LSV Processing and Waste Storage Warehouse.

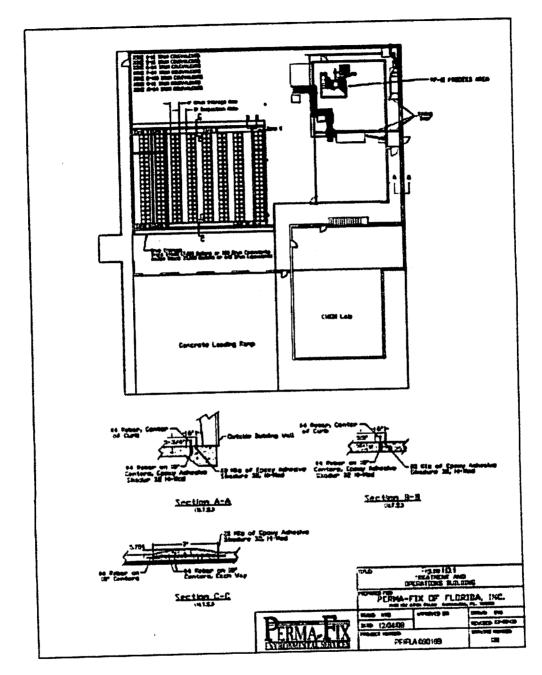
This permitted storage area has seven different zones of secondary containment inside the Treatment and Operations Building (TOB). A maximum volume of 35,200 gallons of hazardous waste can be stored in the TOB as stipulated in the facility's permit. All the containers inspected were properly labeled, dated, closed and in the correct zone.

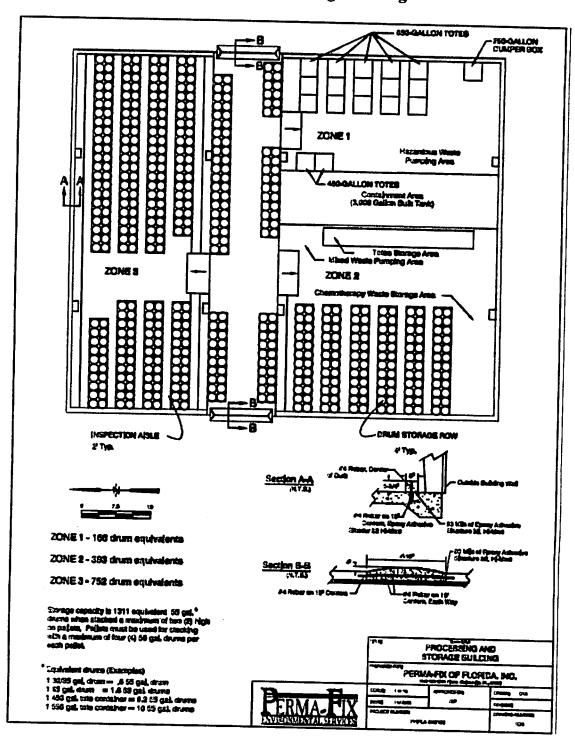
The Processing and Storage Building is a permitted hazardous waste container and tank storage area as well as a fuel-blending location that includes phase separation treatment. The facility is allowed to store a maximum of 72,105 gallons of waste in containers and in sizes up to 718 gallons (B-25 box) or less in this PSB storage area. The hazardous waste containers stored in this area that were examined, were properly labeled and closed, and had been dated with the storage start date. All satellite containers of hazardous waste in the fuel blending section of the permitted storage area were properly closed and labeled. This included one satellite aerosol can waste drum, one drum for storage of pumping equipment, and one drum for solids from the fuel blending process. This area appeared to me all the stored conditions of the permit.

A 3,000-gallon aboveground storage tank (AST) is located in the approximate center of the permitted container storage area. The tank has appropriate secondary containment and a sump to contain any spillage. At the time of this inspection, the AST was empty.
