SUBJ: RCRA Compliance Evaluation Inspection
Liquid Environmental Solutions
EPA ID Number: FLD981928484

RCRA Inspection Report

Liquid Environmental Solutions
1640 Talleyrand Avenue
Jacksonville, Florida 32206
Duval County
EPA ID: FLD981928484

OCTOBER 15, 2012

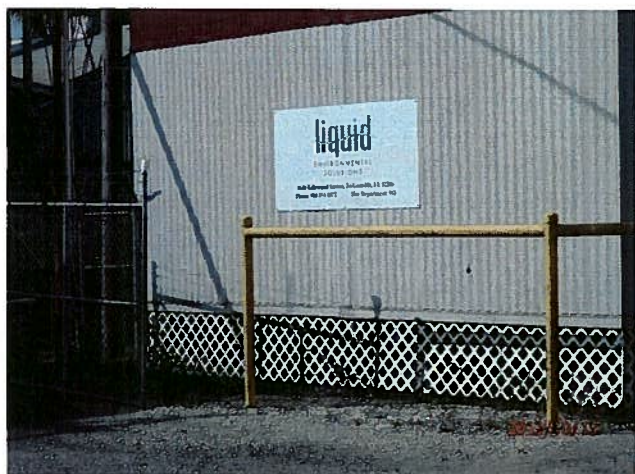
Picture 1 – Facility Sign

Upon arriving at the LES facility (Picture 1), the inspectors entered the main office and were escorted to the conference room. Yuri Turovsky, General Manager, met with the inspectors in the conference room for an opening conference before escorting them around the facility. The inspectors presented their credentials to Mr. Turovsky at 9:45 a.m.

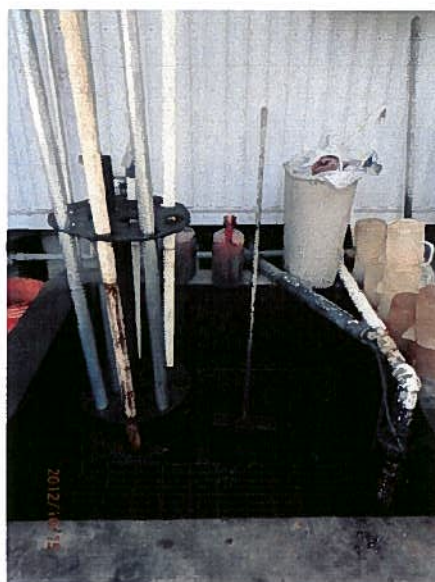
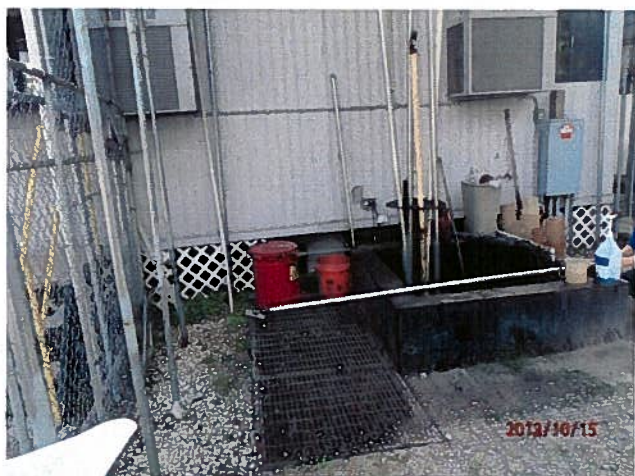
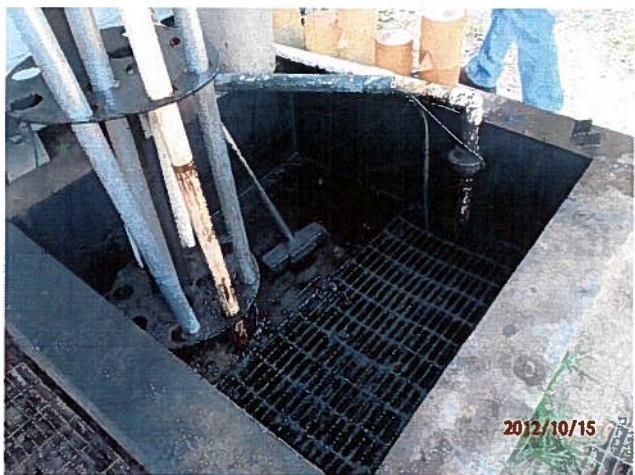
Incoming trucks are required to go to the Receiving Lab first. The drivers give their manifests to the LES staff and then the trucks are sampled. Behind the Receiving Lab, the inspectors observed a secondary containment system with metal drainage grates going to the facility double walled sump (Pictures 2-4). The samples are pulled by the LES staff using composite liquid waste samplers (COLIWASA) in the trucks. The samples are poured into jars, labeled with the work order number, dated, tested and then preserved by refrigeration for 30 days (Pictures 5-6).

Picture 4 – Receiving Lab Sample Area Coli-wasa Storage

Picture 2 – Receiving Lab Sample Area

Picture 3 – Receiving Lab Sample Area Sump

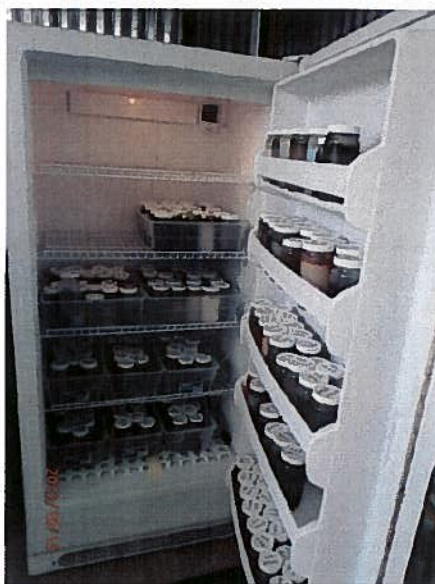
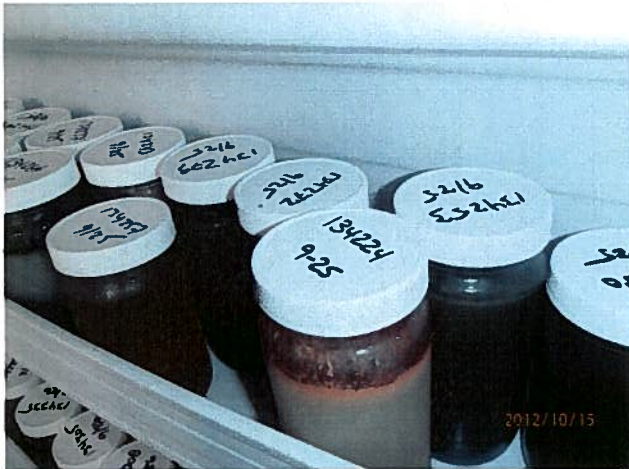
Picture 5 – Receiving Lab Sample Storage

Picture 6 – Receiving Lab Samples

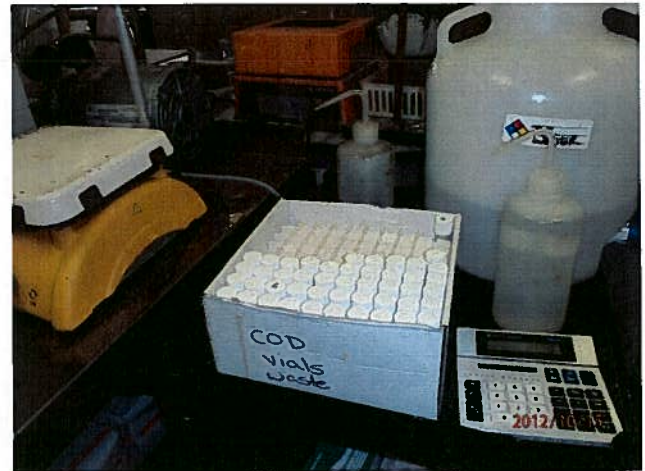
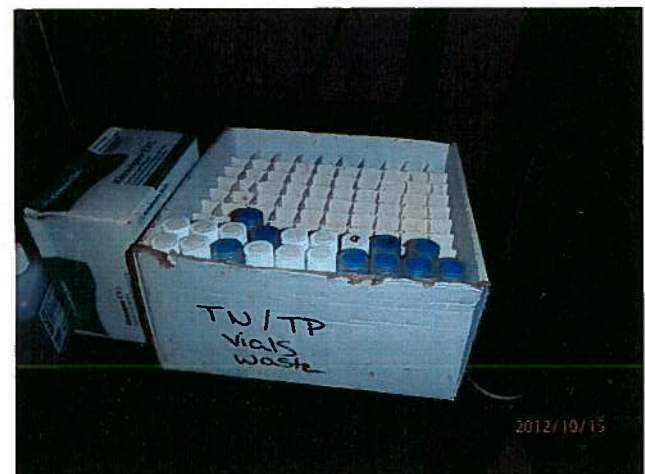
Inside the Receiving Lab, the inspectors observed a carton of spent COD vials and a carton of spent total nitrogen and total phosphorus (TN/TP) vials being collected (Pictures 9-10). The inspectors also observed a bench top with several bottles of expired 30-day receiving samples (Picture 11) staged to be poured into the drainage system.

Picture 9 – Receiving Lab COD Vial Waste

Picture 10 – Receiving Lab TN/TP Vial Waste

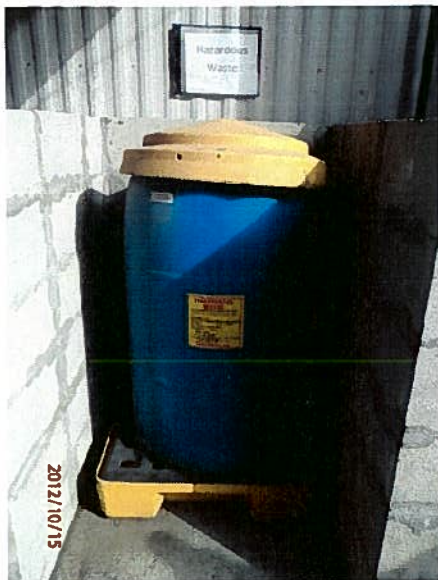
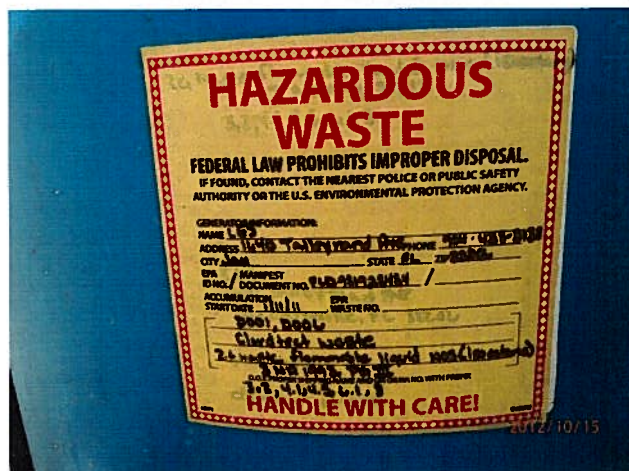
(HWSAA) outside the entrance to the Receiving Lab (Pictures 7-8). The HWSAA contained a blue 55-gallon drum of Chlor-D-Tect waste. The drum was observed labeled and closed.

Picture 7 – Receiving Lab Chlor Detect SAA

Picture 8 – Receiving Lab Chlor Detect SAA label

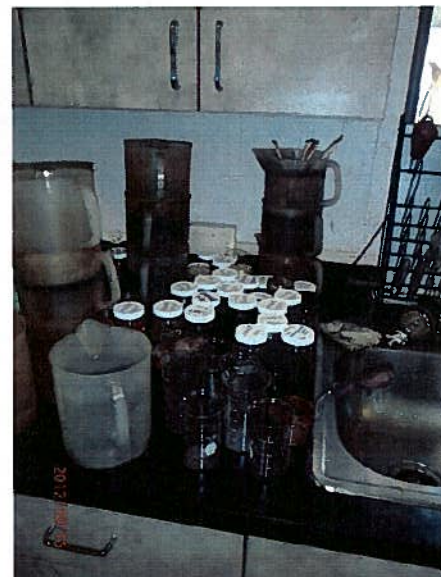
Picture 11 – Receiving Lab Samples to be discarded

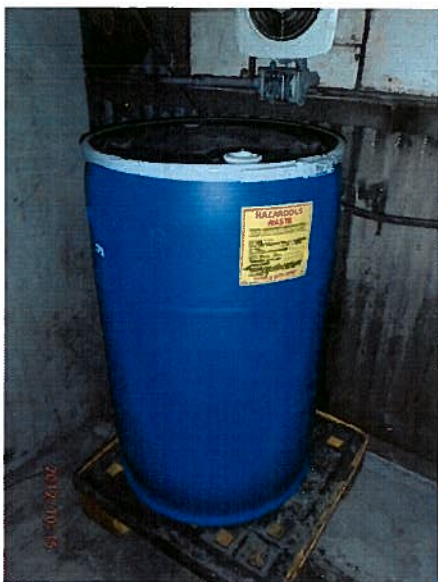
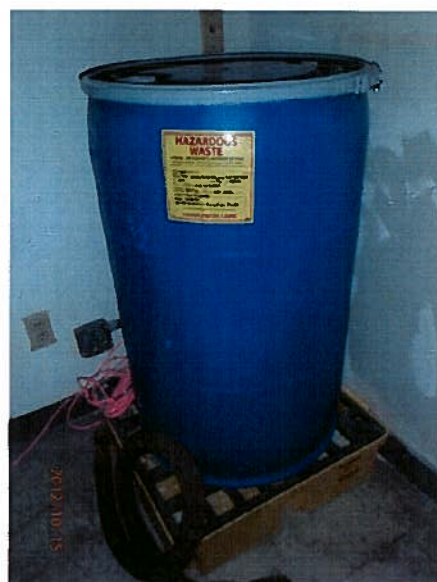
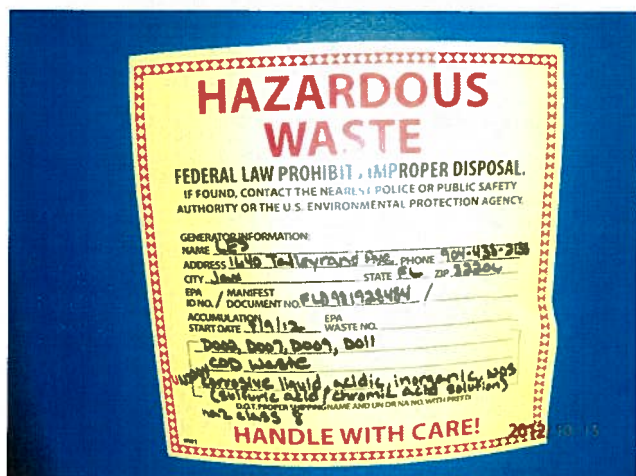
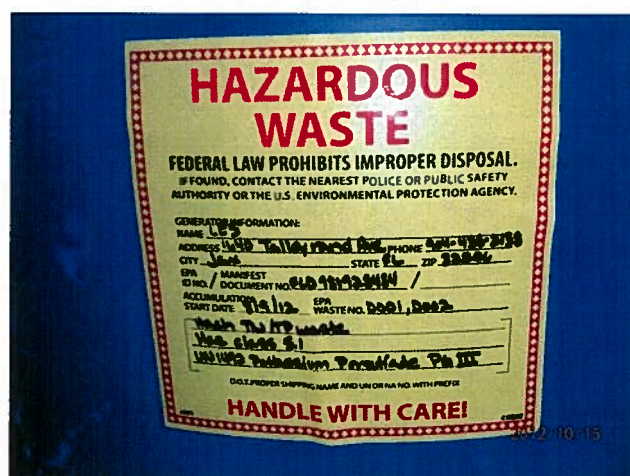
The inspectors were told the Analytical Lab was under renovation because of the water leaks in the ceiling. The Analytical Lab was where the COD and TN/TP tests were originally conducted prior to the renovations. The HWSAA for the spent COD vials was located outside the Analytical Lab in the Maintenance Area (Pictures 12-13). The HWSAA for the spent TN/TP vials was located in a storage room inside the Analytical Lab (Pictures 14-15). Both blue 55-gallon drums were observed labeled and closed. Currently the COD and TN/TP vials were being tested in the Receiving Lab and taken to the Analytical Lab HWSAAs.

Picture 12 – Analytical Lab COD waste SAA

Picture 14 – Analytical Lab TN/TP waste SAA

Picture 13 – Analytical Lab COD waste SAA Label

Picture 15 – Analytical Lab TN/TP waste SAA label

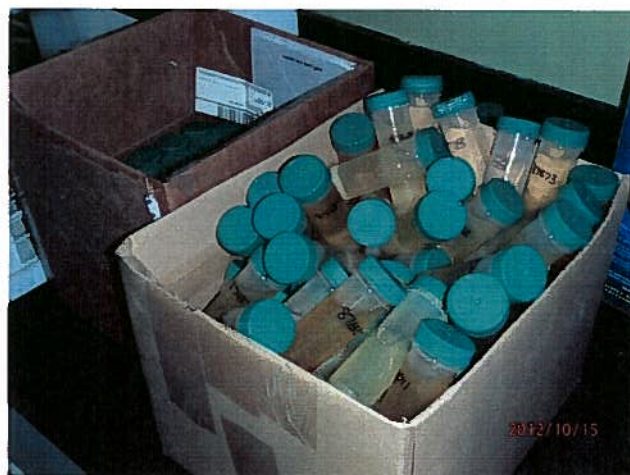
At the time of the inspection, the inspectors observed two boxes of green capped vials labeled with work order numbers (Picture 16). When the inspectors asked Mr. Turovsky what the vials were being stored for, Mr. Turovsky explained that the Spectro Ciros CCD Inductively Coupled Plasma Optical Emission Spectrometry equipment was not working, and LES could not run the metal analysis needed for the digested samples. Instead LES was collecting the vials to send to the LES facility in Chicago, IL for testing. Once the samples are analyzed, the Chicago facility would return the samples to Jacksonville for disposal into the facility sump and back into the process.

Picture 16 – Analytical Lab metal sample vials

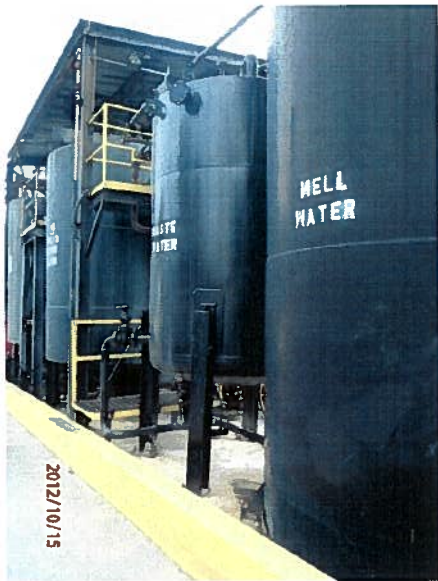
The Used Oil Processing area has three loading bays, a drainage grate that runs the length of the facility, a filter press, wastewater tanks (Picture 17) and a maintenance shop. The maintenance shop is used for small onsite repairs. The inspectors did not observe a part washer, spent aerosols or solvent use in this area. The entire facility is built upon secondary containment that drains directly in a doubled walled sump with a reversible pump.

Picture 17 – Filter Press Area

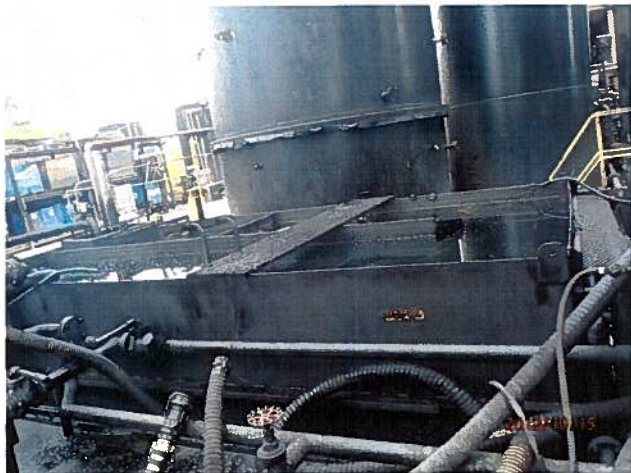
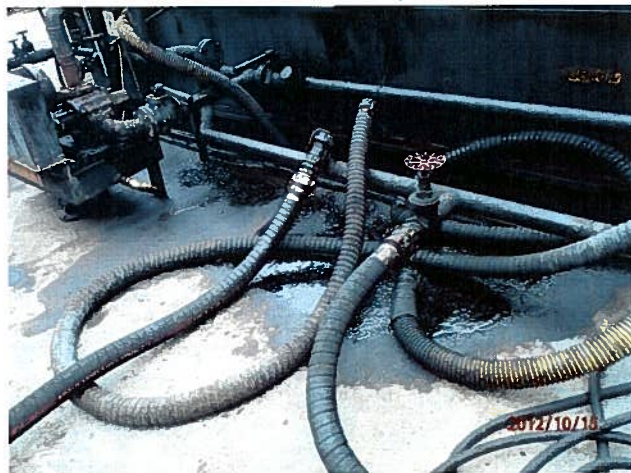
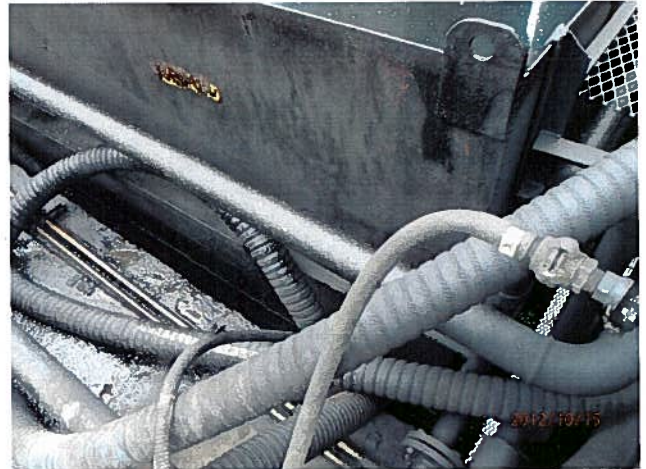
The inspectors observed that the used oil receiving tank has a trash separator and an additional secondary containment filled with used oil (Pictures 18-20). Mr. Turovsky explained that the secondary containment around the separator was pumped out every day and the oil spills around the separator are washed to the drainage grate discharging to the sump. The solid waste removed from the used oil separator is analyzed for hazardous constituents prior to being sent to an industrial landfill.

Picture 18 – Used Oil Processing trash separator

Picture 19 – Used Oil Processing trash separator overflow

Picture 20 – Used Oil Processing trash separator secondary containment

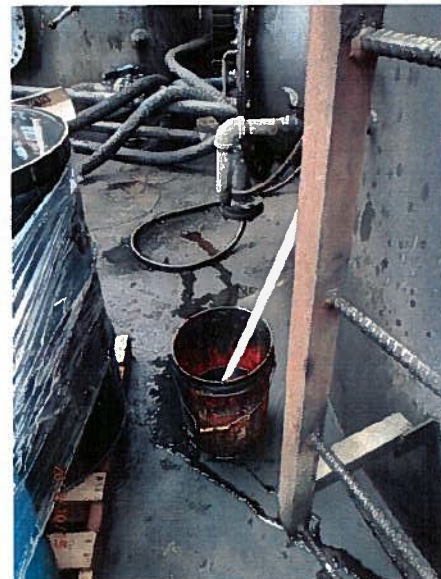
At the time of the inspection, the inspectors observed a container with a PVC pipe connected to a

hose inside. Mr. Turovsky explained that the container was used to catch the flushed Weatherford AS 35, a demulsifier, from the PVC pipe, after the chemical is added to Tank TK-16, Chemical Heating Tank, for treatment of the used oil (Picture 21). The container was not labeled to identify use or content.

Picture 21 – Used Oil Processing Chemical Tank flush bucket

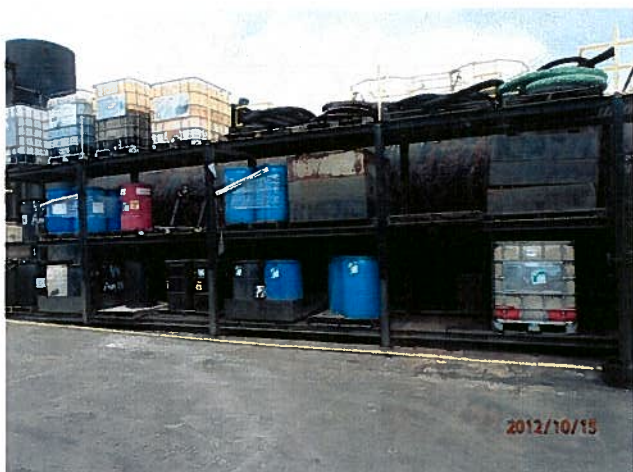
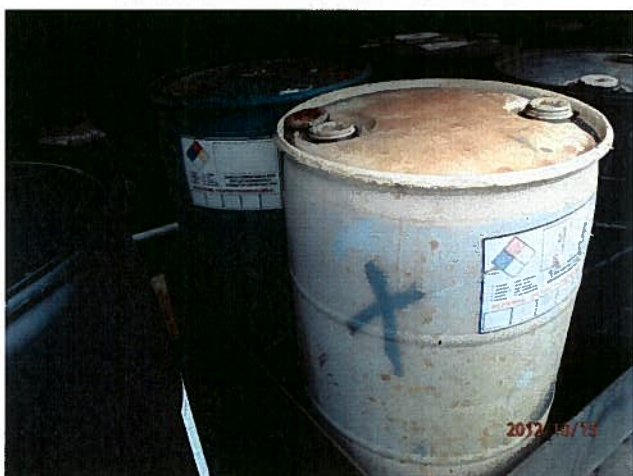
LES stores non-hazardous waste drums and totes (Picture 22) in a metal rack opposite the Chemical Heating Tank. Mr. Turovsky explained that many of the chemicals received at LES were proprietary chemicals no longer used by companies. LES found that these chemicals could be blending into the process to precipitate metals from the used oil. The inspectors recommended that LES not label the proprietary chemicals as non-hazardous waste when the chemicals are used in the process. The inspectors observed a 55-gallon drum of used oil filters and two unknown product drums without labels (Picture 23). Mr. Turovsky stated that the drums would be identified.

Picture 22 – Chemical Storage Rack

Picture 23 – Chemical Storage Rack with unknown drums

On October 24, 2012, Mr. Turovsky emailed the EPA and FDEP, stating that the unknown drums were identified and labeled "TR-50". TR-50 is manufactured and sold by Wastewater Specialists Technologies, LLC. TR-50 is a polythiocarbonate based precipitant of heavy metals from industrial process wastewaters, including metals from chelated/complexed environments. LES also receives and uses MR-40. MR-40 (Metal-Rec 40) is a sodium dimethyldithiocarbamate-based formulation that is designed to provide treatment of heavily chelated metal waste streams. MR-40 is manufactured and sold by Southern Water Treatment Company, Inc.

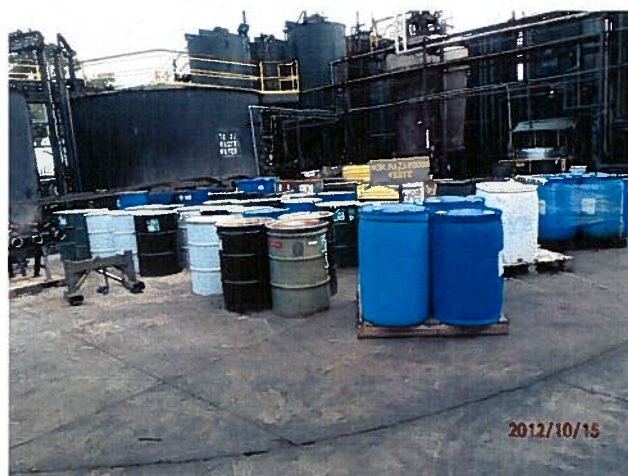
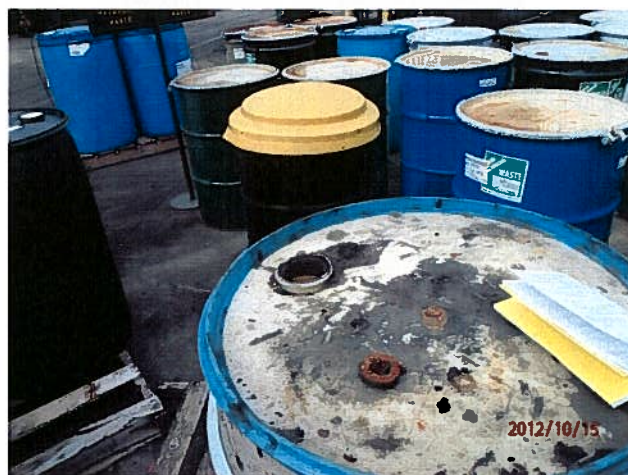
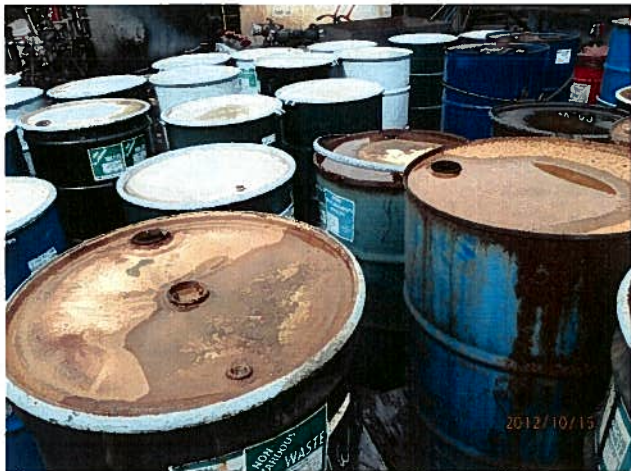
LES has a designated non-hazardous waste storage area located near the wastewater treatment plant. The area contained drums of used oil, sludge, used absorbent and petroleum contact water (Pictures 26-28). The inspectors observed five 55-gallon drums missing lids or bungs. **The EPA recommends LES reference F.A.C. Chapter 62-710.401(6), if tanks or containers are not stored inside a structure, the contents shall be closed, covered or otherwise protected from the weather.**

Picture 26 – Non-Hazardous Waste Storage

Picture 27 – Non-Hazardous Waste Storage drums with open bungs

Picture 28 – Non-Hazardous Waste Storage drums with open bungs

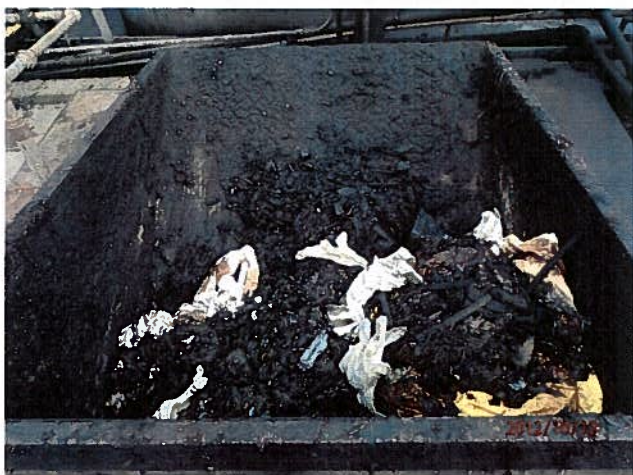
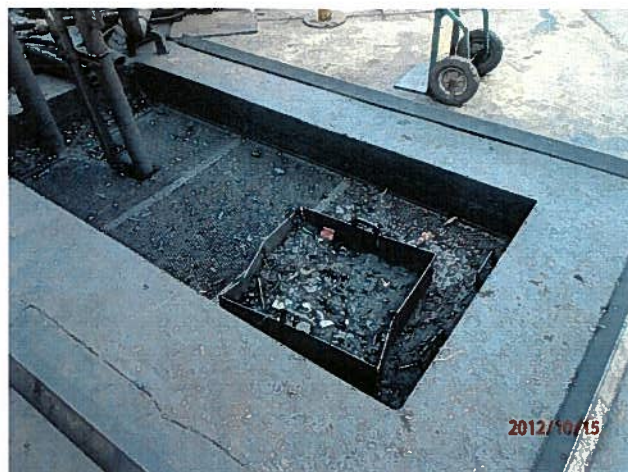
The inspectors also observed a metal trash can filled with debris from the used oil trash separator (Picture 24). A smaller used oil separator was located beside the Chemical Storage area (Pictures 25). No hazardous waste was observed in this area.

Picture 25 – Used Oil Processing trash sorting area

Picture 24 – Used Oil Processing trash bin

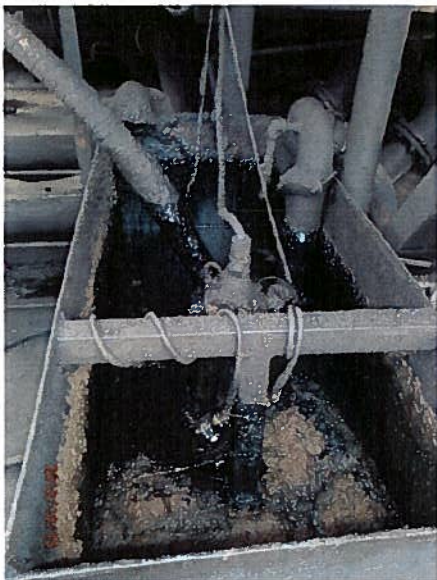
Incoming wastewater is placed in Tank TK-01. Depending on the waste stream LES may feed into Tank TK-06 for DAF and then add caustic, polymer, flocculant and/or proprietary chemicals. Residue forms on the top of the wastewater and is skimmed from the surface, while the finished effluent is sent to the treated water tanks (Picture 29) and tested for pH and COD. No hazardous waste was observed in this area.

Picture 29 – Waste Treatment Processing effluent skimmer

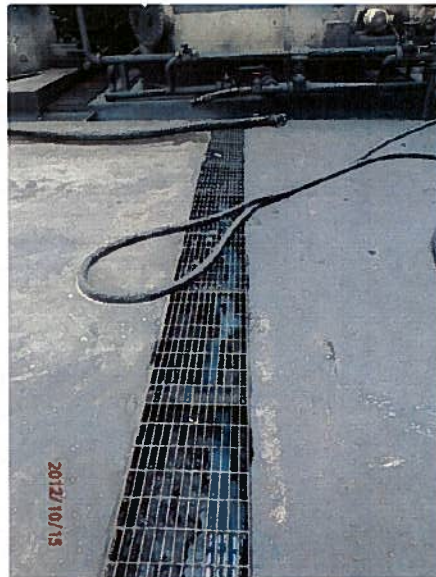
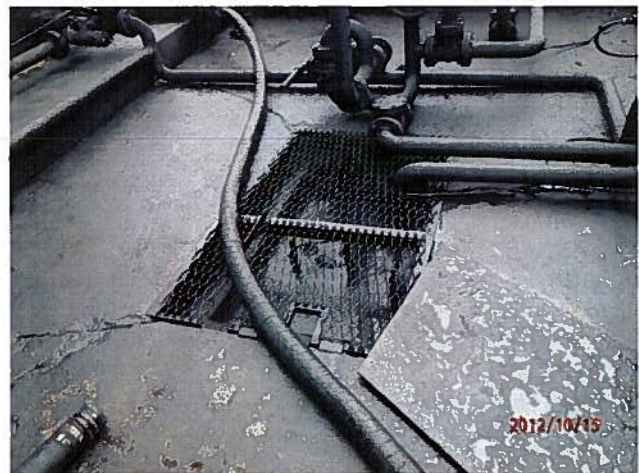
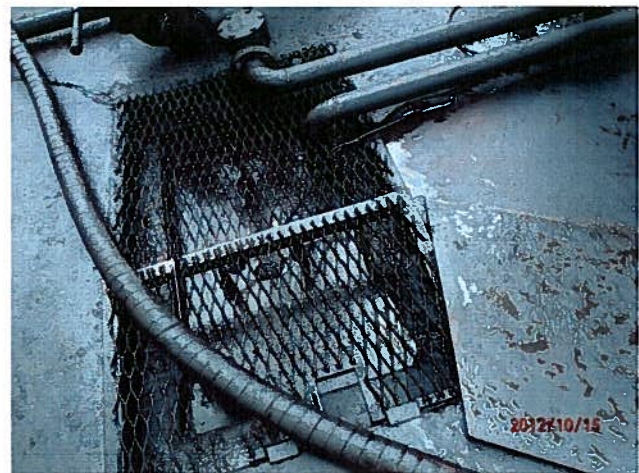
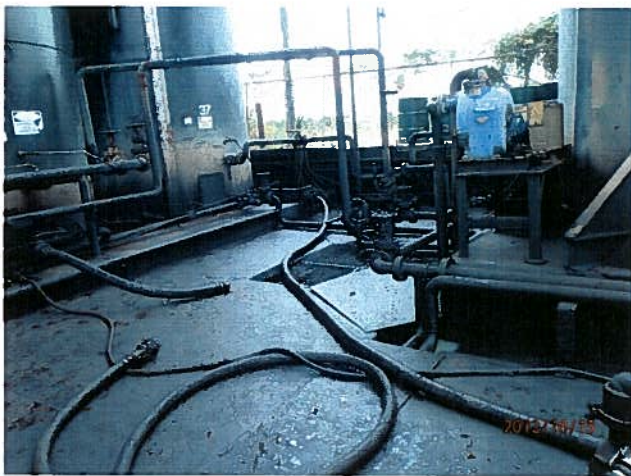
The sump is located at the lowest point in the facility (Pictures 31-33). The underground sump receives all PCW and used oil received at the facility via centralized drainage grate (Picture 30). The grate runs the length of the facility and discharges directly to the sump. At the time of the inspection, the inspectors observed the drainage grate and the sump grate filled with used oil and accumulated sludge.

Picture 30 – Discharge grate to the Sump

Picture 31 – Sump

Picture 32 – Sump

Picture 33 – Sump

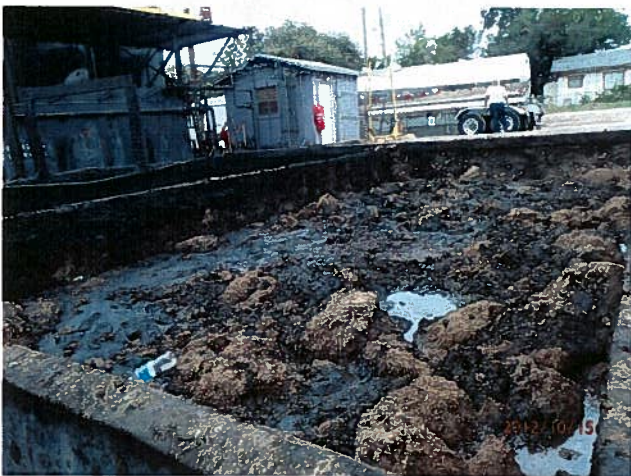
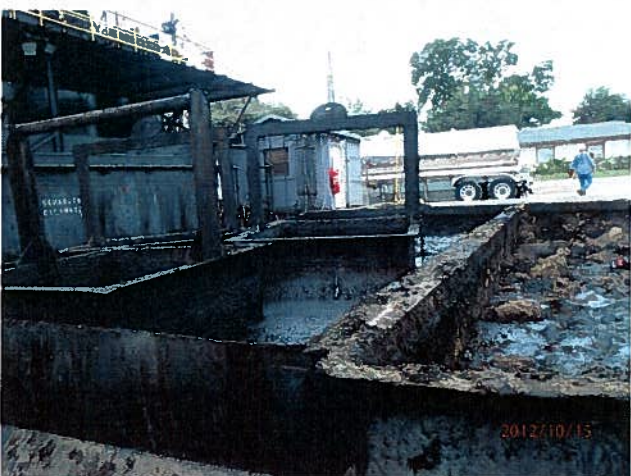
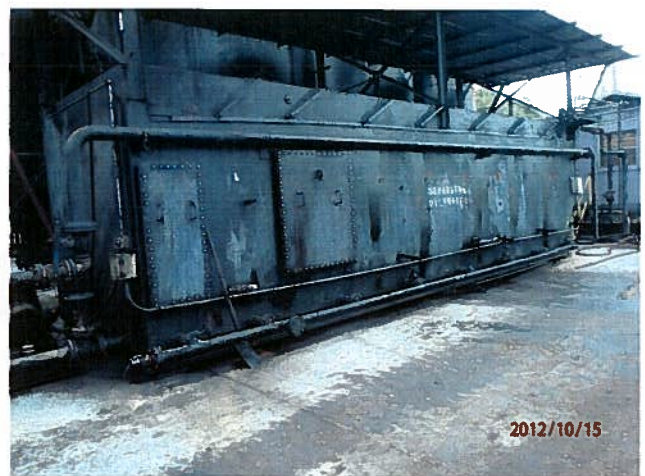
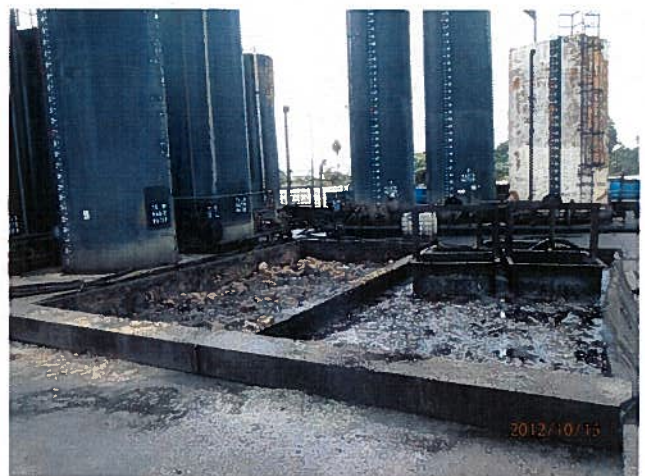
The inspectors observed the oil/water separator and the solidification tanks (Pictures 34-37). LES placed metal screens inside the solidification tank closest to the oil/water separator and then pours the incoming used oil and water mixed with debris and solids into the tank. The screen is used to keep the trash and solids away from the vacuum as it pumps out the oil and water. The residual trash and solids were transferred to the adjacent solidification tank and mixed with material to dry out the residual for disposal at the landfill

Picture 36 – Oil Water Separator

Picture 34 – Solidification Tanks

Picture 37 – Solidification Tanks

Picture 35 – Oil Water Separator and Solidification Tanks

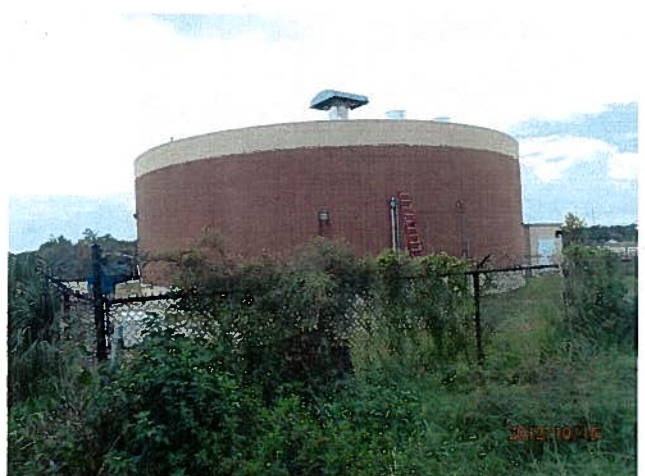
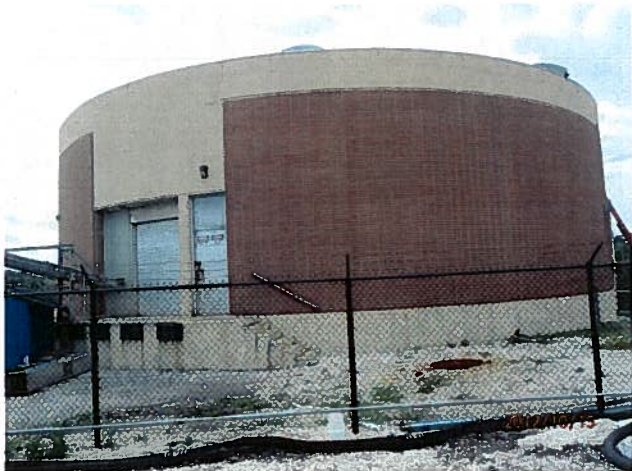
LES generates two waste streams that the facility discharges to the POTW (Pictures 38-39). The POTW is required to monitor centralized waste treatment (CWT) organics and CWT oils and metals at separate points, and then monitored again at a combined point.

Picture 38 – JEA Lift Station

Picture 39 – JEA Lift Station

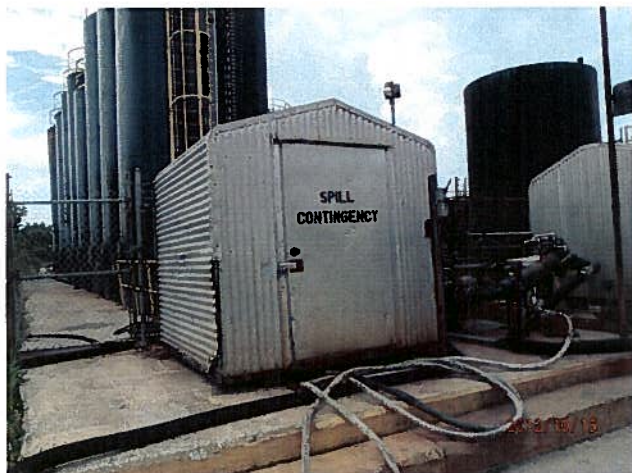
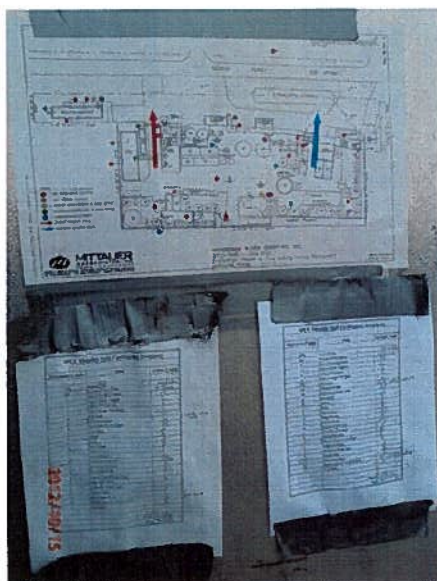
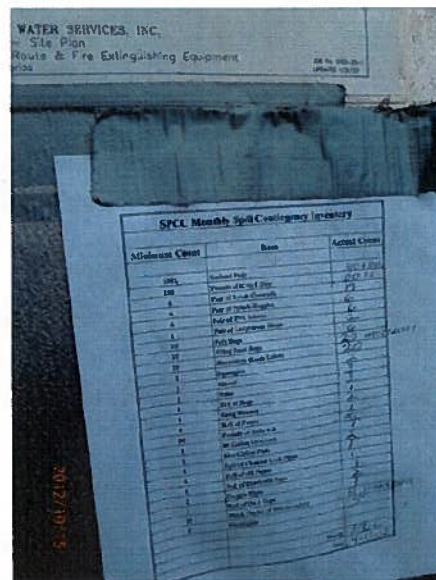
The spill contingency shed (Picture 40) holds the spill supplies and on the inside door was a facility map and an inventory list of the supplies (Pictures 41-42). The shed is inventoried every two months and inspected monthly. At the time of the inspection, the inspectors observed that the inventory in the shed and the inventory list posted was not consistent. Items used or taken from the shed had not been replaced. No hazardous waste was observed in this shed.

LES appears to be in violation of F.A.C. Chapter 62-710. 210(2) [40 C.F.R. § 279.52(b)(2)(v)], (v) The plan must include a list of all emergency equipment at the facility (such as fire extinguishing systems, spill control equipment, communications and alarm systems (internal and external), and decontamination equipment), where this equipment is required. This list must be kept up to date. In addition, the plan must include the location and a physical description of each item on the list, and a brief outline of its capabilities.

Picture 42 – Spill Contingency Shed Inventory

Picture 40 – Spill Contingency Shed

Picture 41 – Spill Contingency Shed Map and Inventory

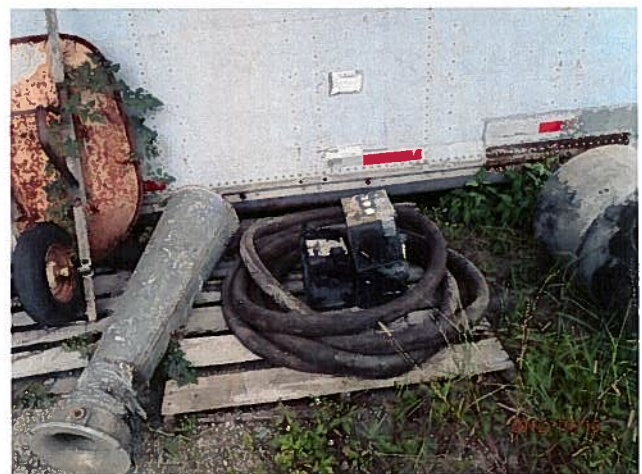
The vehicle staging area was enclosed behind a chain link fence and held the LES tanker trucks. The inspectors observed a pallet with three lead acid batteries, a tanker truck with a hose leaking oil on the ground, four open and empty frac tanks, a 55-gallon drum of diesel used for cleaning out the frac tanks and a metal trash bin with discarded used oil personal protective equipment (Pictures 43-45). The inspectors pointed out to Mr. Turovsky that the lead acid batteries were not identified as usable or discarded, the tanker truck had two oil stains underneath it and the metal trash bin was not labeled "Used Oil"

LES appears to be in violation of F.A.C. Chapter 62-730.160(1) (40 C.F.R. § 262.11), which requires that a generator make a hazardous waste determination on solid wastes at its facility. It appears that LES failed to make a hazardous waste determination on the three lead acid batteries located in the Vehicle Staging Area.

Picture 43 – Vehicle Staging Area pallet of batteries

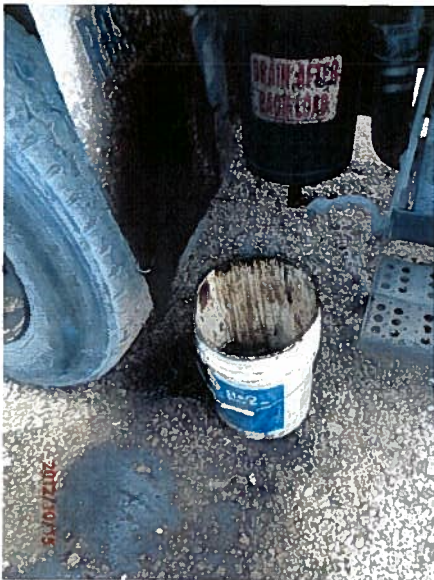
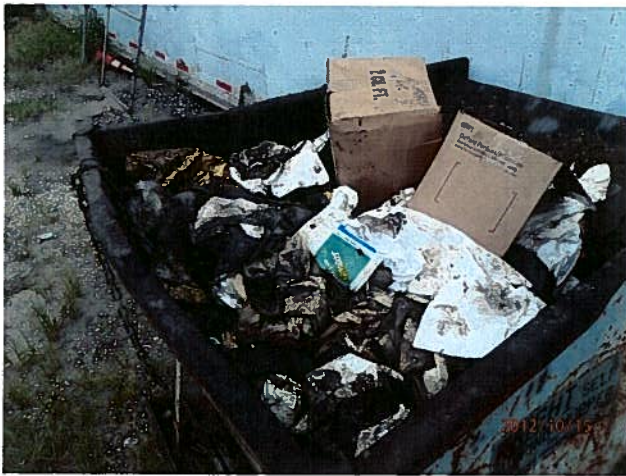
LES appears to be in violation of F.A.C. Chapter 62-710.210(2) [40 C.F.R. § 279.22(d)], Upon detection of a release of used oil to the environment that is not subject to the requirements of part 280, subpart F of this chapter and which has occurred after the effective date of the recycled used oil management program in effect in the State in which the release is located, a generator must perform the following cleanup steps:

LES appears to be in violation of F.A.C. Chapter 62-710.401(6) [40 C.F.R. § 279.22(c)(1)], No person may store used oil in tanks or containers unless they are clearly labeled with the words "Oily Waste" and are in good condition (no severe rusting, apparent structural defects or deterioration) with no visible oil leakage. If tanks or containers are not stored inside a structure, the contents shall be closed, covered or otherwise protected from the weather.

Picture 44 – Vehicle Staging Area leaking oil spills

Picture 45 – Vehicle Staging Area used oil rag trash bin

- (1) Stop the release;**
- (2) Contain the released used oil;**
- (3) Clean up and manage properly the released used oil and other materials; and**
- (4) If necessary, repair or replace any leaking used oil storage containers or tanks prior to returning them to service.**

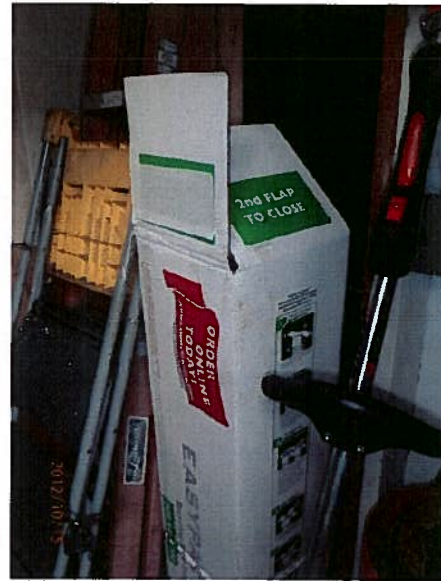
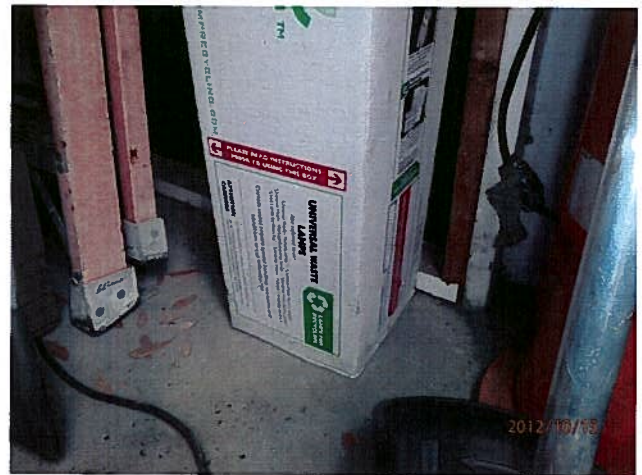
The inspectors observed that the universal waste lamps were stored in a utility closet (Pictures 46-47). The box was open, labeled per F.A.C. requirements and did not have an accumulation start date.

LES appears to be in violation of F.A.C. Chapters 62-737.400(5) [40 C.F.R. § 273.15(d)(1)]. Handlers and transporters shall manage universal waste lamps and devices in a way that prevents breakage, releases of their components to the environment, and their exposure to moisture.

LES appears to be in violation of F.A.C. Chapters 62-737.400(7) [40 C.F.R. § 273.15(c)]. A handler shall not store for more than one year, or a transfer facility for more than ten days, universal waste lamps or devices from the date of generation or from when they were first received, respectively. Handlers and transfer facilities shall be able to demonstrate the length of lamp or device storage as specified in 40 C.F.R. § 273.15 or 273.35 as adopted by reference under Rule 62-730.185, F.A.C.

Picture 46 – Lamp Storage box open

Picture 47 – Lamp Storage box undated but labeled
