Re: Perma-Fix of Florida, Inc
EPA/DEP ID: FLD 980 711 071
Alachua County – Hazardous Waste

**Florida Department of
Environmental Protection
Hazardous Waste Inspection Report**

Facility Name: Perma-Fix Of Florida Inc

Inspection Date: 09/17/2013

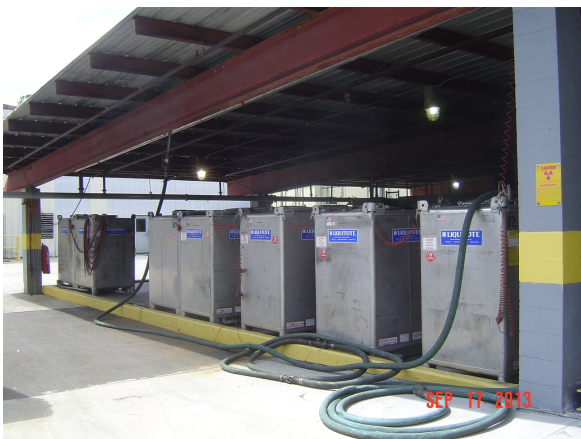
Photo 1

The facility was storing large metal totes that contain hazardous waste waters in Zone 1 of the PSB. These totes were on the edge of the storage zone that bordered where the facility parks its tankers for fuel blending (Photo 1). The Department recommended that the facility move these totes farther into the storage zone to prevent the potential for the contents of these containers to spill outside of the zone in the event of an accident.

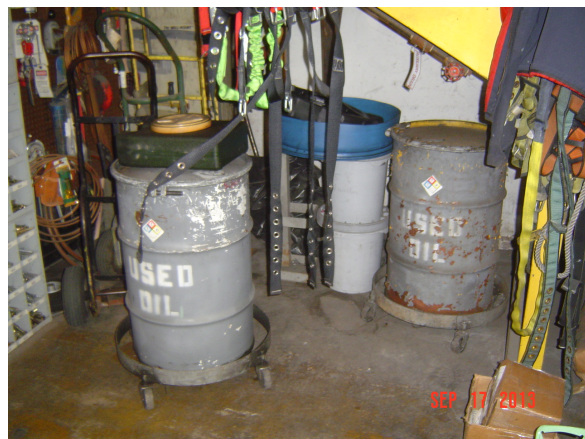
Photo 2

The maintenance shop is located in this building and contains one parts washer. Diesel fuel is used as a solvent, generating a non-hazardous waste parts washer fluid. The facility generates less than 55 gallons per year of this waste stream, which is added to the used oil in the fuel blending area for energy recovery as needed. The facility's used oil filter container was labeled "used oil" (Photo 2). This container was changed to read "used oil filters" during the inspection.
