Re: Safety-Kleen Systems, Inc.
EPA/DEP ID: FLD 980 847 214
Clay County – Hazardous Waste

**Florida Department of
Environmental Protection
Hazardous Waste Inspection Report**

Facility Name: Safety - Kleen Systems Inc

On-Site Inspection Start Date: 09/24/2013

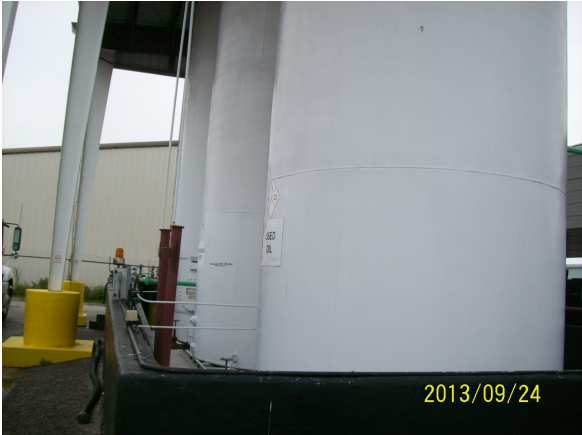
Photo 2

The facility has three aboveground tanks in a tank farm (Photo 2). Two 15,000-gallon tanks contain used oil. Both were properly labeled (Photo 3). The third tank is a 15,000-gallon hazardous waste storage tank that contains waste mineral spirits (Photo 4). The tank was properly labeled. The tank farm provides 110% secondary containment. All piping that was inspected leading to and from the tank appeared to be in good condition.

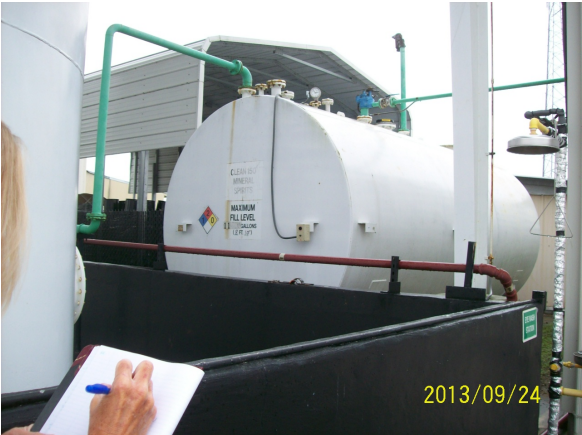
Photo 5

Adjacent to the tank farm, but not within the secondary containment, is a 10,000-gallon tank (Photo 5). This tank contains product solvent 150. The tank is double-walled.
