INTERIM RCRA FACILITY ASSESSMENT  
of the  
QUADREX HPS, INC. FACILITY  
GAINESVILLE, FLORIDA

EPA I.D. NO. FLD980711071

February 22, 1990

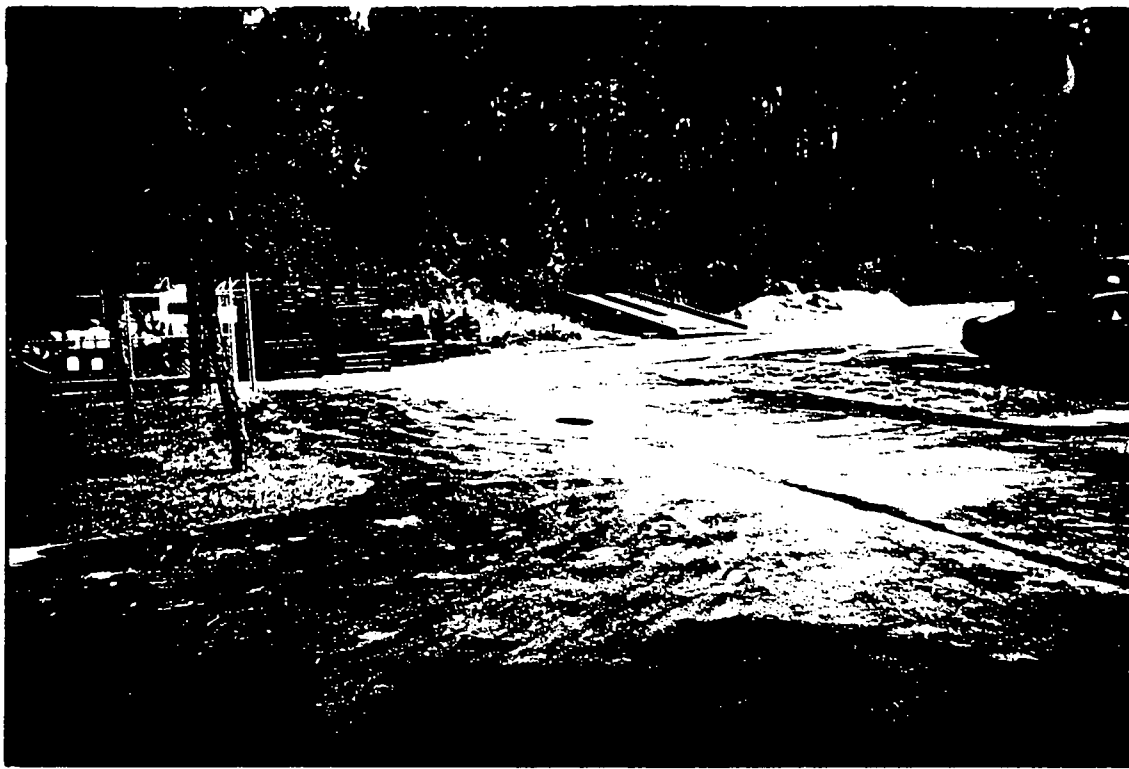
- 1.1 Overview of the North Unloading Area (SWMU 1) located in the north-central section of the facility. The yellow ramp featured in the right-center of the photograph is used during truck unloading operations. The North Drainage Ditch (SWMU 23) is situated between the ramp and the trees in the background. The photograph was taken from the South Unloading Area (SWMU 2).

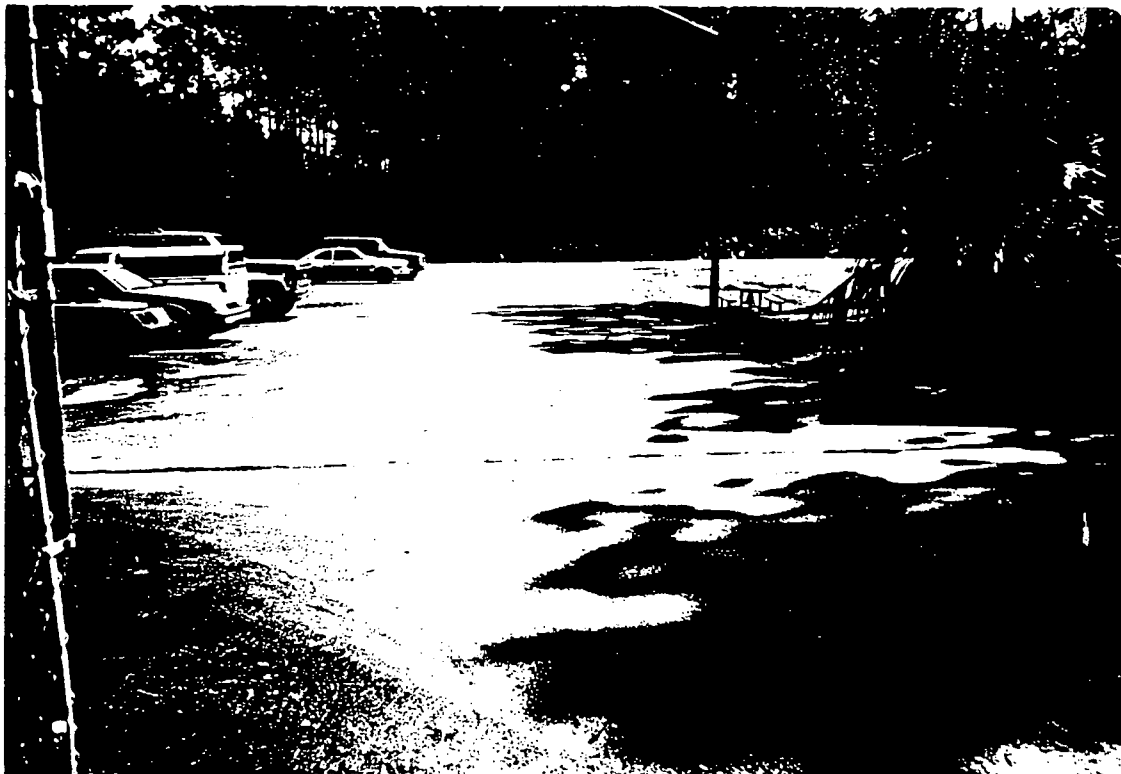
- 2.1 Overview of the South Unloading Area (SWMU 2) facing east. The photograph was taken from the entrance leading to the Container Storage Shed (SWMU 4).

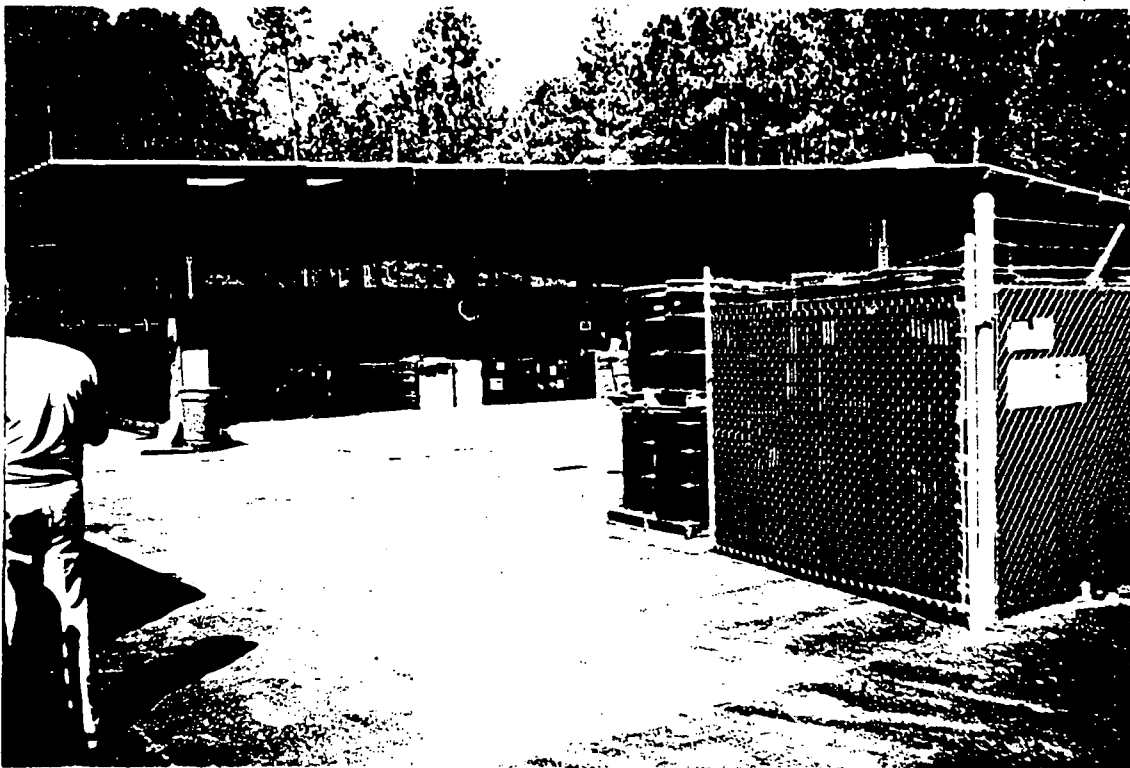
- 3.1 View of the northwest section of the facility facing northwest. A portion of the Temporary Holding Area (SWMU 3), indicated by the yellow lines, is featured in the center of the photograph. The structure in the background is the Container Storage Shed (SWMU 4). The photograph was taken from the South Unloading Area (SWMU 2).

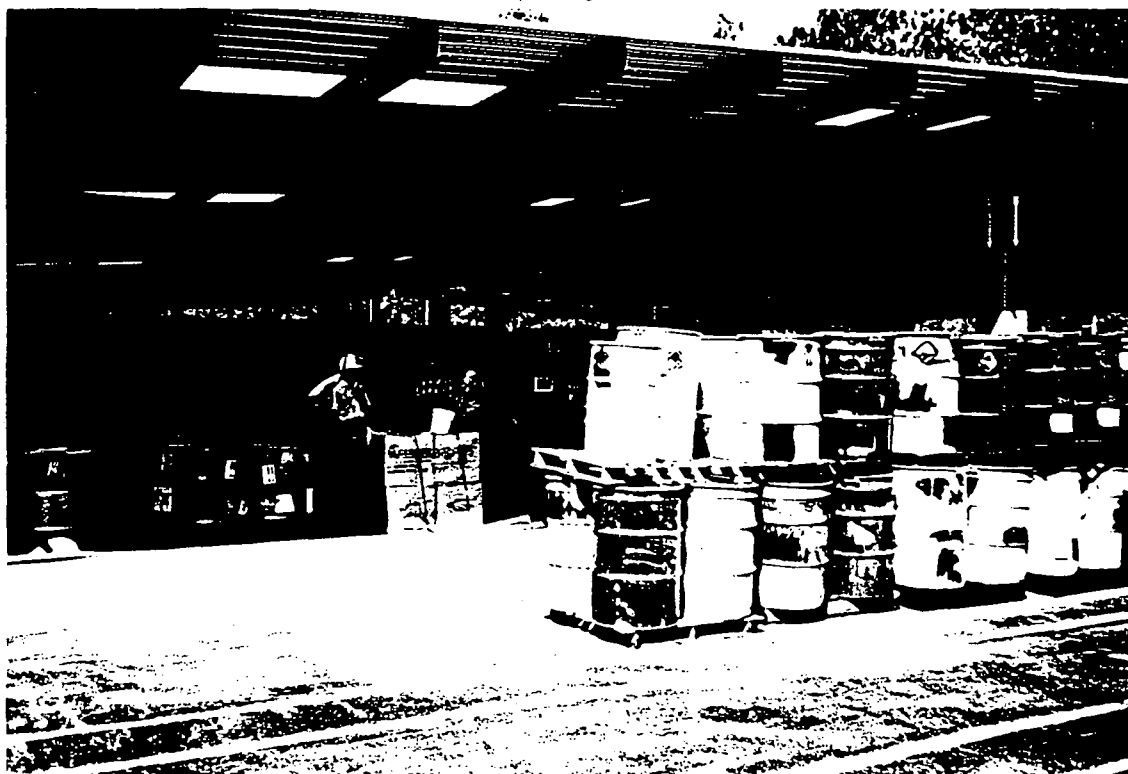
- 3.2 Close-up view of the Temporary Holding Area (SWMU 3) facing west. Drums containing hazardous and mixed wastes are held at this unit until they are labeled. Approximately 50 drums were observed at this unit during the VSI.

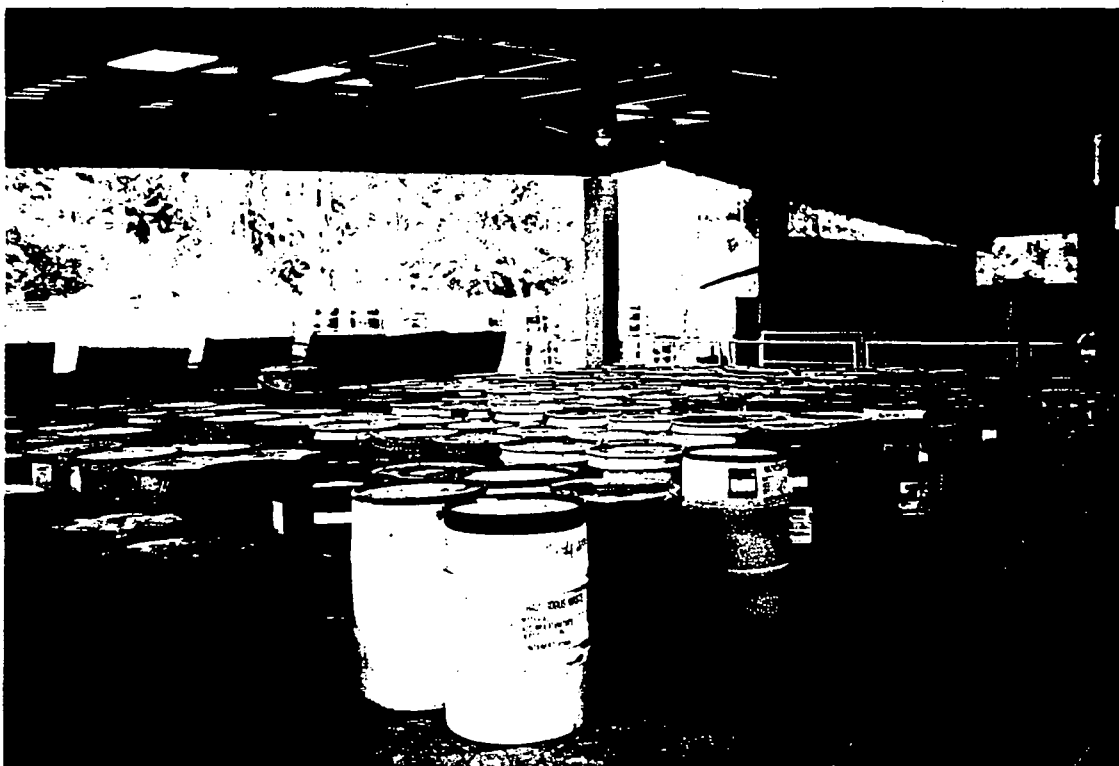
4.1 Interior view of the Container Storage Shed (SWMU 4) showing Zone 2. The view is facing northwest. The lids to the Gondolas (SWMU 18) are shown in the center left of the photograph. The drums stacked outdoors are at the Crushed Glass/Plastic Vials Drum Holding Area (SWMU 15).

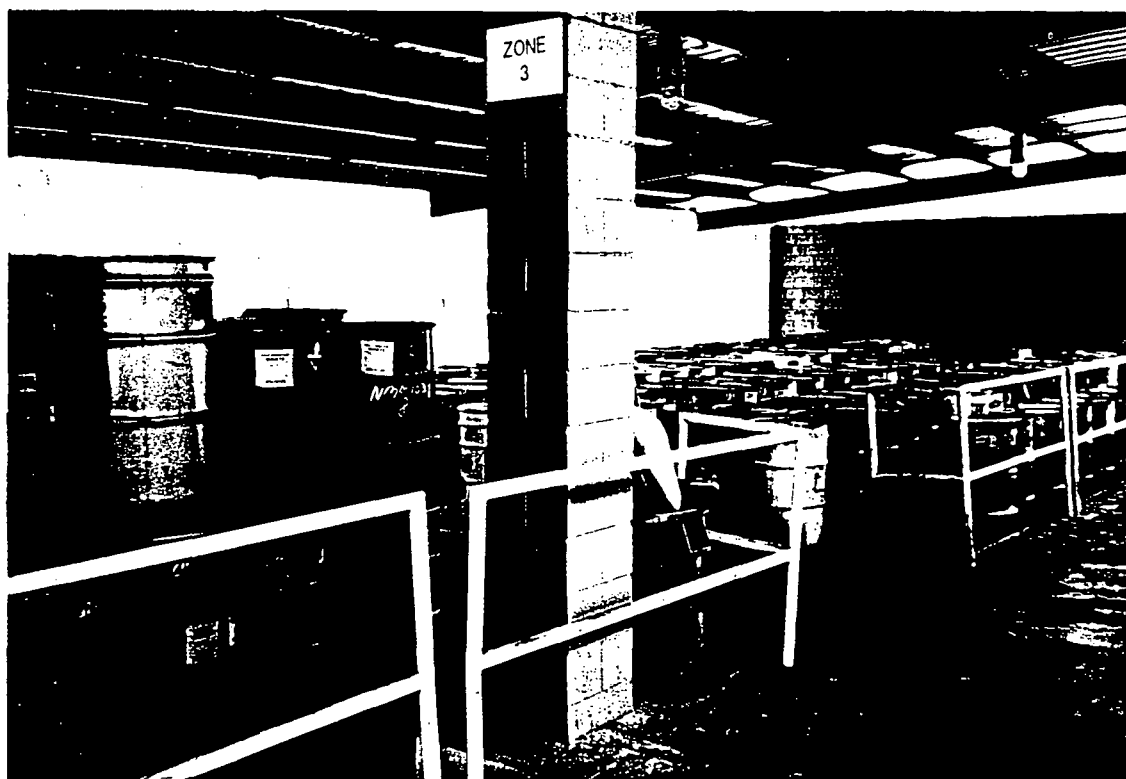
4.2 Interior view of the Container Storage Shed (SWMU 4) showing Zone 3. The view is facing northeast.

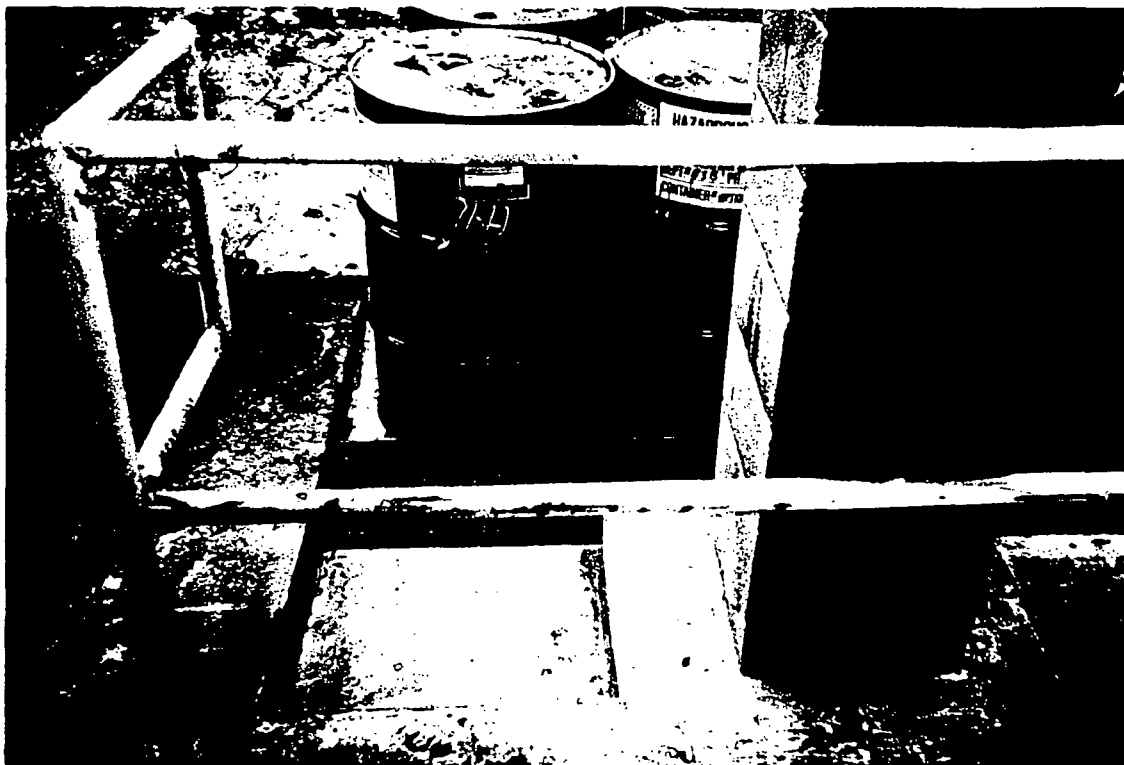
4.3 Close-up view of the trench providing secondary containment for Zone 2 within the Container Storage Shed (SWMU 4).

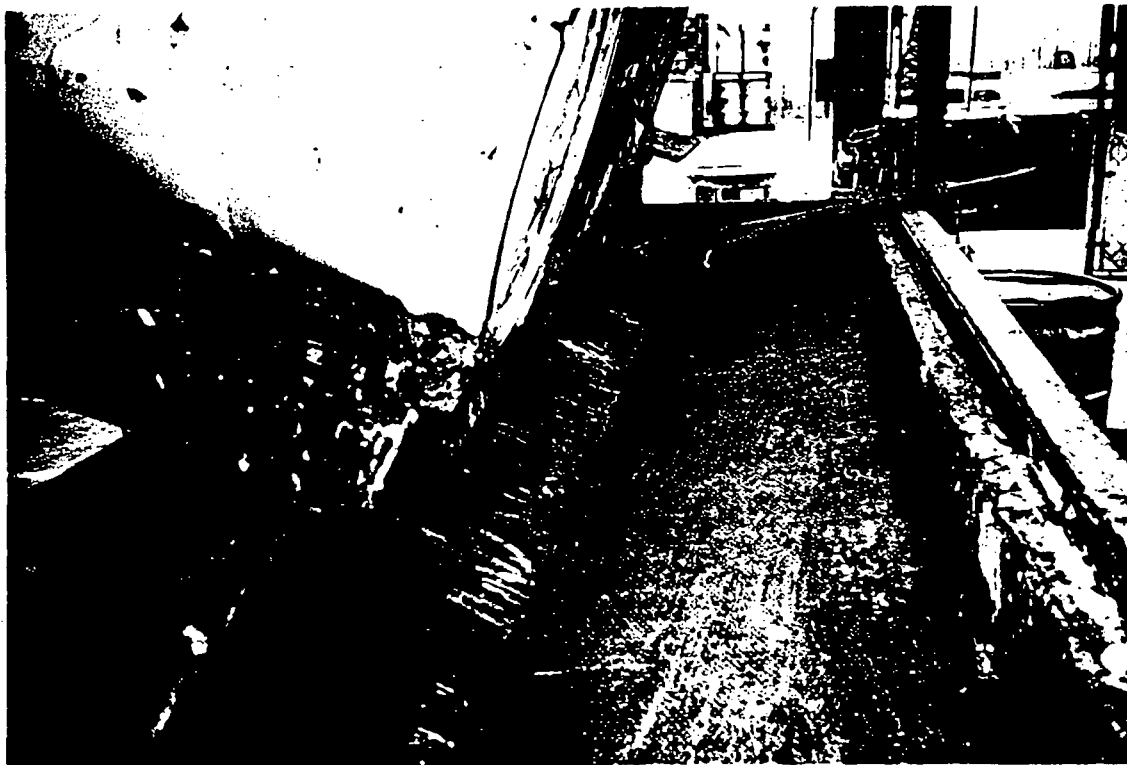
5.2 Close-up view of the screen covering the top of the Incoming Bulk Waste Transfer Station (SWMU 5).

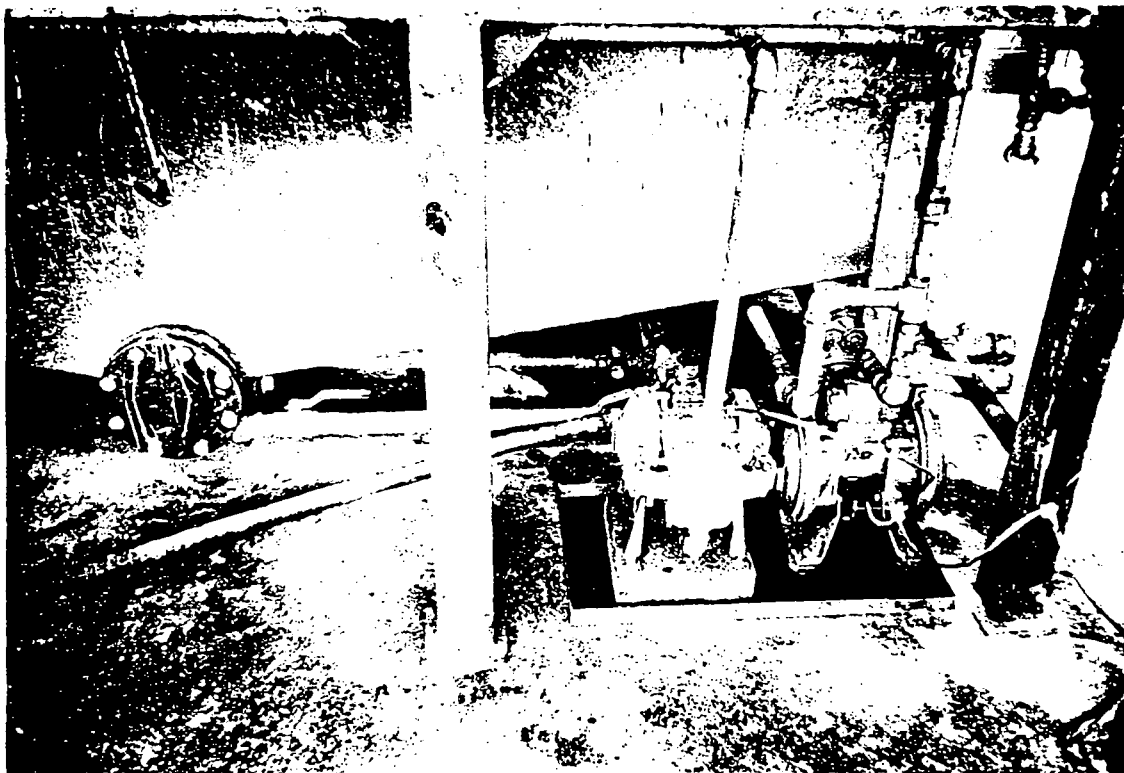
5.3 Close-up view of the pipes and pumps which transfer the contents of the Incoming Bulk Waste Transfer Station (SWMU 5) to the 3,000-Gallon Waste Liquids Tank (SWMU 6). Note the solvents contained in the tray beneath the pumps.

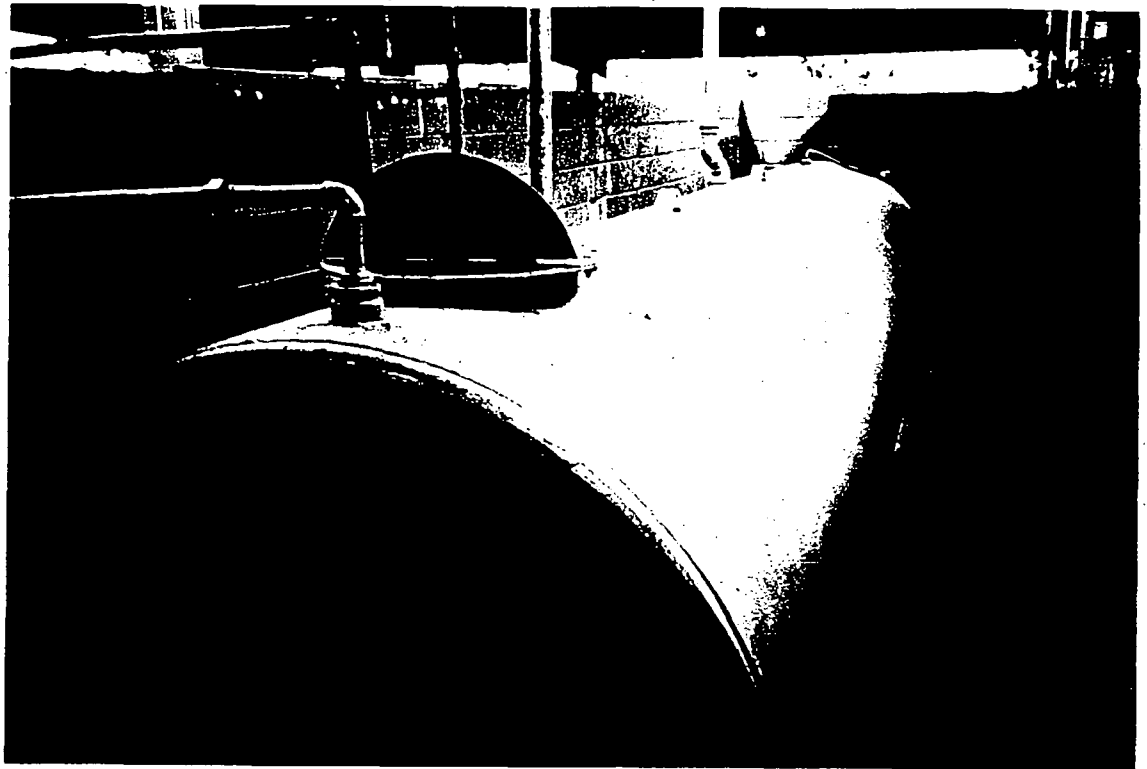
- 6.1 Overview of the 3,000-Gallon Waste Liquids Tank (SWMU 6) also showing the concrete-block wall and floor providing secondary containment for the unit. The tank is located adjacent to the Incoming Bulk Waste Transfer Station (SWMU 5) and the Tanker/Liquids Loading Station (SWMU 7).

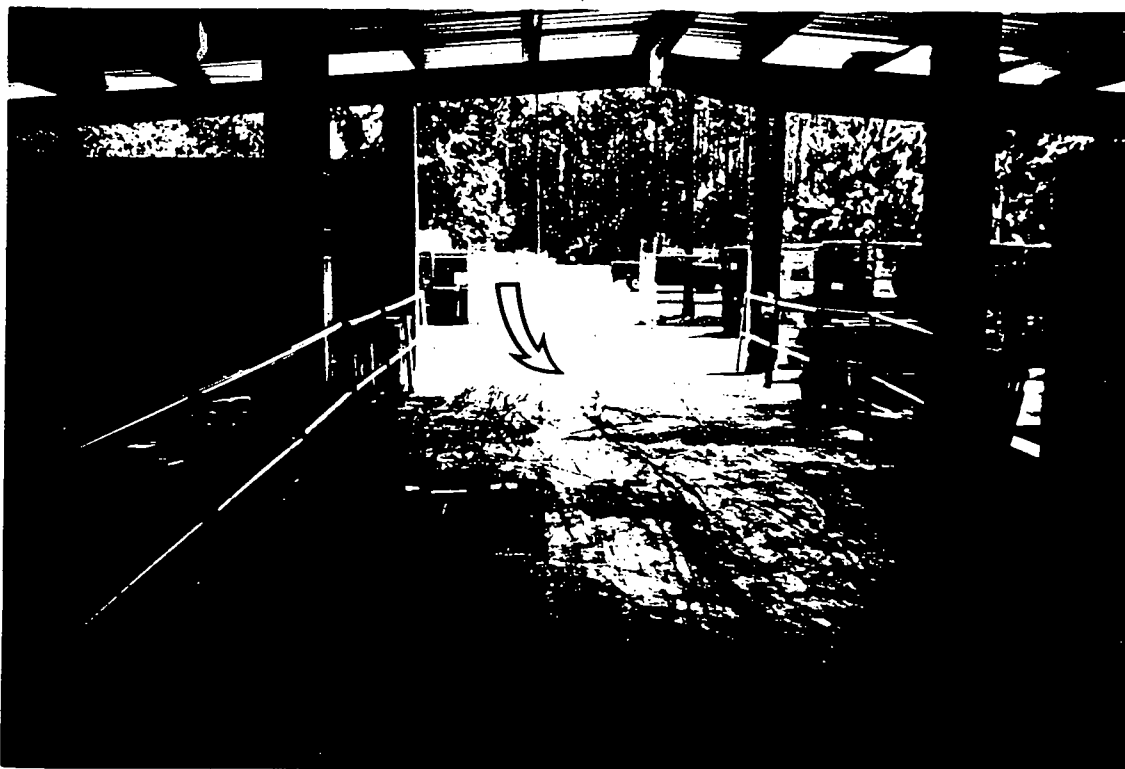
7.1 View of the Tanker/Liquids Loading Station (SWMU 7) facing east. Note the trench at the end of the pad (indicated by an arrow).

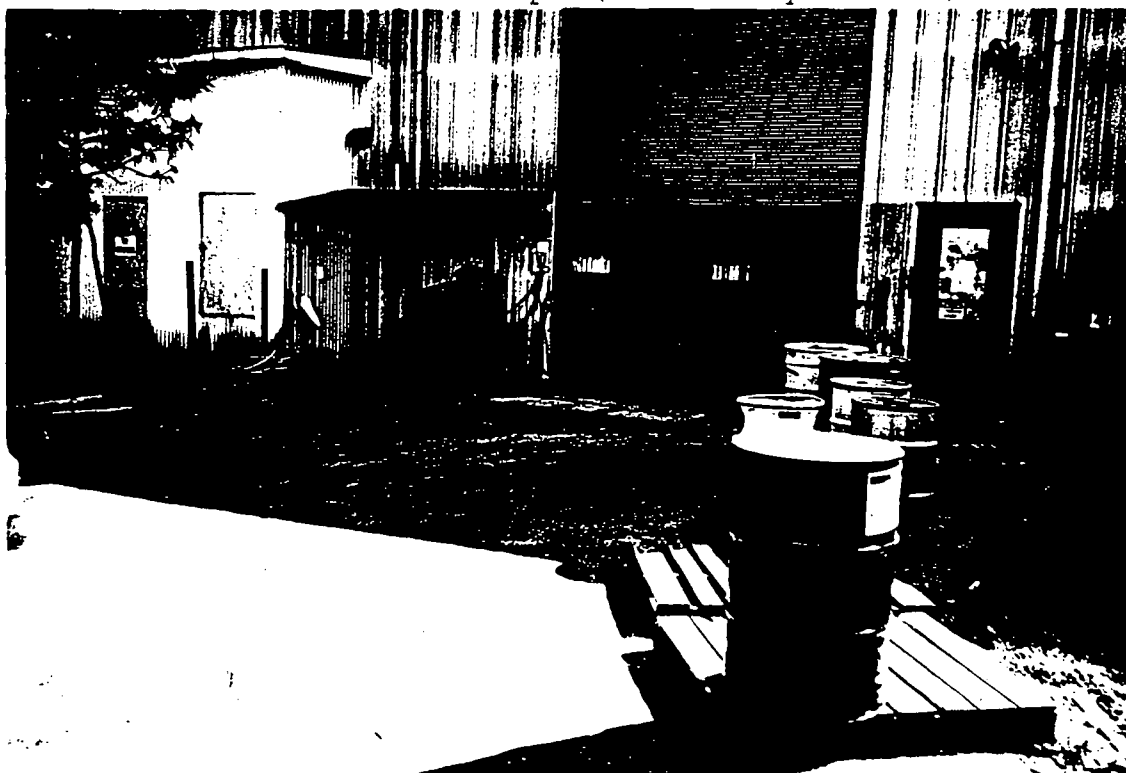
The VSI team observed dark staining on the concrete pad leading to the Indoor Staging and Process Area (SWMU 9). It appeared that runoff from the unit may drain onto grass-covered areas situated on either side of the unit.

8.1 View to the east of Outdoor Staging Area (SWMU 8) where drums of LSF vials are brought from the Container Storage Shed (SWMU 4) for opening and readying for entry into the building and into the process line. The drum in the foreground contained new product material; the other drums had been emptied.

COMMENTS: Evidence of staining is shown in Photographs 8.1 and 8.2., however, the staining appears to be insignificant and does not justify a high release potential.

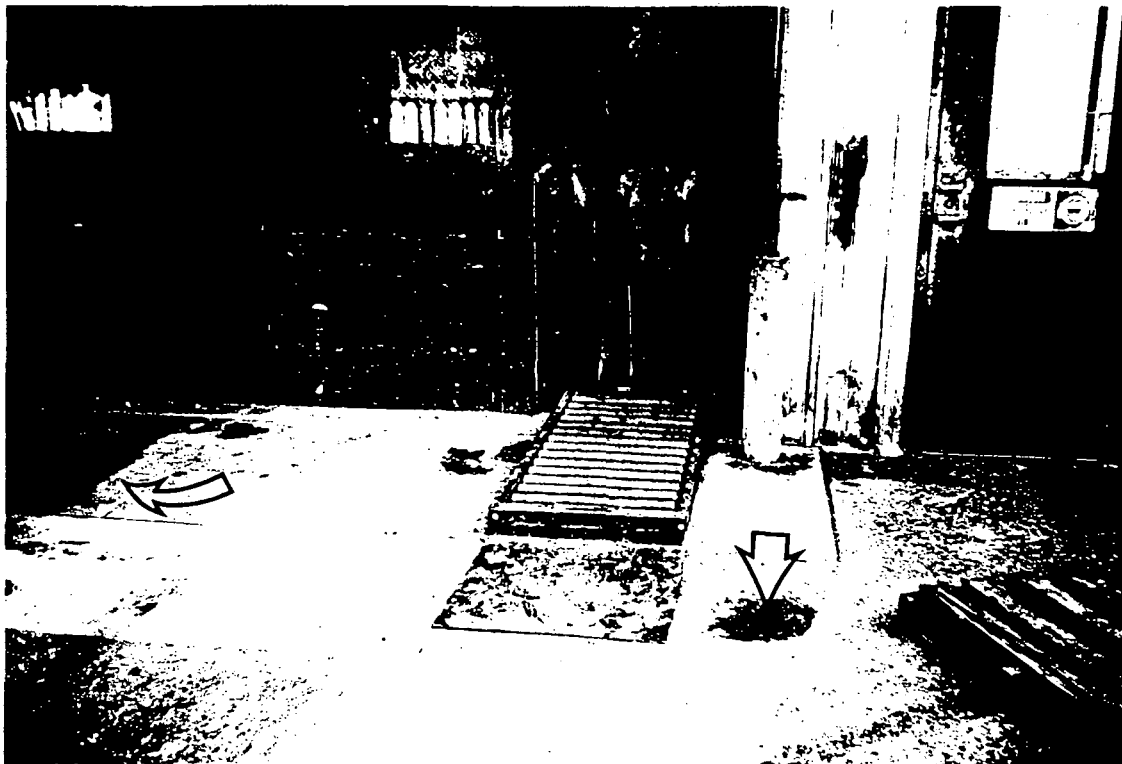
- 8.2 Close-up of opening in door and the pavement at the Outdoor Staging Area (SWMU 8). Drums are moved single-file into the Indoor Staging and Process Area (SWMU 9) through the opening in the door covered by flaps that is shown in the photo. Note stained concrete (indicated by arrows).

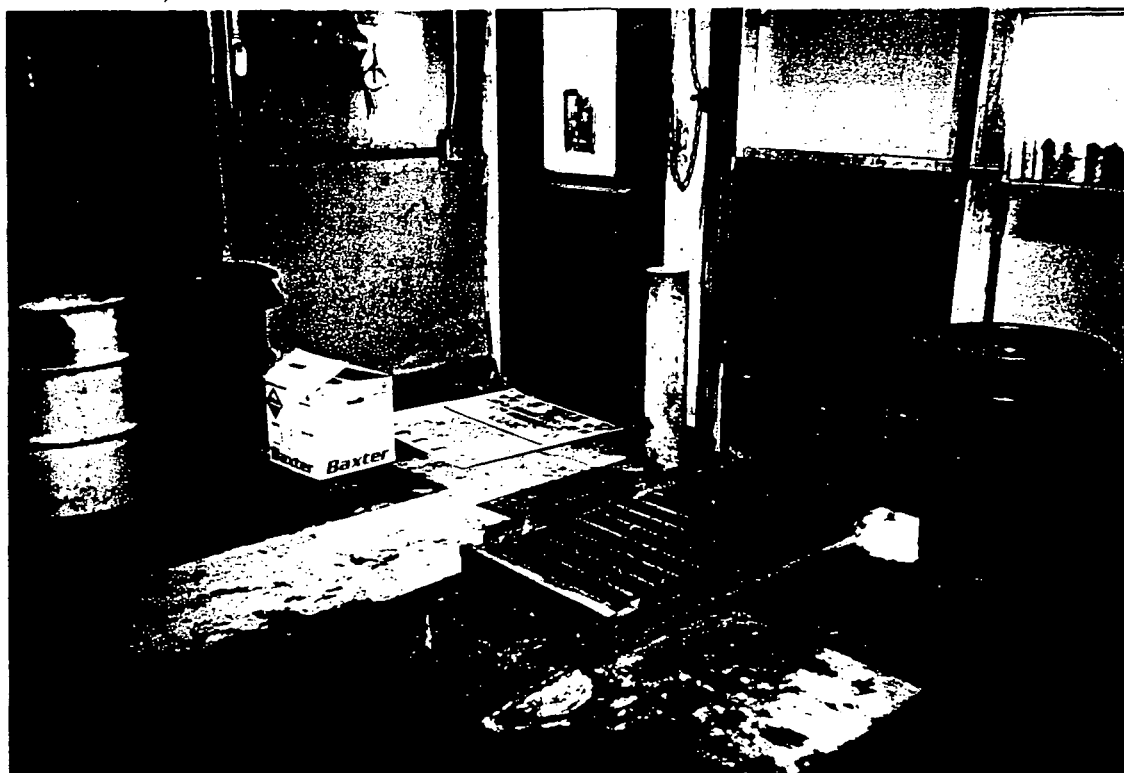
- 9.1 Interior view of the Indoor Staging and Process Area (SWMU 9) showing the Roller Conveyor (SWMU 9a) used to transfer drums from the Outdoor Staging Area (SWMU 8) to the indoor staging area. The process operations were shut down at the time of the VSI enabling the various components to be inspected and photographed.

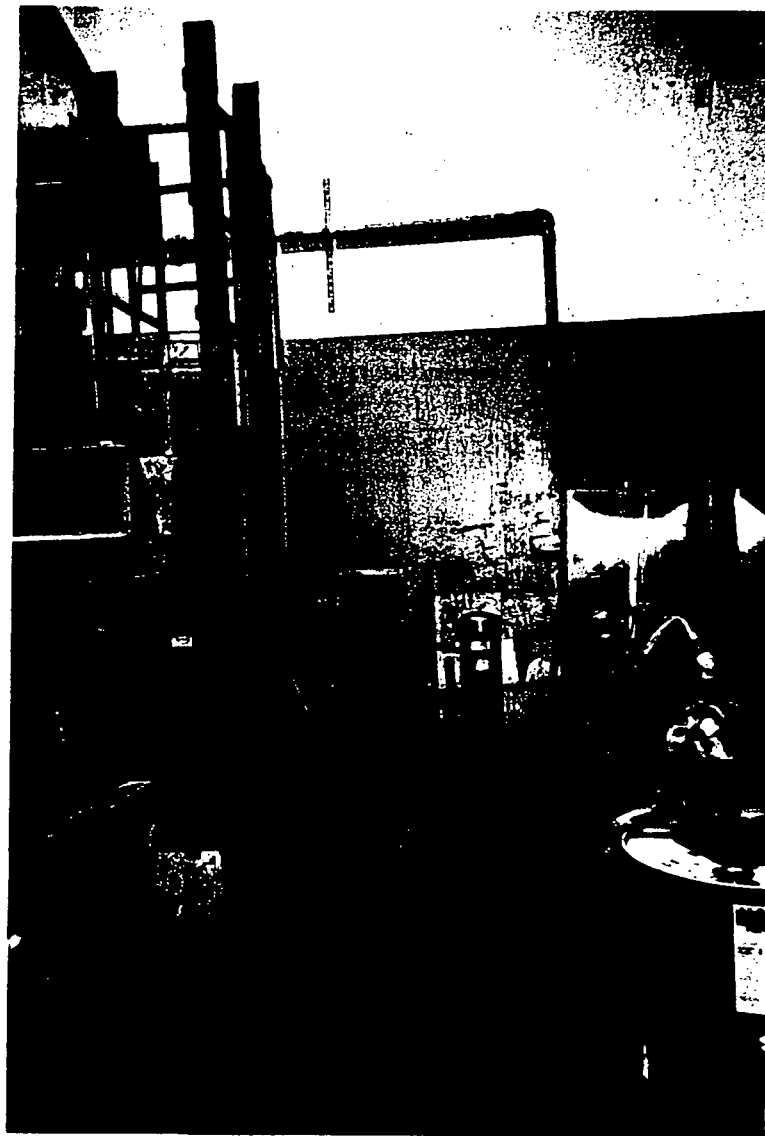
9.3 View of the hydraulic Lift (SWMU 9b) used to raise the drums to the In-Feed Hopper (SWMU 9c) featured in the upper-left-hand corner of the photograph.

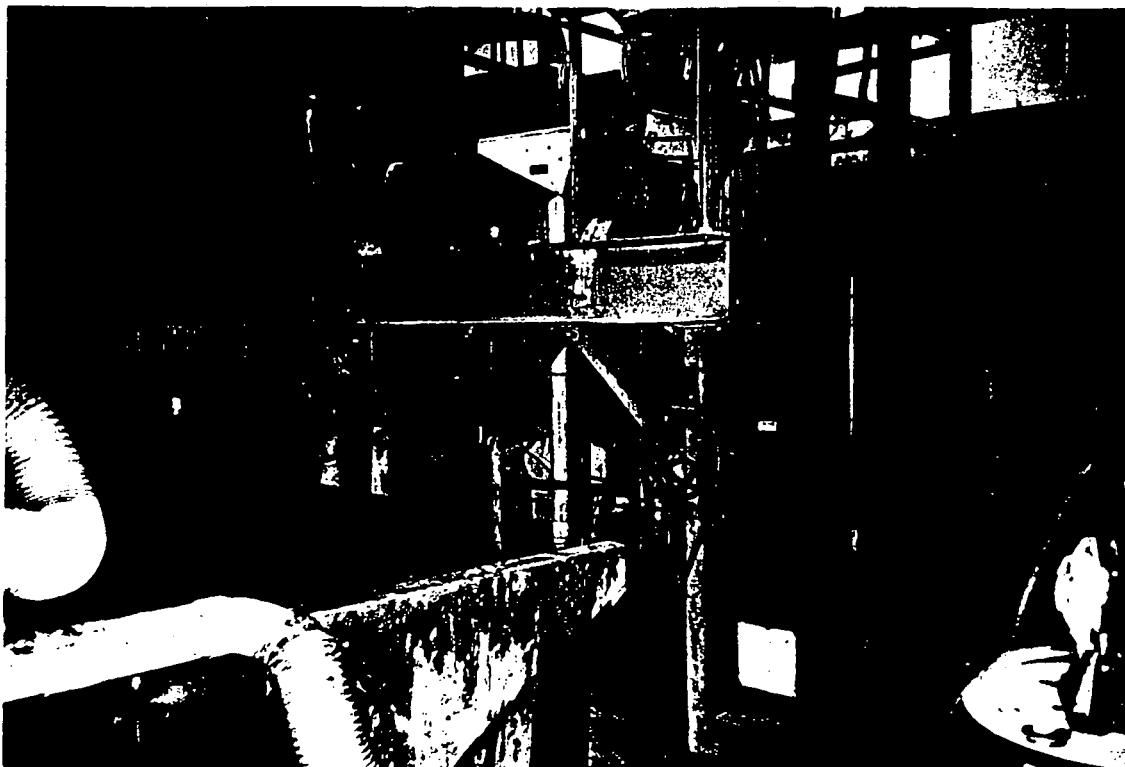
9.5 Overview of some of the components of the Indoor Staging and Process Area (SWMU 9). The blue hydraulic Lift (SWMU 9b) is featured on the right, the Shaker Table (SWMU 9d) in the top center (indicated by an arrow) and the green Crusher/Shredder (SWMU 9e).

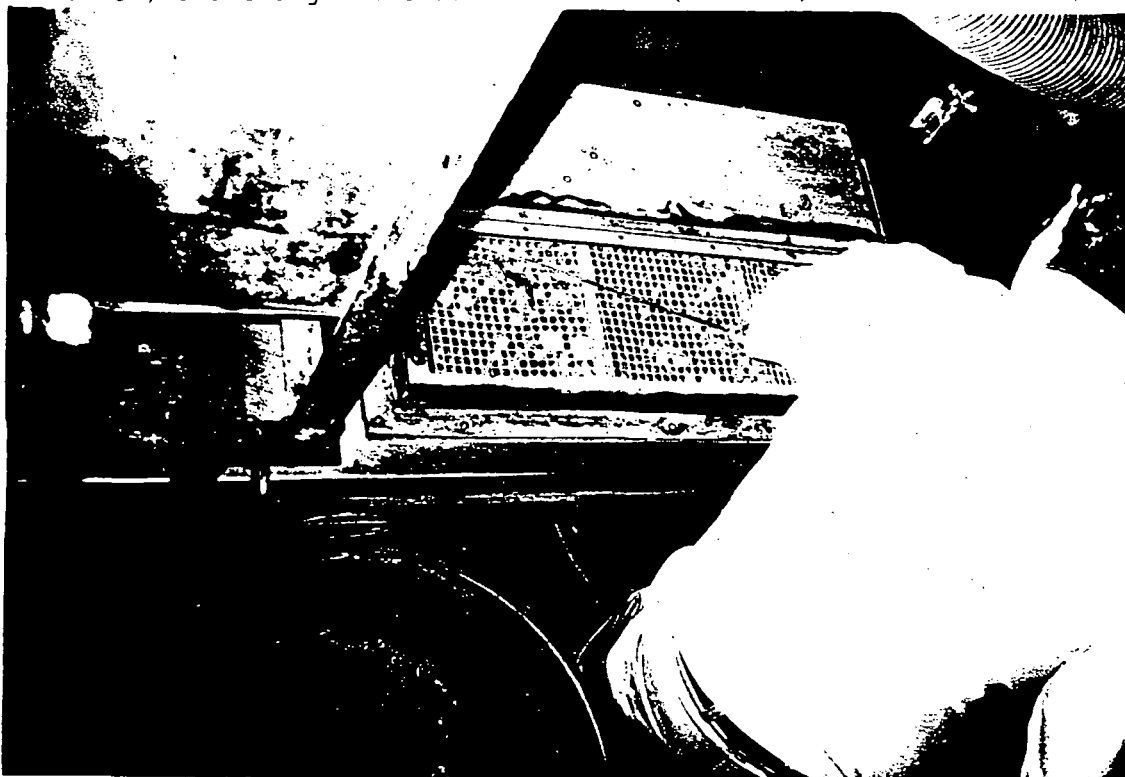
9.6 View of the work station along the Shaker Table (SWMU 9d). Note that this unit (as well as the other SWMU 9 component units) was not operating during the VSI.

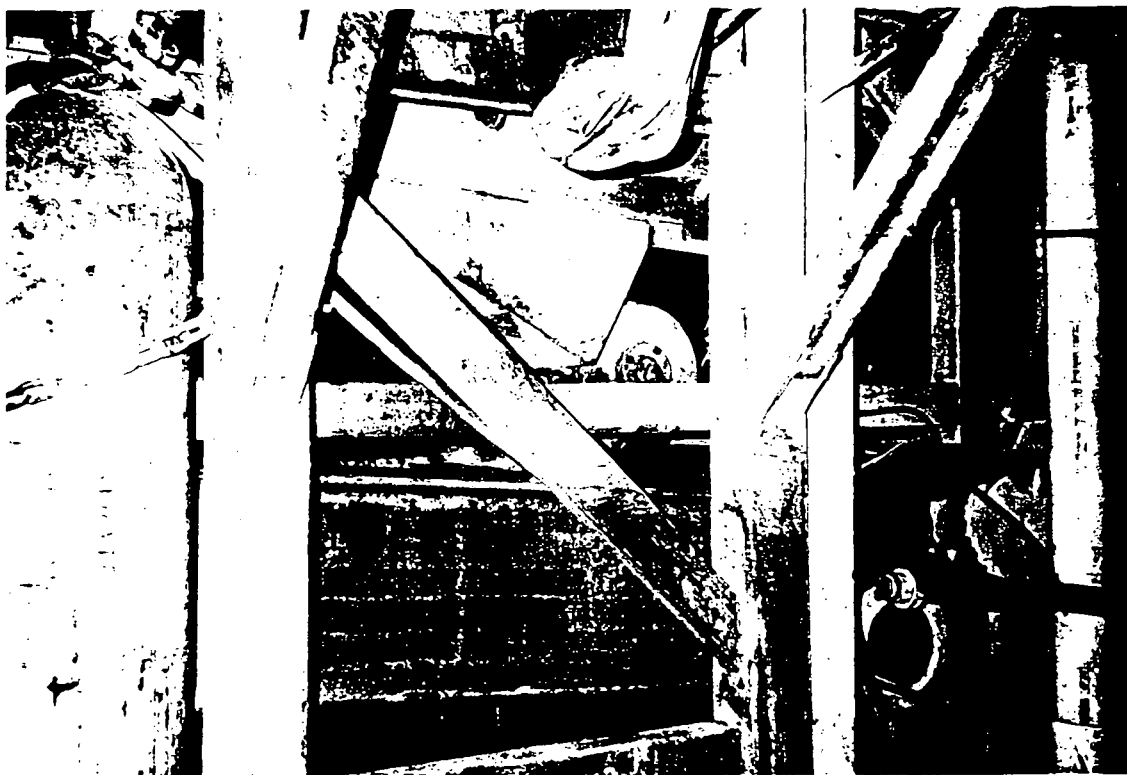
9.8 Bottom view of the Shaker Table (SWMU 9d) showing the cloth socks used to direct the discharge of separated vermiculite into the drums.

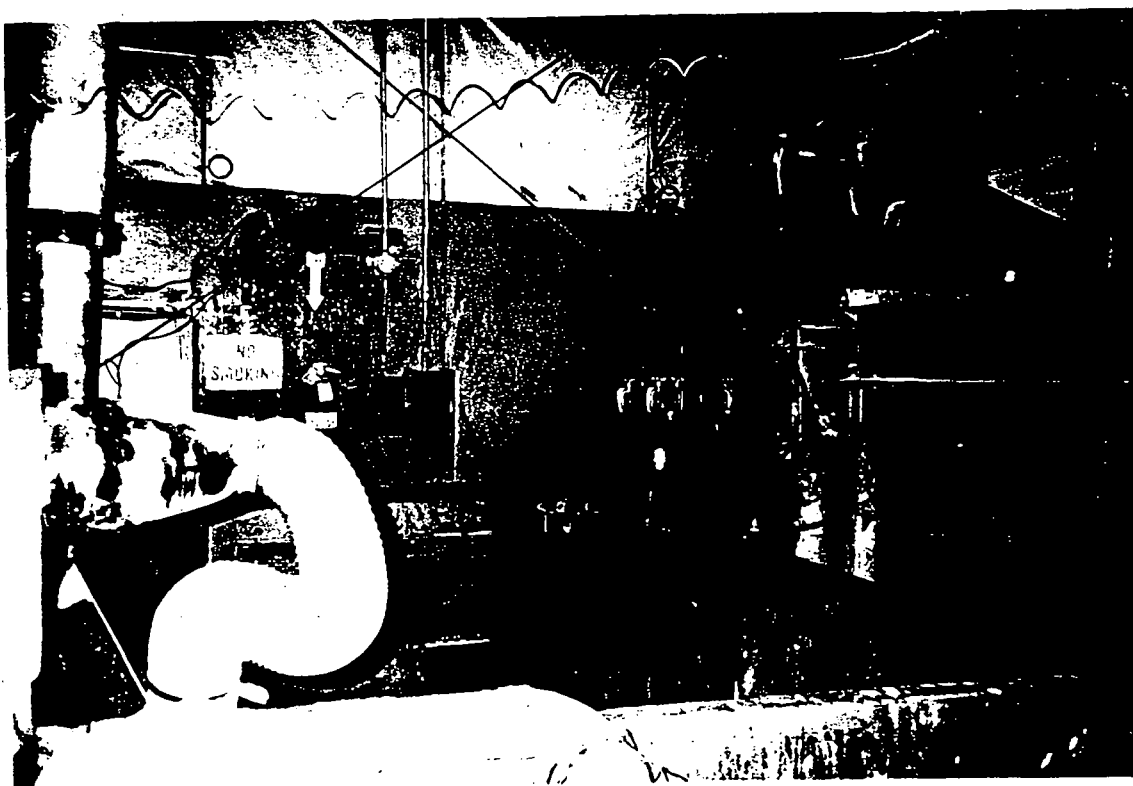
10.1 Overview of the Indoor Staging and Process Area (SWMU 9) showing some of the flexible hoses used to trap vapors and fumes from the various components. These units are part of the Processing Area Ventilation System (SWMU 10). Observe the blue filter in the lower center of the photograph.

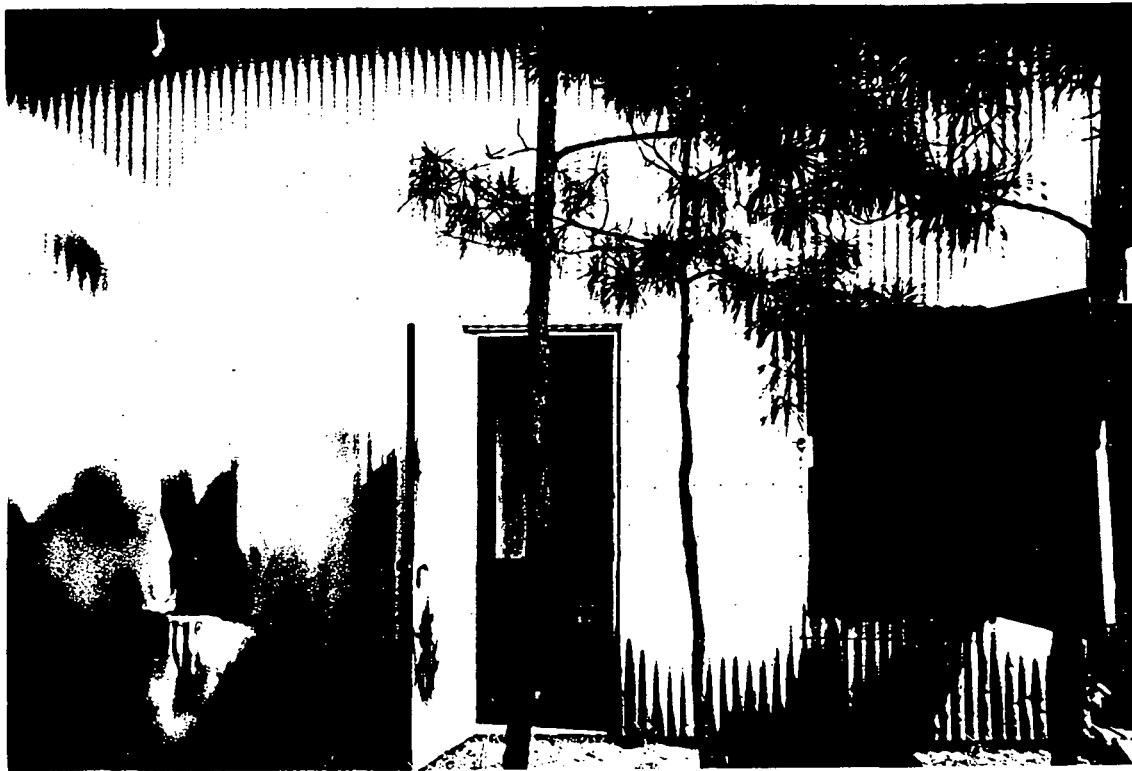
11.1 View of the west side of the manufacturing building outside the process area showing the room used to house the Carbon Adsorption System (SWMU 11).

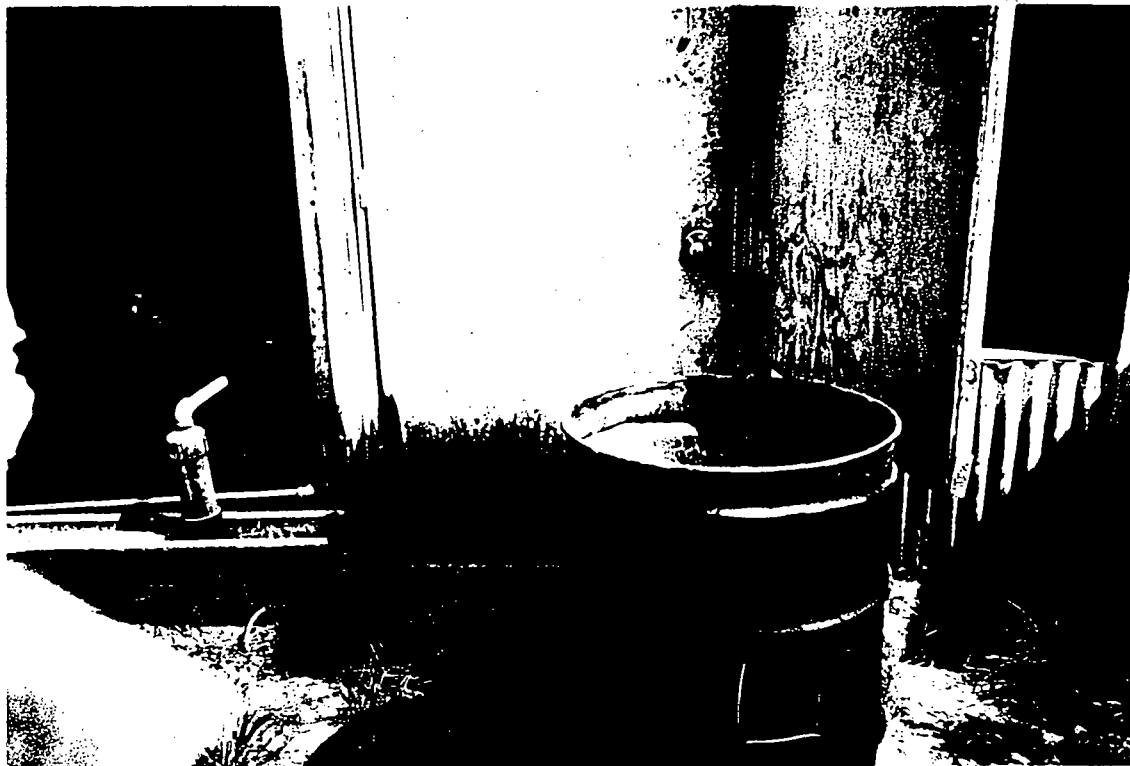
12.1 Close-up view of the area outside the Indoor Staging and Process Area (SWMU 9) showing the LSF Pipe (SWMU 12) which transfers LSF from the process area to the 3,000-Gallon Waste Liquids Tank (SWMU 6) located at the Container Storage Shed (SWMU 4).

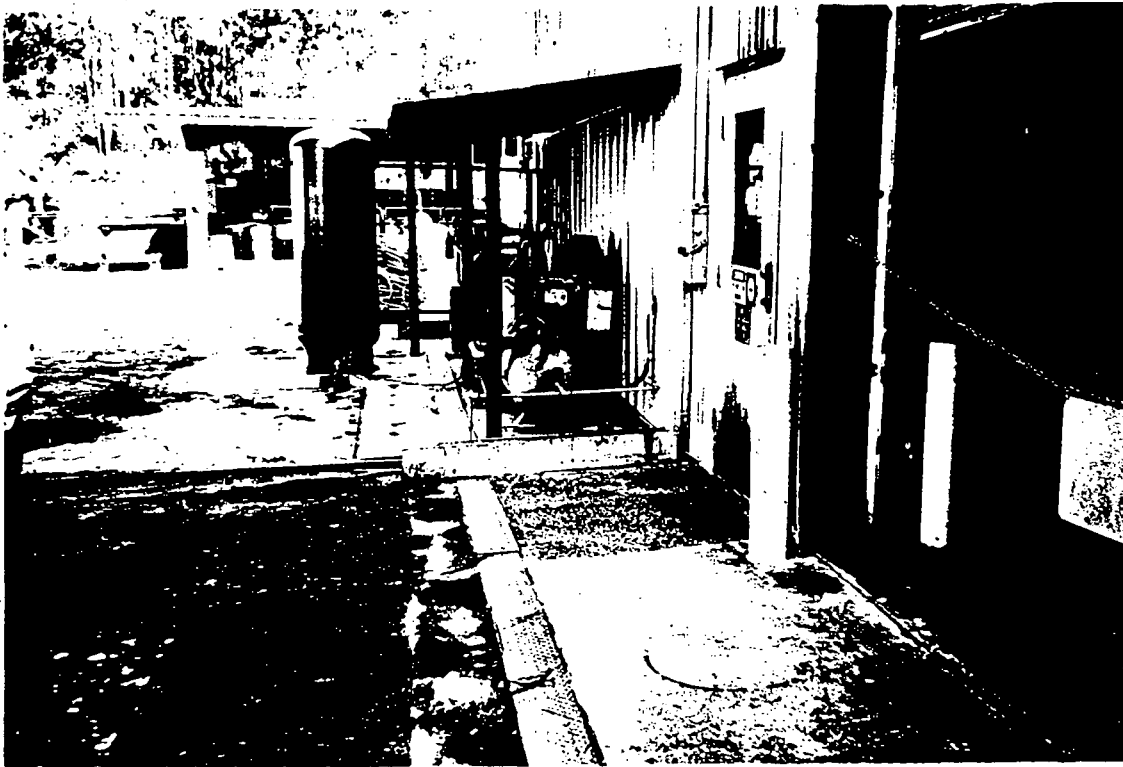
12.3 View of the north showing the covered LSF Pipe (SWMU 12) trough leading to the Container Storage Shed (SWMU 4) which is visible in the left background. The white material next to the trough is sand.

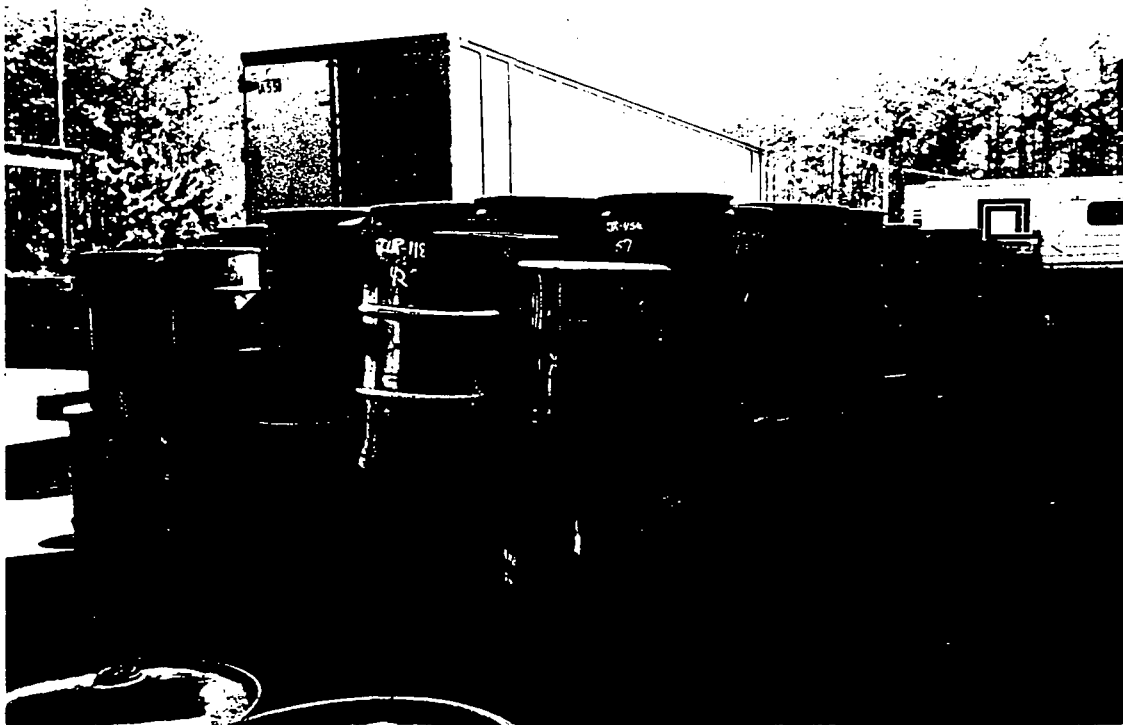
13.1 View to the east of the Packing Material Wastes Drum Holding Area (SWMU 13). Approximately 250 drums were in this area at the time of the VSI.

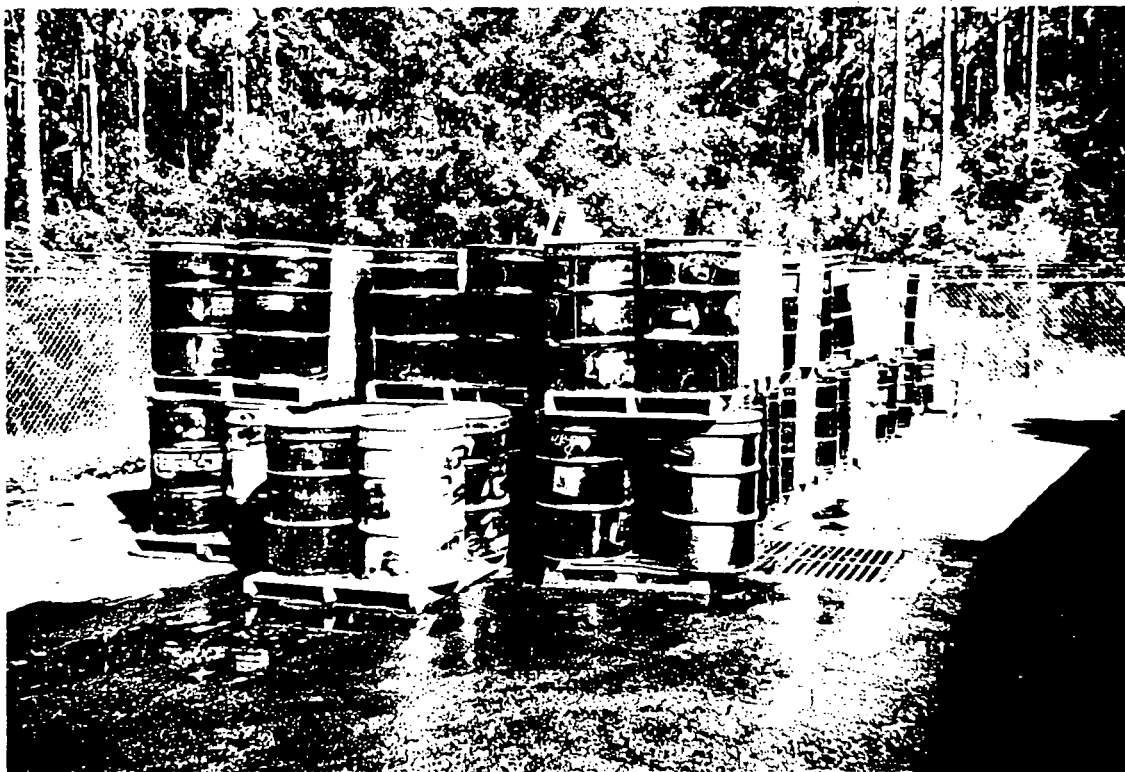
15.1 View to northwest of the Crushed Glass/Plastic Vials Drum Holding Area (SWMU 15). Note drop inlet in pavement which conveys surface washings, rainfall runoff or any other liquids spilled or washed in this area, to the North Drainage Ditch (SWMU 23). Drums containing the freshly-crushed and rinsed vials are brought from the Process Area (SWMU 9) to this area where the liquids on the material inside the drums drain, and the drums await their turn for movement to the Crushed Vials Final Drainage Station (SWMU 16) where the liquids are pumped out.
