INTERIM RCRA FACILITY ASSESSMENT  
of the  
QUADREX HPS, INC. FACILITY  
GAINESVILLE, FLORIDA

EPA I.D. NO. FLD980711071

February 22, 1990

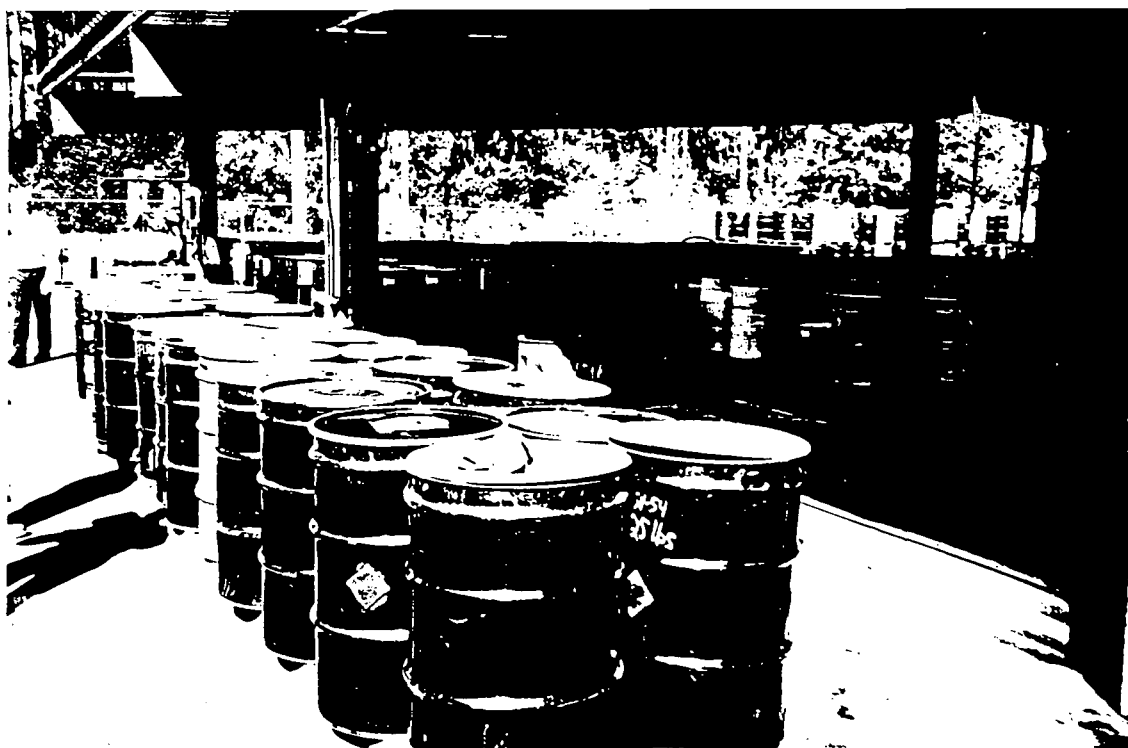
- 16.1 View to the west-northwest of the approximately 28 drums at the Crushed Vials Final Drainage Station (SWMU 16). The drums in this area are within the reach of the green hose shown on the right, which is used to pump any liquids from the bottoms of the drums into the 3,000-Gallon Waste Liquids Tank (SWMU 6). The southwest compartment (Zone 2) of the Container Storage Shed (SWMU 4) is visible in the background.

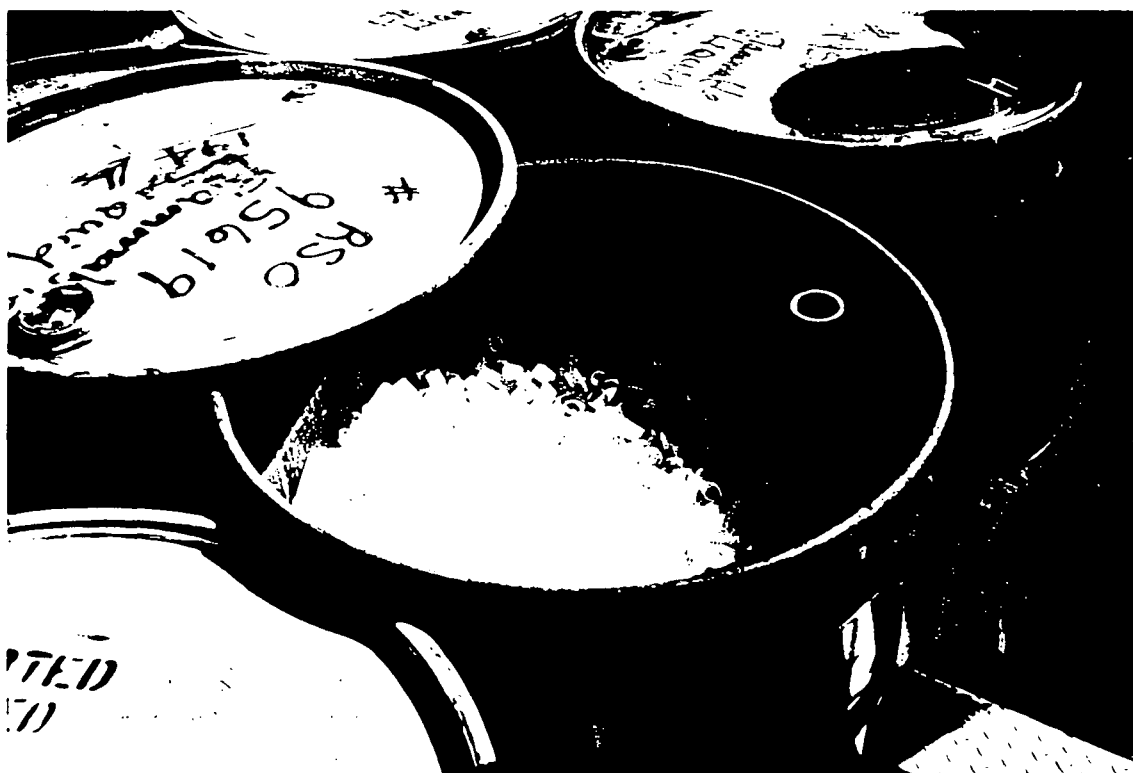
- 16.2 Close-up view of processed plastic vials in drums located at the Crushed Vials Final Drainage Station (SWMU 16). Note the pipe inserted into the drum to suck up and pump any liquids draining from the rinsed processed material from the drum into the 3,000-Gallon Waste Liquids Tank (SWMU 6).

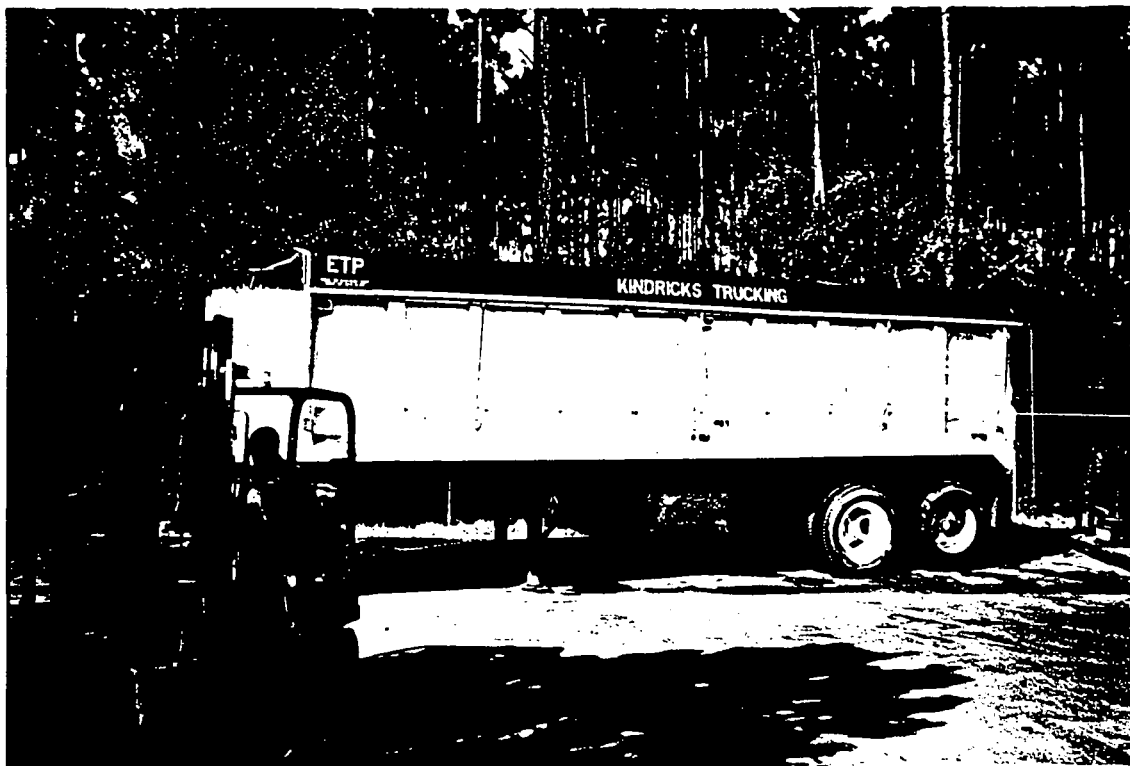
19.1 View of one of the Dumping Trailers (SWMU 19) facing southwest. These trailers are parked in the west section of the facility and are also shown in photograph 20.1.

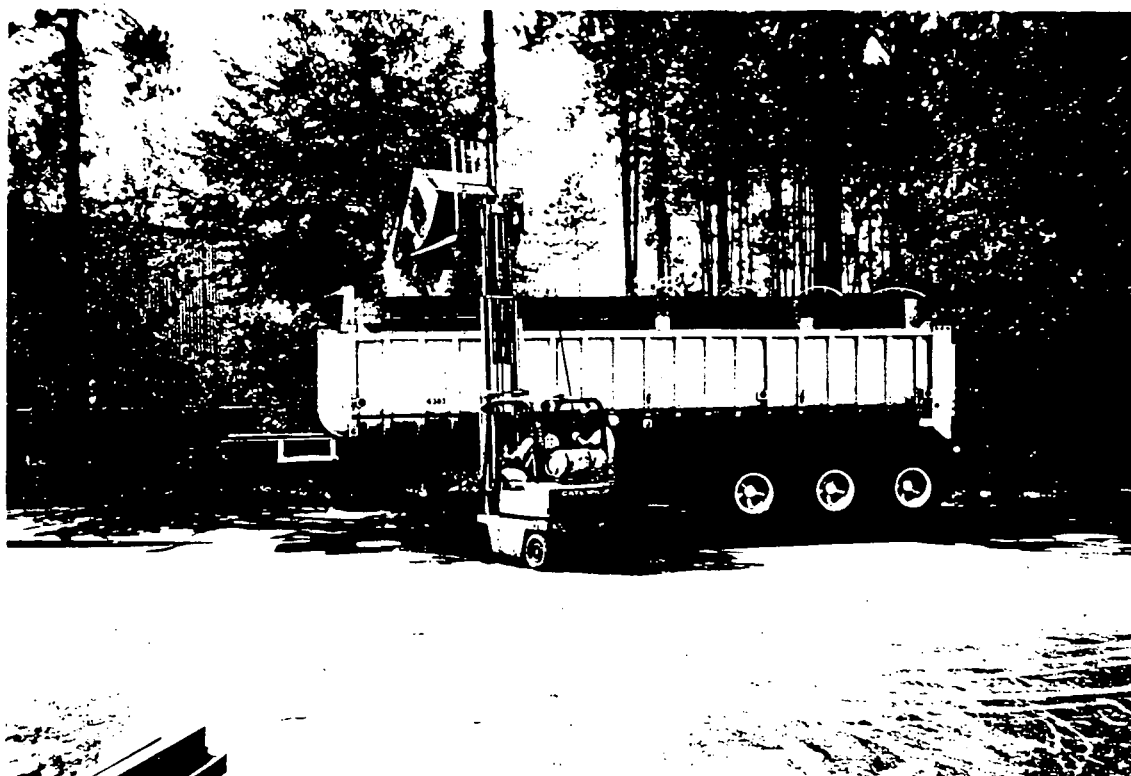
19.2 View of one of the Dumping Trailers (SWMU 19) during loading operations featuring one of the Gondolas (SWMU 18).

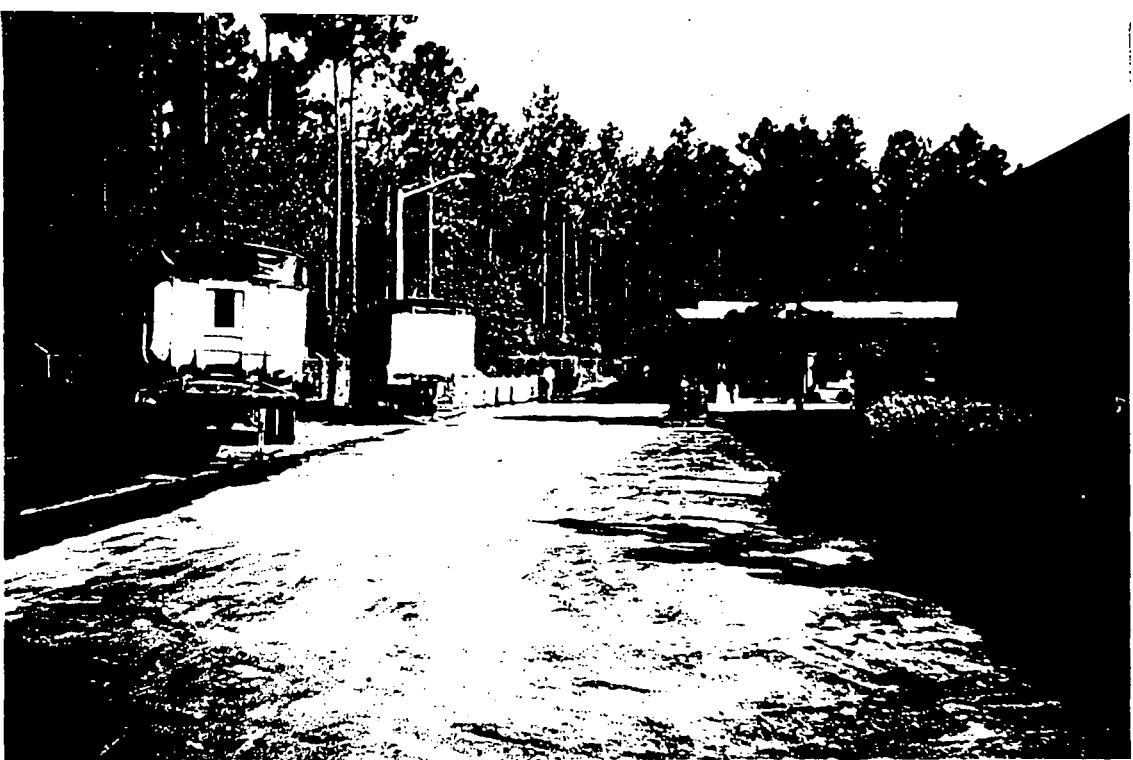
- 20.1 View to the north showing the Waste Handling Route (SWMU 20) used by the forklift trucks to bring pallets of drums from the Container Storage Shed (SWMU 4), shown in the background, to the Outdoor Staging Area (SWMU 8) which is the point from which this photograph was taken. Note surface drainage is to the north in this area. Photographs 15.1, 17.1, 18.1, 19.1 and 19.2, as well as this photograph, show surface water on the pavement during the VSI. The individual in the background of this photograph is pushing water with a broom into the drop inlet at the Crushed Glass/Plastic Vials Drum Holding Area (SWMU 15).

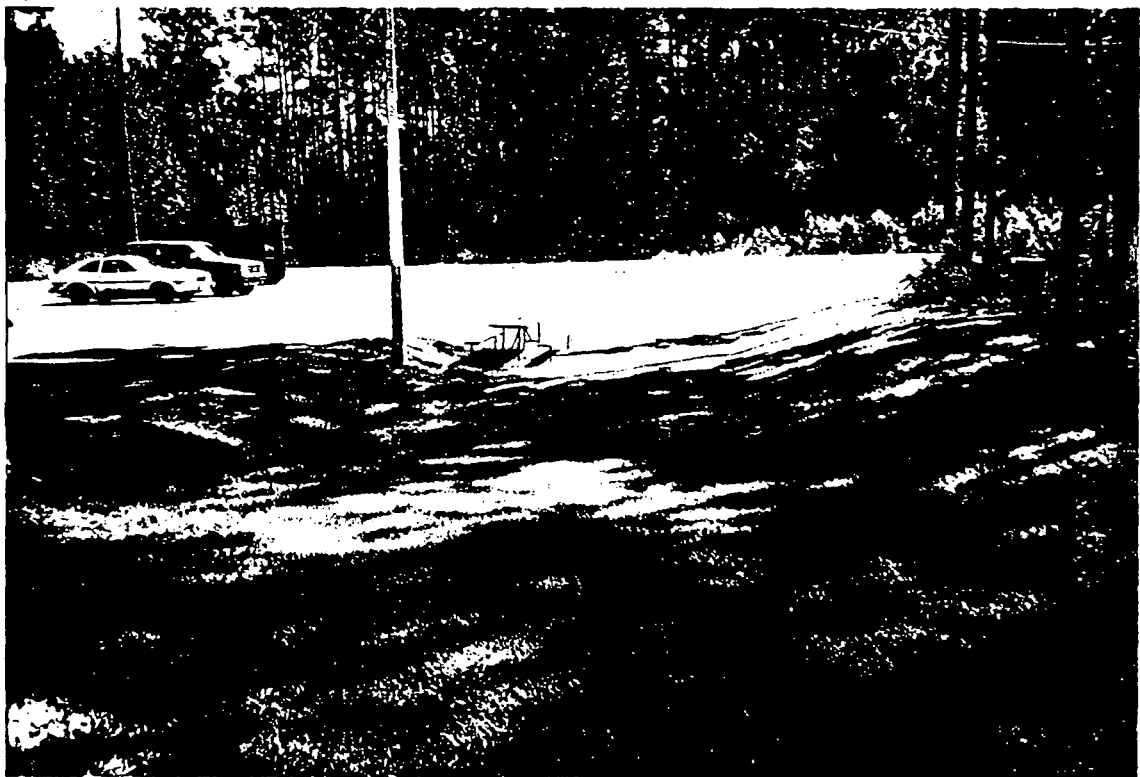
- 21.1 View of the North Retention Pond (SWMU 21) facing east. The photograph was taken from the Field Trailers Service Area (SWMU 26).

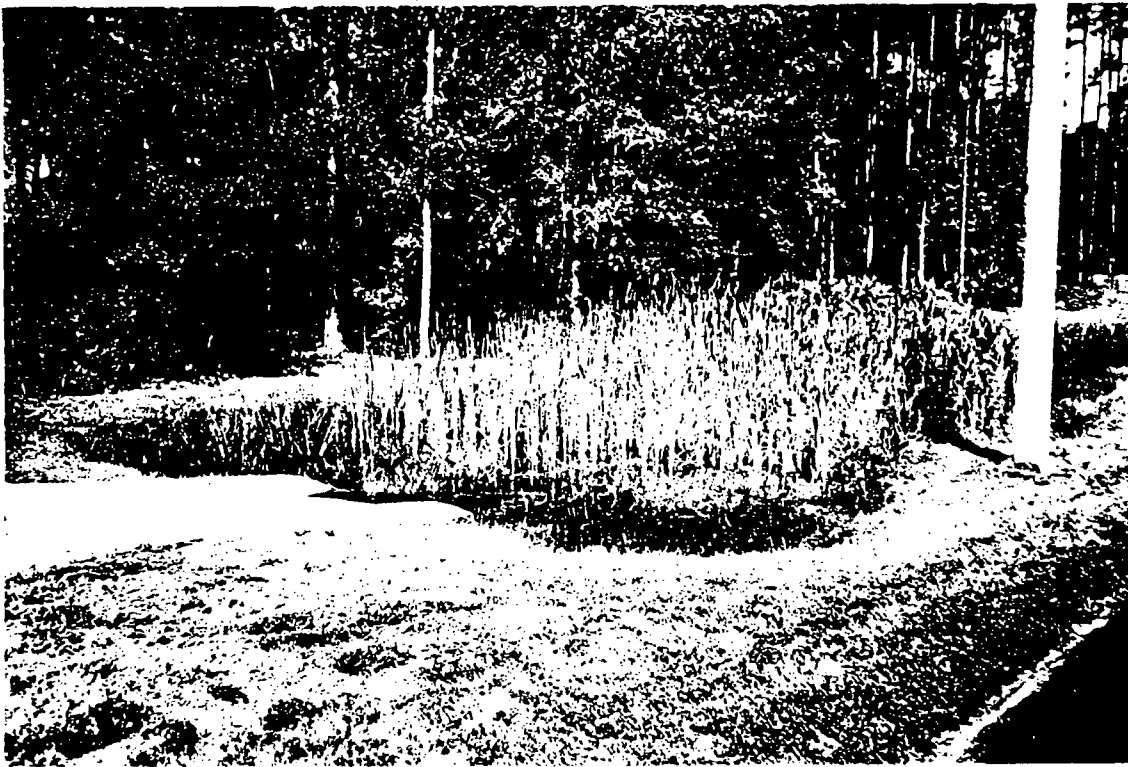
22.1 View of the East Retention Pond (SWMU 22) facing northwest.

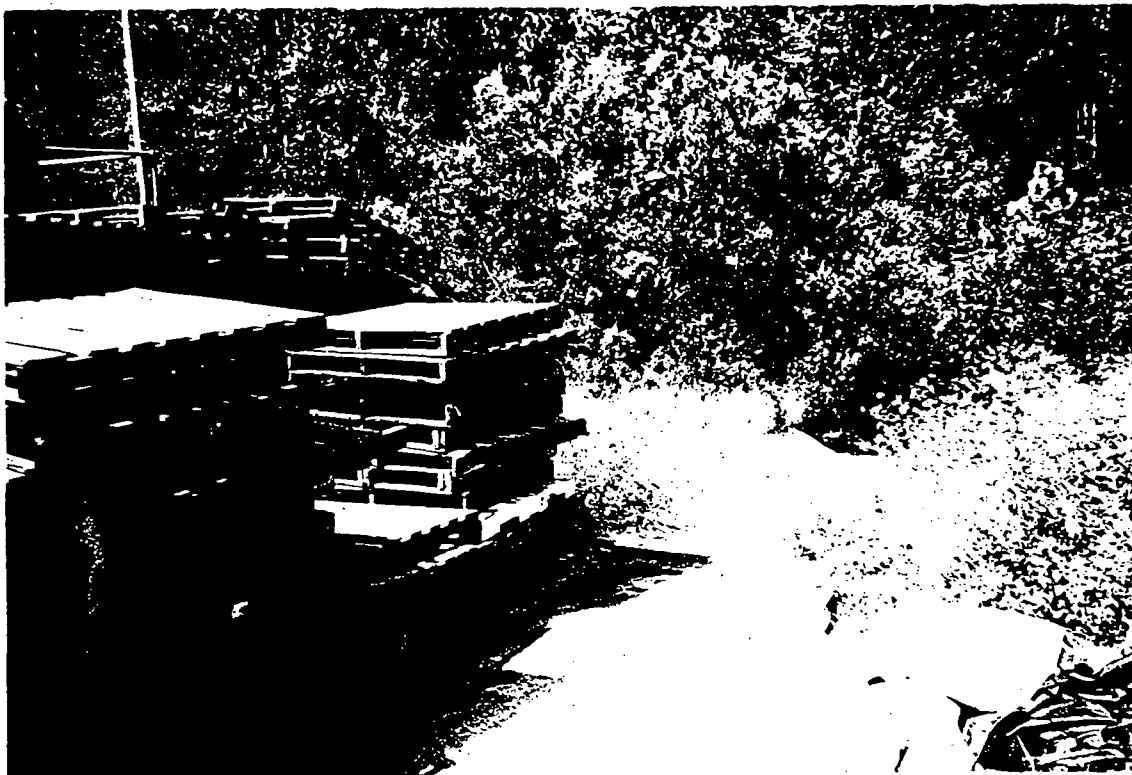
23.1 View of the north section of the facility facing north. The North Drainage Ditch (SWMU 23) is located beyond the concrete swale featured in the right-center of the photograph.

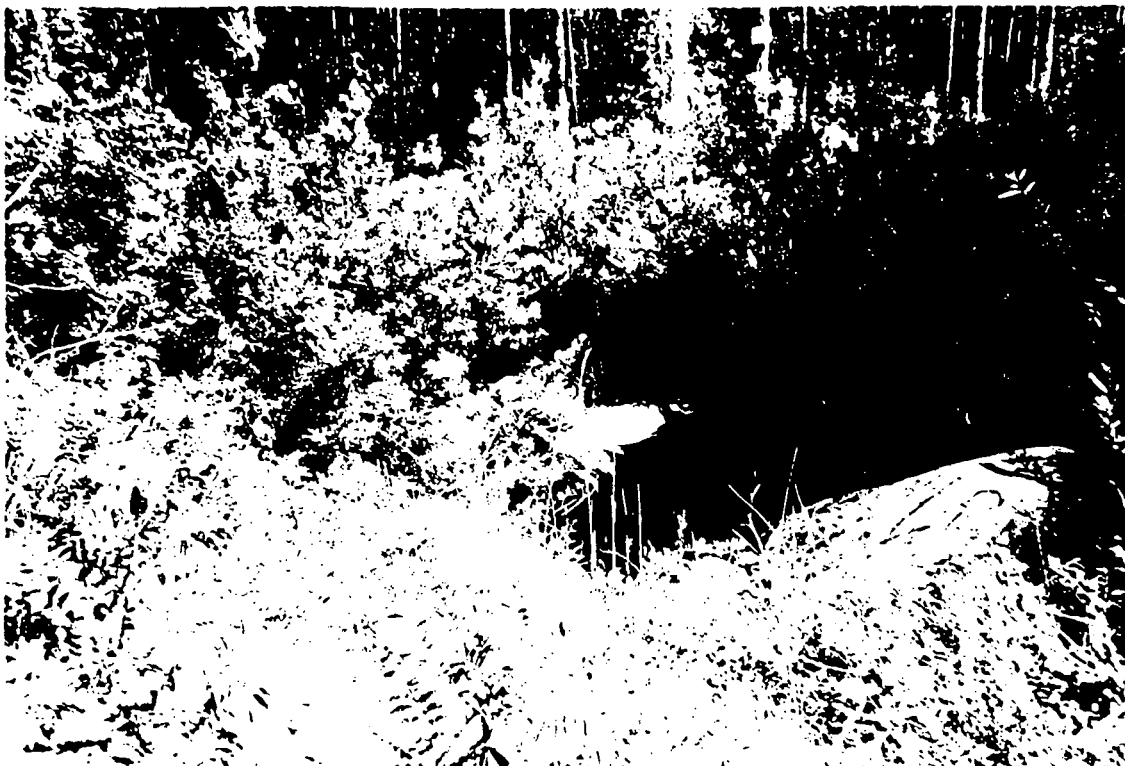
24.1 View of the East Drainage Ditch (SWMU 24) in the vicinity of the North Drainage Ditch (SWMU 23). The view is facing northeast.

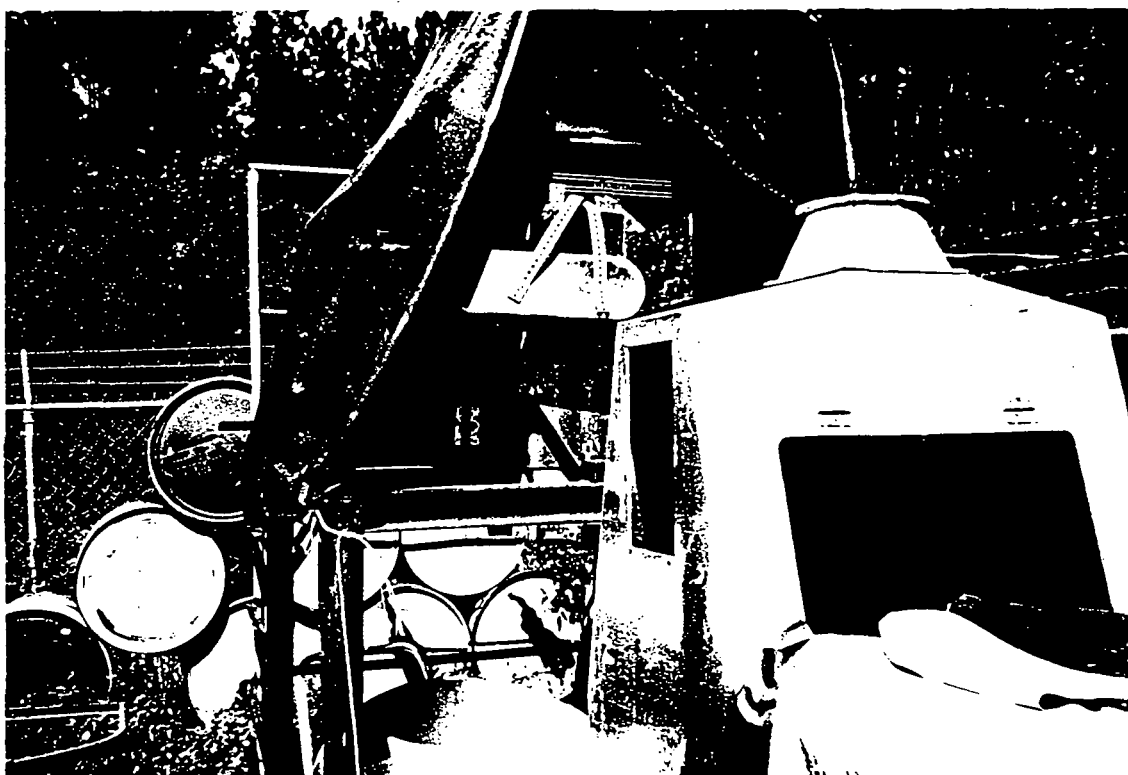
25.1 View of the Former Glass/Plastic Shredder Unit (SWMU 25) presently stored in the north section of the facility. This unit was removed from service during 1988. The view is facing north.

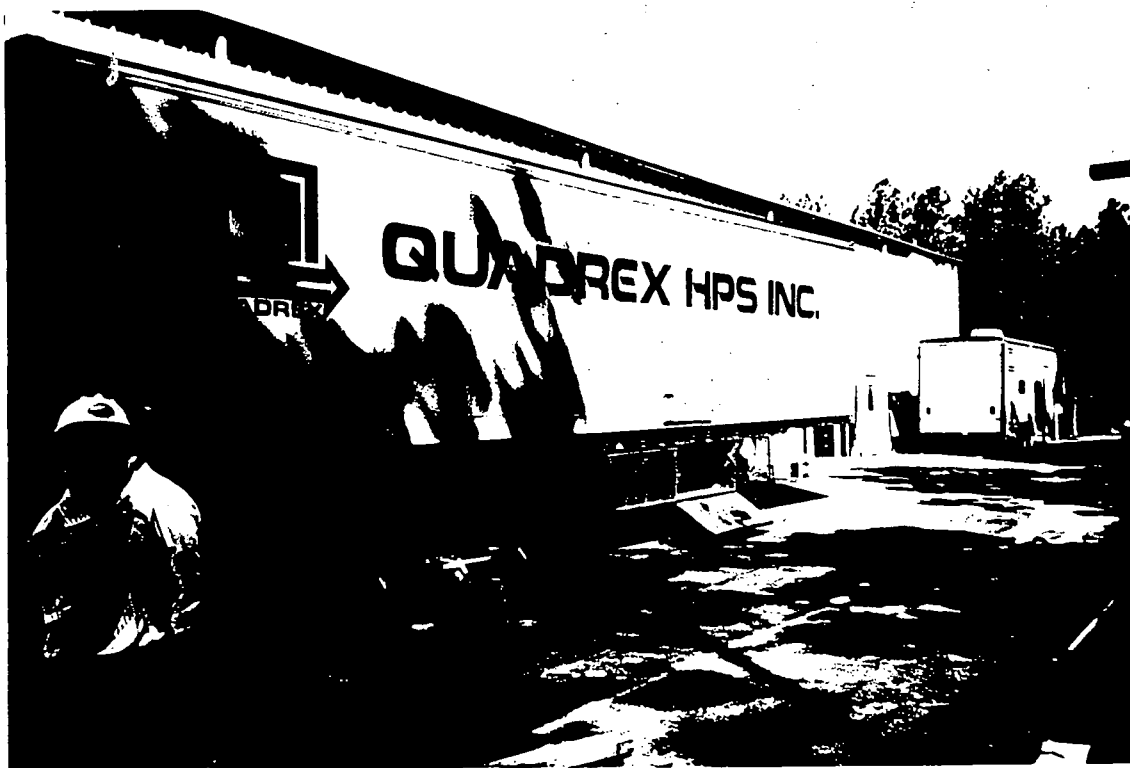
26.1 View of the Field Trailers Service Area (SWMU 26) facing northwest. The small white trailer is a portable laboratory.

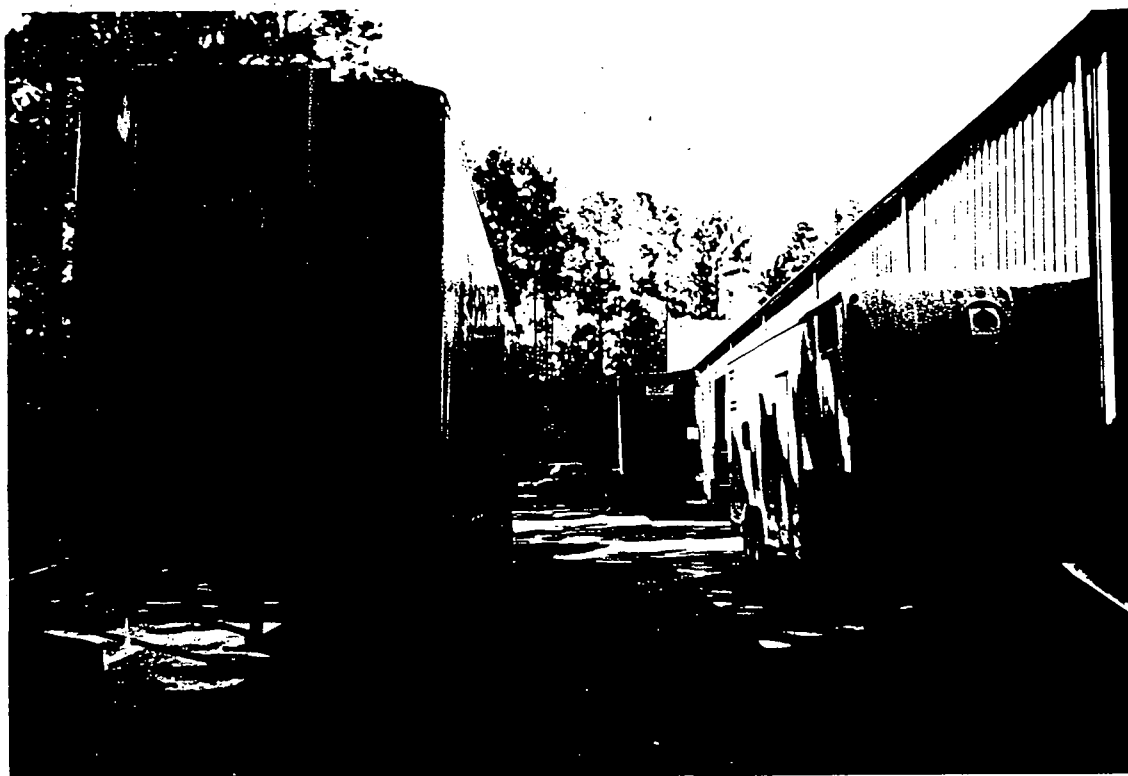
26.2 View of the Field Trailers Service Area (SWMU 26) facing south. The white portable laboratory on the right is the same one shown in Photograph 26.1.

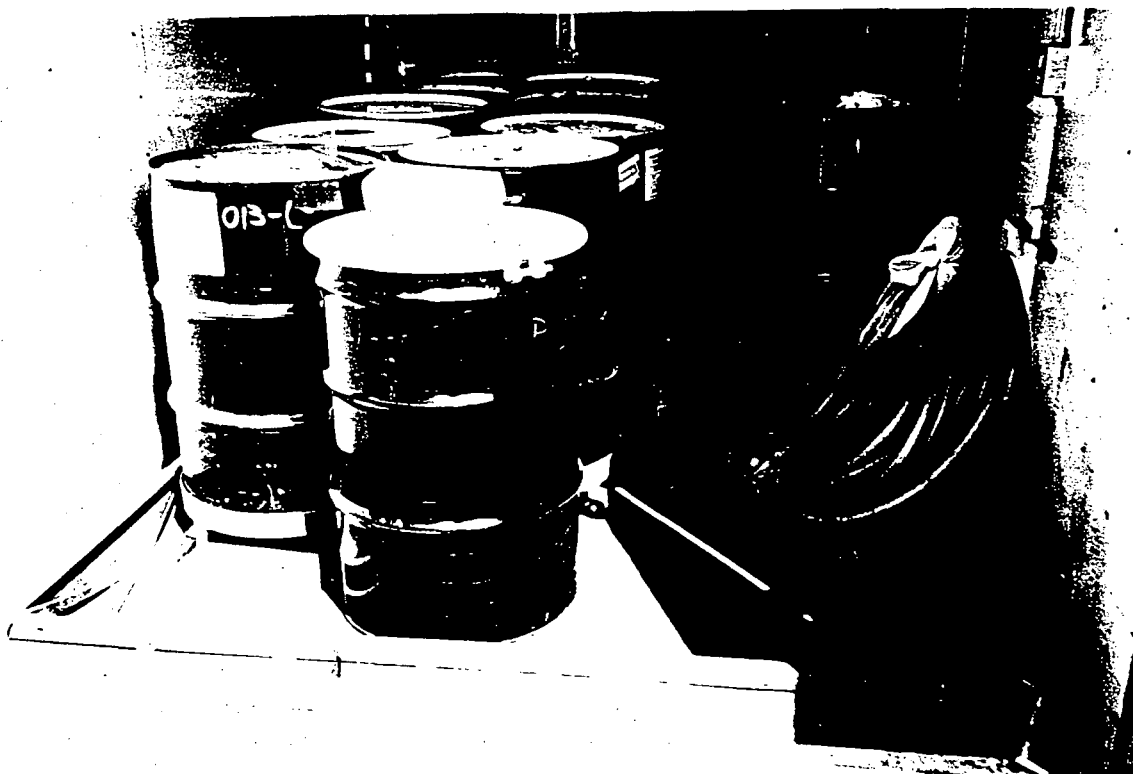
27.2 Close-up view of the interior of the PCB Drummed Waste Storage Area (SWMU 27) showing drums containing PCB material.

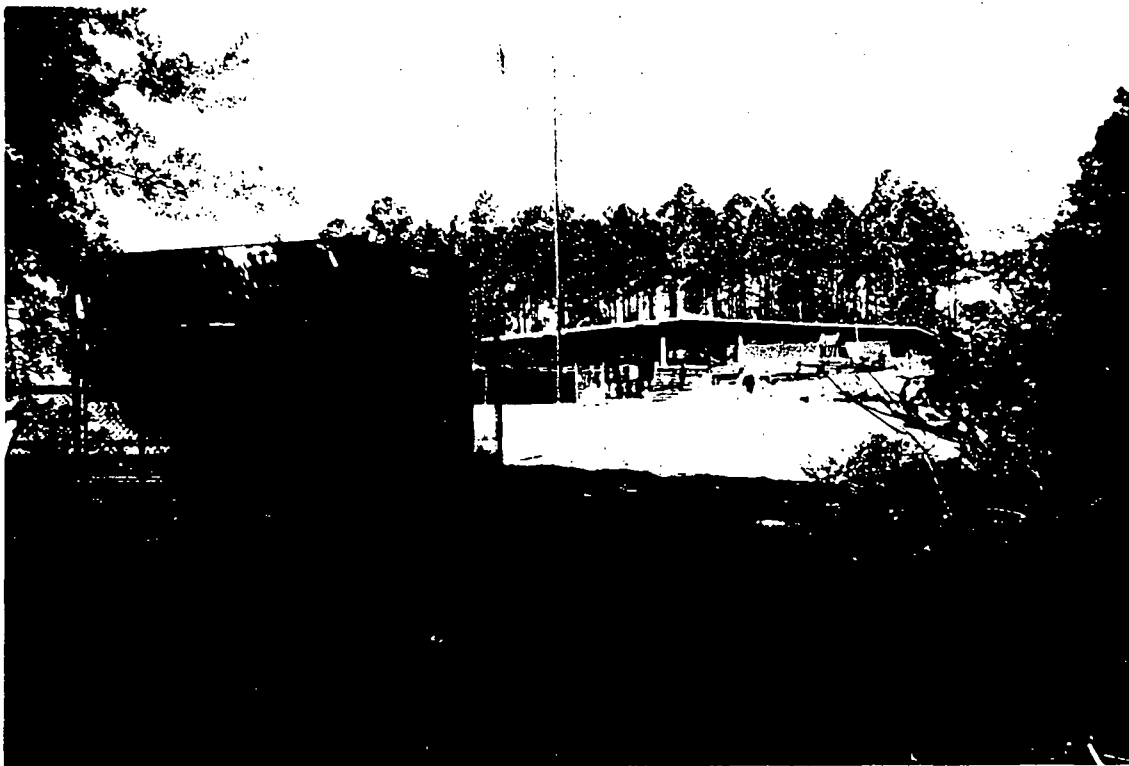
27.3 Overview of the north section of the facility facing west. The container in the foreground is the PCB Drummed Waste Storage Area (SWMU 27) and the structure in the background is the Container Storage Shed (SWMU 4). The photograph is taken from the northeast corner of the site.

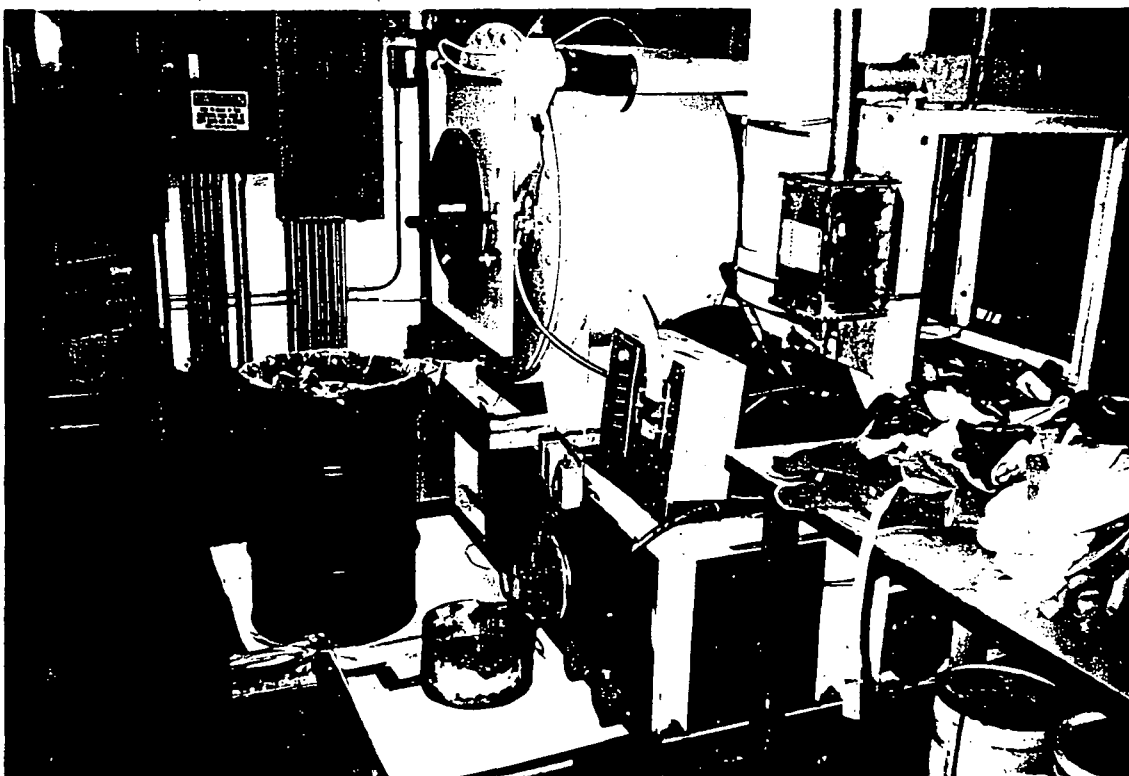
28.1 Interior view of the protective-clothing room showing the Freon Distillation Waste Collection Unit (SWMU 28).

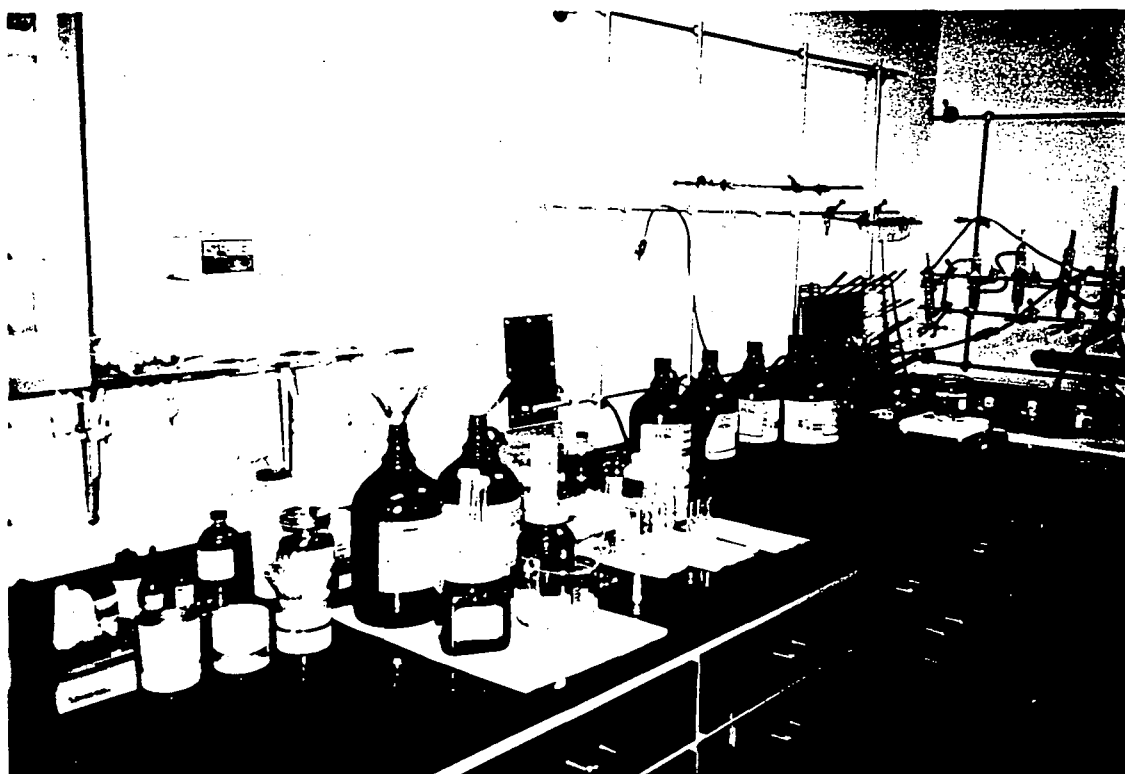
30.1 View of the laboratory that provides support to the hazardous waste field activities and tests the contents of the drums at the Container Storage Shed (SWMU 4). The Laboratory Wastes Accumulation Area (SWMU 30) is located in this room. Note the bottles of PCB waste located on the shelf.

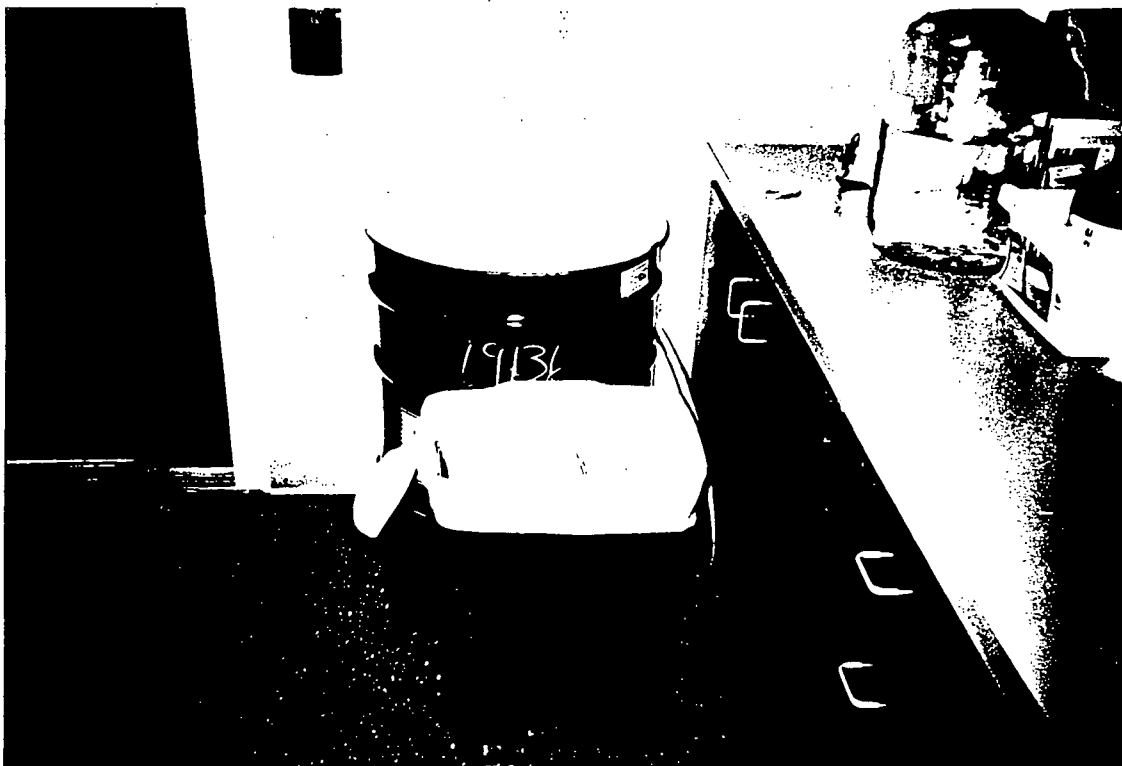
30.2 View of drum used to accumulate wastes in the laboratory - Laboratory Wastes Accumulation Area (SWMU 30).

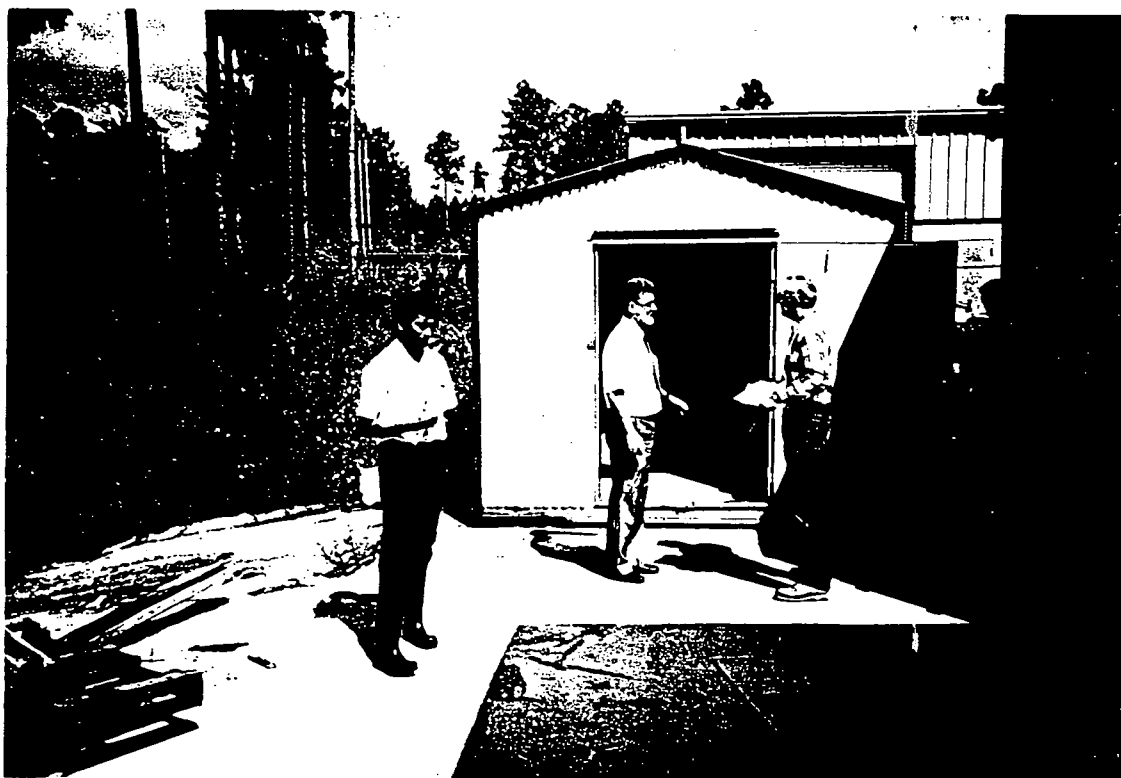
31.1 View to the north of the Laboratory Specimens Storage Building (SWMU 31) located approximately 200 feet west of the laboratory in the Annex.

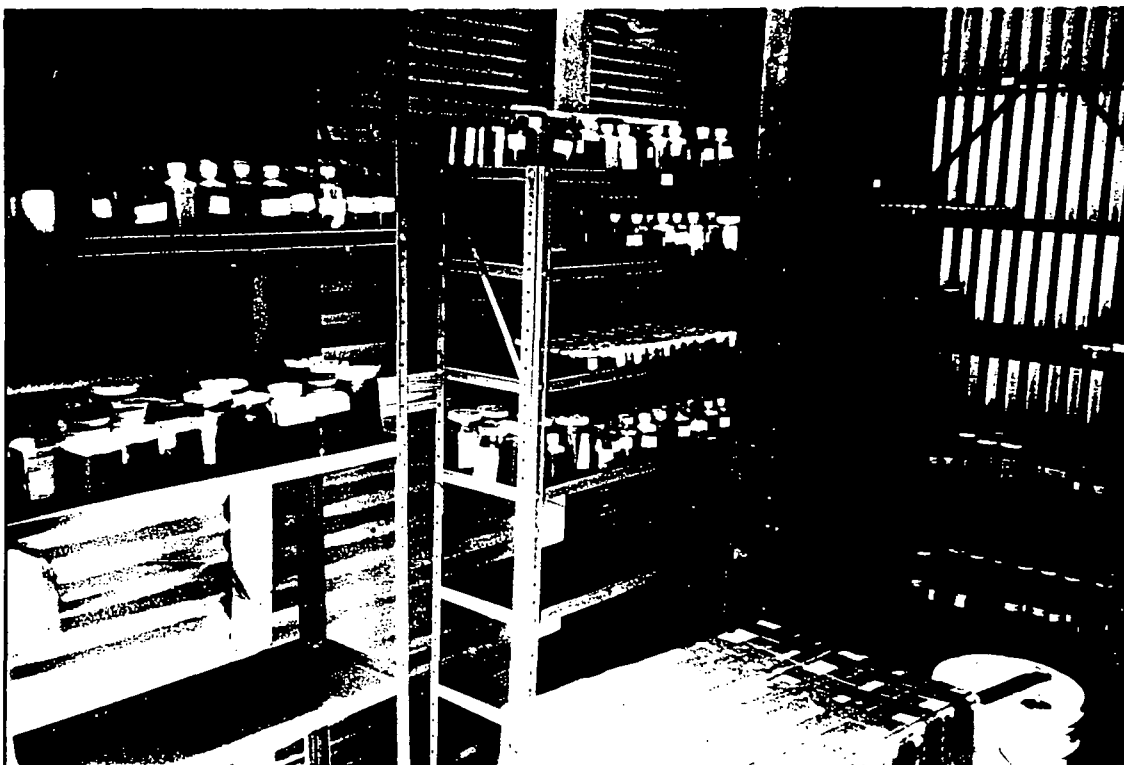
31.2 Interior view of the Laboratory Specimens Storage Building (SWMU 31) showing the specimen bottles stored on shelves.

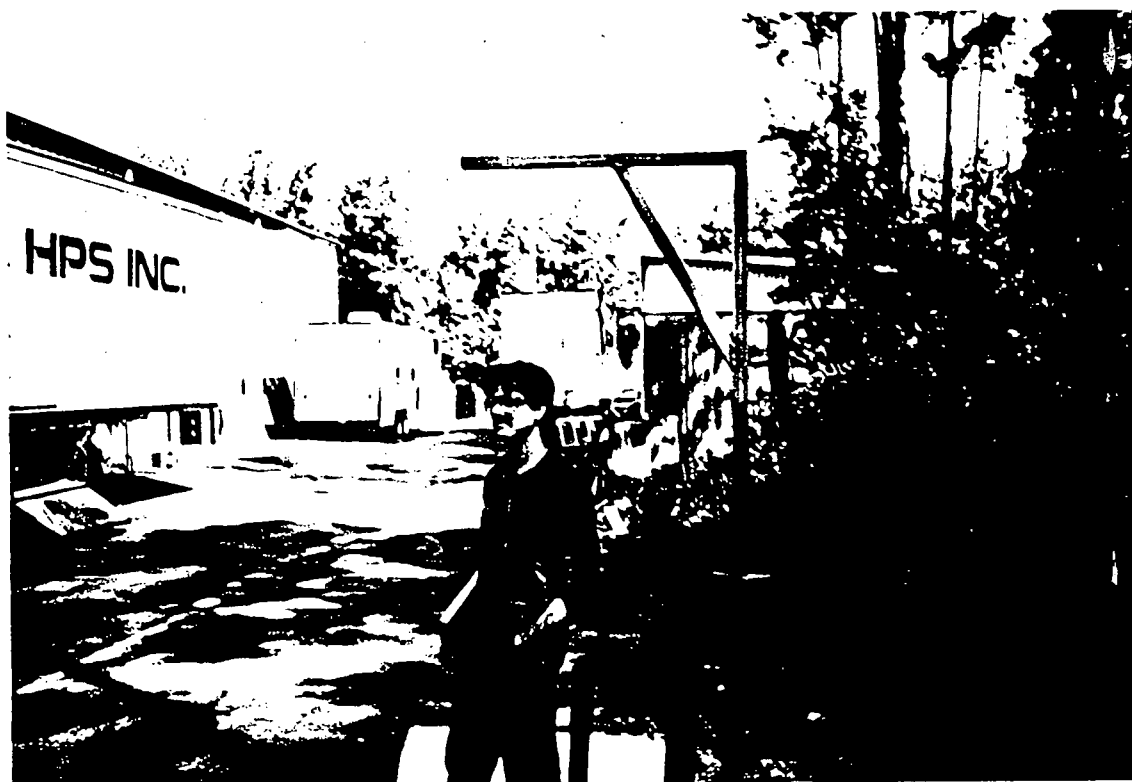
A.1 Overview of the Field Trailers Service Area (SWMU 26) showing the Spray Paint Booth Area (AOC A) (small grey building) in the right center of the photograph. View is facing north.

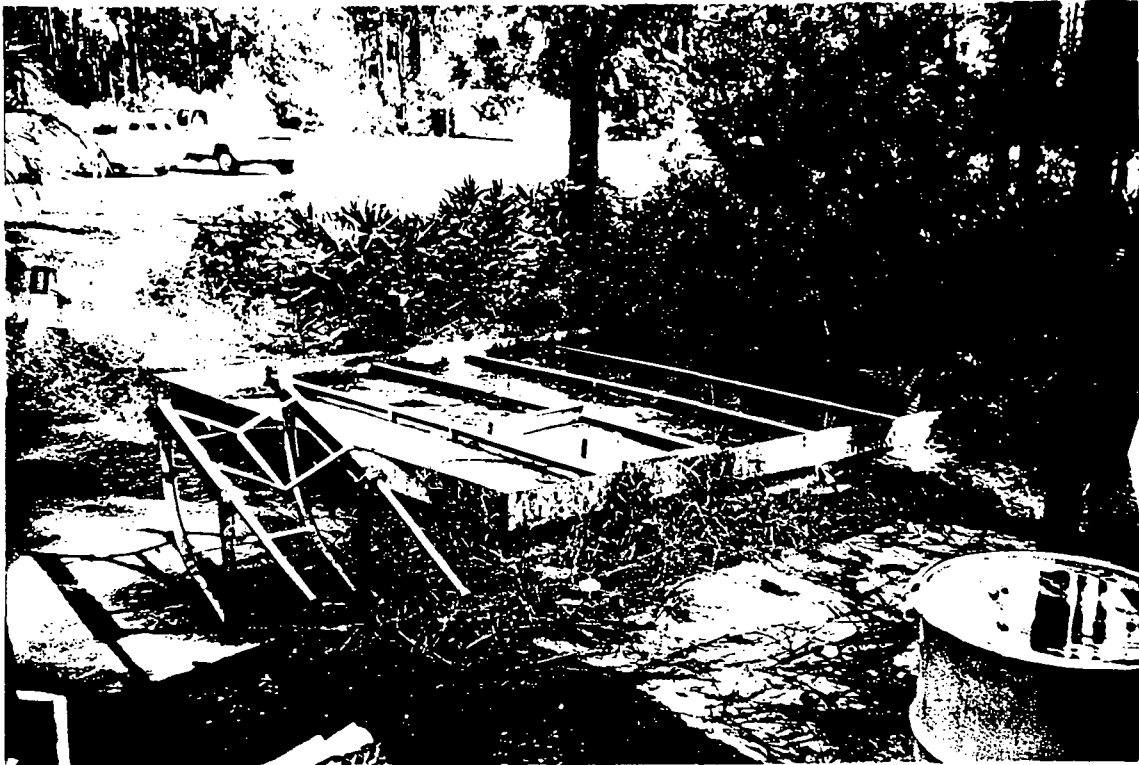
A.2 View facing northeast showing the paint stripping pan utilized by the facility at the Spray Paint Booth Area (AOC A).
