**Re: JEA Westside Service Center
EPA/DEP ID: FLD 981 027 279
Duval County – Hazardous Waste**

**Florida Department of
Environmental Protection
Hazardous Waste Inspection Report**

Facility Name: JEA Westside Service Center

On-Site Inspection Start Date: 06/12/2014

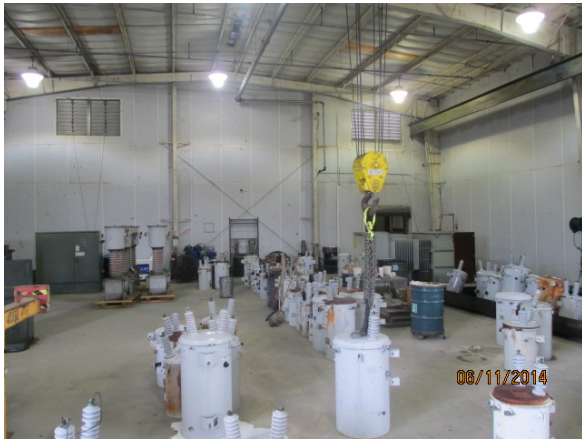
This building is where trucks triage the waste they accumulate in the field from different sites. Transformers are loaded onto the western side of the building where they are inspected (Photo 1). All transformers (good and bad) have a sample taken of the oil inside. If the sample comes back "hot" (PCB concentration of greater than 45 ppm) they are moved to the eastern side of the Hazmat building to be shipped off to TCI in Alabama (ALD983167891) as PCB contaminated waste, which is regulated under the Toxic Substance Control Act (TSCA). If the concentration is under 45 ppm, and the transformer is not going to be reused, the oil is kept inside the unit and shipped to TCI. If the transformer is able to be reused, and does not come back hot, it is taken to the Transformer Shop to be touched up, repainted, and put back into service.

Photo 1 - west side of HazMat Building

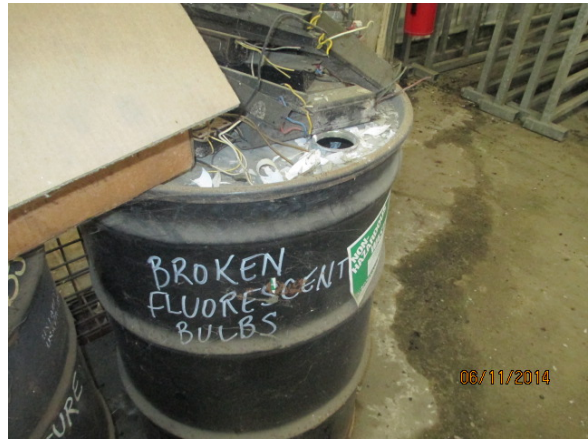
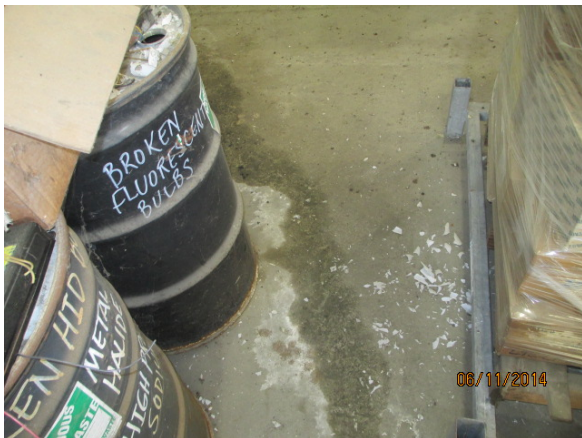
On the east side of the building the facility had an area to store universal waste lamps. On top and on the ground near a drum labeled "broken fluorescent bulbs" were pieces of broken fluorescent bulbs [40 CFR 273.13(d)(2)] (Photos 2-3). This drum was also open [40 CFR 273.13(d)(1)]. Also on the east side of the building is where the facility stores its hazardous waste and non-hazardous waste. The facility accumulates various items from substations and sites that are brought back to this location. Facility personnel then make a hazardous waste determination on these items. At the time of the inspection, no hazardous waste containers were on-site, but there were several items that were awaiting a hazardous waste determination.

Type: Violation
Rule: 273.13(d)(1)
Explanation: The facility's crushed universal waste lamps were stored in a 55-gallon drum that was not closed.
Corrective Action: The facility sent documentation to the DEP on 6.13.14, returning to compliance. No further action is necessary.

Type: Violation
Rule: 273.13(d)(2)
Explanation: The facility did not clean up a spill of universal waste lamps on and around its 55-gallon drum.
Corrective Action: The facility sent documentation to the DEP on 6.13.14, returning to compliance. No further action is necessary.

Photo 2 - broken bulbs

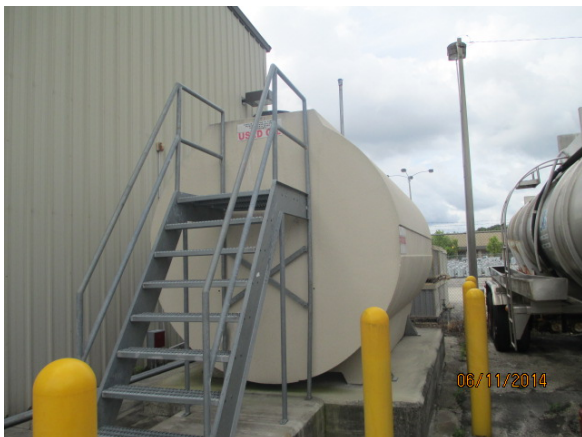
Located outside of the Parts Storage Warehouse is a 5,200-gallon used oil tank (Photo 5). This tank is for when substations require oil to be removed and/or replaced. The oil is removed by a tanker truck and brought to this location to be stored before being shipped for recycling. This used oil tank was double walled and was properly labeled.

Photo 5 - used oil tank
