**Florida Department of
Environmental Protection
Hazardous Waste Inspection Report**

Facility Name: Perma-Fix Of Florida Inc

On-Site Inspection Start Date: 08/14/2014

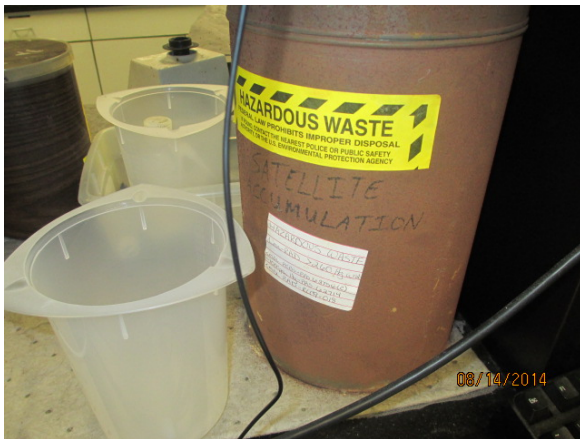
Perma-Fix Analytical Services occupies the southeast corner of the TOB. The laboratory performs fingerprint analyses on each incoming waste stream to confirm that waste received by the facility conforms to the initial waste profile. Laboratory operations generate waste acid, solvents, liquids, glass, and plastic that are managed as mixed waste. There were several satellite containers throughout the lab which were properly labeled and closed. One metal container located on a lab bench appeared to be rusting on the outside (Photo 1). The inside of the container was in good condition, but it was recommended that the facility replace this container. Subsequent to the inspection, the facility replaced this container with a new satellite container.

Photo 1 - rusted satellite container

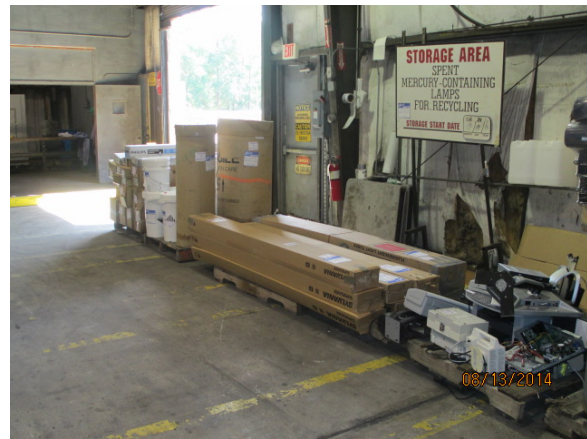
The hazardous waste containers that were examined were properly labeled and closed, and had been dated with the storage start date. At the time of the inspection, the facility was not exceeding the maximum volume or the volume limits for each of the individual storage zones. Universal waste lamps were stored in properly labeled and secure containers (Photo 2).

Photo 2 - universal waste storage area
