SUBJ: RCRA Compliance Evaluation Inspection
Lightning Resources, LLC
EPA ID. No.: FLR 000 070 565

RCRA Inspection Report

Attachment 1 – Photo Log

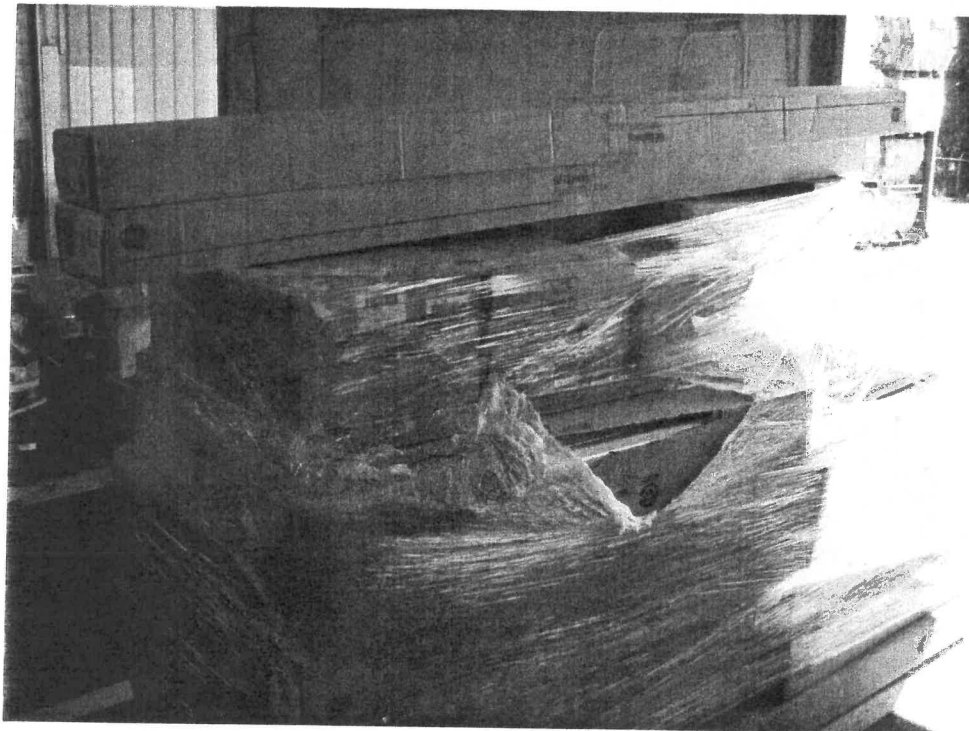
- Some containers of fluorescent bulbs were observed unlabeled (Figures 2 and 3).
- Four 55-gallon drums of "wet" crushed bulbs were noted in Row 10. According to Mr. McDonald, wet-crushed-bulbs tend to clog the processor. LR sends the wet material to a sister facility in Indiana. None of these drums were over the year storage time.
- Inspectors noticed some crush glass on top of containers in Row 10 (Figure 4).
- Several boxes of projection lamps were found in Row 1. According to Mr. McDonald the projection lamps need some dismantling prior to processing, so employees work on them as they can. None of the boxes had been stored greater than one year.
- On some containers, LR uses plastic wraps instead of a lid. These lids don't seal or prevent spillage and they are considered open containers (Figure 5).

Figure 2 - Unlabeled lamp boxes

Pursuant to F.A.C. 62-730.185(1) - Standards for Universal Waste Management, the Department adopts by reference 40 C.F.R. Part 273 revised as of July 1, 2008. LR is in apparent violation of F.A.C. 62-737.400(5)(b)(1) (40 C.F.R. § 273.34(e)). This regulation requires a large quantity handler of universal waste mark or label clearly each lamp, or container or package in which such lamps are contained with any one of the following phrases: "Universal Waste—Lamp(s)," or "Waste Lamp(s)," or "Used Lamp(s)."

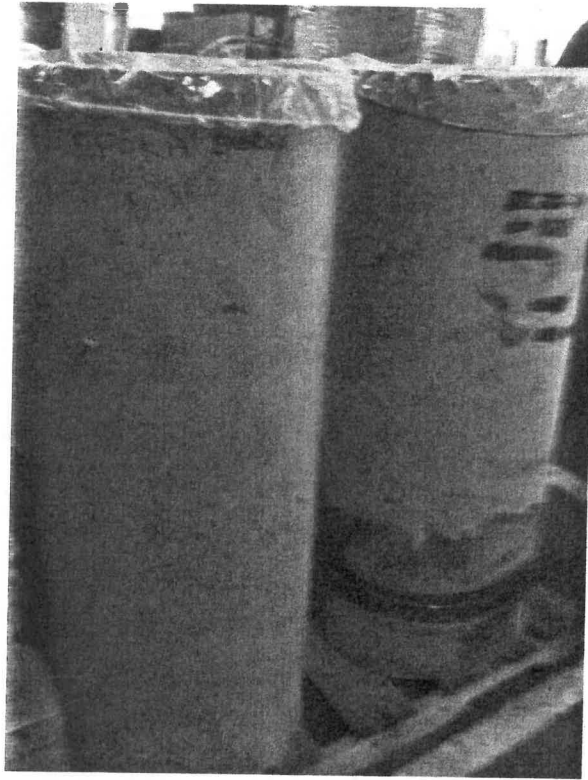
Figure 5 – Photo showing plastic cover

LR failed to adhere to a condition for exemption from F.A.C. Chapter 62-730 [40 C.F.R. §§ 264.31 and 265.31]. This regulation requires owners and operators of hazardous waste management facilities to maintain and operate their facilities to minimize the possibility of a fire, explosion, or any unplanned sudden or non-sudden release of hazardous waste or hazardous waste constituents to air, soil, or surface water which could threaten human health or the environment.

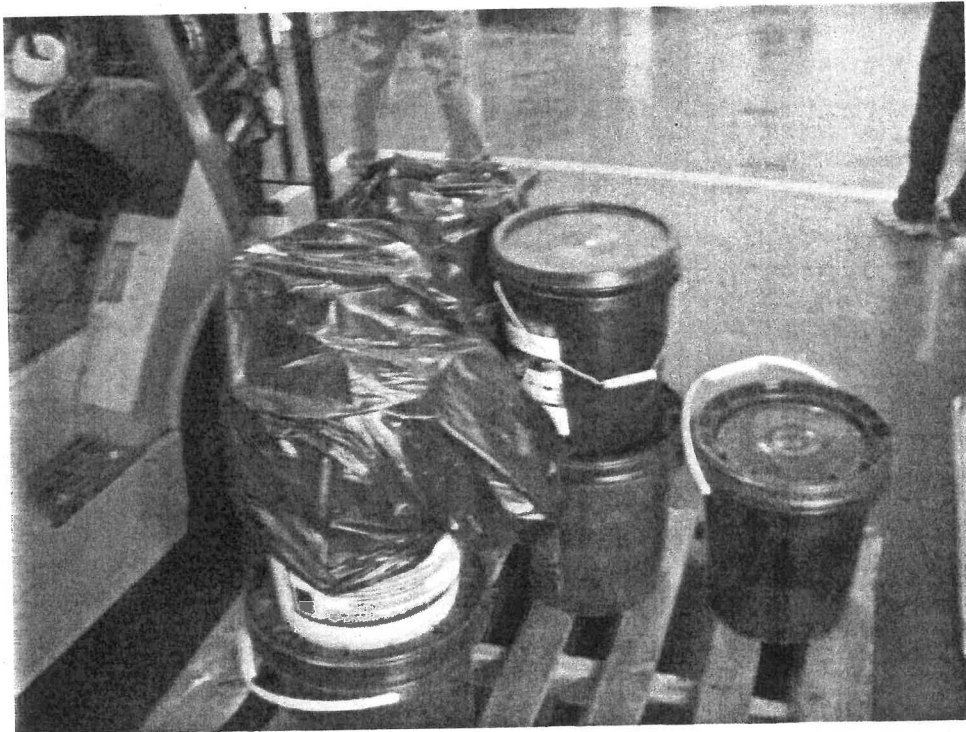
The universal waste batteries storage area is located on the back wall of the warehouse. The batteries (Lead Acid, Lithium, Alkaline, Nickel-Cadmium and Nickel Metal Hydride) are sorted and placed into 55-gallon drums. At the time of the inspection, the area was storing five 55-gallon drums (See Figure 6). The inspection team noticed that one of the 55-gallon drums was not labeled. In addition, near the battery storage area, a pallet of seven 5-gallon buckets and a cart with two boxes and a 5-gallon bucket, all storing batteries were not labeled (See Figure 7 and 8).

Figure 8 - Unlabeled container storing UW Batteries

Pursuant to F.A.C. 62-730.185(1) - Standards for Universal Waste Management, the Department adopts by reference 40 C.F.R. Part 273 revised as of July 1, 2008. Therefore, LR is in apparent violation of F.A.C. 62-730.185(1) [40 C.F.R. § 273.14(a)]. This regulation requires that universal waste lamps or a container or package in which such lamps are contained must be labeled or marked clearly with any one of the following phrases: "Universal Waste—Battery(ies)," or "Waste Battery(ies)," or "Used Battery(ies)."
