SUBJ: RCRA Compliance Evaluation Inspection
Safety-Kleen Systems, Inc. (Tampa)
EPA ID No: FLD 980 847 214

RCRA COMPLIANCE INSPECTION REPORT

Safety-Kleen Systems, Inc. (Safety-Kleen)
5309 24th Avenue S.
Tampa, Florida 33619-5368
Hillsborough County
EPA ID No.: FLD 980 847 271
Permit / Certification Number: 34744-HO -007
Date of Issue: February 21, 2012
Expiration Date: November 23, 2016
Latitude / Longitude: 27°55'33"N / 82°23'69"W
NAICS No.: 562111 – Hazardous Waste Treatment and Disposal
SIC No.: 4953 – Refuse System (Hazardous Waste Treatment and Disposal)

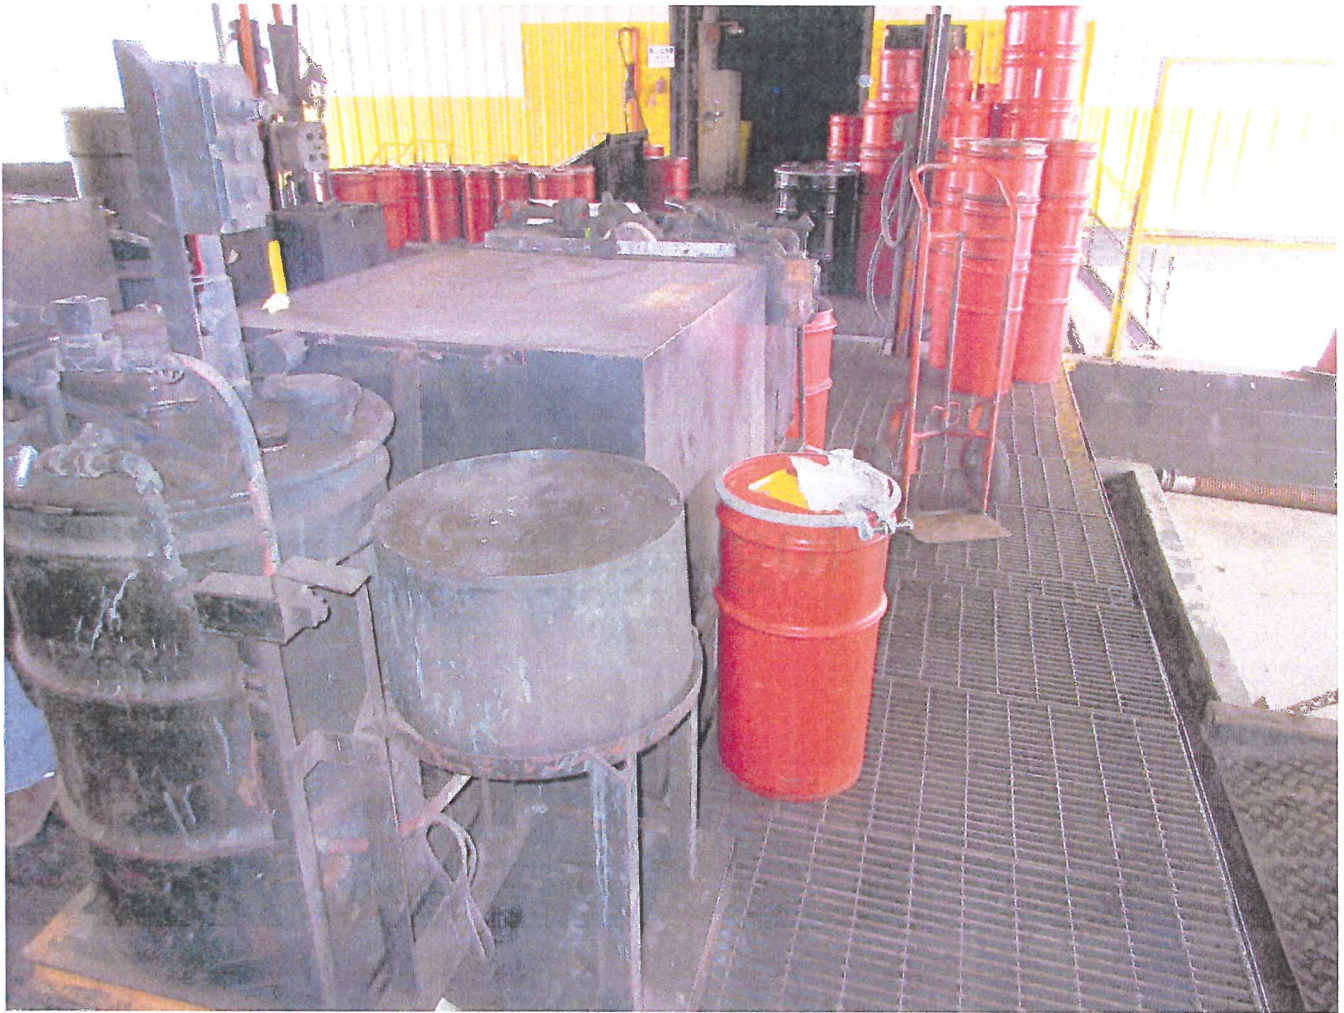
This area of the facility (Photo 1) is designated as a 10 day transfer area for incoming hazardous wastes. Various sizes and types of hazardous waste from incoming vehicles were observed in this area as they waiting on characterization test results before being placed into the permitted storage areas discussed below. One satellite accumulation container of gloves and hazardous containment equipment was observed in this area. The container was labeled with the words "Hazardous Waste" and closed at the time of the inspection.

The facility's dirty solvent reception basin was observed in this area as was the secondary containment area beneath the unit. No spills of hazardous waste were observed on the exterior of the unit or within the secondary containment area.

Photo 1 – Solvent recovery reception bin located on the facility's unloading dock.

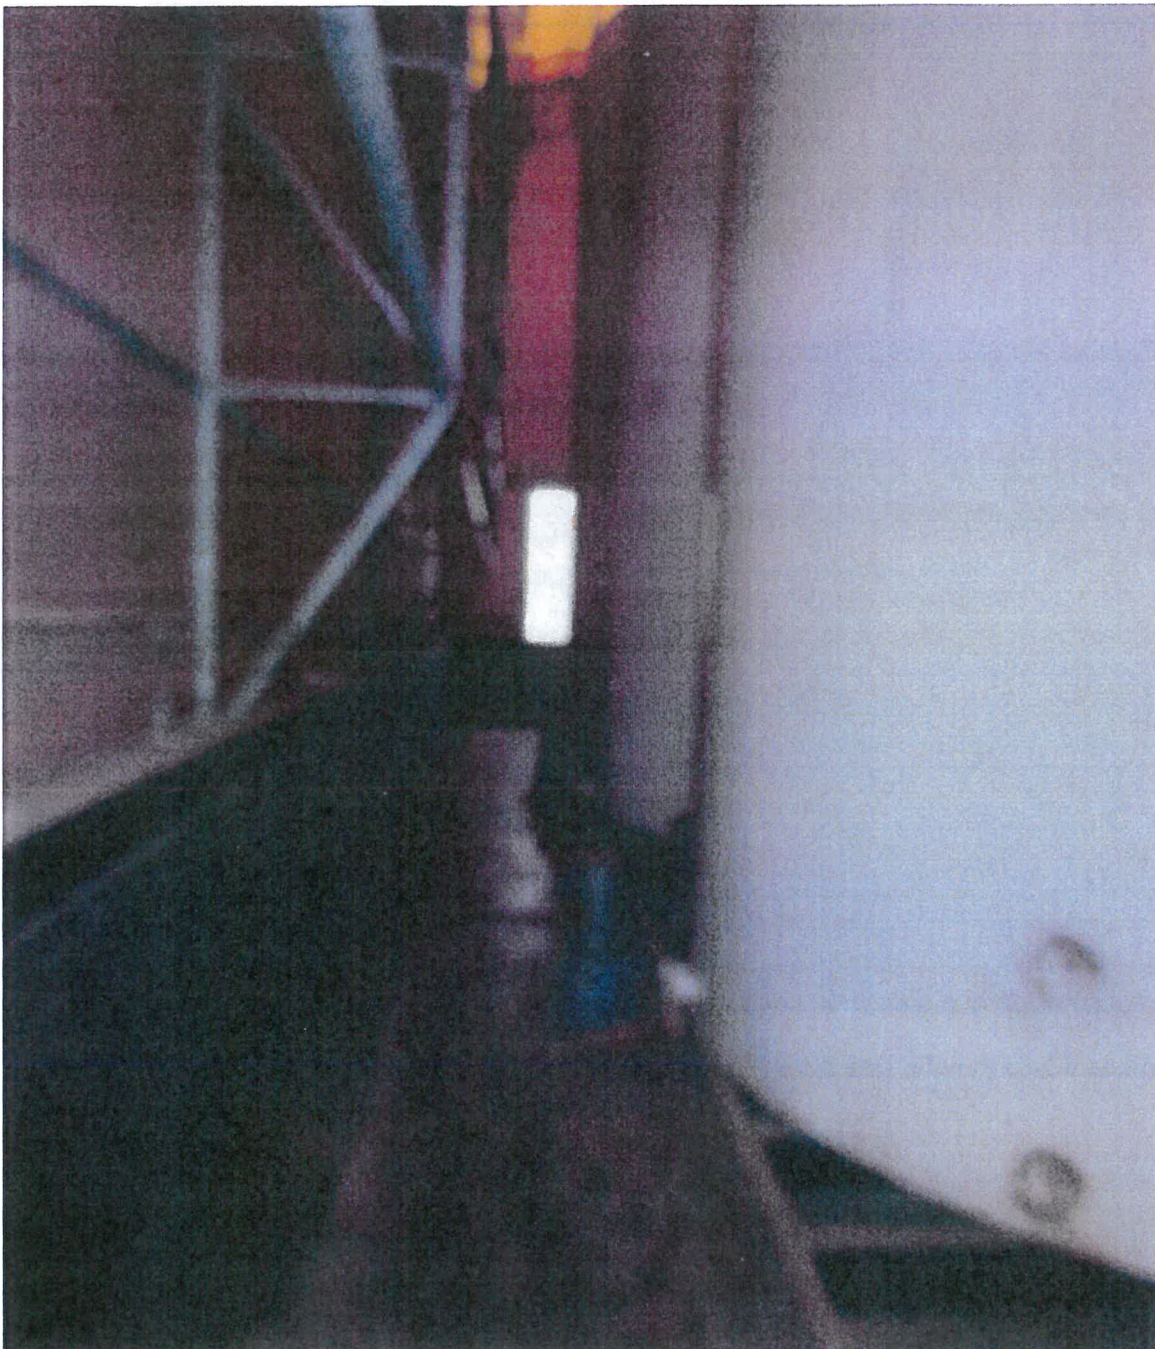
The facility operates a permitted hazardous waste storage tank with a volume of 15,000 gallons. The tank is used to store the facility's hazardous waste flammable solvent generated as part of the facility's recyclable solvent wash recovery program.

The tank is one of three tanks located within a tank farm (Photo 2) consisting of three 15,000 gallon tanks. Each of the tanks is located within a concrete secondary containment system capable of managing the contents of the 15,000 gallon tank. The tanks was labeled with the words "Hazardous Waste" and closed at the time of the inspection. All equipment associated with the 15,000 gallon hazardous waste tank were appropriately labeled with tags for the required air monitoring regulations. The pipe and equipment responsible for the transfer of the hazardous waste solvent from the loading dock to the storage tank (Photo 3) were properly marked.

Photo 2 – Hazardous waste tank storage area

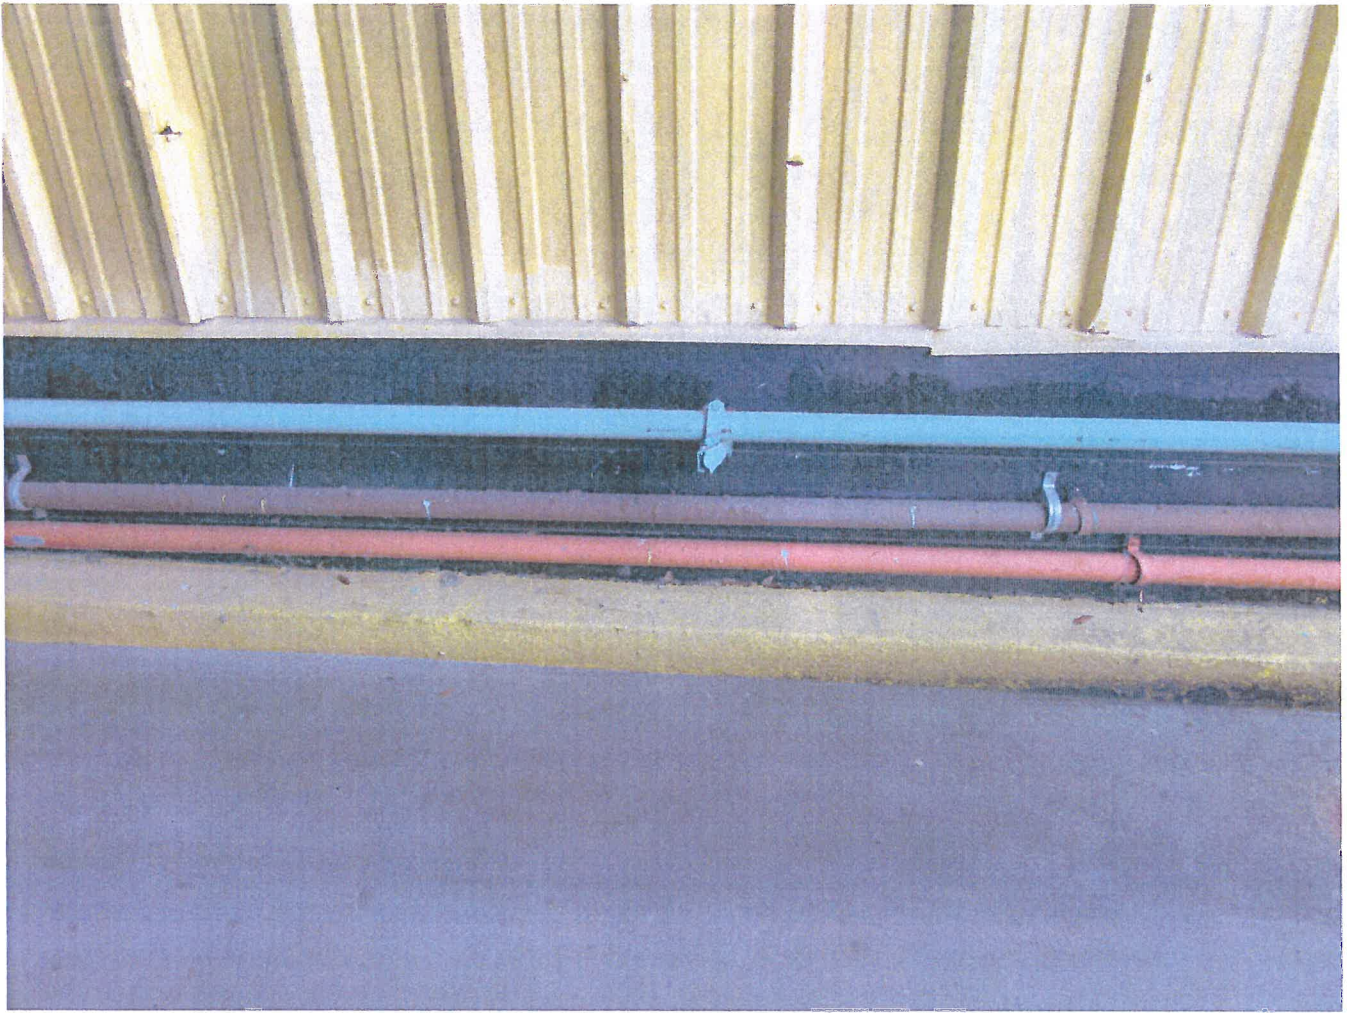
Photo 3 – Hazardous waste transfer line from loading dock to storage tank
