## LIGHTING RESOURCES, LLC

This letter is the response to the FL Dep Inspection Report of July 31, 2015 received from Mr. Michael Eckoff on February 22, 2016 via email.

Inspection Narrative:

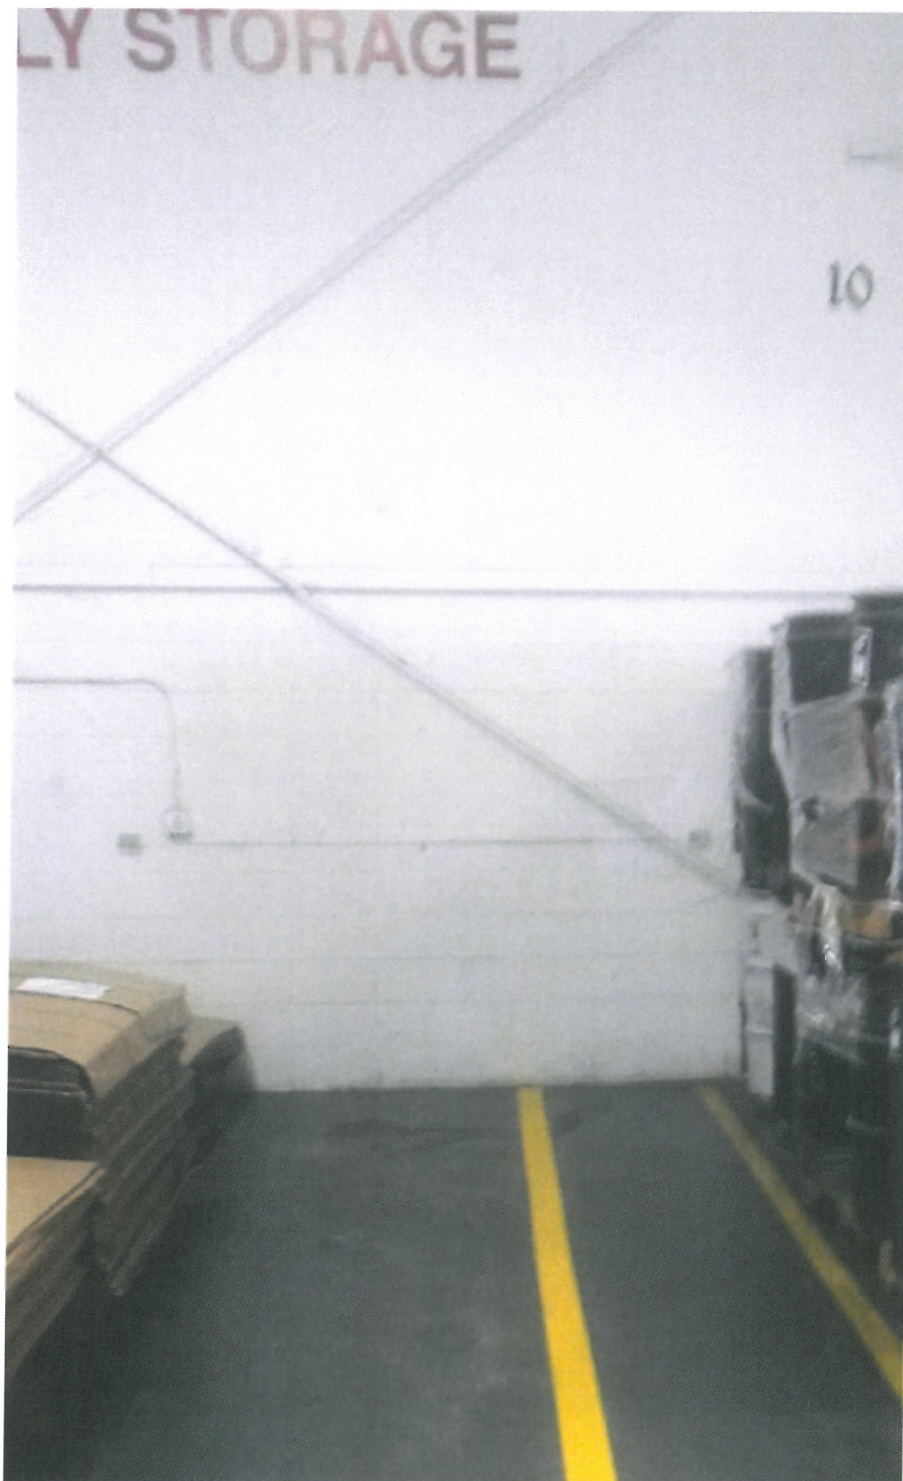
Photo 1. Aisle 10 Spacing and shrink-wrapped pallets.

- I. Row 10 contained forty-three 55-gallon drums of crushed lamps staged on pallets that were double-stacked. **(A)** Aisle space was not provided between the drums and the cubic-yard boxes of electronic waste. This prevents the facility from documenting drums were properly labeled, marked with a received date, closed, and in good condition (Photos 1 to 3) [403.727(1)(a) and (c), Florida Statutes (F.S.)]. **(B)** All the drums were not secured with shrink-wrap, bands, or other binding as required in the operating plan (Photos 1 and 2) [403.727(1)(a) and (c), F.S.]. **(A)** All the labels and the received dates on the drums were either not visible for inspection or not present as required in the operating plan (Photo 2) (A) [403.727(1)(a) and (c), F.S.]. **(C)** One drum had a plywood lid secured with duct tape which is not a U.S. DOT approved container as required in the operating plan (Photo 4) [403.727(1)(a) and (c), F.S.]

Additional stripping has been added to Row 1 and Row 10 to designate the aisle space at both rows. This will allow the labels on the drums to be visible from both sides of the rows. This also allows the staff to verify the received date, see that they are closed, and in good condition. [Photo 1, 2,]

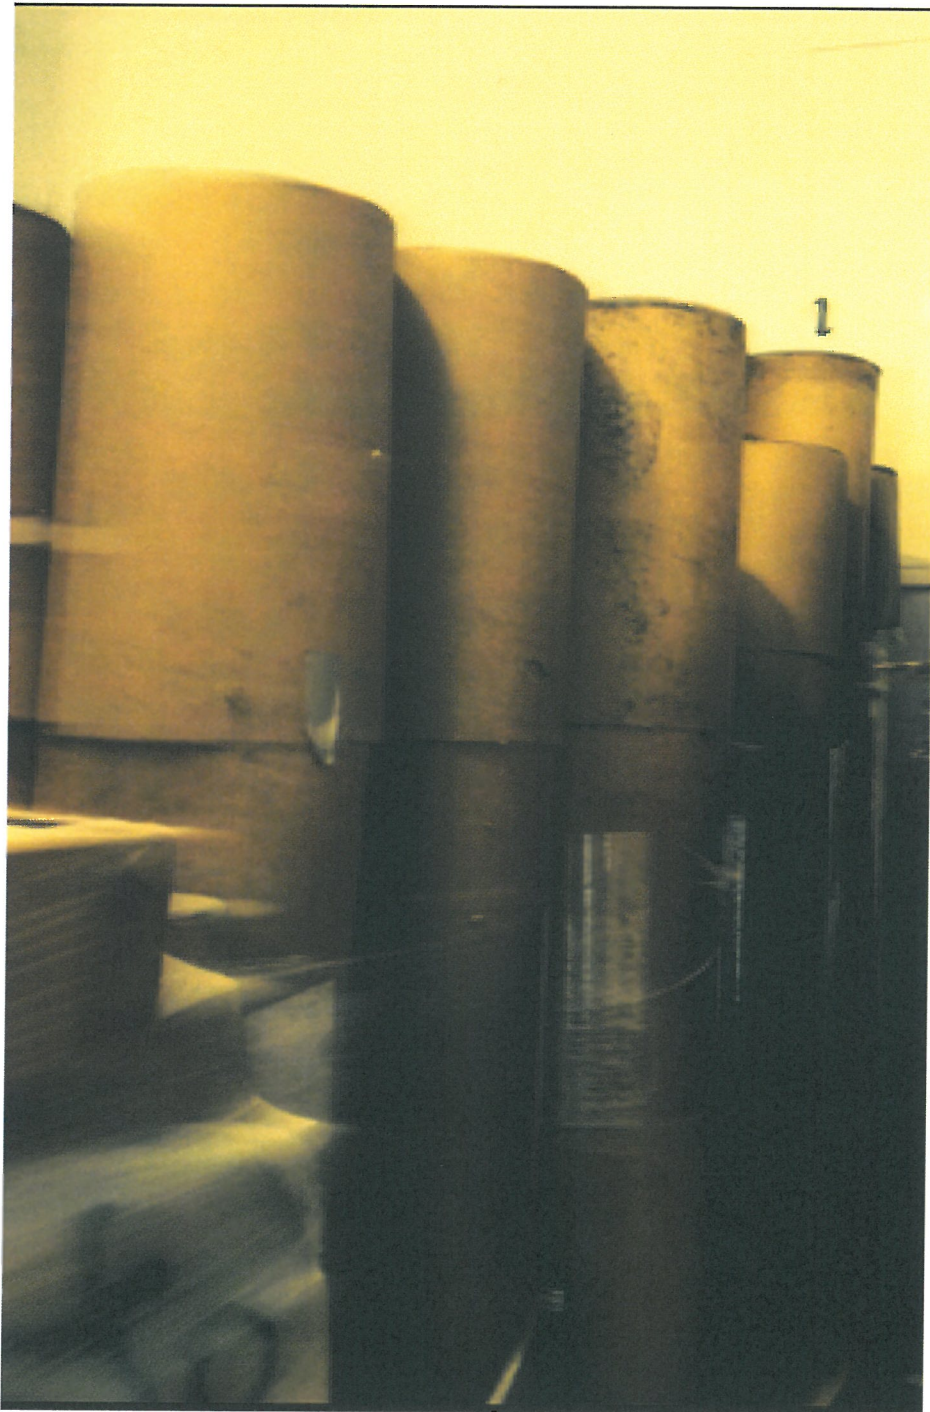
Photo 4  
Shrink Wrapped Fiber Drums

- II. Rows 3 to 7 and 9 contained pallets of universal waste lamps that were double-stacked. **(A)** All the containers were not secured with shrink-wrap, bands, or other binding as required in the operating plan (Photos 1 and 5 to 8) [403.727(1)(a) and (c), F.S.]. **(B)** All the labels and the received dates on the containers or pallets were either not visible for inspection or not present as required in the operating plan (Photos 5 to 7 and 9 to 11) [403.727(1)(a) and (c), F.S.]. **(C)** All the containers were not closed during storage as required in the operating plan (Photos 7 and 12 to 21) [403.727(1)(a) and (c), F.S.]. **(D)** All the containers were not structurally sound or adequate to prevent breakage as required in the operating plan, resulting in buckling and crushed containers, and lamp breakage (Photos 22 to 24) [403.727(1)(a) and (c), F.S., and 40 CFR 264.31]. **(E)** On the west wall of the warehouse in Row 4 was a damaged electrical outlet with exposed wires.

- A. Pallets of boxes and drums were secured with additional shrink-wrap bands at the time of the audit. [Photo 4]

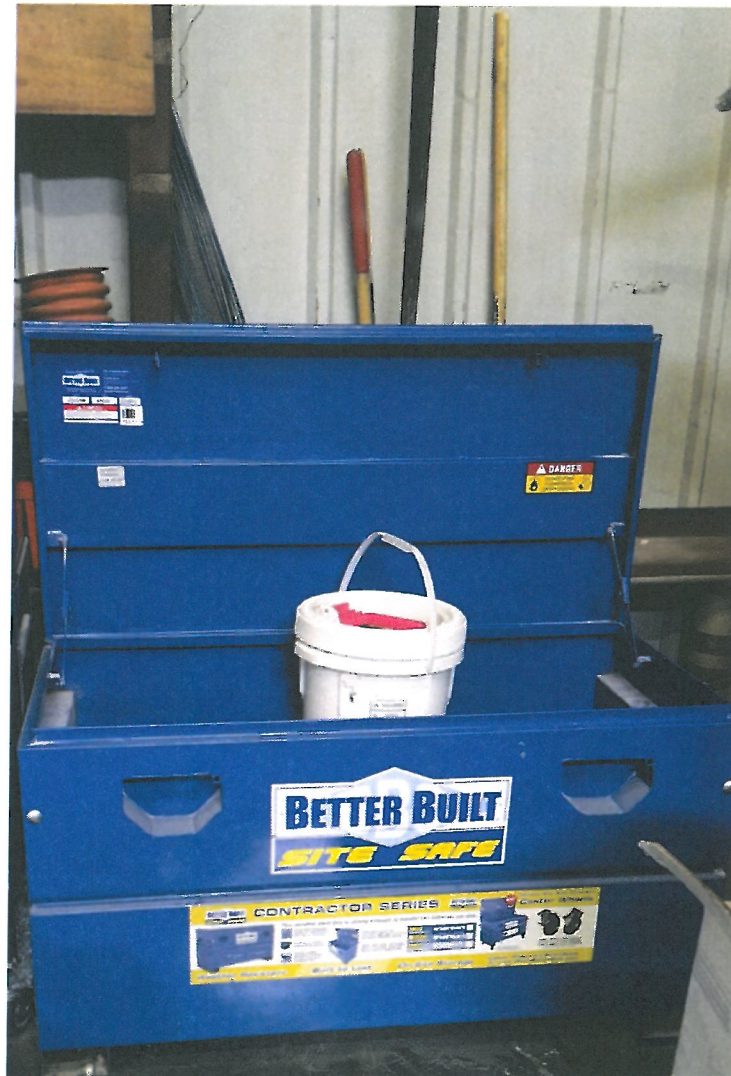
Photo 12 – Used Oil in Secondary Containment in Warehouse C.

- VIII. Outside the northeast corner of the building was a covered area consisting of storage for propane cylinders, an air compressor, a flammable storage cabinet, and four 5-gallon containers that were not labeled. Mr. Muhlenkamp stated the containers were storing used oil from the compressor; one container was opened and verified to contain used oil. **(A)** The containers were not properly labeled "Used Oil" and not provided secondary containment (Photo 35) [403.161(1)(b), F.S., 40 CFR 279.22(c)(1), and 62-710.401(6), F.A.C.]. **(B)** Inside the cabinet was product and one 5-gallon container that was not labeled. Mr. Muhlenkamp stated it contained used oil from the compressor. The container was not properly labeled "Used Oil" but was provided secondary containment via the cabinet (Photo 36) [403.161(1)(b), F.S., 40 CFR 279.22(c)(1), and 62-710.401(6), F.A.C.]. **(C)** Next to this area and located on asphalt was a 35-gallon drum that had a faded non-PCB ballast label. Mr. Muhlenkamp was asked to verify the contents.

- A. The containers of used oil from the compressor were labeled and relocated to a secondary containment location. [Photos 12 -13] The material was sent out for used oil recycling.

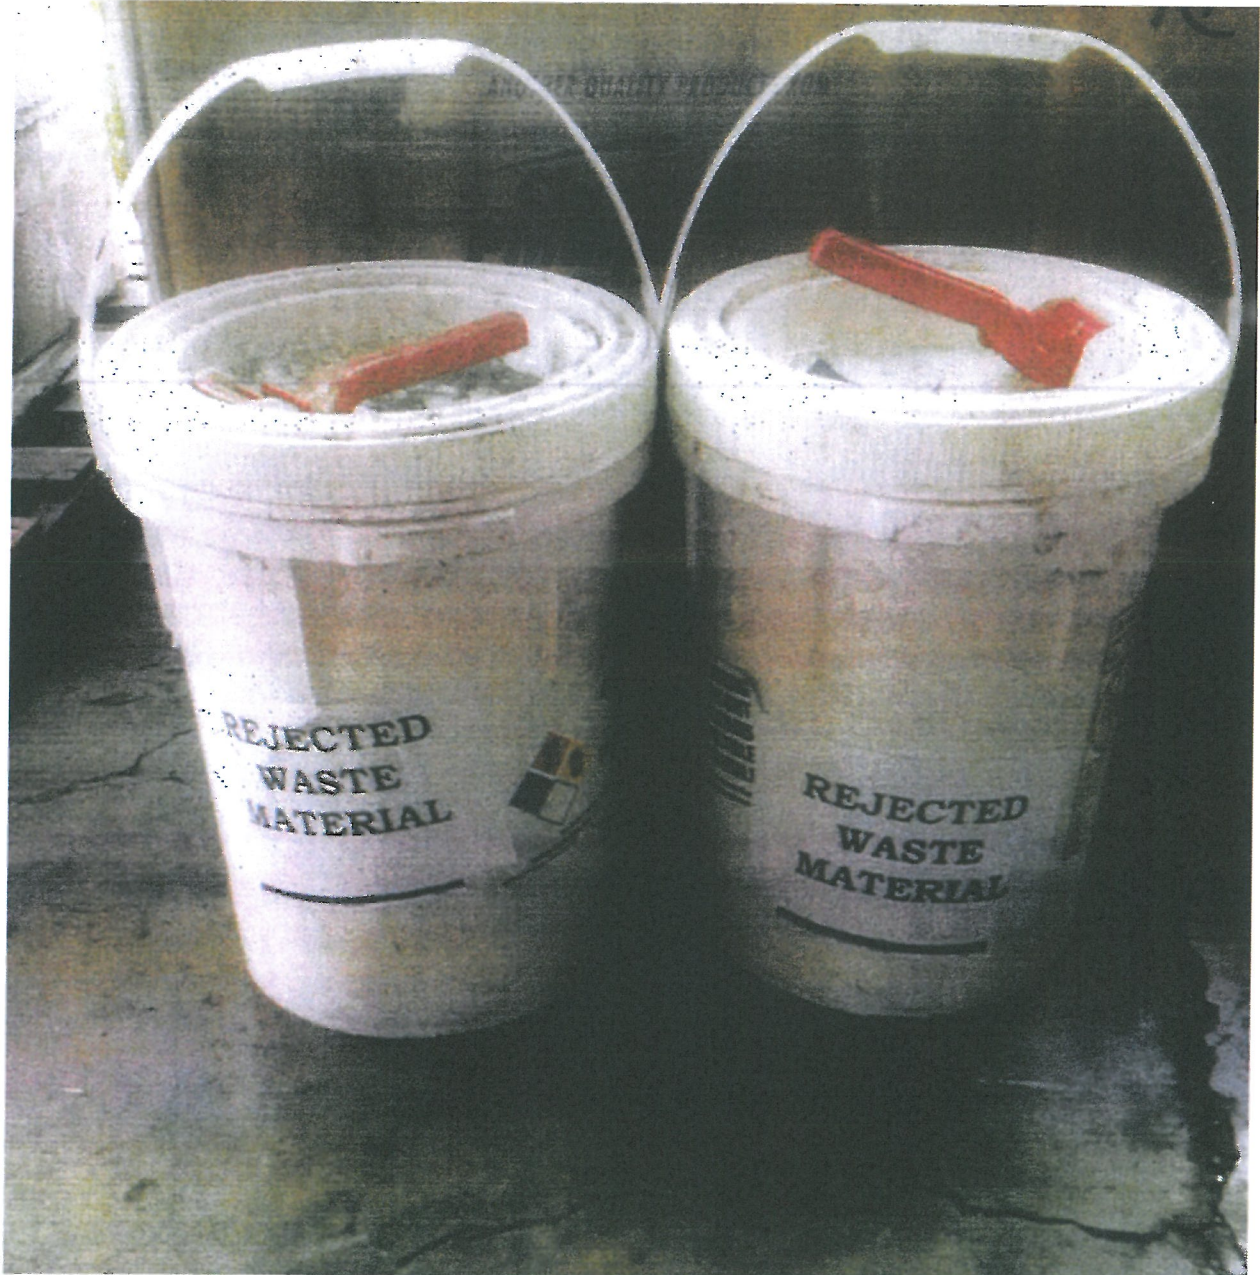
Photo 14 – Rejected Drums of Liquid

IX. On the northeast side of the property were three semi-tractor trailers. Mr. Muhlenkamp stated one contained electronic waste and batteries, one contained supplies including broken-down cardboard boxes, and the last was empty. The supply trailer was open. **(A)**Two 5-gallon containers that were not labeled and appeared to contain liquid were noted in the trailer (Photo 37). When asked, Mr. Muhlenkamp stated he did not know what was in the containers. The containers were removed from the trailer and placed on the covered loading dock next to the two cubic-yard boxes. A sticker on the lid of one container identified Crystal Clean but had no further information. Lighting Resources, LLC failed to follow waste rejection procedures outlined in the operating plan [403.727(1)(a) and (c), F.S.].

A. These containers containing liquid were included in a trailer load from our customer. As we do not receive liquid, we do not open the containers. As liquid, they are rejected and returned to the customer. However, because of the audit, we did open the container and determined that it had the smell and texture of cleaning solvent for tools and parts.

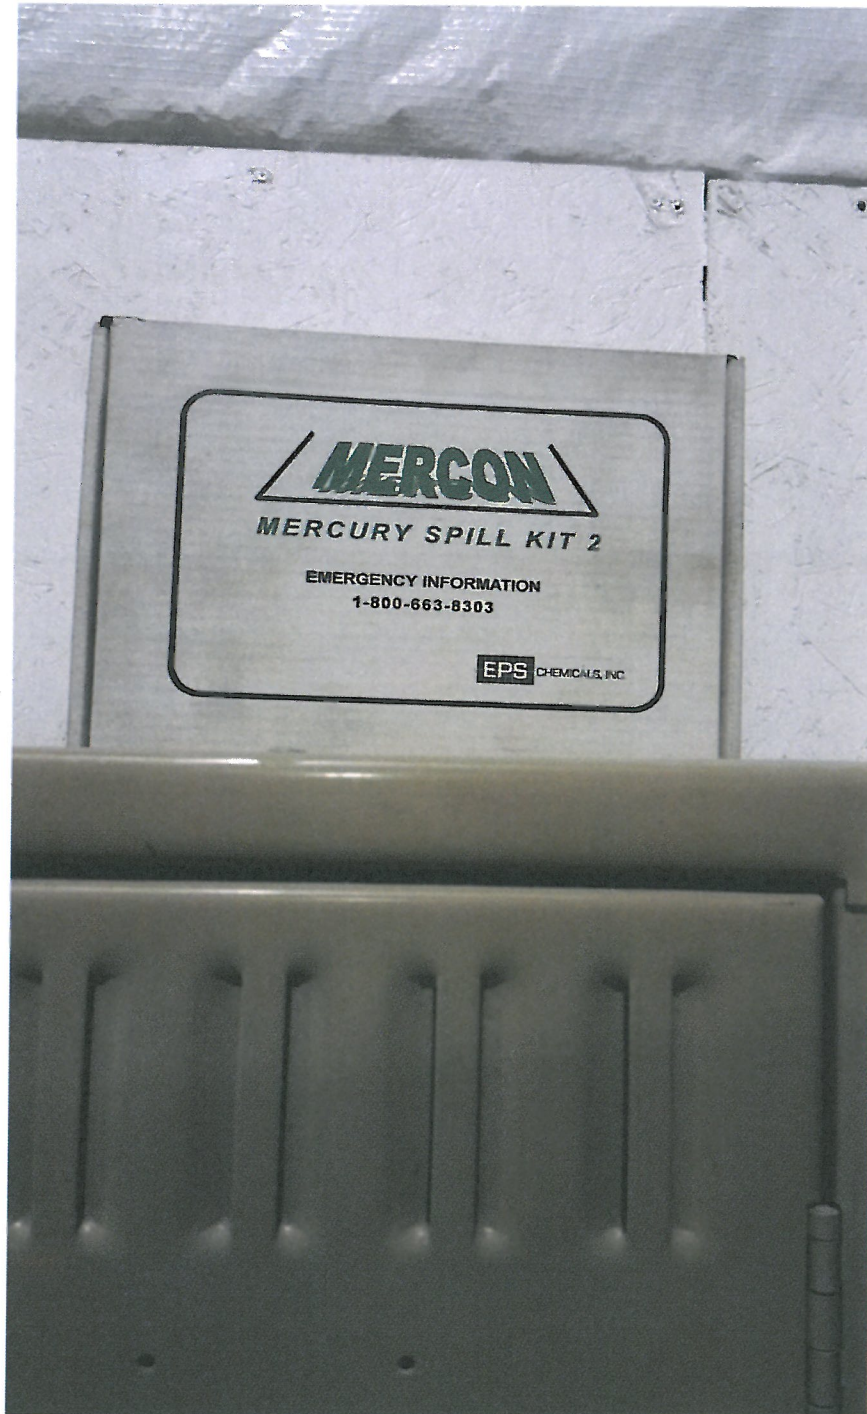
Photo 18 –Mercon Spill Kit

- B. The drum was adjusted to have the label visible at the time of the audit.
- XII. According to the operating plan a mercury spill kit must be located on the south wall near the door to the warehouse. **(A)** The spill kit was missing [403.727(1)(a) and (c), F.S.]. Mr. Muhlenkamp questioned a technician working in the area, the spill kit was eventually found and placed in the proper location.

- A. The spill kit was located on a different wall in the Balcan room. It was relocated to the proper location. [Photo 18]
- XIII. A solid waste trash can was located near a bay door. **(A)** Inside the trash can was metal end caps, spent PPE and used rags [403.727(1)(a) and (c), F.S., and 40 CFR 264.31]. Mr. Fritz immediately removed the trash can from the area and stated the contents would be placed in the drum of hazardous waste floor sweepings.
