May 6, 2016

Re: Veolia ES Technical Solutions LLC
EPA ID No.: FL0000207449 & FLR000124917
Leon County

**Florida Department of
Environmental Protection
Hazardous Waste Inspection Report**

Facility Name: Veolia ES Technical Solutions LLC
On-Site Inspection Start Date: 12/17/2015 **On-Site Inspection End Date:** 12/17/2015
ME ID#: 6716 **EPA ID#:** FL0000207449
Facility Street Address: 342 Marpan Ln, Tallahassee, Florida 32305-0904
Contact Mailing Address: 342 Marpan Ln, Tallahassee, Florida 32305-0904
County Name: Leon **Contact Phone:** (850) 877-8299

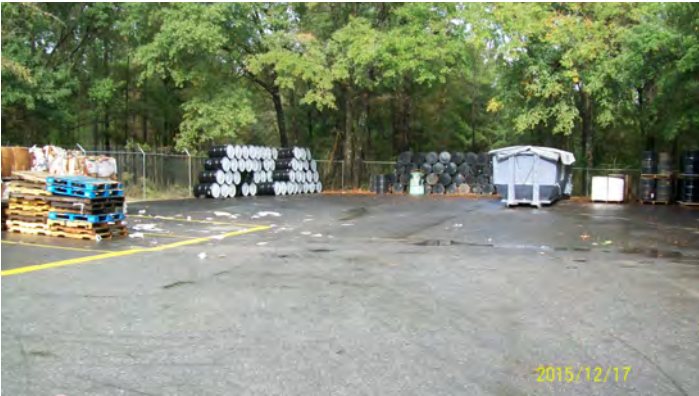
North Outside Storage

Four 20-yard roll-offs for collection of processed glass are staged in this area on a concrete pad. An adjacent asphalt paved area is used for collection of paper-products, wood pallet recycling and various empty container storage. Veolia has removed its two storage containers and empty containers are stored on the paved area. The hazardous waste transfer area is also located here for overnight holding of transport trucks in the event of an arrival after business hours. The trucks are immediately unloaded during the next business day. There were no violations observed in this area.

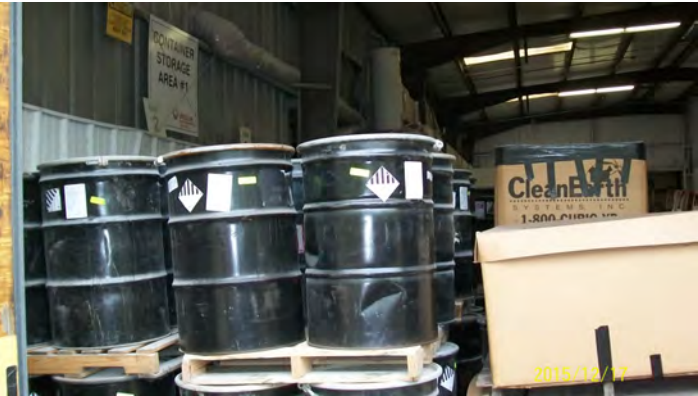
Container Storage Area #1

Veolia has two storage areas designated as "Container Storage Areas One and Two" (CSAs). The CSAs are permitted for up to 27 pallets (108 55-gallon drums) of MCMA; dental amalgam and traps; pre-retort phosphor powder; HID arc tubes; and site-generated hazardous waste (prep room debris and PPE, condensate water, and spent carbon). At the time of this inspection, hazardous waste stored in CSA One included four lab packs. There were approximately 44 drums of pre-retort, four gaylord boxes of post retort aluminum end caps, seven 5-gallon containers of dental amalgam, a 55-gallon drum of non-hazardous PPE. CSA Two contained approximately 13 55-gallon drums of non hazardous post retort powder and aluminum end caps, one drum of mop water, Gaylord box of crushed aluminum end caps and pallet of various preprocess mercury containing articles (Dental amalgam, traps and mercury contaminated materials). The oldest date observed was October 20, 2015. The facility had most of the pre-retort drums labeled as hazardous waste. Inspectors that the containers were in process and should not be labeled as hazardous waste. Inspectors also informed the facility that the facility had placed some pallets outside the permitted area and needed to ensure that all pallets were kept within the permitted areas.

<hr/>	
Type:	Violation
Rule:	265.35
Explanation:	Veolia had several pallets in its Universal waste storage area that were not properly in their permitted area according to its operating permit and state and federal hazardous waste regulations.
Corrective Action:	Veolia needs to ensure that all pallets and containers are within the permitted facility storage areas to ensure compliance with its operating permit and state and federal hazardous waste regulations.
<hr/>	
Type:	Violation
Rule:	265.71(a)(2)
Explanation:	Veolia did not have the final signed copy of the uniform hazardous waste manifest for Manifest # 000666944 VES- 08-17-2015. The waste manifest was not acquired within the 45-day time limit
Corrective Action:	Veolia during the course of the inspection acquired the manifest and showed it to inspectors. Veolia needs to ensure that a final signed copy of all manifests are retained onsite for three years. The final signed copy must be attained within 45-days of the hazardous waste being transported offsite for recycling or disposal.

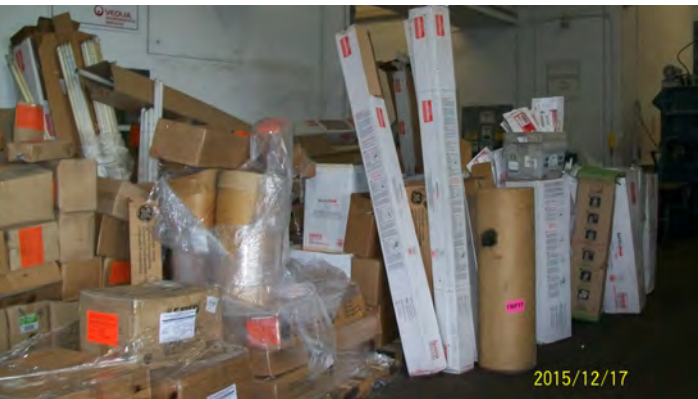
Fluorescent lamps are staged immediately adjacent to the lamp processing feed belts. Fluorescent lamps are hand fed into the lamp processing room via a conveyor belt. The Fluorescent Lamp Processing room, located in the northwest corner of the facility, is designed to process approximately 200,000 feet of lamp equivalents per 8-hour shift. Lamps are crushed with a drum

crusher and dry-separated into glass, aluminum and phosphor powder. Phosphor powder is collected by a bag tower and accumulated in 55-gallon drums. There are two processing lines that are used to facilitate this operation. The second processing line is used when there is a need to process a larger volume of materials. During the previous compliance inspection the facility has purchased a new 22.5 foot auger for the second processing line which had not been installed. Veolia has installed the new auger and has both processing lines in operation at the time of the inspection. There were four 55-gallon drums of pre-retort arc tubes

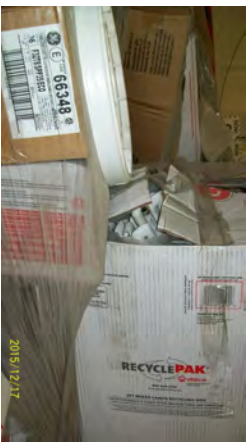
Universal Waste Storage

This area, located on the west side in the southern portion of the building, is the lamp storage area. The area has a permitted maximum storage capacity of 7,424 cubic feet of mixed fluorescent and HID lamps. The area is used for temporary storage of universal waste lamps that cannot be immediately processed. These lamps normally consist of HID lamps, U-shaped lamps and other specialty lamps that require manual processing prior to recycling/reclamation. The area is also used for temporary storage of universal waste batteries and non-RCRA hazardous materials.

During the inspection there were several boxes that were not properly closed (Rows 6, 7 and 10). Rows 10 and 11 also had issues with aisle spacing. Palletized materials were beyond the permitted lines and some were leaning into the aisle area. Inspectors reviewed the permit conditions with the facility personnel to ensure understanding of the permit requirements for the universal waste storage area. Adjacent to the area is a SAA for an aerosol can puncturer. The new SAA was not apart of the facility permit and had just been implemented by the new operating manager. Inspectors informed Mr. Melott that any new changes to the facility site plan should be discussed with the Department permitting staff before being implemented. The Department permitting staff must determine if the change is a minor, moderate, or major modification and follow all appropriate regulations to modify the facility operating permit.

The facility needs to ensure that all pallets are within their permitted areas in the Universal waste Storage area and Container Storage Areas (1 and 2). Veolia also needs to ensure that boxes and containers in the Universal waste storage area are properly closed at all times while awaiting processing. Final signed copies of waste manifests need to be acquired by the facility before the 45-day time limit is exceeded to ensure compliance with state and federal hazardous waste regulations. The facility also needs to ensure that all employees are thoroughly trained in the requirements of the facility's operating permit and enclosed permit conditions.

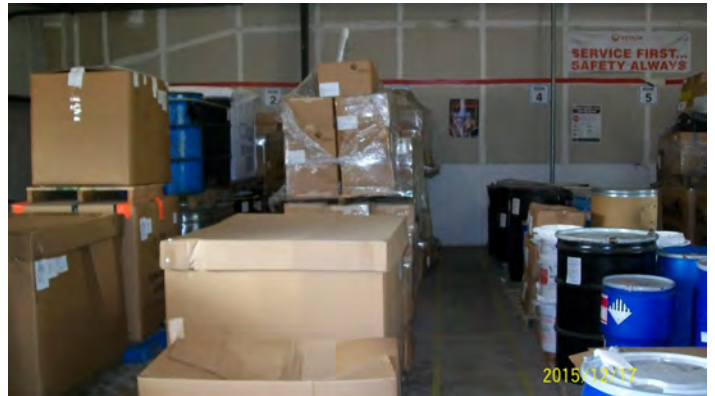
South Bldg Battery storage and E-waste

This building is immediately south of the main building and is divided into two large storage areas. The Container storage area is used to hold empty fiber drums and cardboard boxes. No universal or hazardous wastes are stored in this area. The second room in this building is used for storage of e-waste and battery storage. The space is permitted to store up to 72 pallets. At the time of the inspection, all pallets were properly labeled and protected from the environment. A new battery sorting table has been added to help in sorting of the various battery types received by the facility. No violations were observed at the time of the inspections.

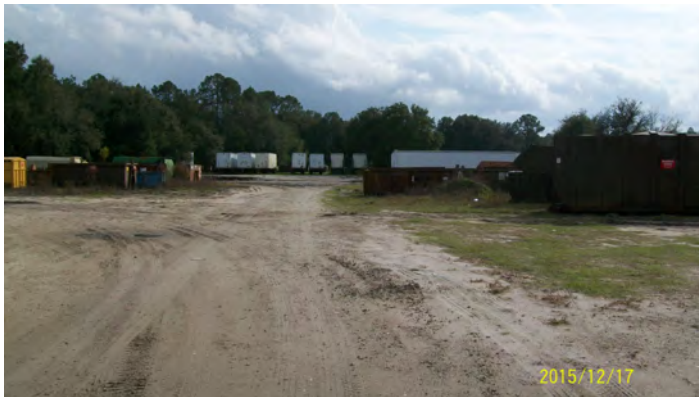
Universal Waste Transfer Area

The Veolia Transfer Yard (Veolia) is used for the storage of facility transport trailers and is a registered Universal Waste Transfer Area.

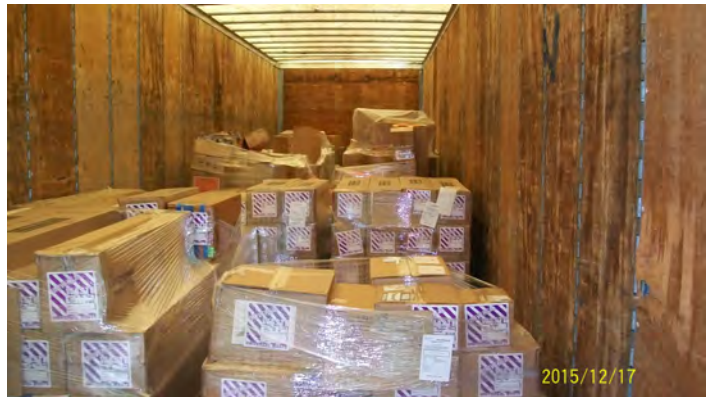
Universal Waste on Trailer

Fourteen trailers were randomly inspected to ensure compliance with state and federal regulations. Trailers 800401, 817421, and 622828 were empty. Trailers 484466, 889890, 889222, and 694756 contained inbound Universal Waste. The inbound materials were various batteries (NiCad, Li...etc.), universal waste lamps (HIDs and Fluorescent), mercury containing devices, and other universal wastes permitted to be processed at the facility. All containers were labeled, dated, and matched the transport documentation used by Veolia. Trailers 683536, 622832, 889985, 8000398, and 818134 contained outbound Universal Waste, post retort materials, (aluminum end caps and post-retort phosphor powder) and electronic waste. The Outbound universal waste shipments are sent to sister Veolia processing sites in Port Washington, Wisconsin and Phoenix, Arizona. All Outbound shipments were properly closed labeled and matched the facility shipping documentation. Trailer 8181358 was used for the storage of Georgia Power containers that were sent to the facility for the transport of their Universal Waste. Trailer 818133 was damaged and is being used for the storage of empty drums and containers used by Veolia to ship universal wastes.
