**Florida Department of  
Environmental Protection  
Hazardous Waste Inspection Report**

**Facility Name:** Veolia ES Technical Solutions LLC

**On-Site Inspection Start Date:** 12/17/2015

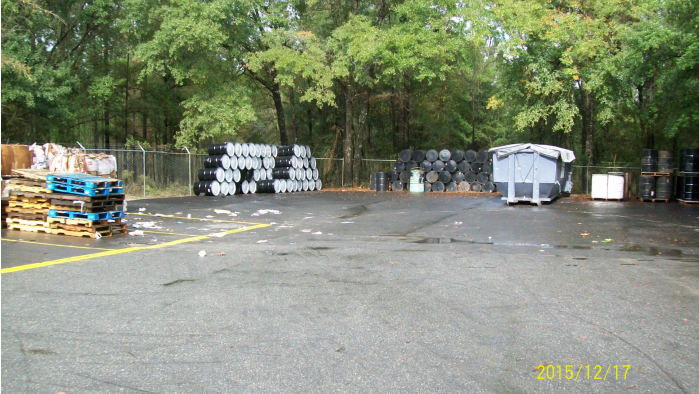
North Outside Storage

Four 20-yard roll-offs for collection of processed glass are staged in this area on a concrete pad. An adjacent asphalt paved area is used for collection of paper-products, wood pallet recycling and various empty container storage. Veolia has removed its two storage containers and empty containers are stored on the paved area. The hazardous waste transfer area is also located here for overnight holding of transport trucks in the event of an arrival after business hours. The trucks are immediately unloaded during the next business day. There were no violations observed in this area.

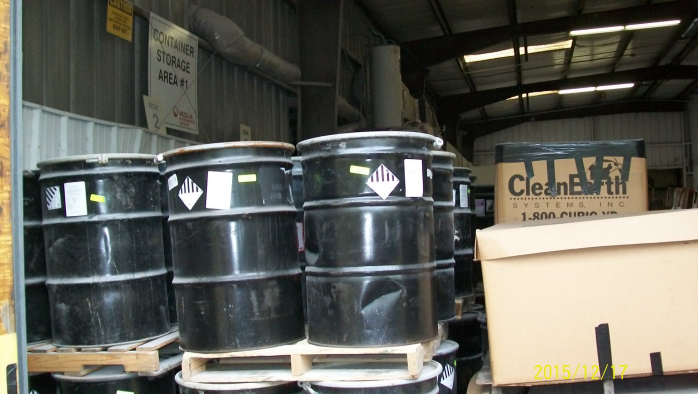
Container Storage Area #1

Veolia has two storage areas designated as "Container Storage Areas One and Two" (CSAs). The CSAs are permitted for up to 27 pallets (108 55-gallon drums) of MCMA; dental amalgam and traps; pre-retort phosphor powder; HID arc tubes; and site-generated hazardous waste (prep room debris and PPE, condensate water, and spent carbon). At the time of this inspection, hazardous waste stored in CSA One included four lab packs. There were approximately 44 drums of pre-retort, four gaylord boxes of post retort aluminum end caps, seven 5-gallon containers of dental amalgam, a 55-gallon drum of non-hazardous PPE. CSA Two contained approximately 13 55-gallon drums of non hazardous post retort powder and aluminum end caps, one drum of mop water, Gaylord box of crushed aluminum end caps and pallet of various preprocess mercury containing articles (Dental amalgam, traps and mercury contaminated materials). The oldest date observed was October 20, 2015. The facility had most of the pre-retort drums labeled as hazardous waste. Inspectors that the containers were in process and should not be labeled as hazardous waste. Inspectors also informed the facility that the facility had placed some pallets outside the permitted area and needed to ensure that all pallets were kept within the permitted areas.

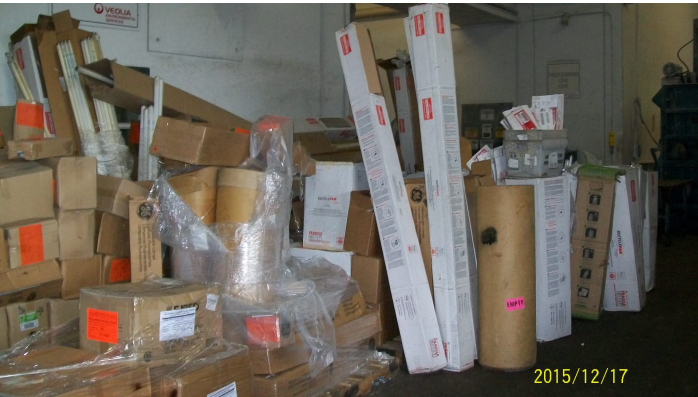
Fluorescent lamps are staged immediately adjacent to the lamp processing feed belts. Fluorescent lamps are hand fed into the lamp processing room via a conveyor belt. The Fluorescent Lamp Processing room, located in the northwest corner of the facility, is designed to process approximately 200,000 feet of lamp equivalents per 8-hour shift. Lamps are crushed with a drum

crusher and dry-separated into glass, aluminum and phosphor powder. Phosphor powder is collected by a bag tower and accumulated in 55-gallon drums. There are two processing lines that are used to facilitate this operation. The second processing line is used when there is a need to process a larger volume of materials. During the previous compliance inspection the facility has purchased a new 22.5 foot auger for the second processing line which had not been installed. Veolia has installed the new auger and has both processing lines in operation at the time of the inspection. There were four 55-gallon drums of pre-retort arc tubes

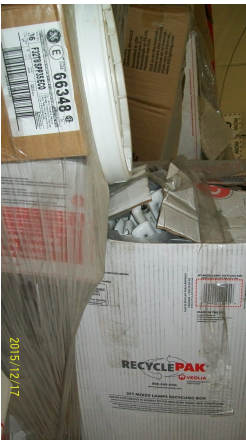
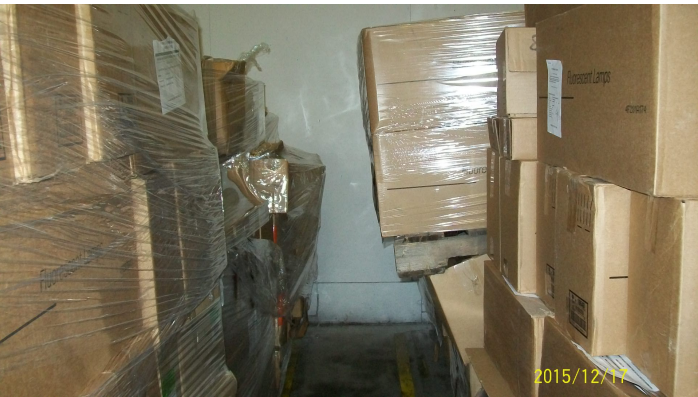
Universal Waste Storage

This area, located on the west side in the southern portion of the building, is the lamp storage area. The area has a permitted maximum storage capacity of 7,424 cubic feet of mixed fluorescent and HID lamps. The area is used for temporary storage of universal waste lamps that cannot be immediately processed. These lamps normally consist of HID lamps, U-shaped lamps and other specialty lamps that require manual processing prior to recycling/reclamation. The area is also used for temporary storage of universal waste batteries and non-RCRA hazardous materials.

During the inspection there were several boxes that were not properly closed (Rows 6, 7 and 10). Rows 10 and 11 also had issues with aisle spacing. Palletized materials were beyond the permitted lines and some were leaning into the aisle area. Inspectors reviewed the permit conditions with the facility personnel to ensure understanding of the permit requirements for the universal waste storage area. Adjacent to the area is a SAA for an aerosol can puncturer. The new SAA was not apart of the facility permit and had just been implemented by the new operating manager. Inspectors informed Mr. Melott that any new changes to the facility site plan should be discussed with the Department permitting staff before being implemented. The Department permitting staff must determine if the change is a minor, moderate, or major modification and follow all appropriate regulations to modify the facility operating permit.

<hr/>	
Type:	Violation
Rule:	265.35
Explanation:	Veolia had several pallets in its Universal waste storage area that were not properly in their permitted area according to its operating permit and state and federal hazardous waste regulations.
Corrective Action:	Veolia needs to ensure that all pallets and containers are within the permitted facility storage areas to ensure compliance with its operating permit and state and federal hazardous waste regulations.
<hr/>	
Type:	Violation
Rule:	265.71(a)(2)
Explanation:	Veolia did not have the final signed copy of the uniform hazardous waste manifest for Manifest # 000666944 VES- 08-17-2015. The waste manifest was not acquired within the 45-day time limit
Corrective Action:	Veolia during the course of the inspection acquired the manifest and showed it to inspectors. Veolia needs to ensure that a final signed copy of all manifests are retained onsite for three years. The final signed copy must be attained within 45-days of the hazardous waste being transported offsite for recycling or disposal.

The facility needs to ensure that all pallets are within their permitted areas in the Universal waste Storage area and Container Storage Areas (1 and 2). Veolia also needs to ensure that boxes and containers in the Universal waste storage area are properly closed at all times while awaiting processing. Final signed copies of waste manifests need to be acquired by the facility before the 45-day time limit is exceeded to ensure compliance with state and federal hazardous waste regulations. The facility also needs to ensure that all employees are thoroughly trained in the requirements of the facility's operating permit and enclosed permit conditions.

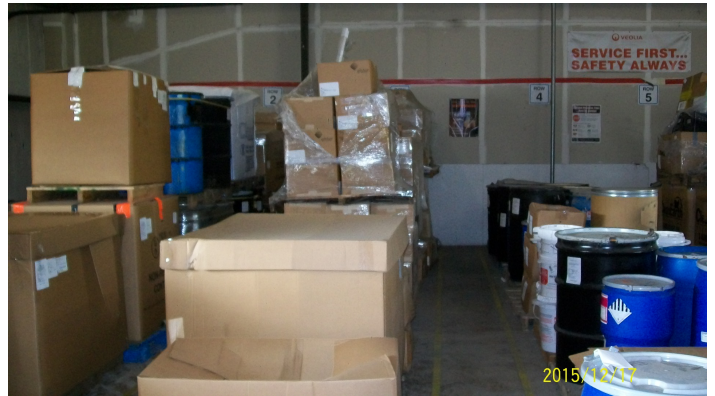
South Bldg Battery storage and E-waste

This building is immediately south of the main building and is divided into two large storage areas. The Container storage area is used to hold empty fiber drums and cardboard boxes. No universal or hazardous wastes are stored in this area. The second room in this building is used for storage of e-waste and battery storage. The space is permitted to store up to 72 pallets. At the time of the inspection, all pallets were properly labeled and protected from the environment. A new battery sorting table has been added to help in sorting of the various battery types received by the facility. No violations were observed at the time of the inspections.
