## **RCRA Inspection Report**

Veolia ES Technical Solution LLC  
342 Marpan Lane  
Tallahassee, Florida 32305-0904  
EPA ID No.: FLD 0000207449  
Tel. No.: (850) 877-8299

ATTACHMENT A  
VEOLIA ES TECHNICAL SOLUTIONS  
TALLAHASSEE, FLORIDA  
FLD # 0000207449  
DECEMBER 17, 2015

ATTACHMENT A  
Veolia ES Technical Solutions LLC  
Tallahassee, FLORIDA  
FL #000124917  
DECEMBER 17, 2015

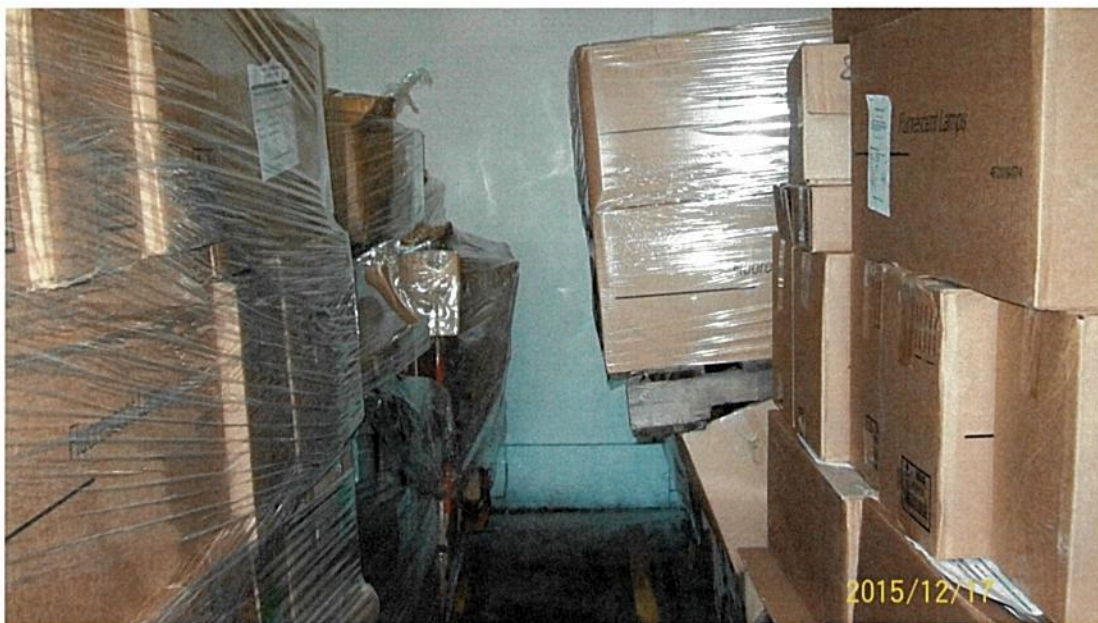
During the inspection there were several boxes that were not properly closed (Rows 6, 7 and 10). Rows 10 and 11 also had issues with aisle spacing (Picture-1, 2). Palletized materials were beyond the permitted lines and some were leaning into the aisle area.

Picture-1 Universal Waste Storage (inadequate aisle space)

**Veolia's Operating Permit 0071455-HO-011 dated February 3, 2012, requires that the permittee shall maintain aisle space as required by 40 C.F.R. § 264.35 which requires owner or operator to maintain aisle space to allow unobstructed movement of personnel, fire protection equipment and decontamination equipment to any area of the facility operation in an emergency. Veolia failed to maintain aisle space as required in their**

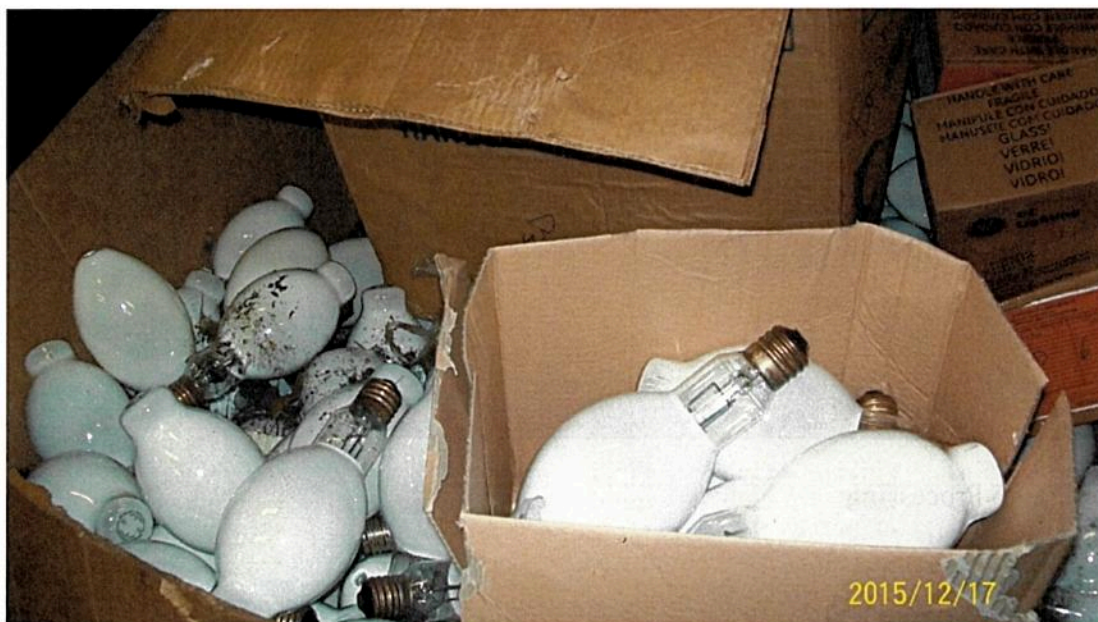
Picture-2 Universal Waste Storage (open waste lamps boxes)

**Pursuant to Fla. Admin. Code Ann. r. 62-730.160(1) [40 C.F.R. § 264.173], a container holding a hazardous waste must always be closed during the storage, except when it is necessary to add or remove the waste. Veolia failed to close boxes containing universal waste lamps stored in the storage area.**

**Veolia's Operating Permit 0071455-HO-011, Part II –Operating Conditions 2 and 3 require that the facility personnel must successfully complete the approved training program indicated in the training plan in attachment 7 of the permit application within six months of employment or assignment to a facility or to a new position at the facility. Veolia failed to provide proper training to the facility personnel in managing the universal waste storage area which included maintain proper aisle space and ensuring that all the universal waste storage containers were closed.**

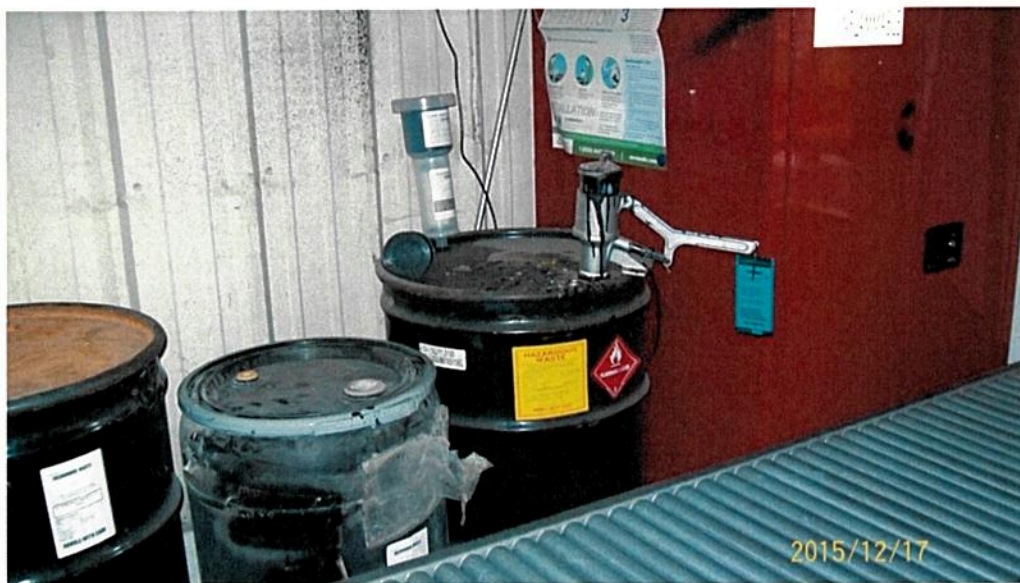
Adjacent to the universal waste storage area is a Satellite Accumulation Area (SAA) for an aerosol can puncture (Picture-3). The new SAA was not a part of the facility permit and had recently been implemented by the new Operations Manager. Inspectors informed Mr. Melott that any new changes to the facility process plan should be discussed with the FDEP Permitting staff before being implemented. The FDEP Permitting staff shall determine whether the requested change in the process plan is a minor, moderate, or a major modification and approve accordingly.

Picture-3 Aerosol Can Area (SAA)

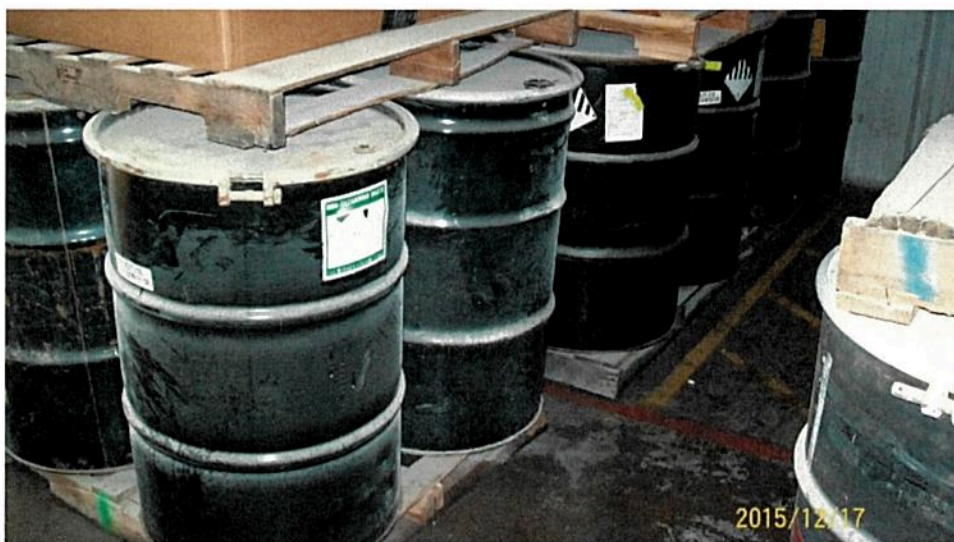
At the time of this inspection, in CSA #1, the inspectors observed four lab packs with a removal from service date of 10/20/2015; 44-containers of pre-retort materials, four Gaylord boxes of post retort aluminum end caps, seven 5-gallon containers labeled as dental amalgam and a 55 gallon container of nonhazardous PPE (Picture-5). The CSA #2 comprised of 13 55-gallon containers of nonhazardous post retort powder and aluminum end caps, one container of mop water, a Gaylord box of crushed aluminum end caps and several pallets of preprocessed mercury containing articles (Dental amalgam, traps, and mercury containing materials) (Picture-6). The oldest date noted was October 20, 2015. The inspectors noted that facility had several pallets outside the designated permitted area. All containers were properly closed, labeled, and dated. Veolia failed to maintain aisle space as required in their operating permit.

Picture-5 Container Storage Area 1 (Containers outside the permitted areas)

**Veolia's Operating Permit 0071455-HO-011 dated February 3, 2012, requires that the permittee shall maintain aisle space as required by 40 C.F.R. § 264.35 which requires owner or operator to maintain aisle space to allow unobstructed movement of personnel, fire protection equipment and decontamination equipment to any area of the facility operation in an emergency.**

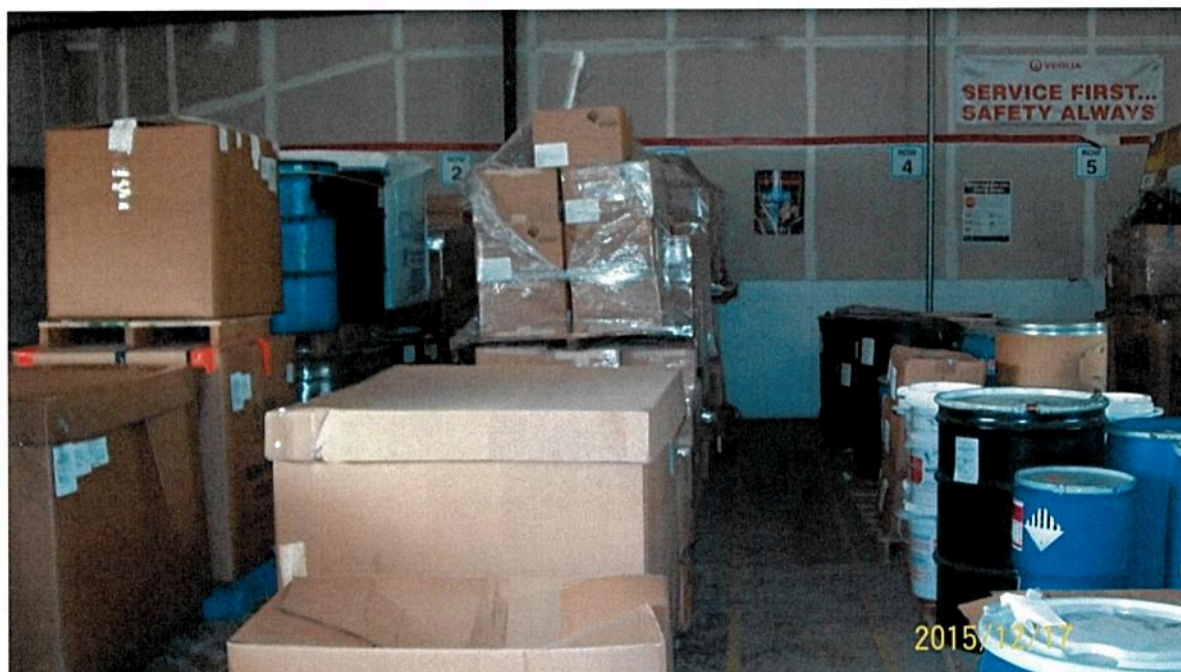
This building is immediately south of the main building and is divided into two large storage areas. The Container storage area is used to hold empty fiber drums and cardboard boxes. No universal or hazardous wastes are stored in this area. The second room in this building is used for storage of e-waste and battery storage (Picture-8). The space is permitted to store up to 72 pallets. At the time of the inspection, all pallets were properly labeled and protected from the environment. A new battery sorting table has been added to help in sorting of the various battery types received by the facility. No deficiencies were observed at the time of the inspection.

Picture-8 South Building ( Batteries, Containers and E-Waste Storage)

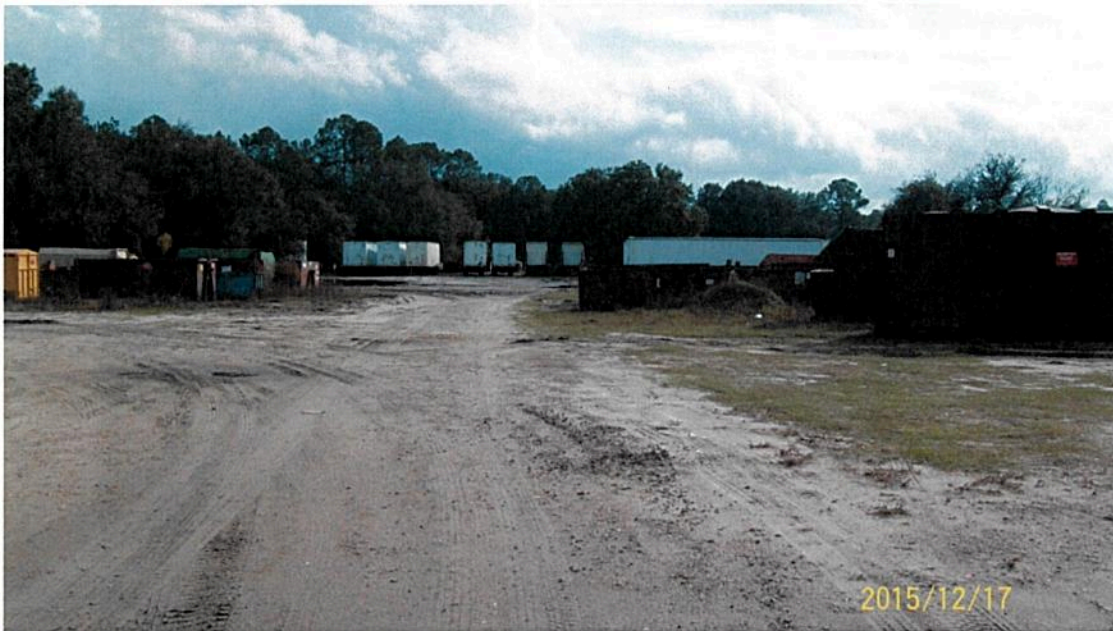
The Veolia Transfer Yard (Veolia) is used for the storage of facility transport trailers and is a registered Universal Waste Transfer Area (Picture -1). Fourteen trailers were randomly inspected to ensure compliance with state and federal regulations. Trailers 800401, 817421, and 622828 were empty. Trailers 484466, 889890, 889222, and 694756 contained inbound Universal Waste. The inbound materials comprised of various batteries (NiCad, Li etc.), universal waste lamps (HIDs and Fluorescent), mercury containing devices, and other universal wastes permitted to be processed at the facility (Picture-2). All the containers were labeled, dated, and matched the transport documentation used by Veolia Trailers 683536, 622832, 889985, 8000398, and 818134 contained outbound Universal Waste, post retort materials, (aluminum end caps and post-retort phosphor powder) and electronic waste (Picture-3). The Outbound universal waste shipments are sent to sister Veolia processing sites in Port Washington, Wisconsin and Phoenix, Arizona. All Outbound shipments were properly closed labeled and matched the facility shipping documentation. Trailer 8181358 was used for the storage of Georgia Power containers that were sent to the facility for the transport of their Universal Waste. Trailer 818133 was damaged and is being used for the storage of empty drums and containers used by Veolia to ship universal wastes (Picture-4). No deficiencies were observed at the time of the inspection.

Picture-1 Universal Waste Transfer Area

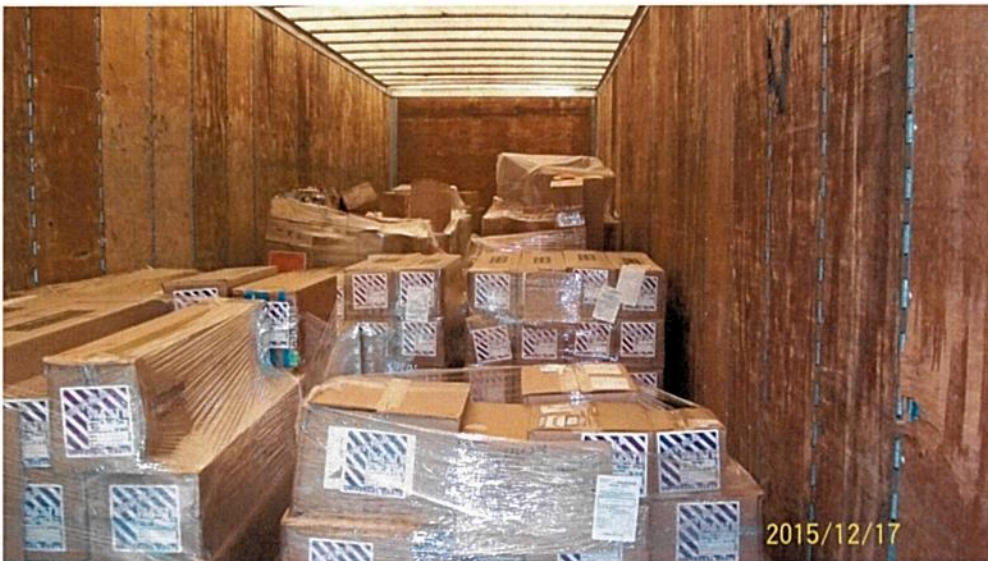
Picture-2 Universal Waste on Trailer

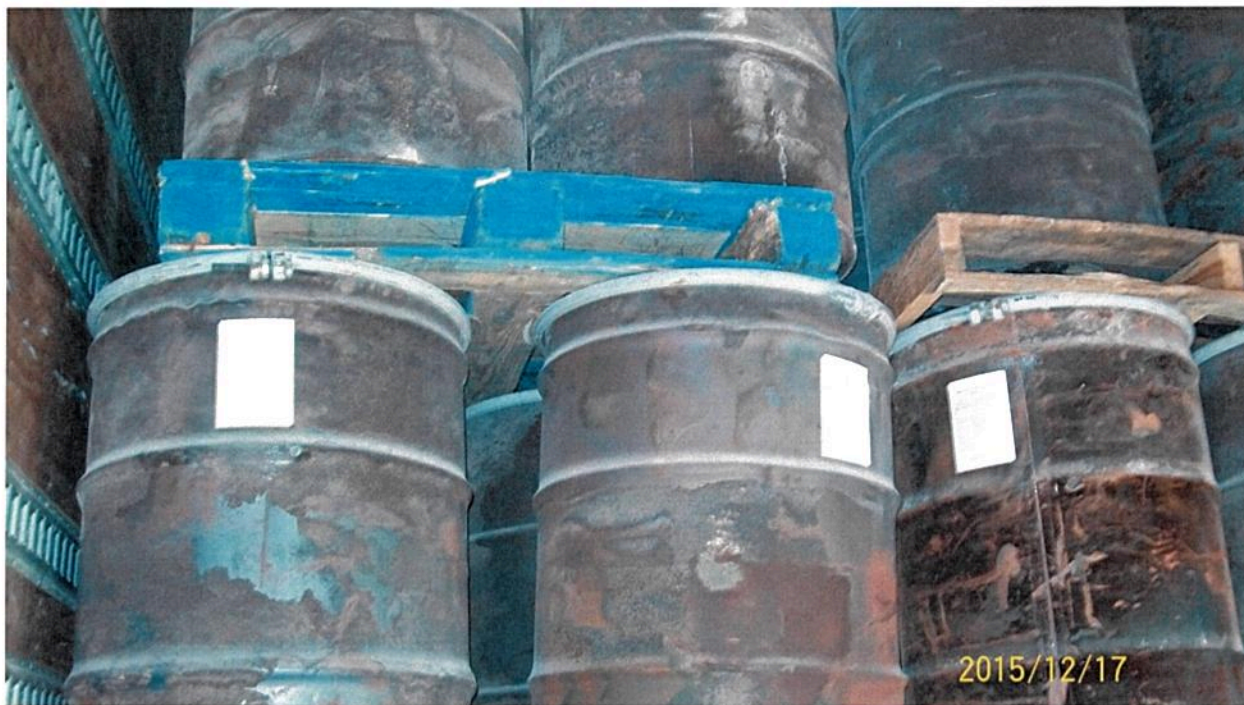
Picture-3 Post Retort Phosphor Powder

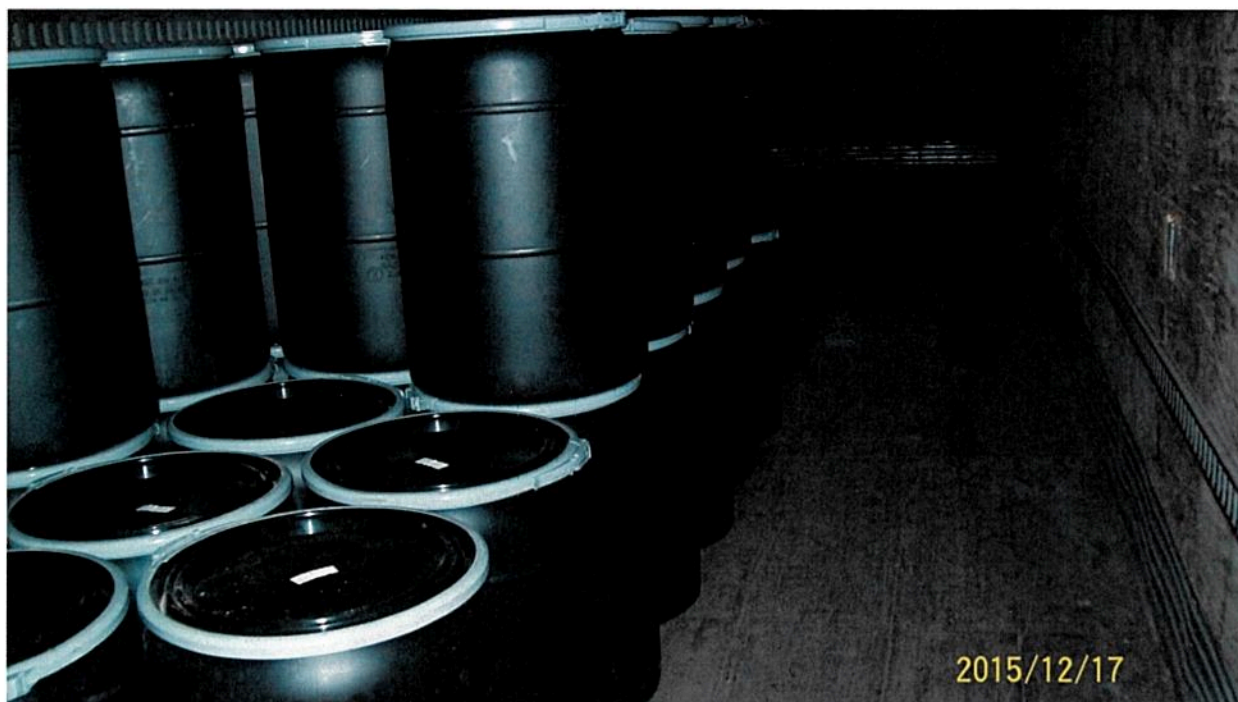
Picture-4 Container Storage Trailer
