Subject: Semi-Annual Groundwater Monitoring Report
Okeechobee Transfer Facility
14000 Northwest 112th Avenue
Miami, Miami-Dade County, Florida
Permit No. 0157225-005-SO
File-17023/SW-1409
LandScience Project No. 2176683

**SEMI-ANNUAL
GROUNDWATER MONITORING REPORT**

**OKEECHOBEE TRANSFER FACILITY
PERMIT No. 0157225-005-SO / FILE-17023/SW-1409
LOCATED AT 14000 NORTHWEST 112TH AVENUE
MIAMI, MIAMI-DADE COUNTY, FLORIDA**

**July 2017
Project Number 2176683**

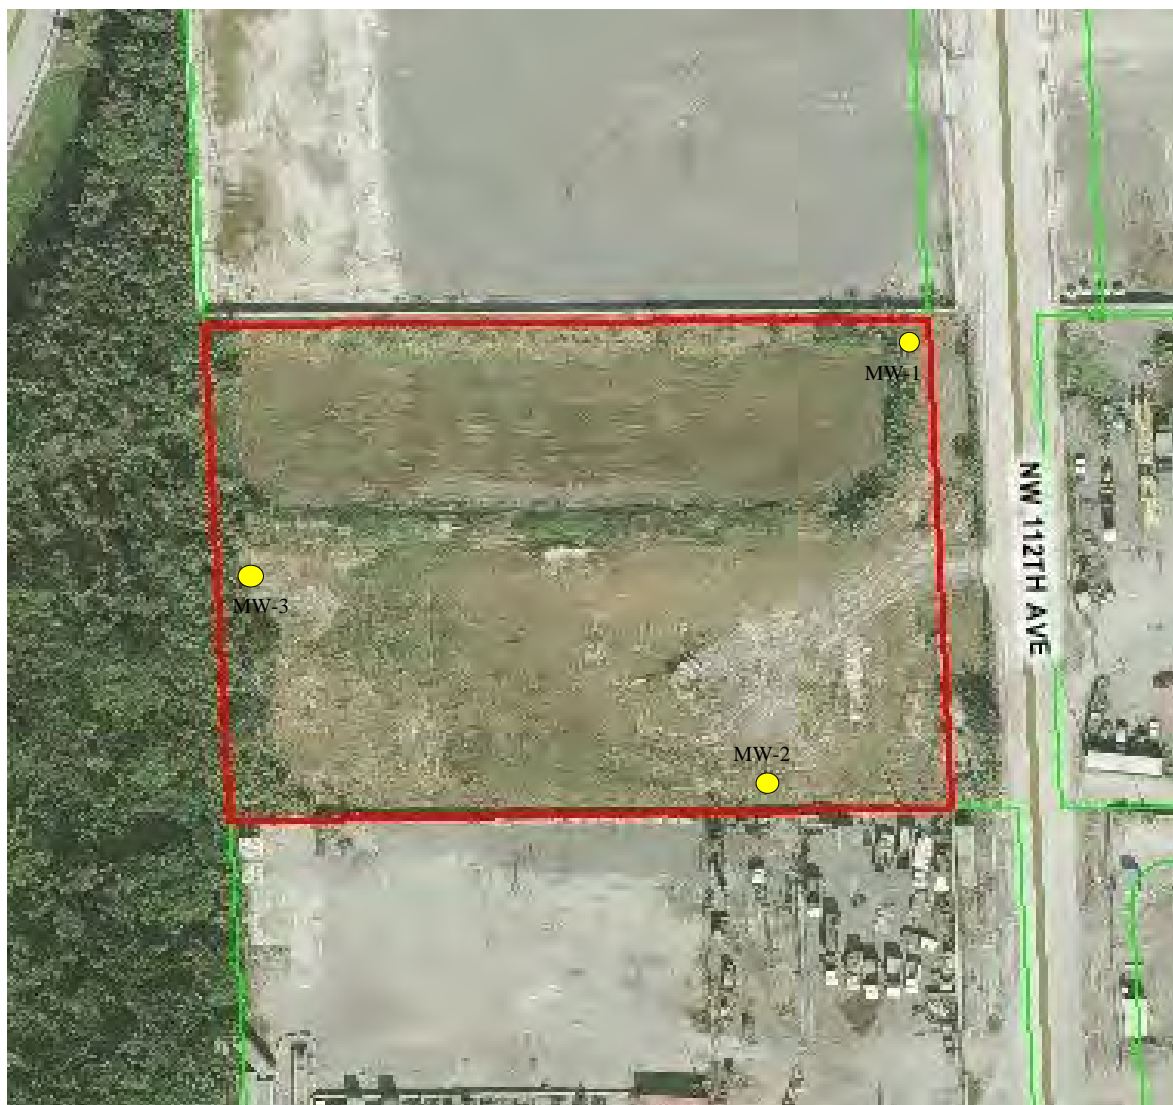
**FIGURE 1- SITE PLAN
(2012 AERIAL PHOTOGRAPH)**

The subject property, situated on the west side of Northwest 112th Avenue, is located in Miami, Miami-Dade County, Florida. According to information obtained from the Miami-Dade County Property Appraiser’s Office, the subject property is approximately 3.36 acres in size and consists of vacant land. The site plan (2012 aerial photograph) showing the subject property boundaries and monitoring well locations is provided as **Figure 1**.

Figure 1 is a scaled Site Layout (2012 aerial photograph) that illustrates the locations of the existing monitoring wells and site appurtenances.

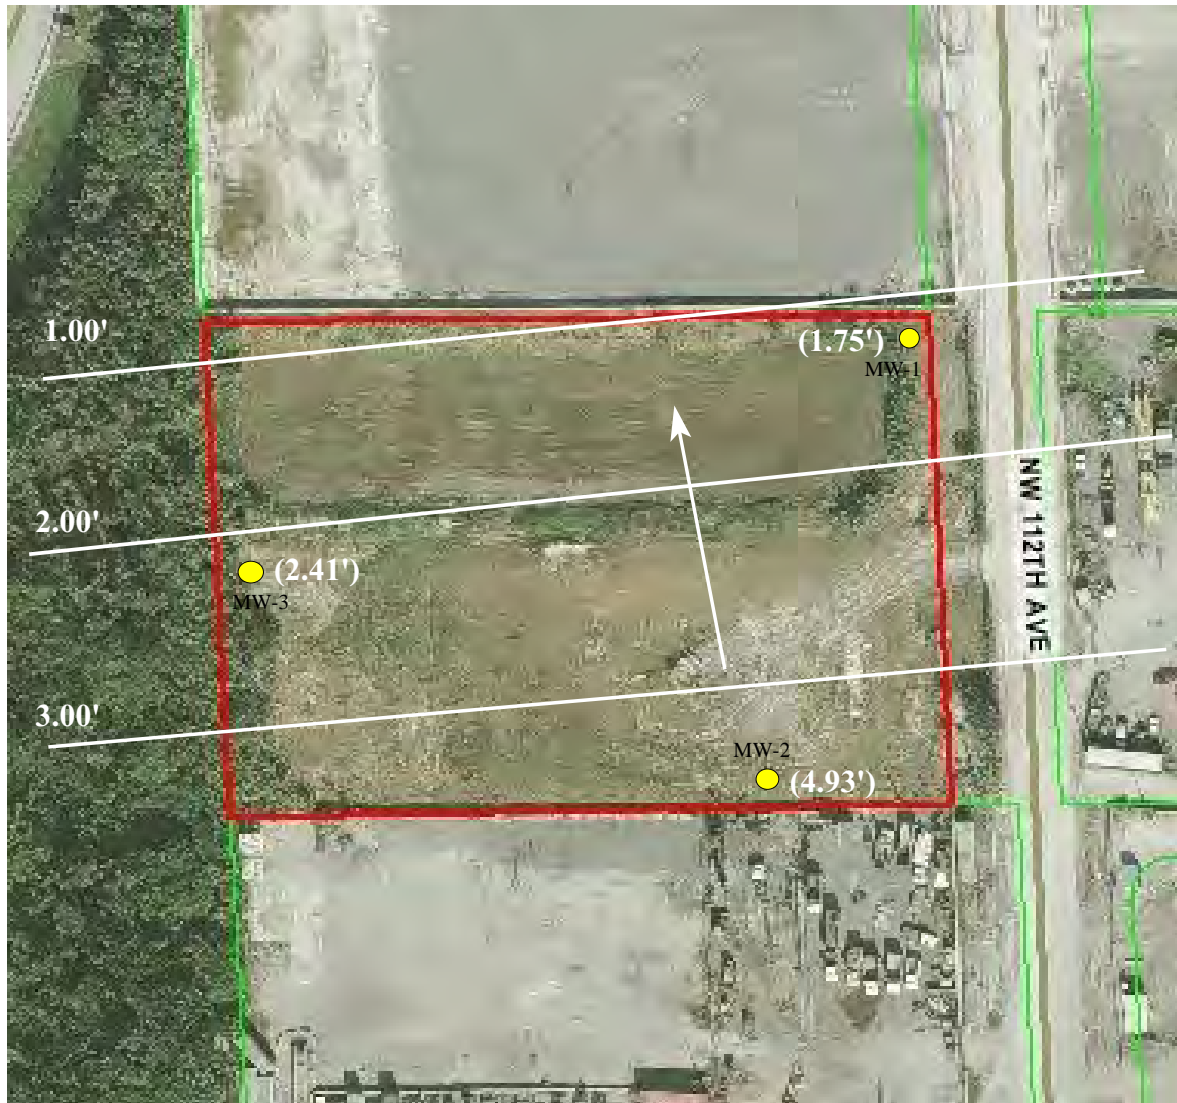
**FIGURE 2- WATER TABLE
ELEVATIONS- July 24, 2017**

Prior to groundwater sample collection on July 24, 2017, a representative of LandScience performed an evaluation of the groundwater flow direction by collection of liquid levels from monitoring wells, MW-1, MW-2, and MW-3. The depth to groundwater was determined by use of a Heron electronic interface probe, capable of detecting liquid thickness to an accuracy of 0.01-feet. The probe is also capable of detecting non-aqueous phase liquids, which were not detected within any site monitoring wells. Using the top of casing survey data from previous assessments, water table elevations were calculated and plotted on a site layout which is illustrated on **Figure 2**. Water table elevation iso-contours were plotted on the map to illustrate the generally northwestern groundwater flow direction. **Table 1** summarizes the historical through recent water table elevations.

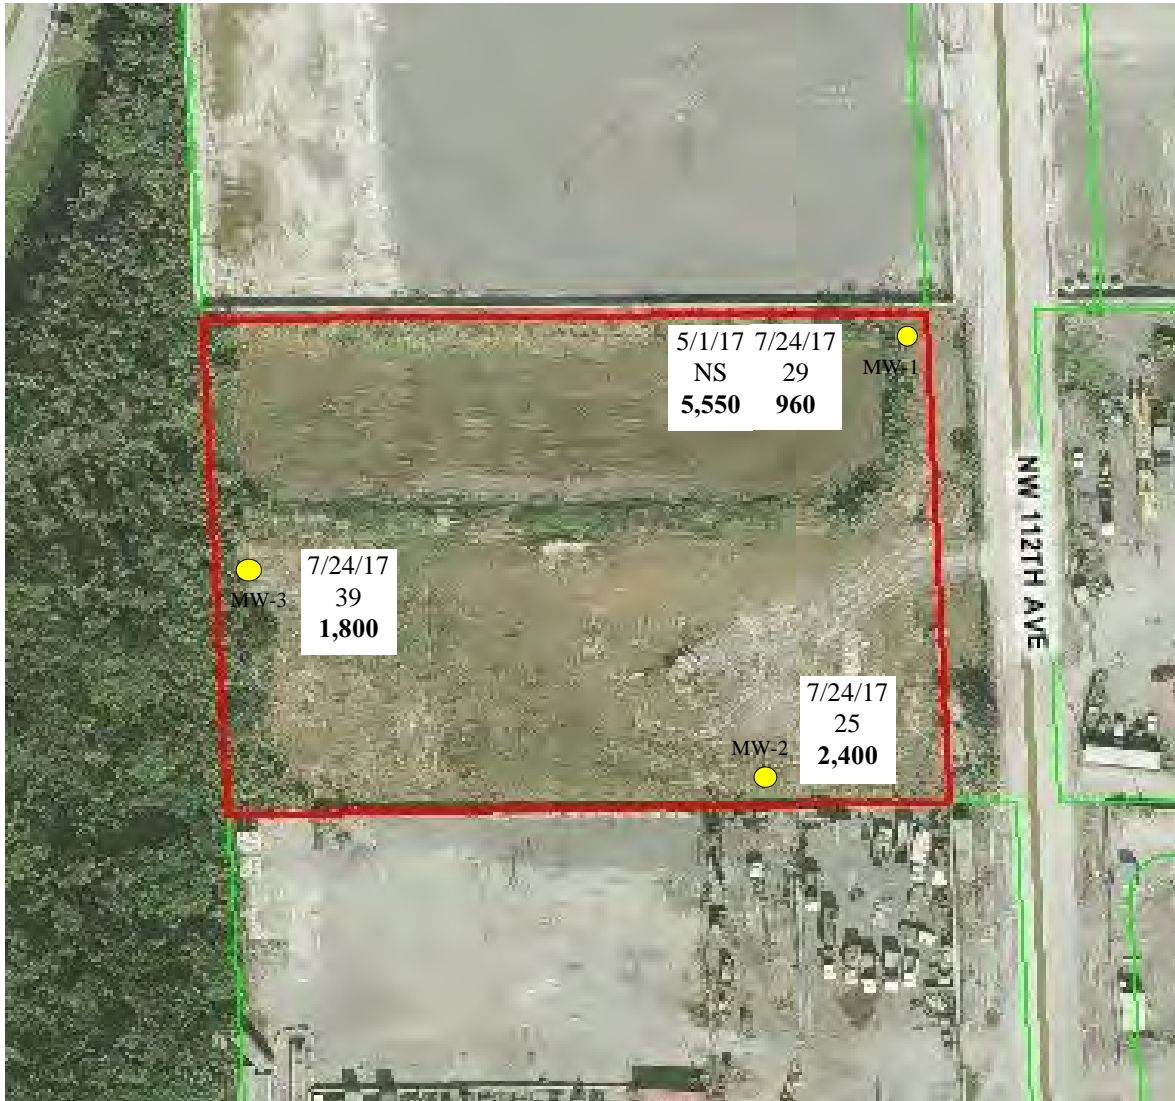
**FIGURE 3- IRON AND ALUMINUM
CONCENTRATIONS IN
GROUNDWATER-**

The laboratory analytical results for the groundwater sample collected from MW-1 on May 1, 2017, indicated that the concentration of iron exceeded the FDEP GCTL, and the FDEP NADC. The laboratory analytical results for the groundwater sample collected from MW-1 on July 24, 2017, indicated that the concentration of iron exceeded the FDEP GCTL, but was below the FDEP NADC. Laboratory analytical results indicated that the concentration of aluminum in MW-1 was below the FDEP GCTLs.

The laboratory analytical results for the groundwater sample collected from MW-2, indicated that the concentration of iron exceeded the FDEP GCTL, but was below the FDEP NADC. Laboratory analytical results indicated that the concentration of aluminum in MW-2 was below the FDEP GCTLs.

The laboratory analytical results for the groundwater sample collected from MW-3, indicated that the concentration of iron exceeded the FDEP GCTL, but was below the FDEP NADC. Laboratory analytical results indicated that the concentration of aluminum in MW-3 was below the FDEP GCTLs.

Appendix B includes a copy of the laboratory analytical results and the chain of custody. The groundwater quality results from the May 1, and July 24, 2017, sampling events are depicted in **Figure 3**. The groundwater quality results from the May 1, and July 24, 2017, sampling events, as well as from the previous sampling events, are included in **Table 2**. Also included on the table are applicable GCTLs and NADCs established by the FDEP.

Based upon the conclusions discussed above, it appears that iron continues to be present the only constituent above the FDEP GCTL but below the FDEP NADC in the groundwater as represented by the groundwater samples collected from MW-1, MW-2 and MW-3. Therefore, LandScience recommends that the GWMP activities continue to assess the longer-term trend of contaminant concentrations in the groundwater.

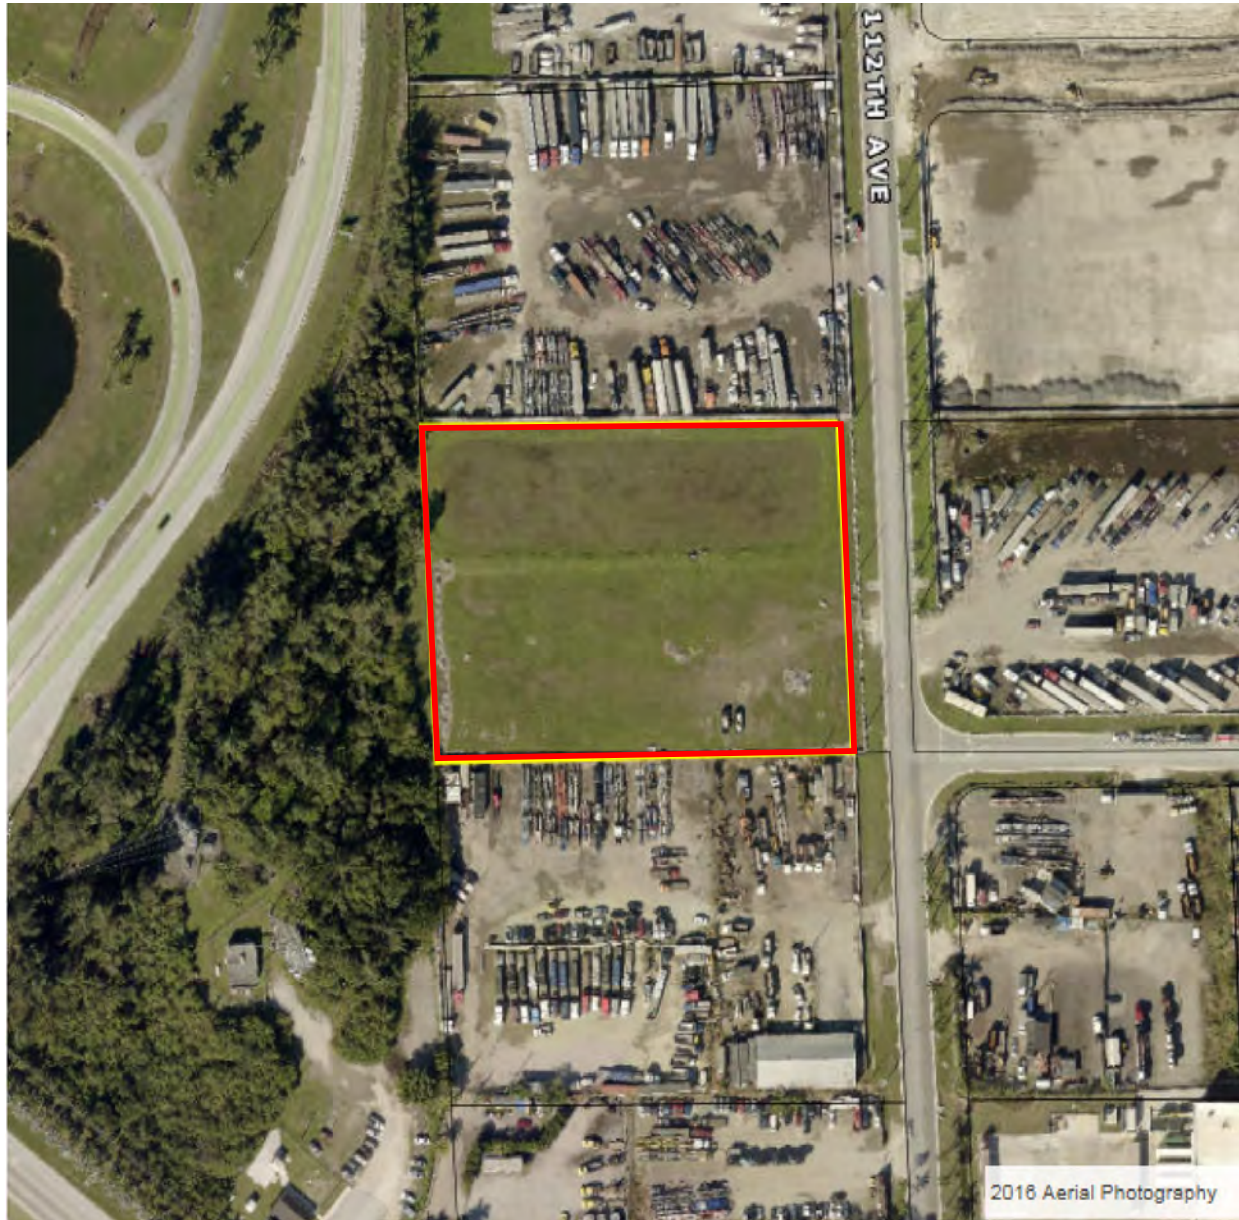
FIGURE 1
2016 AERIAL PHOTOGRAPH
SHOWING THE SUBJECT
PROPERTY

The Subject Property has consisted of vacant land with a low-lying vegetation consisting of a grassy bermed area on the northern portions and grassy areas on the southern portions similar to the current conditions since at least 2010. Prior to 2010, the Subject Property had consisted of vacant land with several soil piles on the southern portions and vacant land with a grassy bermed area on the northern portions since 2009. Prior to 2009, the Subject Property had consisted of vacant land used for metal container storage on the southern portions and the northern portions consisted of vacant land with a grassy bermed area since 2007. Prior to 2007, the Subject Property had consisted of vacant land with a sandy surface on the southern portions and the northern portions consisted of vacant land with a sandy bermed area since 2006. Prior to 2006, the Subject Property had consisted of vacant land with low-lying vegetation on the southern portions and consisted of damp slightly submerged vegetation on the northern portions since at least 2005. Prior to 2005, the Subject Property had consisted of vacant land with low-lying vegetation since at least 1998. Prior to 1998, the Subject Property had consisted of vacant land with truck parking and areas of soil piles since at

Based on the review of historical aerial photographs, which detailed property usage of the Subject Property and adjacent/abutting properties, there does not appear to be a definitive conclusion as to whether these properties have contributed to the elevated iron levels detected on the Subject Property. The property located to the north/northeast, beyond Northwest 112th Avenue, had conducted soil/debris staging for several years prior to 2016. The general groundwater flow direction at the Subject Property has historically been toward the north. The remaining properties appear to have been historically generally used for semi-trailer truck parking and/or vacant land.

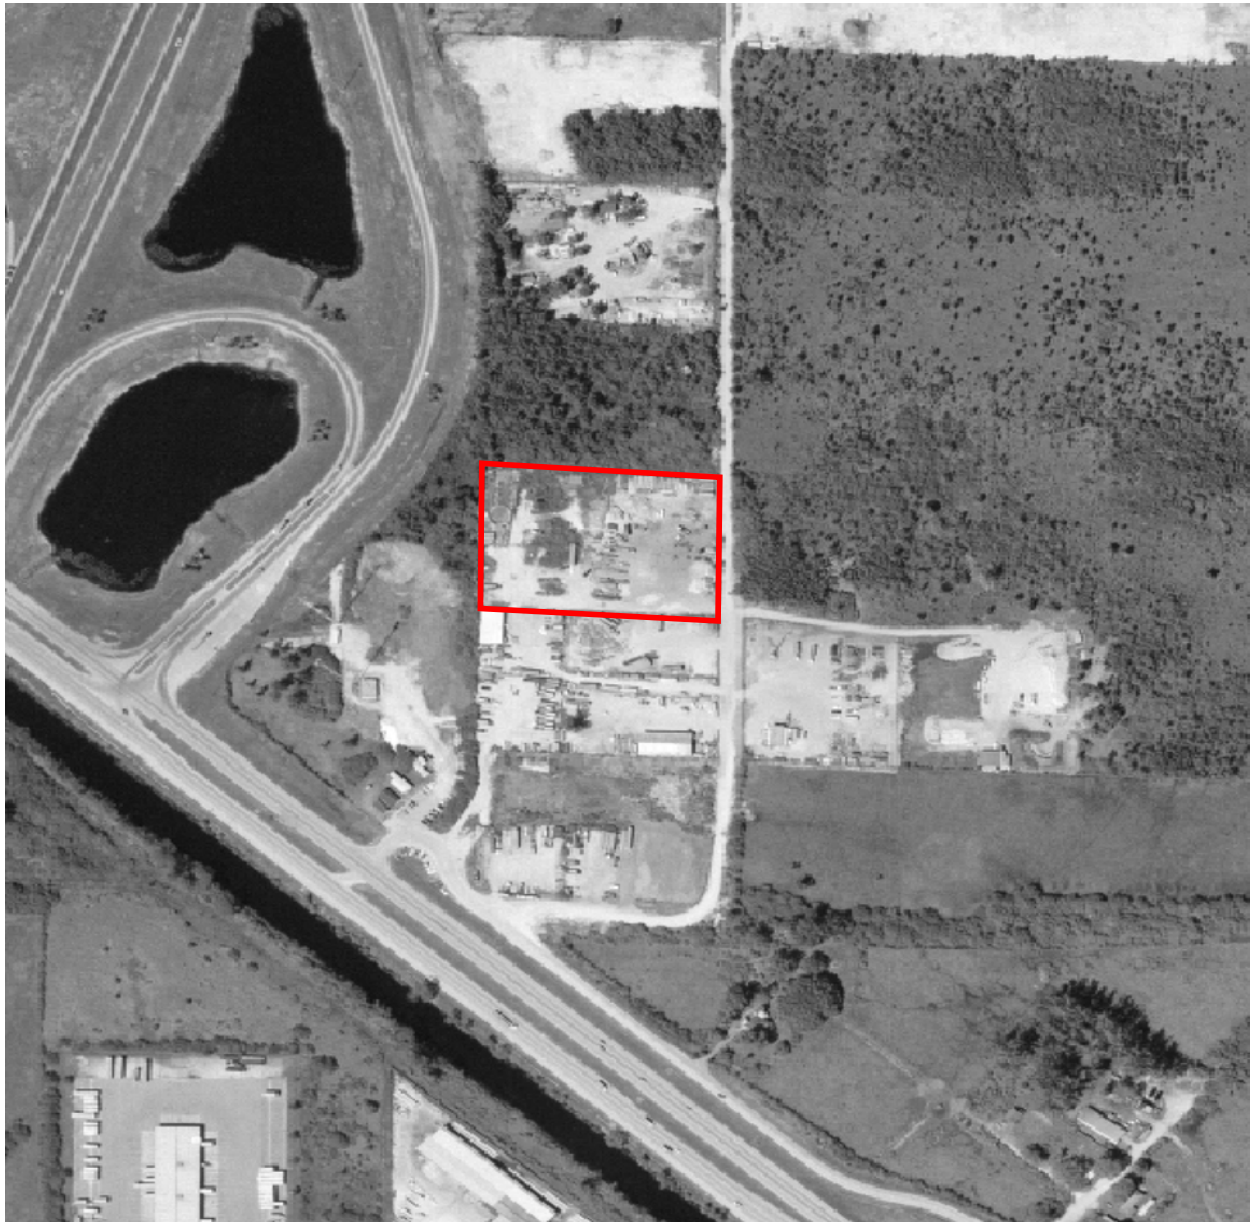
FIGURE 5
1991 AERIAL PHOTOGRAPH
SHOWING THE SUBJECT
PROPERTY

least 1991. Prior to 1991, the Subject Property had consisted of vacant land with low-lying vegetation since at least 1968.

The abutting property to the south of the Subject Property, has consisted of vacant land with semi-trailer truck parking similar to the current conditions since at least 1991. Prior to 1991, this property had consisted of vacant land with low-lying vegetation since at least 1968.

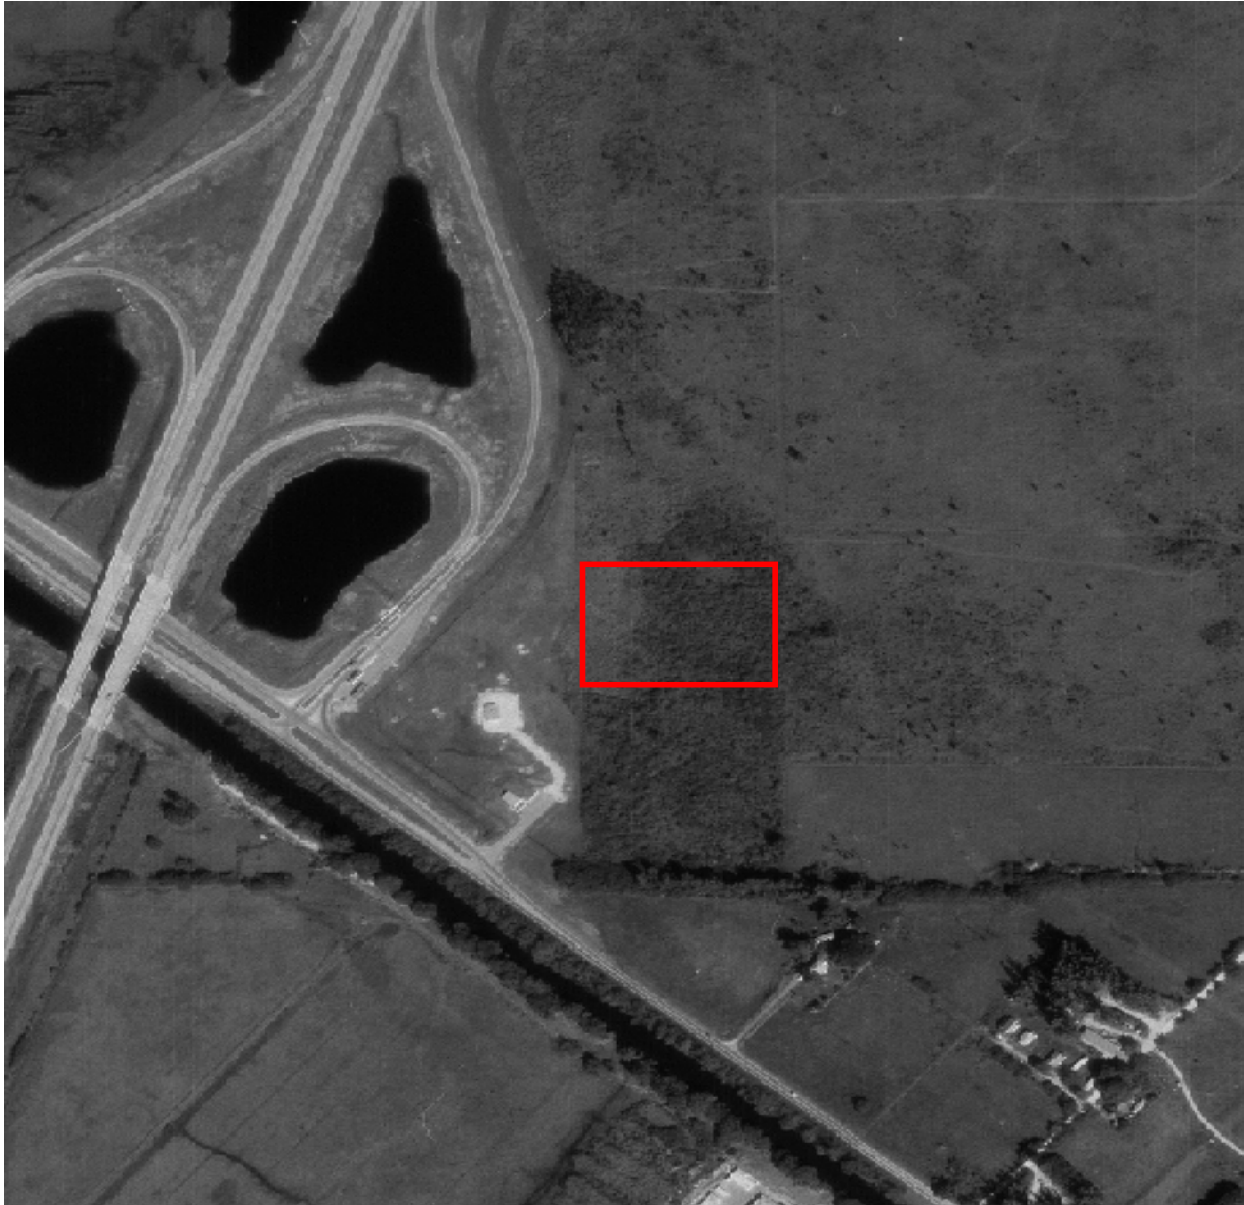
FIGURE 7
1978 AERIAL PHOTOGRAPH
SHOWING THE SUBJECT
PROPERTY

The abutting property to the west/southwest of the Subject Property, has consisted of vacant land with vegetation and a utility tower further bounded by a highway similar to the current conditions since at least 1978. Prior to 1978, this property had consisted of vacant land since at least 1968.

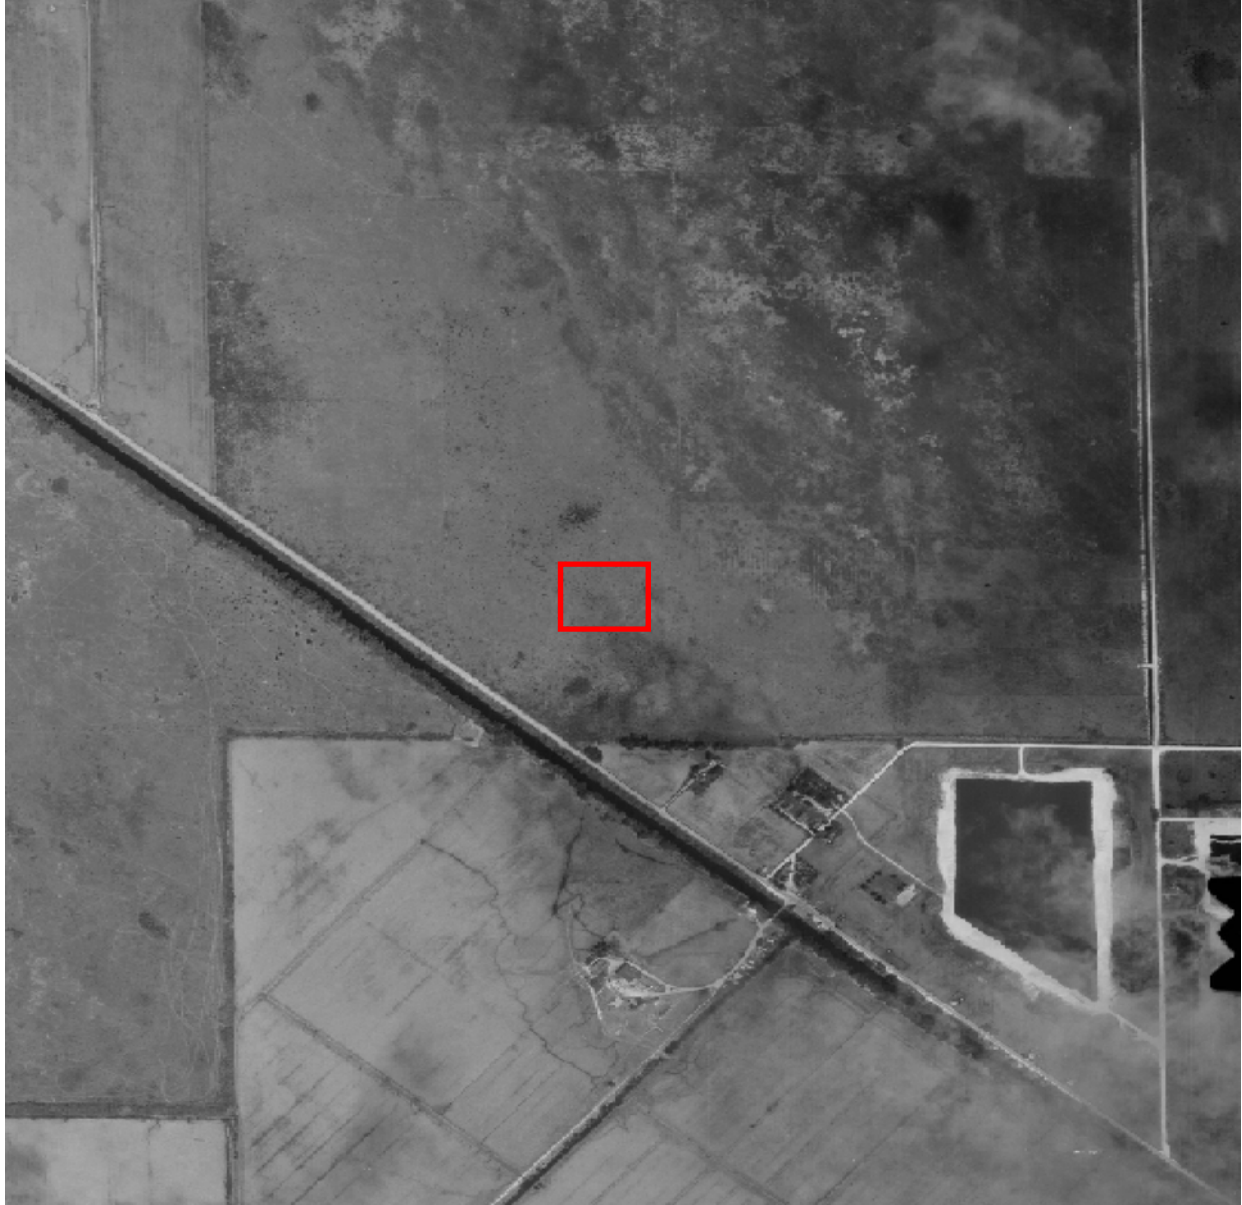
FIGURE 9
1968 AERIAL PHOTOGRAPH
SHOWING THE SUBJECT
PROPERTY

The abutting property to the west, west/northwest of the Subject Property, has consisted of vacant land with vegetation further bounded by a highway similar to the current conditions since at least 1968.
