**Florida Department of
Environmental Protection
Hazardous Waste Inspection Report**

Facility Name: Aerc Com Inc

On-Site Inspection Start Date: 07/27/2016

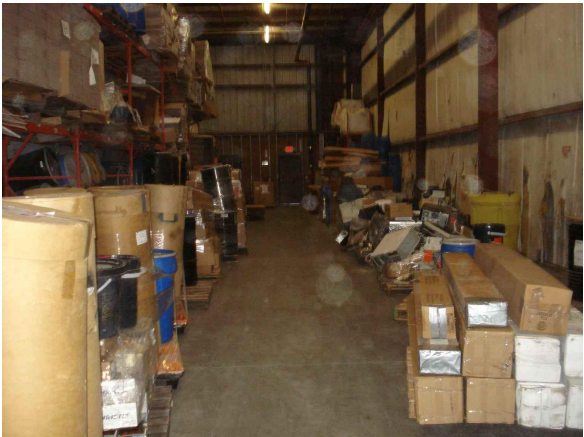
1. Recyclables and Electronics

Across from the Bay 1 Receiving Area is the Recyclables and Storage Area (Figure 1). In the area were electronics recyclables and empty containers storage. On the back wall of the area was the fire suppression sprinkler riser, a fire extinguisher, and a fire alarm pull station. The riser was last checked on 4/27/2016 and the extinguisher on 7/8/2016.

Staged in the Recyclables Area were fifteen pallets recently offloaded from the truck in bay 4 and eleven pallets of electronic waste (e-waste) containing:

- 533 pounds of CPUs
- 433 pounds of CRTs, LCDs, hard drives, keyboards and miscellaneous e-waste
- 512 pounds of CPUs, printers, and modems
- A single 113 pound projection TV
- 384 pounds of CRTs, LCDs, and miscellaneous e- waste
- 360 pounds of CRTs, Printers & fax machines, and miscellaneous e-waste
- 364 pounds of CPUs, CRTs, and fax/printers
- 475 pounds of CPUs, DVD players, VCRs, fax/printers, miscellaneous e-waste and a coffee machine
- 332 pounds of CRTs, a vacuum cleaner, CPUs, a keyboard, and miscellaneous e-waste
- 797 pounds of CPUs (server blades), printer/fax, and LCDs
- 525 pounds of CPUs, LCDs, and miscellaneous e-waste

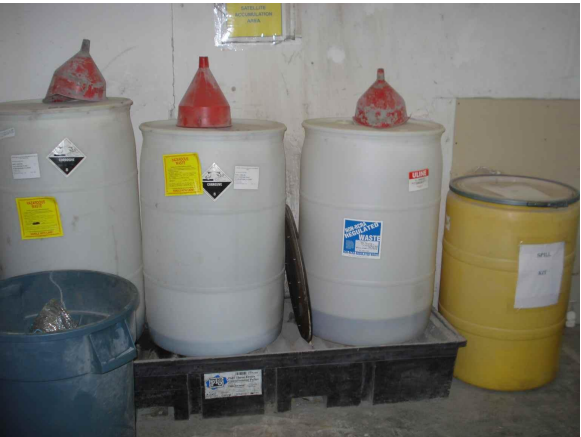
2. Battery Processing Waste Containers

Located at the southeast corner of the main storage area is the Battery Processing Area (Figure 2). AERC accepts lead-acid, lithium ion, nickel metal hydride, nickel cadmium, and alkaline batteries for recycling. Fluid is removed from leaking batteries and placed in the appropriate acid or base accumulation drum in the satellite accumulation area. In the satellite accumulation area were three 55-gallon poly drums. One drum contained sodium hydroxide, another sulfuric acid, and the last contained non-hazardous mineral oil. All containers were properly labeled with words identifying the contents and closed. A spill kit was located next to the drums. Also in the area was a pallet of lead acid batteries being prepared for shipment off-site. Approximately 70 feet away is a safety shower/eye wash station.

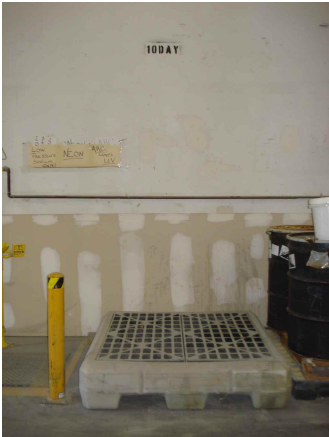
3. 10-Day Transfer Area

No hazardous waste was stored in the 10-day transfer area at the time of this inspection (Figure 3). In an area adjacent to the 10-day transfer area were drums and containers of mercury containing devices to be shipped to AERC's Allentown facility for processing. In the area were six 55-gallon drums, one 30-gallon drum, one 5-gallon container, one 2.5-gallon container, and one cardboard box of mercury containing devices.

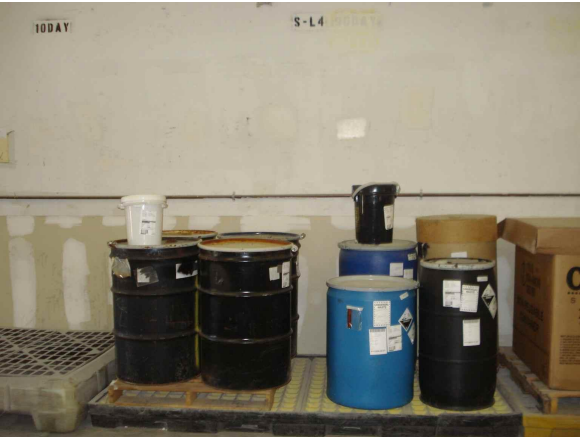
4. 90-Day Storage Area

In the 90-day storage area was one cardboard box of hazardous waste containing HID lamps and phosphor powder. The cardboard box was properly labeled "Hazardous Waste" and closed but was not marked with an accumulation start date. Upon further investigation, Mr. Larsen determined the box was improperly located in the 90-day storage area, it should have been located in a satellite accumulation area for sump pump/bilge pump floats processing area where mercury switches are removed. All other containers were properly labeled "Hazardous Waste," marked with accumulation start dates, and were closed. Also in the area were four 55-gallon drums, one yard box, and one 55-gallon drum of non-hazardous waste.

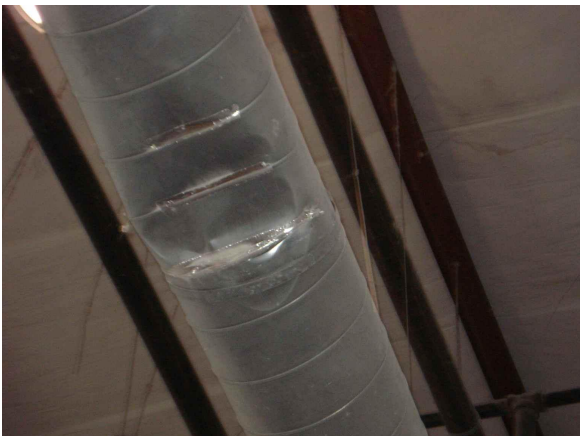
11. Damaged vent pipe

Ductwork leading from the LSS-1 filter system is connected to a bank of filters located in the warehouse storage area. There was a visible gap in the ductwork (Figure 11). It was requested the gap be repaired. There were visible signs of phosphor powder on, and around, the processing equipment and the equipment shows visible signs of repair. There was also phosphor powder around a compressor that is located adjacent to the bay door.

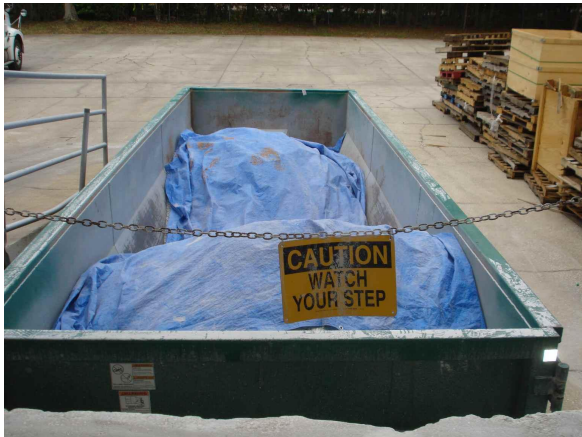
13. Processed glass roll-off

Outside the processing area bay door is the staging area for the roll-off container accumulating processed glass. The container stores glass generated by the lamp processing equipment. Once sampling of the glass has documented the glass does not exhibit a hazardous waste characteristic of toxicity, the glass is disposed of at a Subtitle D, non-hazardous waste landfill. The tarp that is supposed to completely cover the roll-off container was not adequate and did not meet the requirements of permit condition Part II Subpart B, Specific Operating Conditions Number 1 which requires compliance with Rule 62-730.800(9), F.A.C., which requires containers be closed, covered, and sealed. The tarp was just laying over the glass in the roll-off container (Figure 13). At one end of the roll-off is a door that goes top to bottom and side to side, a gap was visible around the door which would allow rain water to drain out (Figure 14).
