Re: AERC.Com
HW Facility ID FLD984262782
Brevard County

**Florida Department of
Environmental Protection
Hazardous Waste Inspection Report**

Facility Name: Aerc Com Inc

On-Site Inspection Start Date: 07/27/2016

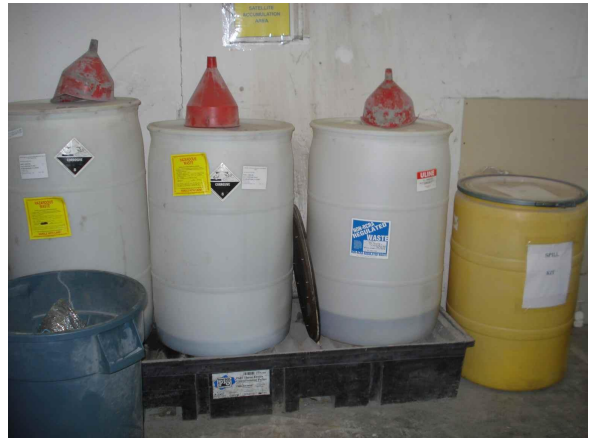
2. Battery Processing Waste Containers

Located at the southeast corner of the main storage area is the Battery Processing Area (Figure 2). AERC accepts lead-acid, lithium ion, nickel metal hydride, nickel cadmium, and alkaline batteries for recycling. Fluid is removed from leaking batteries and placed in the appropriate acid or base accumulation drum in the satellite accumulation area. In the satellite accumulation area were three 55-gallon poly drums. One drum contained sodium hydroxide, another sulfuric acid, and the last contained non-hazardous mineral oil. All containers were properly labeled with words identifying the contents and closed. A spill kit was located next to the drums. Also in the area was a pallet of lead acid batteries being prepared for shipment off-site. Approximately 70 feet away is a safety shower/eye wash station.

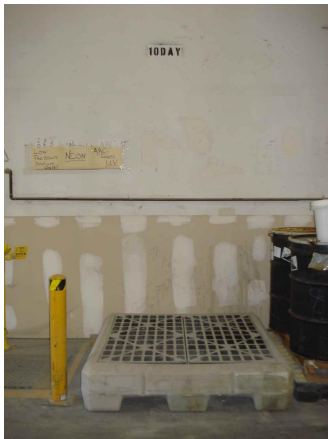
3. 10-Day Transfer Area

No hazardous waste was stored in the 10-day transfer area at the time of this inspection (Figure 3). In an area adjacent to the 10-day transfer area were drums and containers of mercury containing devices to be shipped to AERC's Allentown facility for processing. In the area were six 55-gallon drums, one 30-gallon drum, one 5-gallon container, one 2.5-gallon container, and one cardboard box of mercury containing devices.

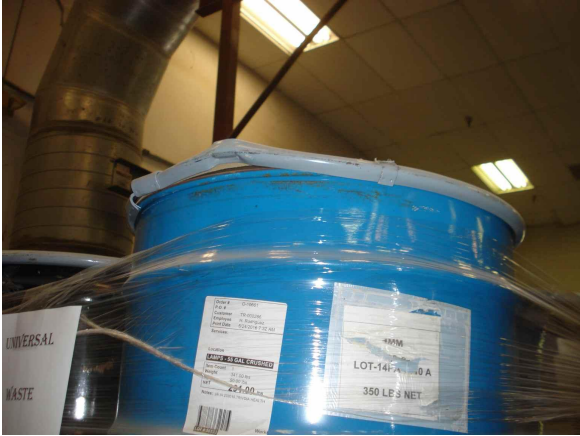
7. Crushed glass drum with damaged ring

Located in Row 8 was one 55-gallon drum of crushed glass with a damaged, unsecured drum ring in apparent violation of 40 CFR 264.171 (Figure 7). The drum ring was secured during the inspection.

Type:	Violation
Rule:	264.171
Explanation:	If a container holding hazardous waste is not in good condition (e.g., severe rusting, apparent structural defects) or if it begins to leak, the owner or operator must transfer the hazardous waste from this container to a container that is in good condition or manage the waste in some other way that complies with the requirements of this part. Specifically, a container of crushed glass located in the storage area had a damaged lid and drum ring.
Corrective Action:	AERC must ensure containers that are found with damage to the container, lid, or drum ring, are managed appropriately and the container or damaged portion of the container replaced. The lid and drum ring of the damaged crushed glass container were replaced during the inspection.

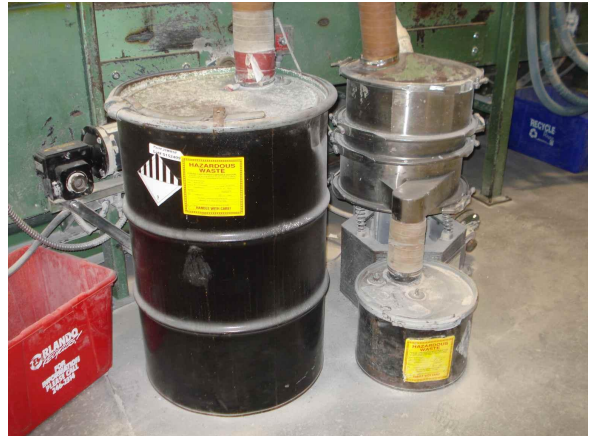
8. Containers collecting waste from processing equipment

labeled "Hazardous Waste" accumulating phosphor powder and a 5-gallon container labeled "Hazardous Waste" accumulating glass fines (Figure 8). Both containers are directly connected to the processing equipment. Lamp end caps drop into a cubic yard cardboard box and glass is discharged into a hopper. The air handler is equipped with high-efficiency particulate arrestance (HEPA) carbon filters. The carbon is replaced as necessary which is typically annually. A Jerome mercury vapor analyzer is used to assist in making that determination.

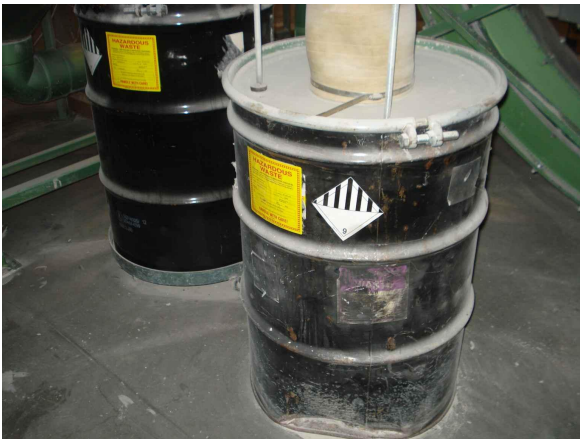
9. Drums collecting phosphor powder from filters

Two 55-gallon drums directly connected to the filter housing were accumulating phosphor powder from the filter blow-down for the vacuum filter (Figure 9). Both drums were properly labeled "Hazardous Waste." One drum was incorrectly marked with an accumulation start date of 3/5/2015. This drum was also dented at the bottom, was not in good condition, and had visible signs of phosphor powder and glass around its base (Figure 10).

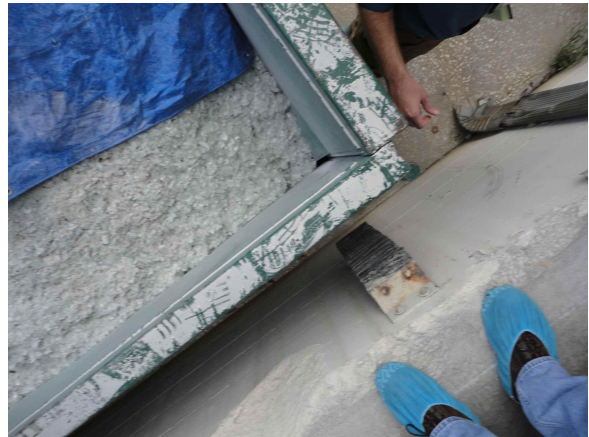
14. Processed glass container gate - not sealed

Outside the processing area bay door is the staging area for the roll-off container accumulating processed glass. The container stores glass generated by the lamp processing equipment. Once sampling of the glass has documented the glass does not exhibit a hazardous waste characteristic of toxicity, the glass is disposed of at a Subtitle D, non-hazardous waste landfill. The tarp that is supposed to completely cover the roll-off container was not adequate and did not meet the requirements of permit condition Part II Subpart B, Specific Operating Conditions Number 1 which requires compliance with Rule 62-730.800(9), F.A.C., which requires containers be closed, covered, and sealed. The tarp was just laying over the glass in the roll-off container (Figure 13). At one end of the roll-off is a door that goes top to bottom and side to side, a gap was visible around the door which would allow rain water to drain out (Figure 14).

Type:	Violation
Rule:	62-737.800(9)
Explanation:	Separated glass and metal that is stored outdoors shall be stored in covered, watertight containers or in a manner that otherwise prevents contact with water and prevents the release of hazardous materials into the environment. Two 20-cubic yard roll-off containers used to store non-hazardous processed glass had tarps that did not cover the roll-off containers. This would allow rain water to enter the containers resulting in a discharge to the environment.
Corrective Action:	AERC must ensure containers storing separated glass and metal outdoors are provided with watertight covers.

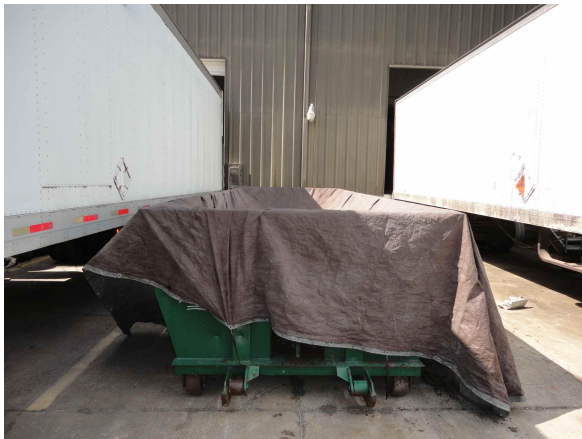
15. Processed glass roll-off container

A second roll-off of crushed glass was noted to the east of the first (Figure 15). The second roll-off was covered with a black tarp but the tarp was stretched and sagging into the roll-off and had multiple holes that will allow water to enter (Figure 16). The tarp was not adequate and did not meet the requirements of permit condition Part II Subpart B, Specific Operating Conditions Number 1 which requires compliance with Rule 62-730.800(9), F.A.C. Storm drains near the loading dock and roll-offs were inspected and no signs of glass were noted entering the stormwater conveyance.

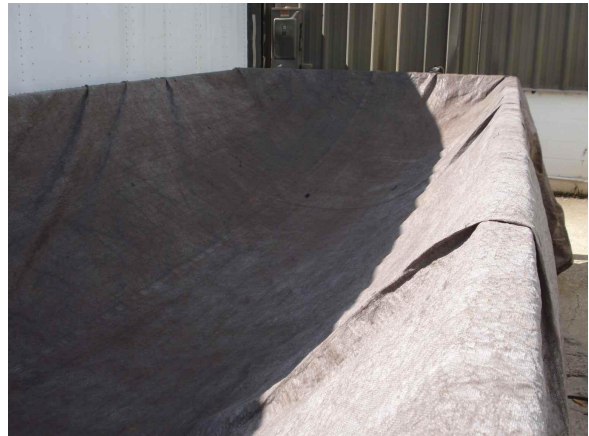
16. Tarp over processed glass container is not water tight
