**Re: Compliance Assistance Offer  
Univar USA Inc.  
EPA/DEP ID: FL0 000 596 866  
Duval County – Hazardous Waste**

**Florida Department of  
Environmental Protection  
Hazardous Waste Inspection Report**

**Facility Name:** Univar USA Inc

**On-Site Inspection Start Date:** 02/28/2017

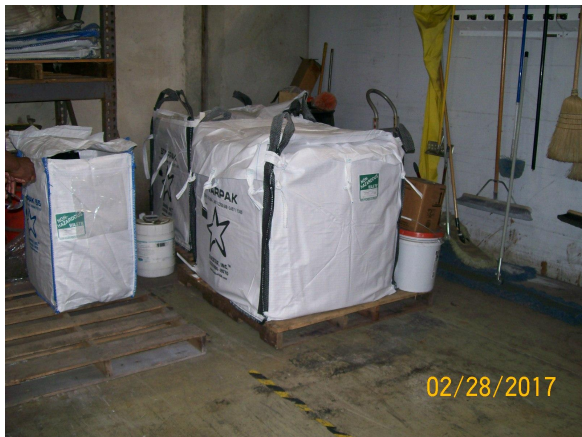
Photo 1 - 90-day waste accumulation area

This area is located in the northwest corner of the Warehouse. Mr. Simms stated that the facility typically holds hazardous waste prior to transfer for less than 24 hours. Univar only picks-up waste on Mondays and Wednesdays and off-site transportation occurs on Tuesdays and Thursdays. At the time of the inspection, there were three non-hazardous waste 'Starpack' polyfiber containers in the area (Photo 1). The facility also stores damaged or expired products and pharmaceuticals for reverse distribution in this area. The damaged and expired products are manifested off-site as hazardous waste with U-code designations as appropriate. The majority of the facility's hazardous waste generated is from expired product. At the time of the inspection, there was no hazardous waste expired product being stored in this area.

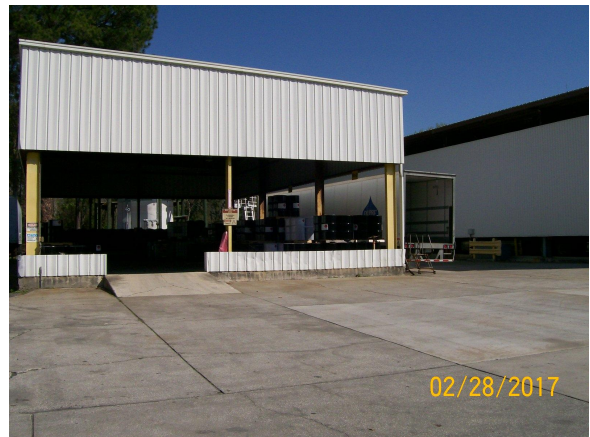
Photo 2 - Storage Yard

The Storage Yard is located outside and to the north of the Warehouse. The Storage Yard is an open bay area used to store flammable products and empty containers to be used for products shipped to customers (Photo 2). There were several pallets of drums and totes of product waiting to be shipped to customers. There were also empty drums and totes stored in this area that will be filled with product or sent for reconditioning. No hazardous waste is generated in this area.

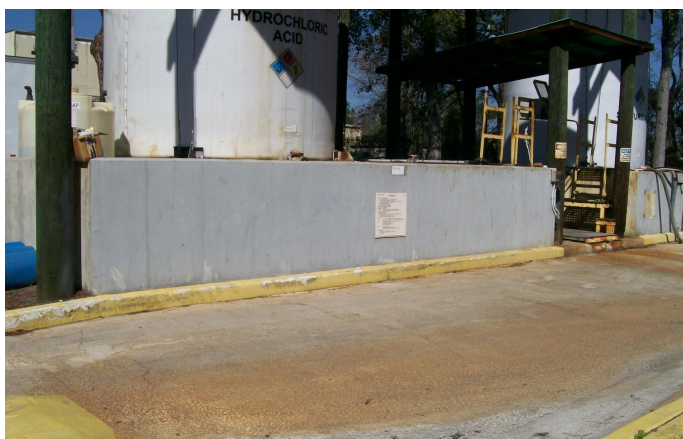
Photo 3 - acid product storage tanks

Located behind the Storage Yard and to the west of the main Tank Farm warehouse are two 8,000 gallon acid product storage tanks. Both tanks are located inside secondary containment (Photo 3). There was water accumulating in both secondary containments from a recent rain event (Photo 4). The pH of the water within the tank secondary containments was tested using pH paper and was found to be neutral. A truck and container loading area in front of these tanks has secondary containment and a catch basin with no discharge outlet. The catch basin is a low point within the containment where any drips or releases are collected and neutralized as needed prior to discharge to city sewer. There was water in the catch basin. The pH of water was found to be 3 when tested with pH paper (Photo 5). The facility is reminded that any drips or releases within the secondary containment should be cleaned up immediately and neutralized to prevent a release of D002 hazardous waste.

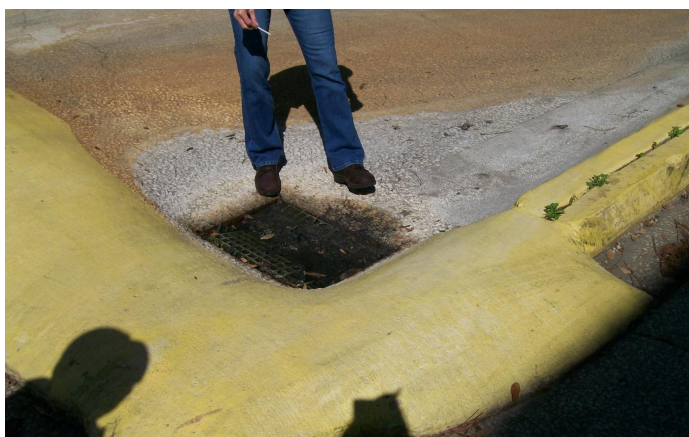
Photo 5 - catch basin within truck loading secondary containment

The main Tank Farm is located outside and to the north of the Warehouse within an open bay warehouse. The Tank Farm warehouse holds 35 tanks, separated into two bays, and a truck loading bay (Photos 6 and 7). Flammable products are stored in Bay 1, and corrosive products are stored in Bay 2. Each tank is located within secondary containment. Satellite accumulation areas (SAA) are located within the warehouse for D001 flammable and D002 corrosive wastes that are typically generated during line flushes for the tanks. At the time of the inspection, there were two 55-gallon D002 hazardous waste satellite drums and one 55-gallon D001 hazardous waste satellite drum within the warehouse. The drums were closed and properly labeled and staged at different SAAs within the warehouse. Two 55-gallon drums of non-hazardous propylene glycol and one "Starpack" polyfiber container of used oil spill debris were also located within the warehouse.

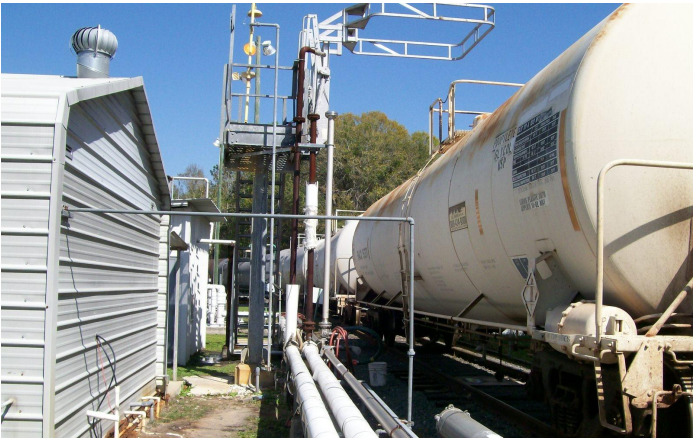
Photo 8 - Rail Car Area

This area is located to the northeast of the main Warehouse and east of the Tank Farm warehouse. Products arrive on rail cars that are parked in this area until the product is offloaded to tanker trucks. During offload, the operators place 5-gallon buckets underneath the hose connections to collect any drips when the hoses are disconnected. At the time of the inspection, several rail cars were parked in this area after products had been offloaded. No waste was observed in two buckets in the area, and no stained soils or evidence of spills were observed at the time of the inspection.
