**Re: Perma-Fix of Florida, Inc**  
**EPA/DEP ID: FLD 980 711 071**  
**Alachua County – Hazardous Waste**

Department personnel conducted a compliance inspection of the above-referenced facility on May 4, 2017. Based on the information provided during and following the inspection, the facility was determined to be in compliance with the Department's hazardous waste rules and regulations. A copy of the inspection report is attached for your records. Any non-compliance items which may have been identified at the time of the inspection have been corrected.

**Florida Department of  
Environmental Protection  
Hazardous Waste Inspection Report**

**Facility Name:** Perma-Fix Of Florida Inc

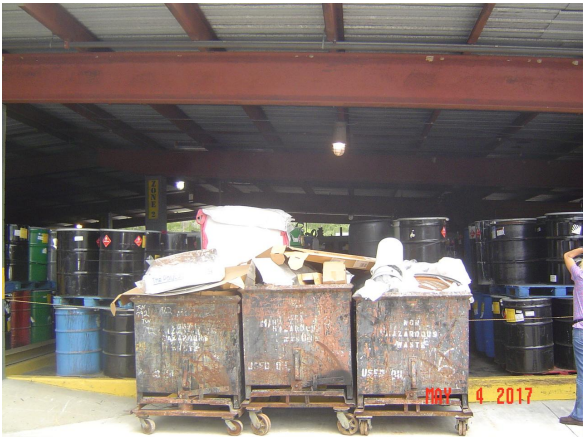
Photo 1 - PSB

The area is not enclosed but is under a roof and has a containment system and concrete curbing with three different zones for storage of waste. This storage area is permitted to store up to 72,105 gallons of hazardous waste with a maximum container size of 718 gallons that is equivalent to a B-25 box container. At the time of the inspection, this storage area was within its permitted volume capacity and all containers had been accumulating for less than one year as documented in the facility's electronic inventory system.

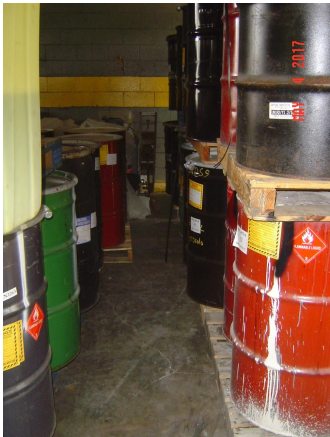
Photo 2 - PSB aisle space & container condition

Drums are moved to different zones within the building for storage and treatment as appropriate. The following activities occur in this area: fuel-blending including phase separation treatment, decanting and bulking of wastes; lab-pack decommissioning; and bulking of chemotherapy and pharmaceutical wastes. The building was near capacity and most of the drums were stacked two high (Photo 1), aisle space was tight and a few of the drums observed were not in good condition (Photo 2). It was recommended to the facility that drums may need to be over packed if the condition is questionable or if waste is on the outside of the drum. The facility was also reminded about maintaining adequate aisle space around the drums.

Type:	Violation
Rule:	264.35
Explanation:	The facility failed to maintain adequate aisle space in the PSB and WSW storage areas.
Corrective Action:	No further action is required. The facility cleared the aisle in the WSW storage area the day of the inspection and the PSB aisle space was cleared prior to the May 17 visit.

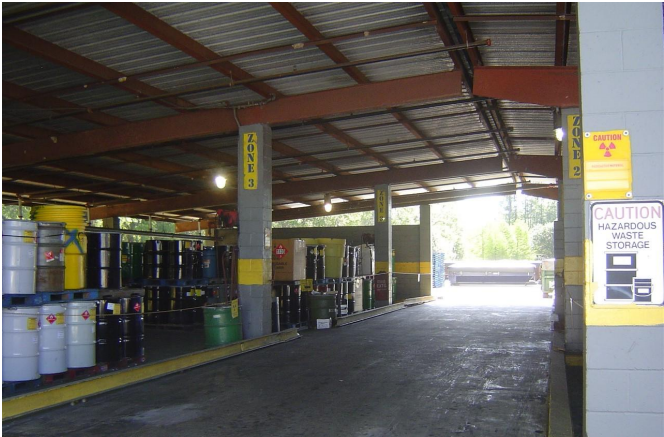
Photo 3 - PSB sampling aisle

An aisle near the middle of the PSB separates Zones 1 and 2 from Zone 3 (Photo 3). Containers are staged here for initial sampling. There was sufficient spill control equipment in this area, but the closest eyewash station was on the opposite side of the building between Zones 1 and 2 and a good distance away from the sampling area. It was suggested to the facility to install an eyewash adjacent to the drum sampling area.

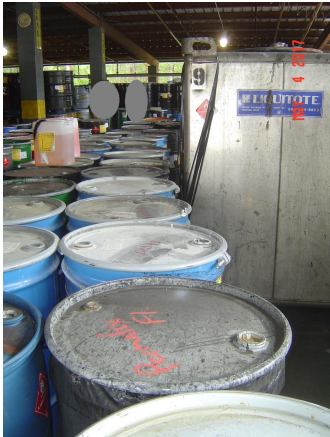
Photo 4 - PSB aisle space

Zone 2 is used for storage and bulking of chemotherapy, pharmaceutical and other non-infectious medical waste for transfer off-site. At the time of inspection, several pallets of waste were staged in the middle of the space for off-site shipment the following day and aisle space in this zone was tight. Mr. Singleton stated that this pre-staging only occurs the day before a shipment, and the area was cleared and accessible during the visit on May 17, 2017.

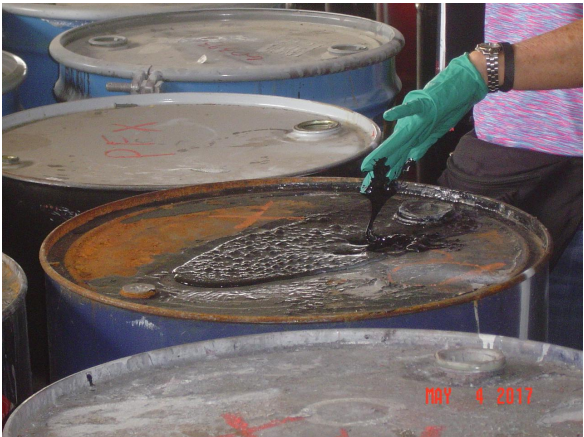
Photo 5 - PSB waste on top of container

Zone 1 and a portion of Zone 2 are used to stage containers for bulking of liquid hazardous wastes. The facility pumps the liquid waste from the drums via an overhead pumping/dispensing system into poly or stainless totes or tanker trucks. Bulking of waste usually occurs the later part of the week to allow for Monday or Tuesday shipment. The drums staged in the Zone 1 area were being pre-staged for shipment on the following Monday, but the facility failed to ensure adequate aisle space in this area (Photo 4) [40 CFR 264.35]. Additionally, there was a small amount of liquid waste on top of one of the drums (Photo 5) [40 CFR 264.171].

Type:	Violation
Rule:	264.171
Explanation:	The facility stored hazardous waste in containers that did not appear to be in good condition in the following areas: 1) One container in the PSB had spilled hazardous waste on the lid. 2) One container in the LSV-WSW was significantly dented.
Corrective Action:	No further action is required. The facility made the following corrective actions during the inspection: 1) In the PSB, the spilled hazardous waste was cleaned-up and the container was inspected to ensure it was in good condition. 2) In the LSV-WSW, the dented container was over-packed.

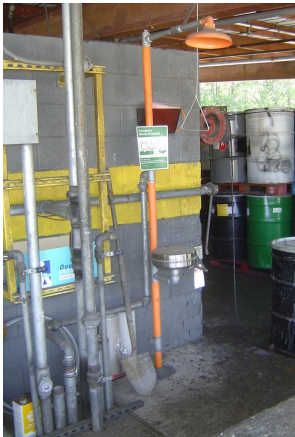
Photo 6 - PSB eye wash

Fire extinguishers were present throughout the storage area, No Smoking signs were posted, adequate spill control and decontamination equipment was available but the eye wash was not completely accessible due to a drum blocking the path (Photo 6). The facility corrected the issue by moving the drum during the inspection.

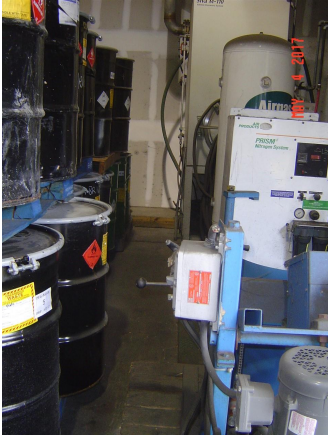
Photo 7 - LSV-WSW aisle space

In a couple of areas, the aisle space was tight (Photo 7), and the facility was reminded that it should provide sufficient aisle space around all containers of hazardous waste. The space should be sufficient for inspections and movement of emergency equipment. Prior to the May 17 visit, the facility re-positioned the equipment shown in the photo to provide adequate space. In addition, one hazardous waste container was found to be in poor condition (Photo 8) [40 CFR 264.171]. The dented container was over-packed during the inspection.

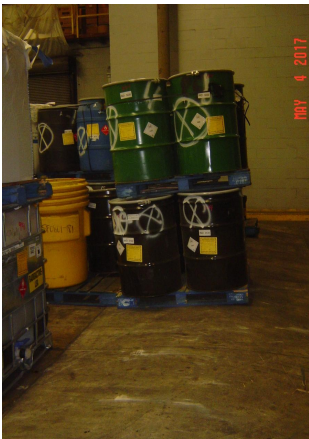
Photo 9 - TOB pallet on containment berm

This storage area has seven zones for different types/classifications of wastes, and it is permitted to store up to 35,200 gallons of hazardous waste with a maximum container size of 718 gallons that is equivalent to a B-25 box container. At the time of the inspection, this area was within its permitted volume capacity and all containers had been accumulating for less than one year as documented in the facility's electronic inventory system. One pallet of containers stored in Zone 9 and one pallet of containers stored in Zone 10 were staged on top of the concrete berm (Photo 9). This is an Area of Concern. The pallet was moved during the inspection, and facility personnel were made aware that wastes should be stored in a manner that minimizes the potential for spills or releases outside the containment system.

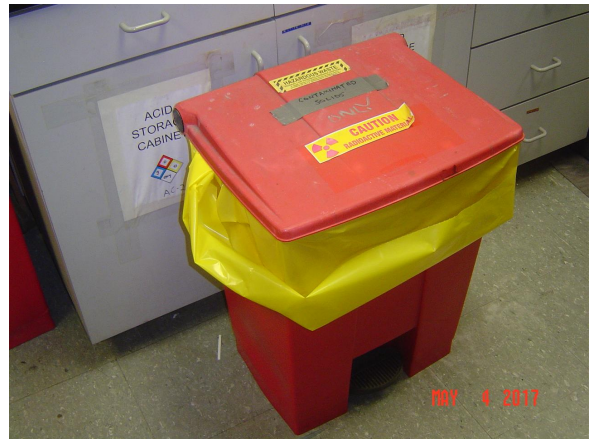
Photo 10 - TOB Chem Lab SA solids container

Lab operations generate waste acid, solvents, solid debris (vials, wipes), and radioactive and mixed wastes. There were eight satellite accumulation containers located in separate areas throughout the lab which were closed and properly labeled (Photos 10 and 11). When full, the waste is either transferred to the lab's <90-day waste accumulation area in the TOB or bulked with similar wastes for fuel-blending. The lab's <90-day accumulation area is located just outside the lab in the TOB. At the time of the inspection, there were three 55-gallon accumulation drums of waste acids, waste flammable liquids, waste vials/solids. The containers were closed, properly labeled and had been accumulating for less than 90 days.
