Re: Bay Line Railroad LLC  
EPA ID No.: FLD984229906  
Bay County

**Florida Department of  
Environmental Protection  
Hazardous Waste Inspection Report**

**Facility Name:** Bay Line Railroad LLC

**On-Site Inspection Start Date:** 09/25/2017

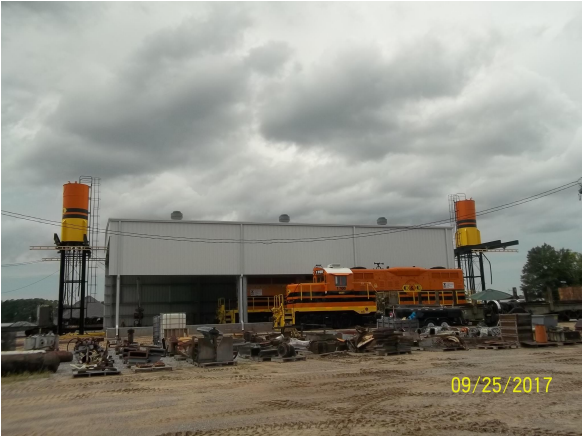
Photo 1 - New Roof Structure

The drains in the maintenance area and refueling/wash station lead to a system of two water/oil separators prior to storage in the used oil tank or discharge into the city sewer system. The first water/oil separator collects residues and the second targets metal concentrations. Oil from the separator goes to the used oil tank and industrial wastewater is discharged to the city sewer system. In an effort to reduce the amount of water sent to the city sewer system and as an NPDES best management practice BAYL installed a new roof and walled structure over the refueling/wash station (Photo 1).

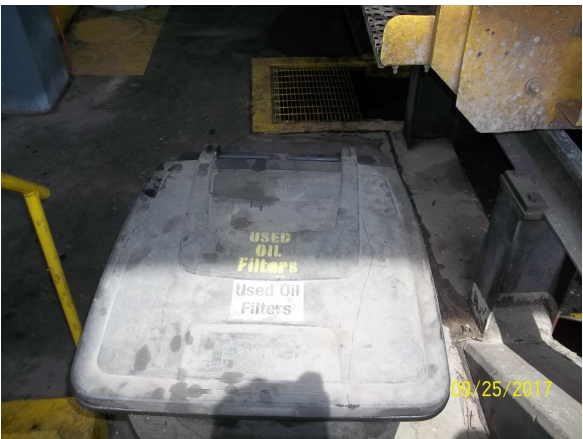
Photo 3 - Used Oil Filters

There was one 55-gallon container of non-RCRA petroleum-impacted sand waste. It was closed and labeled. Used oil filters, pads, rags, etc. were collected in a 3-yard dumpster container. Another 55-gallon container was being used for the collection of used oil filters only. Both containers were labeled and stored indoors (Photos 2-3). One Safety Kleen parts washer was in this building affixed to a 35-gallon drum. There was also a 55-gallon container with a can puncturing device to collect aerosol residues. It was labeled and closed. The empty cans are collected for recycling. No issues were noted.

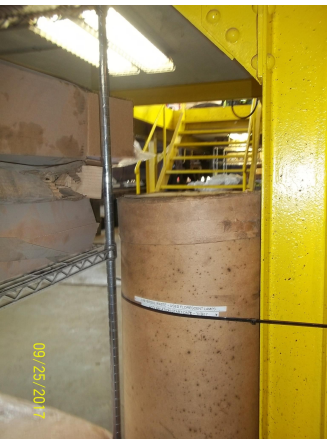
Photo 4 - Universal Waste Lamps

Within this building a portion of the floor is lowered to access the underside of locomotives. Items being stored on the lower deck included a 55-gallon container for paint skimmings within a secondary containment barrel with adequate labeling. The container was securely closed during the inspection. There was also one 4-ft cardboard container of universal waste lamps that was labeled and dated 1/19/17. The container lid was not securely closed but was fixed during the inspection (Photo 4).

Type: Violation  
Rule: 62-737.400(5)  
Explanation: The lid to the universal waste lamp container was not securely closed.  
Corrective Action: The manager fixed this deficiency during the inspection. See Photo 4. This violation was corrected while the inspectors were onsite.

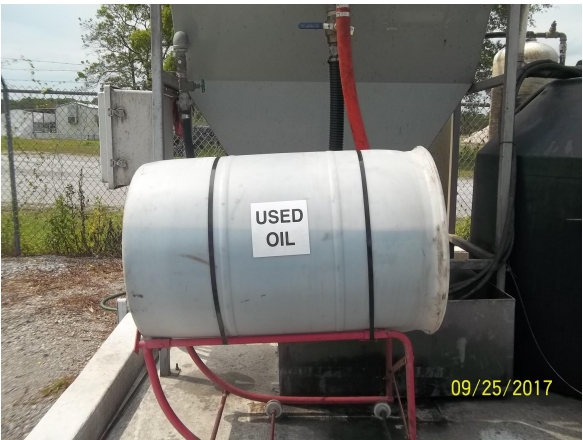
Photo 5 - Labeled Used Oil sludge: water/oil separator

The first water/oil separator is west of the maintenance building next to a gravel road. It consists of the separator unit, two solution tanks, and a 55-gallon drum for the collection of used oil sludges. The whole unit is situated within a sealed secondary containment berm. The 55-gallon drum was not labeled as "Used Oil." Mr. Nunnery corrected this deficiency while the inspectors were on site (Photo 5). The second water/oil separator is located within the refueling/wash station behind the maintenance building. The oil sludge from this unit is diverted directly to the used oil storage tank.

Type: Violation  
Rule: 279.22(c)(1)  
Question Number: 5.4  
Question: Are used oil containers/tanks labeled or marked clearly with the words "Used Oil"? 279.22(c)(1)  
Explanation: One container being used to collect Oil sludges from the water/oil separator did not have a label on it.  
Corrective Action: A label was applied during the inspection. See Photo 5. This violation was corrected.

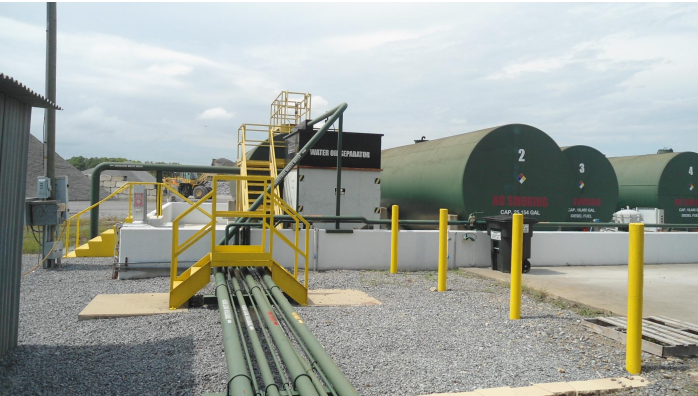
Photo 6 - Tank Storage

This area is referred to as "The Pit" by BAYL employees. The Pit consists of 5 aboveground storage tanks within a sealed concrete secondary containment structure (Photo 6). Materials being stored include diesel fuel and used oil from the water/oil separators. Used Oil is stored in a 15,000-gallon tank. All tanks appeared to be in good condition. No issues were noted.

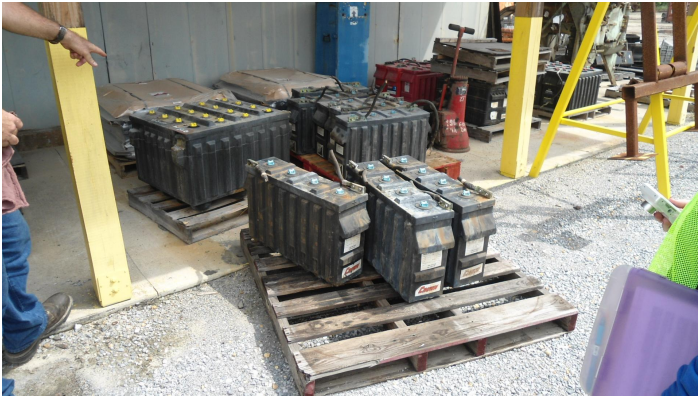
Photo 7 - Locomotive Batteries (Pallet moved under roof on 10/3/17)

BAYL accumulates locomotive batteries on site for recycling. Batteries are stored under a roof structure that is connected to a storage shed southeast from the maintenance building. One pallet of batteries was not fully covered by the roof (Photo 7). The batteries were moved under the roof and photo documentation was provided to the Department on October 3, 2017 via electronic communication.

Type: Violation  
Rule: 273.33(a)(1)  
Explanation: One pallet of locomotive batteries was not protected from the weather or in a way to prevent releases.  
Corrective Action: The batteries were relocated after the inspection and picture documentation of return-to-compliance efforts were provided to the Department via electronic communication on October 3, 2017. This violation was corrected.
