RCRA COMPLIANCE INSPECTION REPORT

Clean Harbors Florida LLC
170 Bartow Municipal Airport
Bartow, Florida 33830

March 22, 2017

SESD's RCRA Organic Emission Monitoring Report

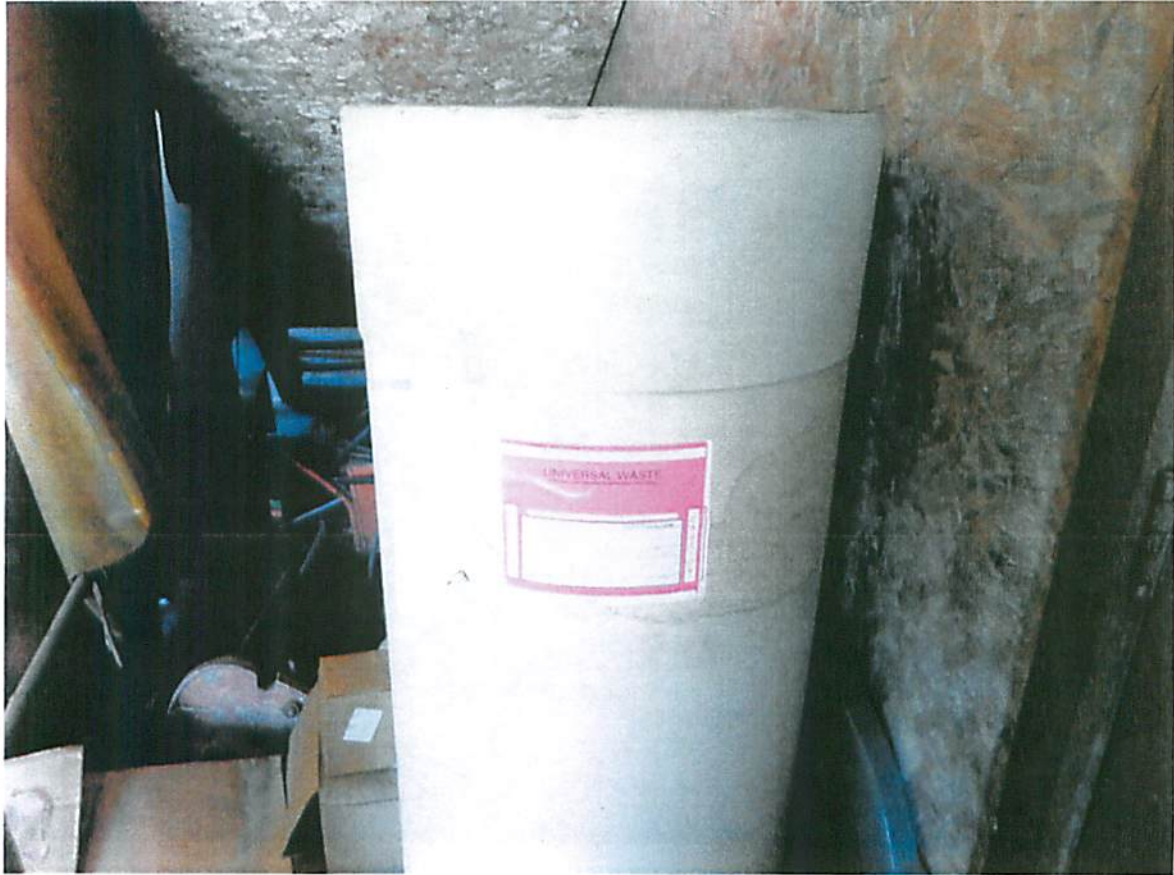
One universal waste fluorescent lamps accumulation container was observed in this building. The container was properly labeled with universal waste labeling and closed; nevertheless, the container was not marked with the accumulation start date (Photo 1). Mr. Bosek indicated that container was going to be dated with the date of the facility's latest universal waste lamps shipment (December 2016).

Photo: 1: Undated universal waste lamps accumulation container in the Maintenance Shop.
Photo taken by Javier Garcia on March 22, 2017, at 10:46 am.

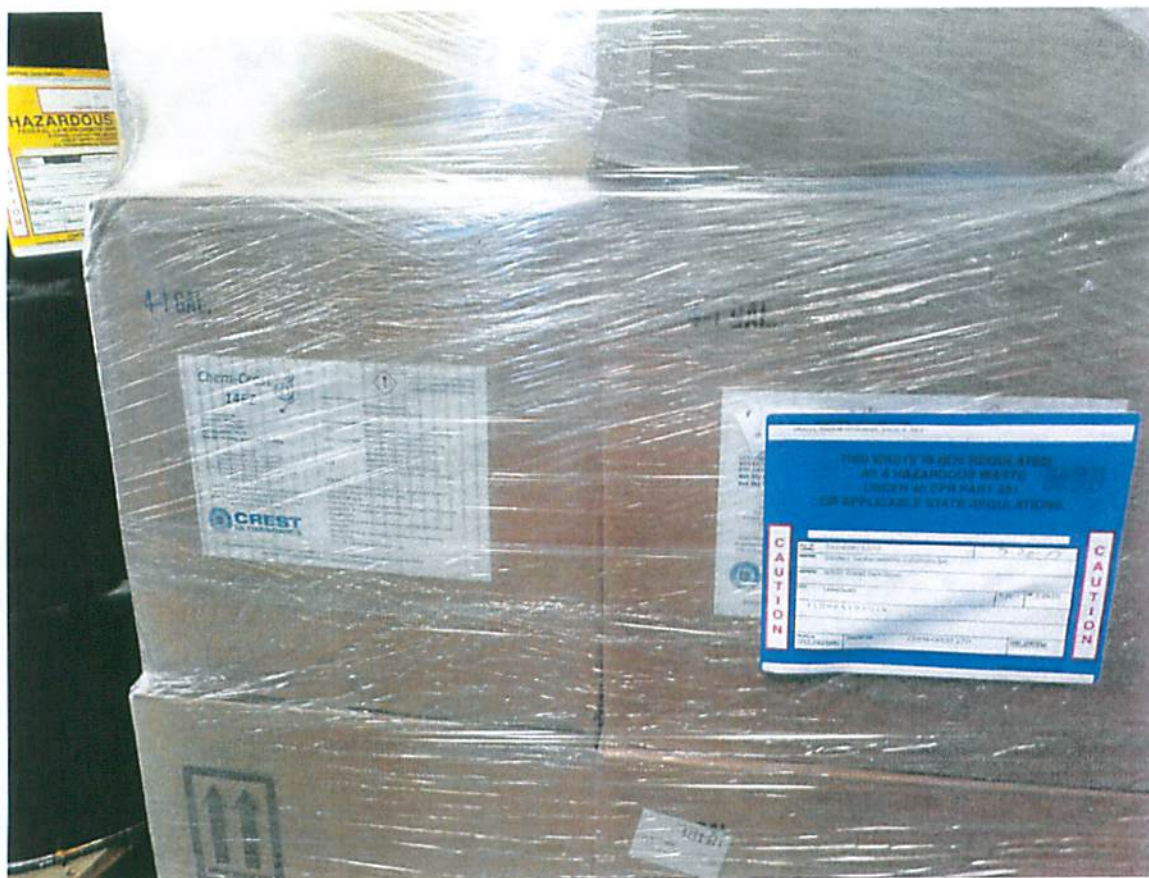
The containers storage unit is divided in 17 self-contained cells, designated as cells "A" through "Q." At the time of the inspection all cells were properly identified and appeared to be in good condition. In Cell G, the inspectors observed a pallet of containers that had been labeled by the generator as non-RCRA material. On the pallet were containers of waste Chem-Crest® 275, an ultrasonic corrosive cleaner (Photos 2 and 3). CHF picked up this waste load from Stryker Sustainability Solutions, Inc. on 3/20/2017 and brought it to the facility the same day. Per its permit, CHF has five working days after receipt of a waste load to verify the contents of the incoming containers. Pursuant to permit condition I.8.g(1), CHF has 15 days to report to FDEP the receipt of unmanifested hazardous waste.

Photo 2: Pallet of containers labeled a non-RCRA material that included containers of Chem-Crest® 275 (D002). Photo taken in Cell G by Javier Garcia on March 22, 2017, at 11:10 am.

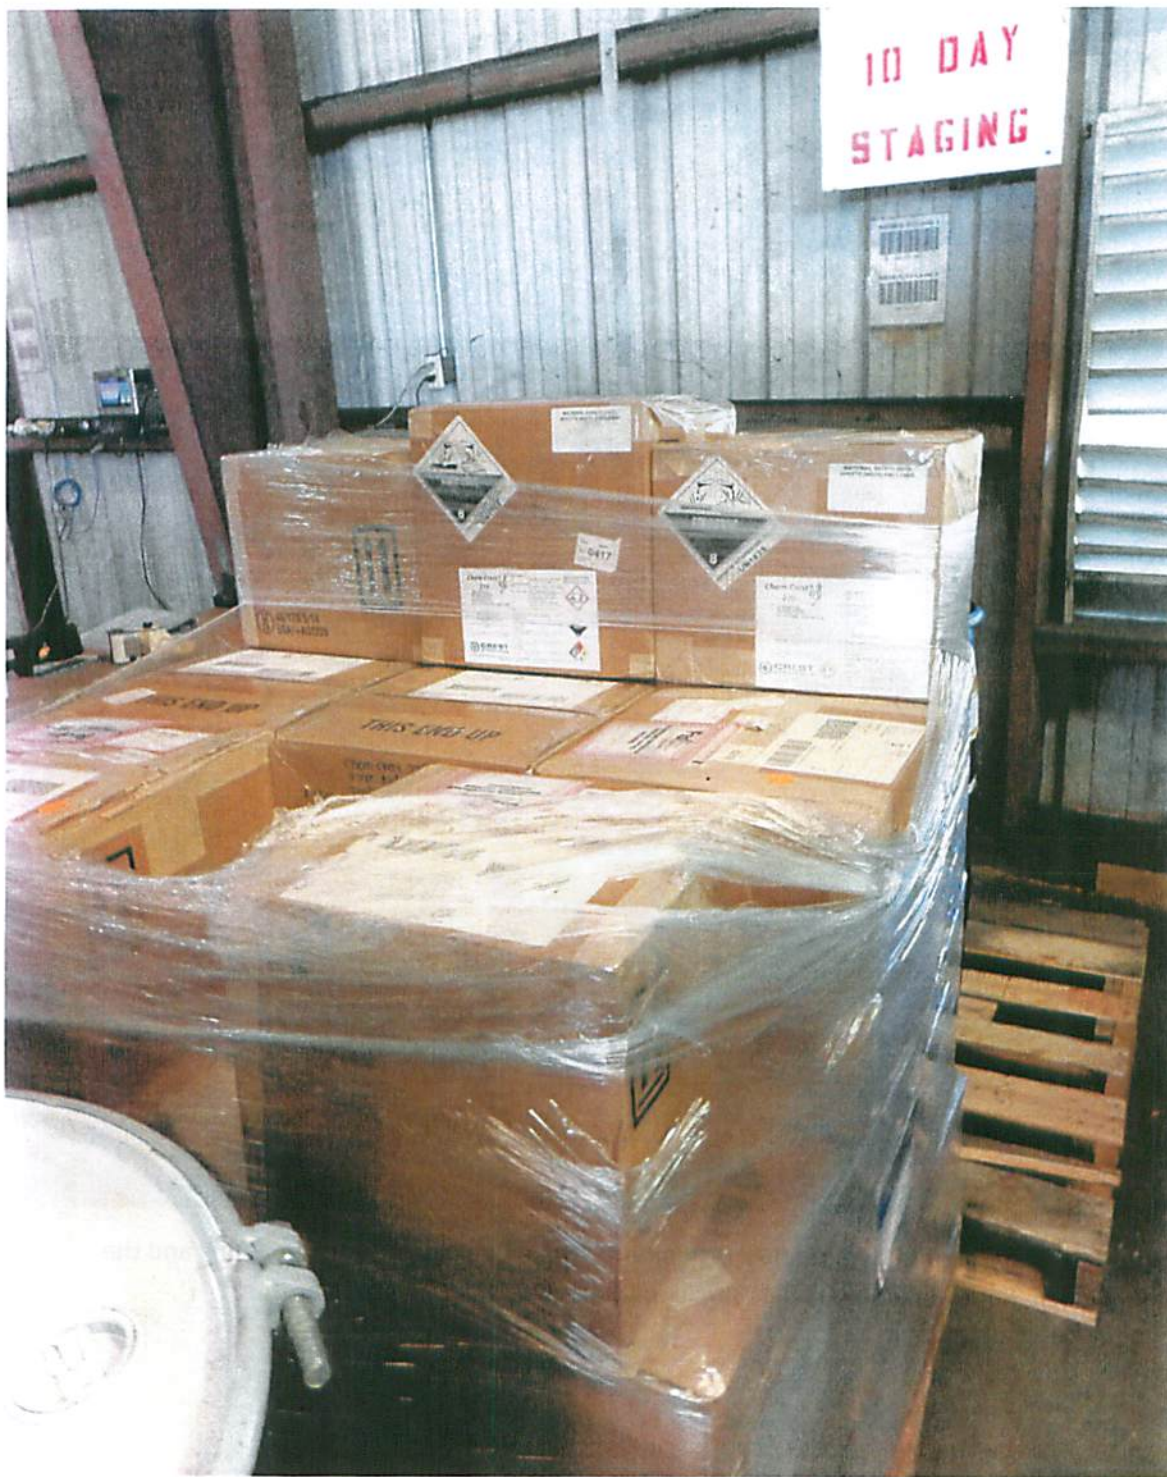
Photo 3: Pallet of containers labeled a non-RCRA material that included containers of Chem-Crest® 275 (D002). Photo taken in Cell G by Javier Garcia on March 22, 2017, at 11:10 am.

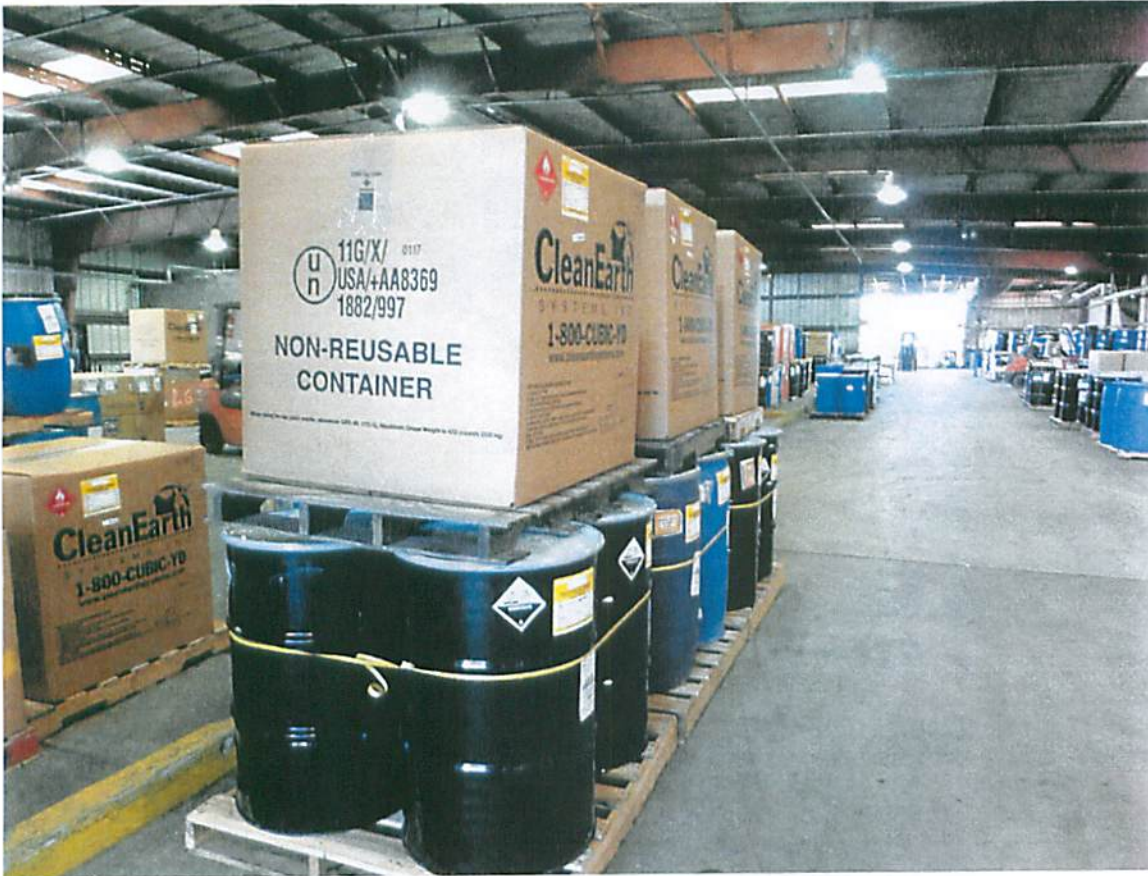
In the aisle between Cell P and the loading dock, the inspectors observed six pallets of hazardous wastes ready to be shipped off-site (Photo 4). No deficiencies were observed in the area.

Photo 4: Pallet of containers ready for shipment. The pallets were between Cell P and the loading dock. Photo taken by Javier Garcia on March 22, 2017, at 11:14 am.

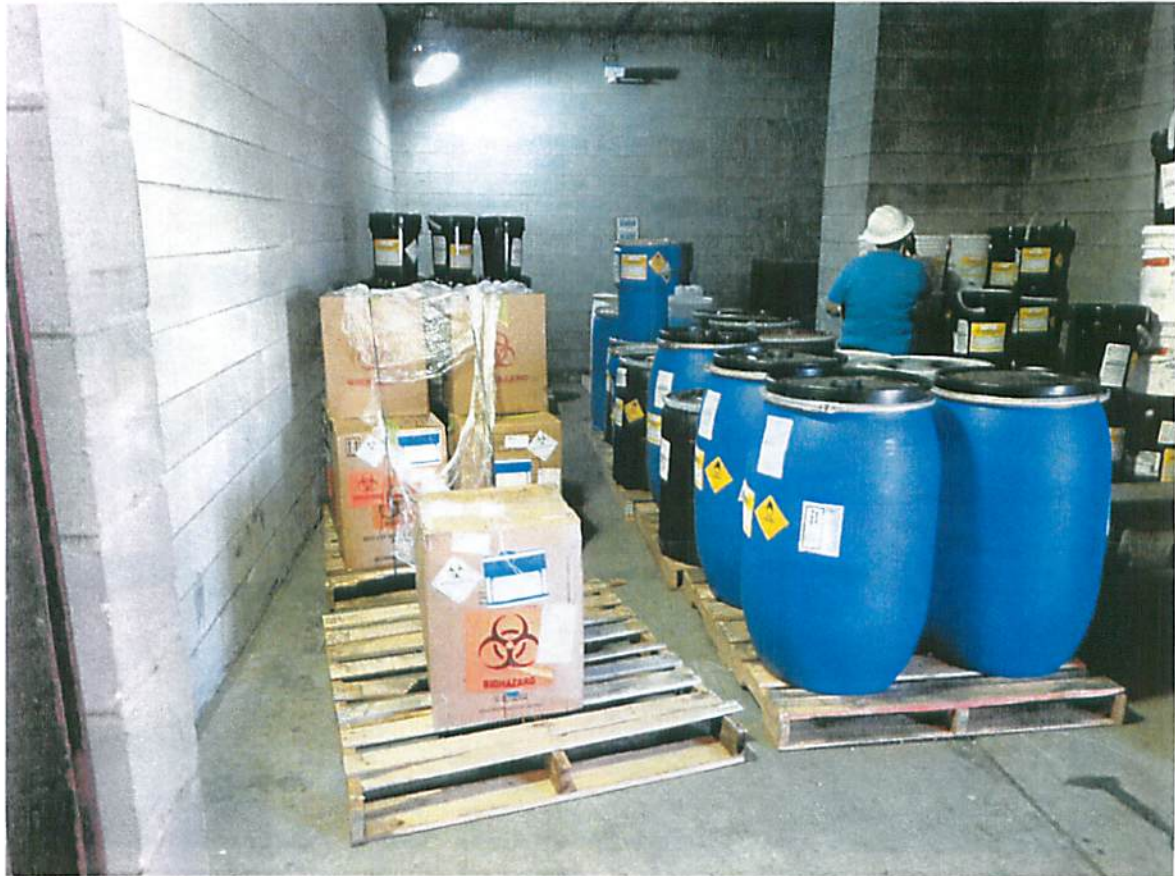
The quantity of hazardous waste within the North Building was within the capacity limits. The containers were segregated based on waste types [universal, D001 (flammable), D002 (acidic or caustic), D003 (reactive), toxics and PCBs]. All observed containers were closed, labeled, dated and appeared to be in good conditions. All the cells had adequate aisle space except for Cell L (area designated for reactive waste storage). The container pallets in this cell were not properly aligned limiting the aisle space (Photos 5 and 6). The lack of adequate aisle space was corrected the same day of the inspection.

Pursuant to permit condition 1.26.c, CHF shall maintain, at a minimum, aisle space to allow the unobstructed movement of personnel, fire protection, and emergency response equipment to any area of the Facility.

Photo 5: Limited aisle space at Cell L of the North Container Storage Area. Photo taken by Javier Garcia on March 22, 2017, at 11:54 am.

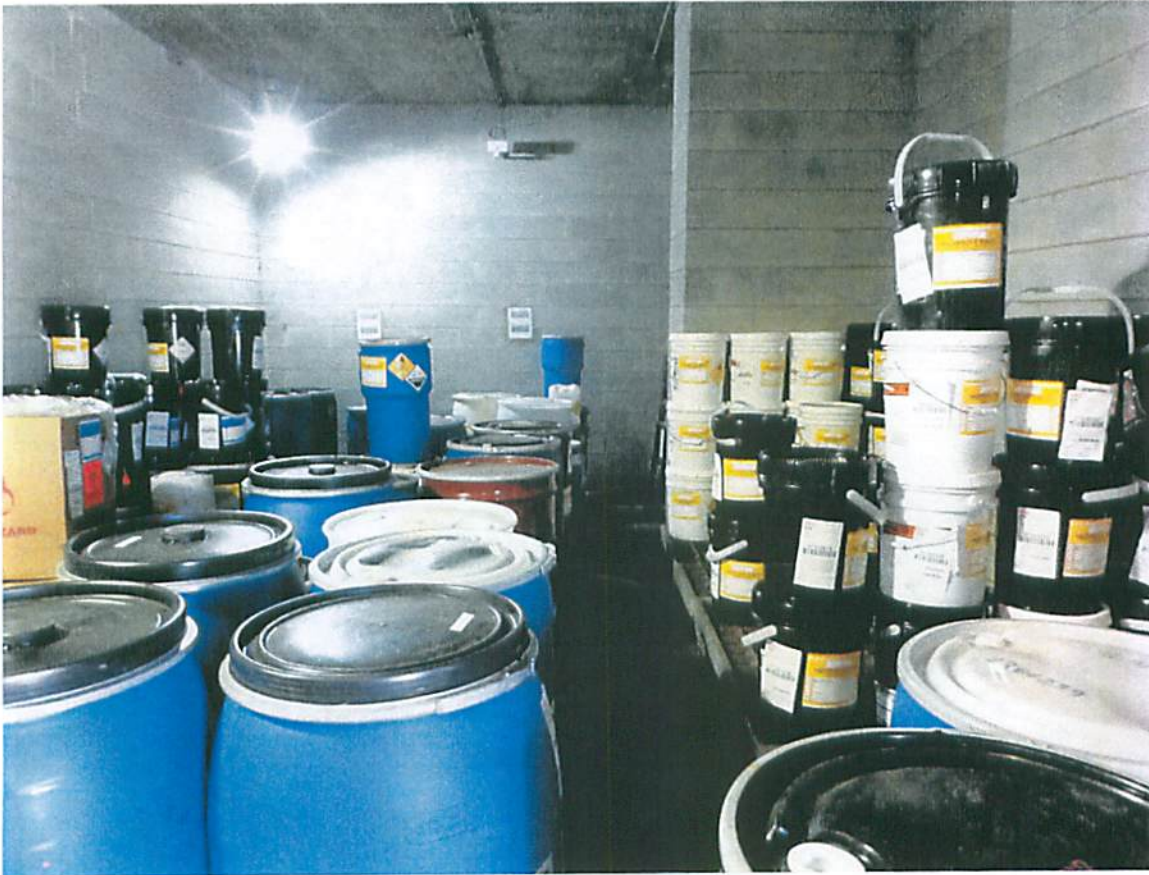
Photo 6: Limited aisle space at Cell L of the North Container Storage Area. Photo taken by Javier Garcia on March 22, 2017, at 11:58 am.

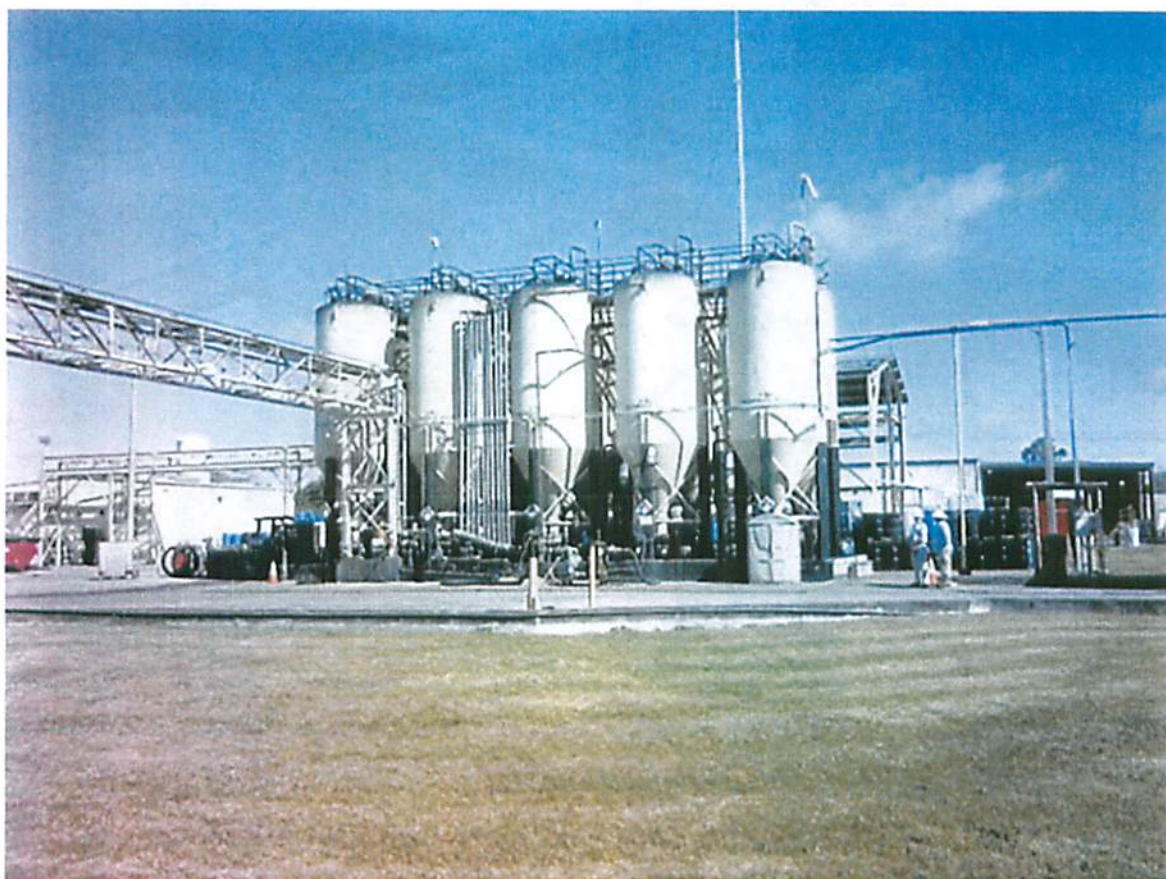
The tank farm has 10 aboveground storage steel tanks. Each tank has a maximum storage limit of 6,000 gallons (Photo 7). During the inspection, the EPA surveyed the tanks and ancillary equipment for fugitive organic emissions with an infrared camera, FLIR® GF-320. In addition, the EPA monitored roughly 170 components of the tank system with a Thermo® Toxic Vapor Analyzer (TVA)-2020 using EPA Method 21. The highest TVA readings were found at the Pressure Relief Devices (PRDs) of tanks T-102, T-101, T-108 and T-109. Fugitive organic emissions of the PRD (tagged 5031) on tank T-102 was initially measured as 830 ppm. The FLIR® GF-320 was used to locate the source of the organic vapors which was identified to be a defective gasket (Photos 8 & 9). Replicate measurements of the PRD (5031) was 1.06% or 10,600 ppm, and 1.1% or 11,000 ppm. The next highest TVA reading was 4,000 ppm and a replicate reading of 4,800 ppm for the PRD tagged 5001 on tank T-101. Also, TVA readings for tanks T-108 and T-109 were 700 ppm and 800 ppm, respectively. The complete air monitoring report is attached to this inspection report. All valves, pumps and threaded connections were tagged and inspected in accordance with the permit. After the inspection, CHF documented that it had repaired the releases.

Photo 7: View of hazardous waste storage tanks T-101 (far right) through T-105 (far left). Each tank has a permitted capacity of 6,000 gallons. Photo taken by Mike Neil on March 22, 2017, at 10:42am.

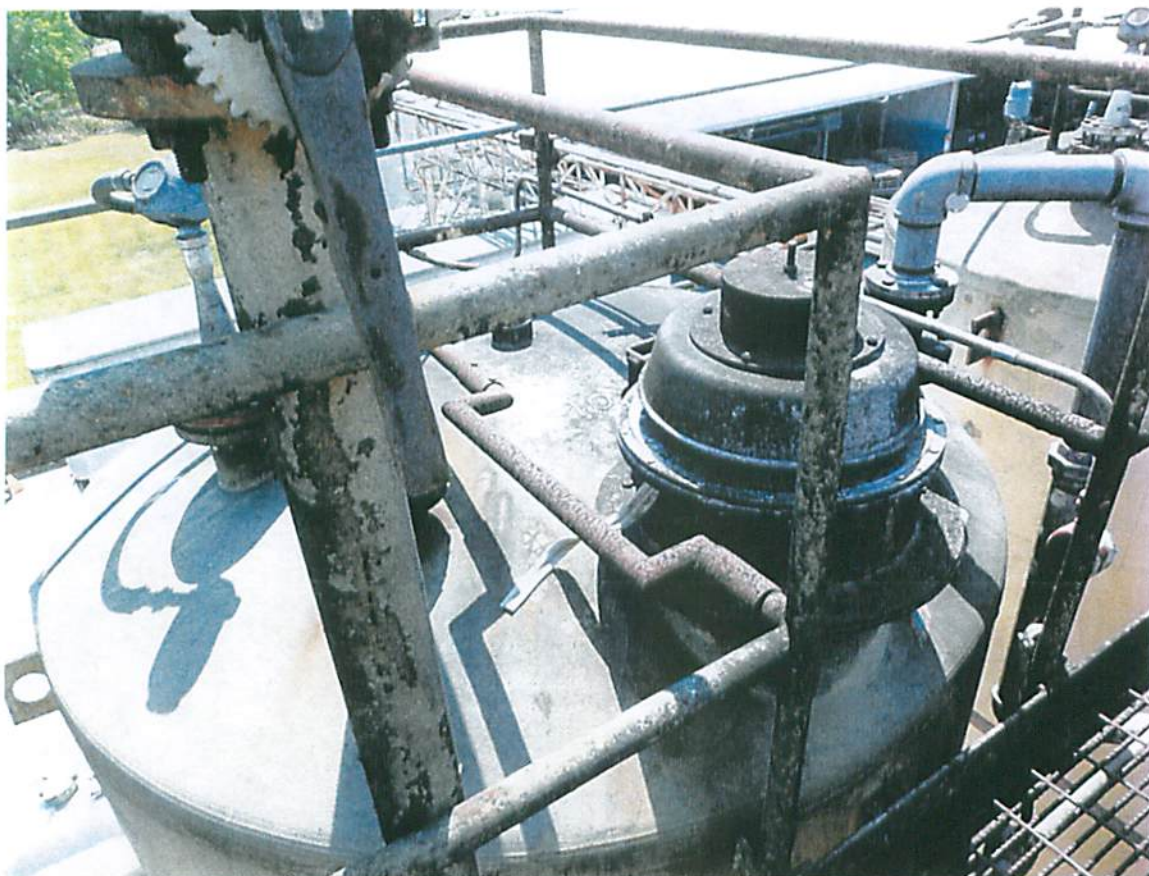
Pursuant to 40 C.F.R. § 264.1084(c), as referred to by permit condition V.3, pressure relief equipment shall be designed to operate with no detectable organic emissions when the device is secured in the closed position.

Photo 8: View of the top section of hazardous waste storage tank T-102. The apparatus on the right of the tank is the tank's pressure relief device. This device was found to be leaking organic vapors at the time of the inspection. Photo taken by Javier García on March 22, 2017, at 2:40 pm.

The highest TVA readings observed occurred at some of the Pressure Relief Devices (PRDs) on top of the hazardous waste tanks. Air monitoring found four of the tank's PRDs, T-102, T-101, T-108 and T-109, exceeded the 500 ppm above background limit listed in Section S of the CHF hazardous waste permit. Fugitive organic emissions of the PRD (tagged 5031) on tank T-102 was initially measured as 830 ppm. The FLIR® GF-320 was used to locate the source of the organic vapors which was identified to be a defective gasket. A video documenting the release is in Appendix A. Replicate measurements of the PRD (5031) was 1.06% or 10,600 ppm, and 1.1% or 11,000 ppm. The next highest TVA reading was 4,000 ppm and a replicate reading of 4,800 ppm for the PRD tagged 5001 on tank T-101. Also, TVA readings for tanks T-108 and T-109 were 700 ppm and 800 ppm, respectively. CHF staff scheduled repairs for the PRDs with detected fugitive emissions for the next morning.

Pursuant to permit condition V.5, observed tanks' defects will be repaired as soon as practicable, but not later than 15 calendar days after it is detected, unless repairs must be delayed until the unit is shut down, and the tank is emptied. A first attempt at repair will be made within 5 calendar days after a leak is detected.

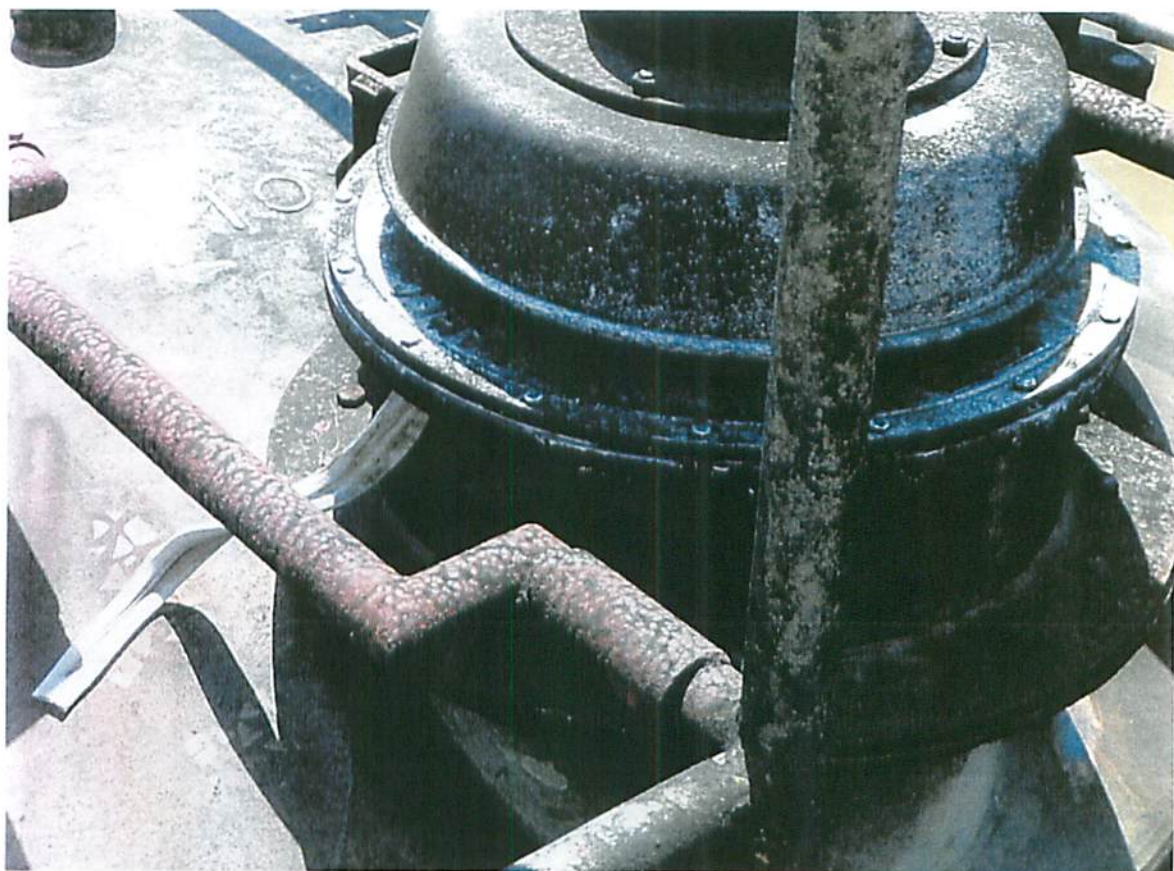
Photo 9: Close-up of tank T-102's pressure relief device that was found to be leaking organic vapors at the time of the inspection. Photo taken by Javier García on March 22, 2017, at 2:40 pm.

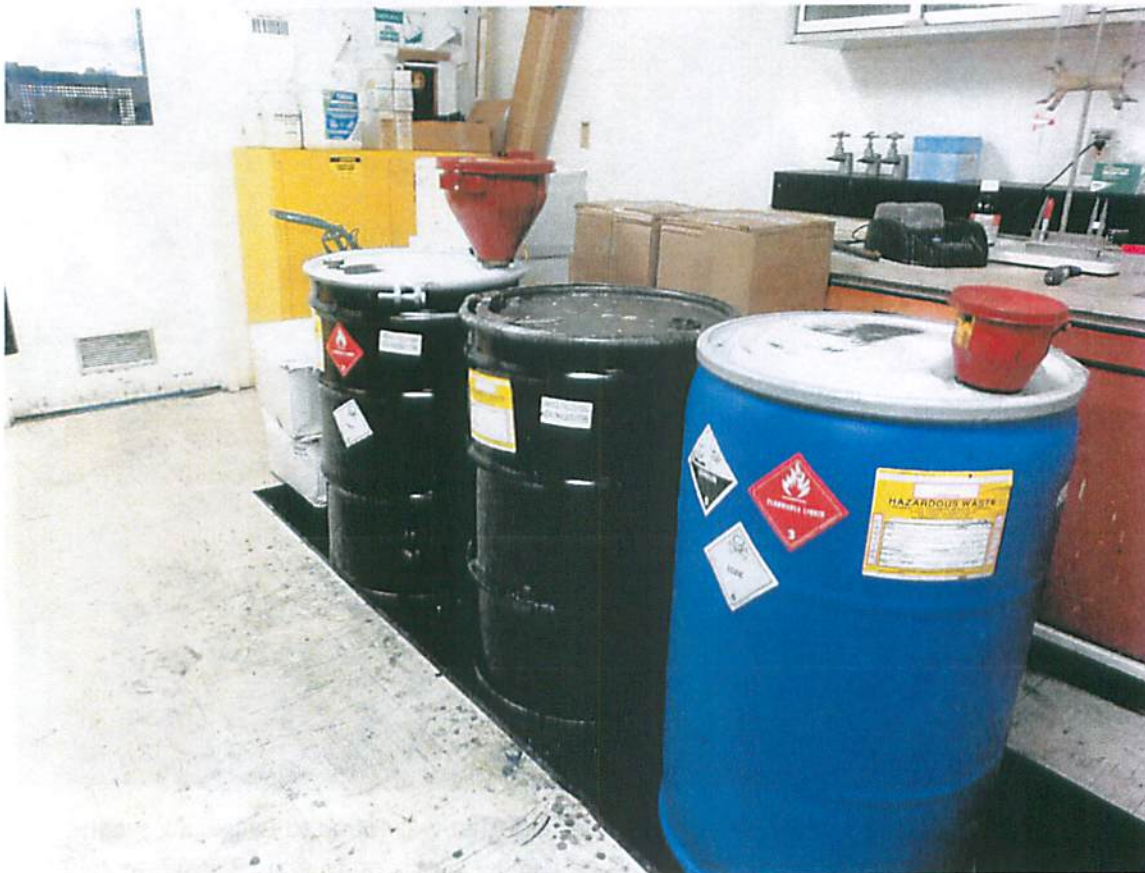
The facility has a laboratory on-site that generated small amounts of various wastes. The inspectors observed three SAA containers for flammable liquids, flammable solids and flammable corrosives. The containers were closed and properly labeled.

Photo 10: Satellite accumulation containers for hazardous waste generated at the facility's laboratory. Photo taken by Javier García on March 22, 2017, at 2:59 pm.

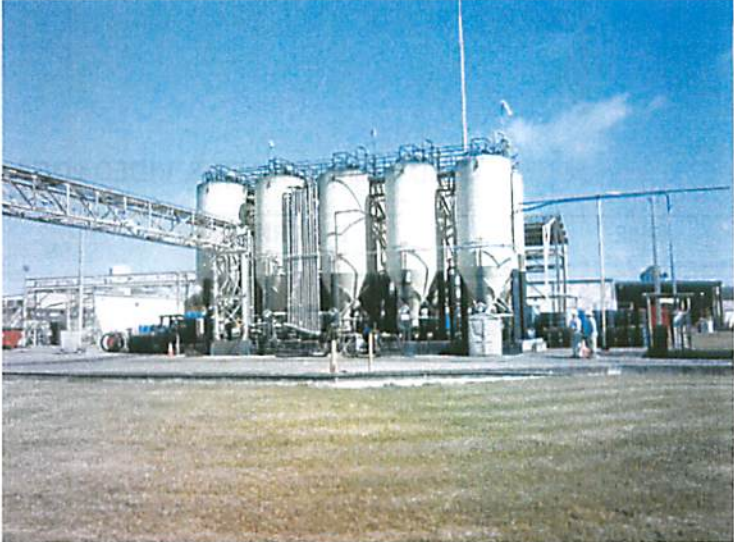
FILE	DESCRIPTION	PHOTO
DC.0024.jpg	<p>Tank Farm: Hazardous Waste Tanks –</p> <p>T-101 (far right) through T-105 (far left)</p> <p>Each tank has a capacity of 6,000 gallons</p> <p>Time: 10:42</p>

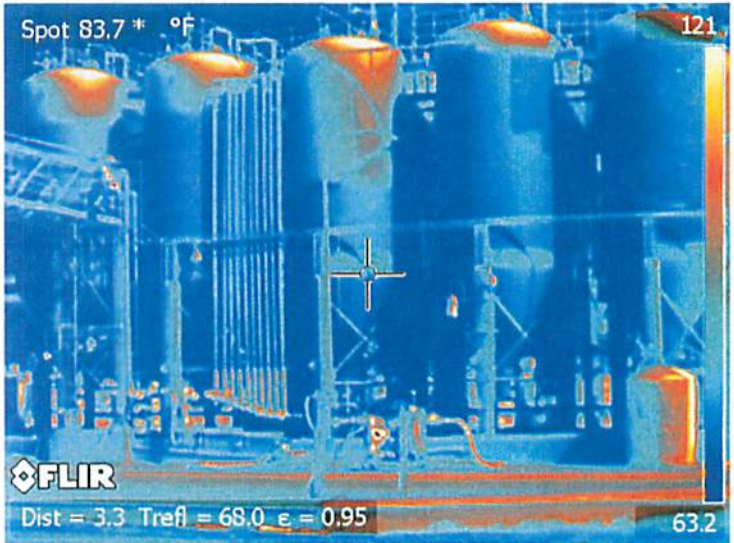
IR-0025.jpg	<p>Infrared image of hazardous waste tanks</p> <p>T-101 – T-105: The middle tank T-103 is approximately ½ full while all other tanks are full.</p> <p>Time: 10:44</p>
