Florida Department of Environmental Protection

Re: Cliff Berry Inc.
EPA/DEP ID: FLR 000 119 784
Duval County – Hazardous Waste

**Florida Department of
Environmental Protection
Hazardous Waste Inspection Report**

Facility Name: Cliff Berry Inc - Jacksonville Facility
On-Site Inspection Start Date: 08/09/2017 **On-Site Inspection End Date:** 08/09/2017
ME ID#: 42441 **EPA ID#:** FLR000119784
Facility Street Address: 1518 Talleyrand Ave, Jacksonville, FL 32206-5436
Contact Mailing Address: PO Box 13079, Fort Lauderdale, FL 33316-0100
County Name: Duval **Contact Phone:** (954) 763-3390

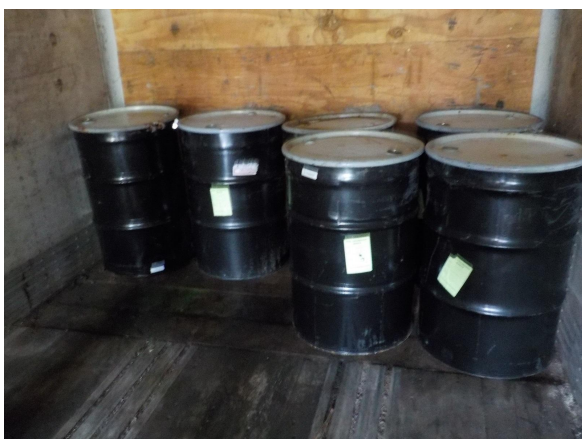
The Waste Storage Area consists of an on-site semitrailer for storage of non-hazardous waste, universal waste and used oil filters received from customers. The facility keeps a log of what drums are inside the trailer and when they were delivered. At the time of the inspection, there were six drums of non-hazardous "oily dirt" waste accumulating inside the trailer (Photo 1). The drums were properly labeled, closed and in good condition.

Photo 1, Six drums of non-hazardous "oily dirt" waste

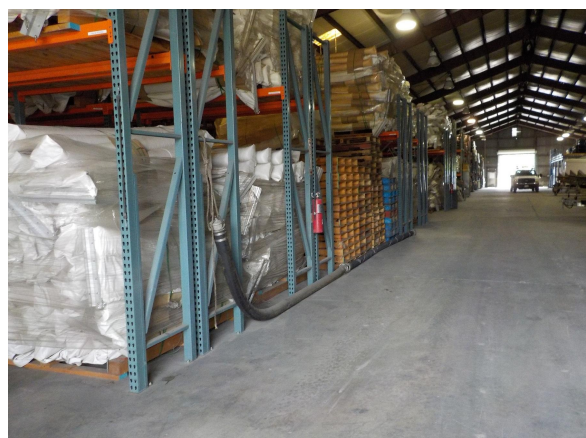
The Large Storage Warehouse is used to store emergency response equipment and materials used in clean-up efforts (Photos 2 and 3). No hazardous waste is generated inside or around the Large Storage Warehouse.

Photo 2, North side Large Storage Warehouse

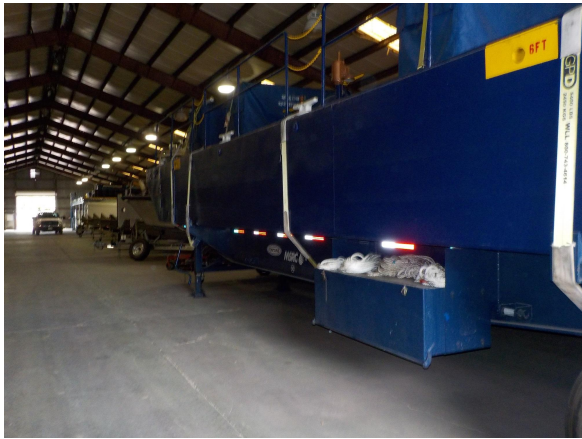
Photo 3, South side Large Storage Warehouse

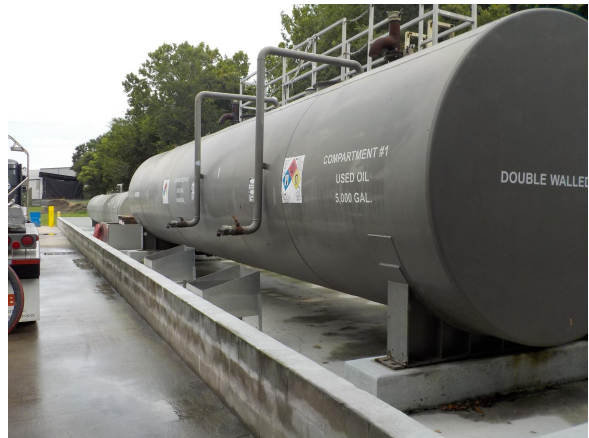
The AGST Area is located adjacent Large Storage Warehouse. There are three double-walled storage tanks located within secondary containment (Photo 4). The tanks are in-line and end-to-end in the order Tank 1, Tank 3 and Tank 2. These tanks are not included in the facility's Used Oil Processing Permit. Tanks 1 and 2 are currently being used for used oil storage of less than 35 days. Tank 3 is currently being used for PCW storage of less than 35 days.

Photo 4, Above Ground Storage Tank (AGST) Area

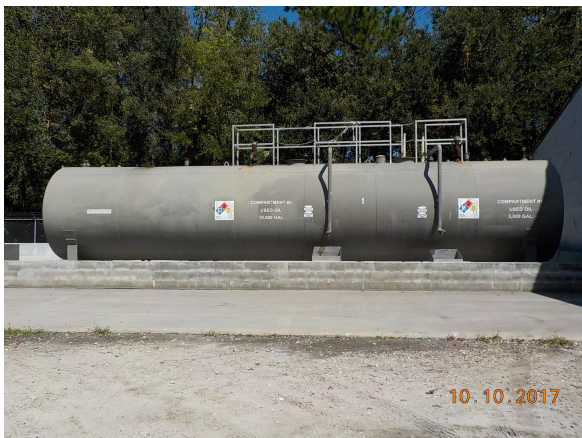
Tank 1 has a 15,000-gallon total capacity divided into two sections (5,000-gallon C-1 and 10,000-gallon C-2) (Photo 5). Used oil is stored for less than 35 days in this tank. According to the facility records, only C-2 has been used for storage to date. Tank 2 has a 4,000-gallon total capacity (Photo 6). Used oil is stored for less than 35 days in this tank. Both Used Oil tanks were closed and properly labeled. The secondary containment

is sealed and adequate for the tanks.

Photo 5, Tank 1 Used Oil

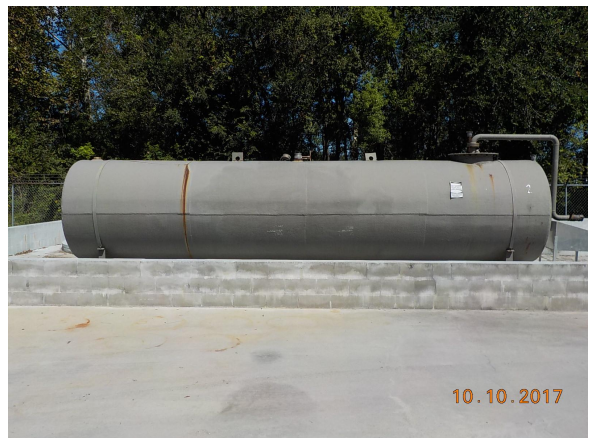
Photo 6, Tank 2 Used Oil

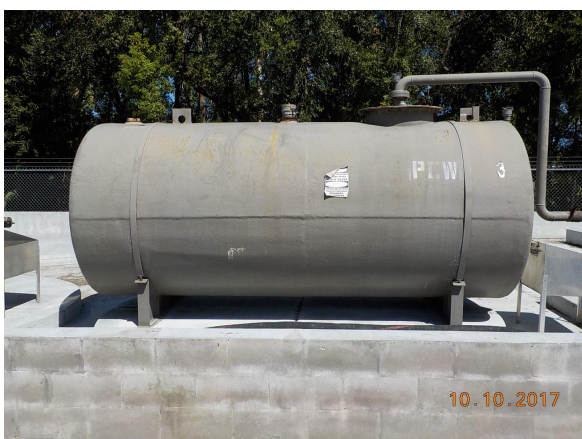
Tank 3 has a 2,000-gallon total capacity (Photo 7). Only PCW is stored inside this tank. The PCW tank was closed and properly labeled. The secondary containment is sealed and adequate for the tank.

Photo 7, Tank 3 PCW

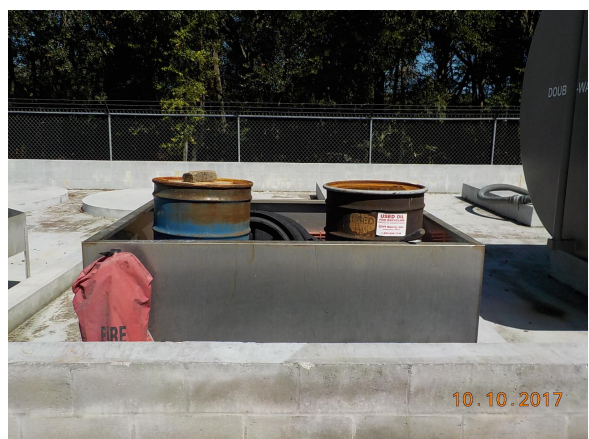
In between Tank 1 and Tank 3 is a staging area for equipment and containers used for off-loading and on-loading operations (Photo 8). There was one 55-gallon drum of product absorbent and rags, one 55-gallon drum of spill clean-up material, two sets of hoses and four empty used oil buckets. When full, the spill clean-up drum is transported to LES.

Photo 8, Storage Area

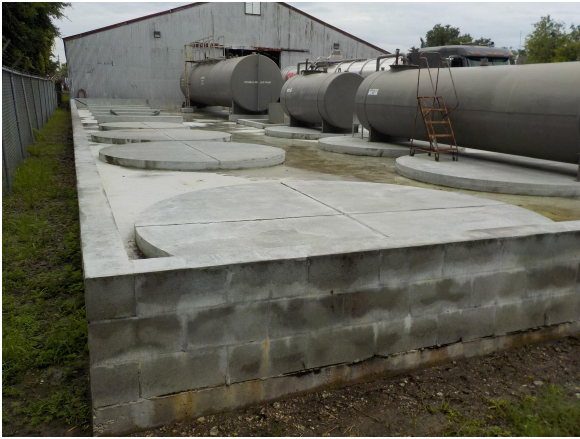
The Used Oil Processing Permit for CBI includes future expansion of the current used oil storage area to include the installation of ten aboveground storage tanks. The secondary containment and the anchor pads for the tanks is complete (Photo 9). Adjacent to the Waste Storage Area are seven tanks that are waiting refurbishment, certification and final installation (Photos 10-14).

Photo 9, New secondary containment with tank anchor pads

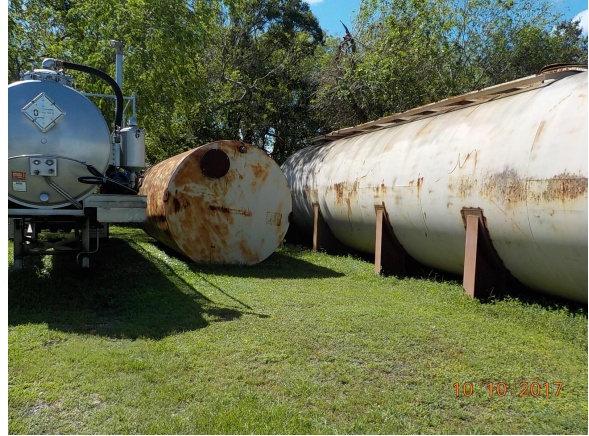
Photo 10, Tanks 1 and 2 of 7 waiting installation

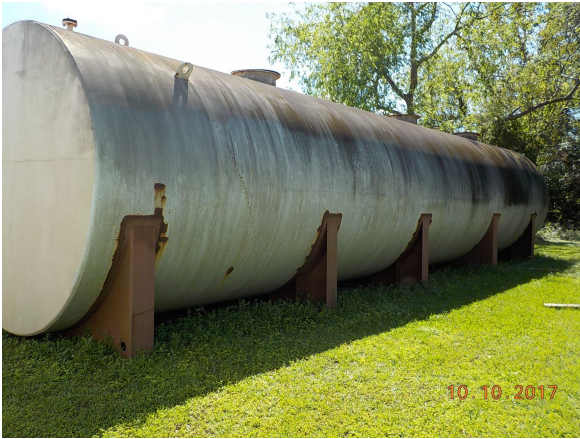
Photo 11, Tank 3 of 7 waiting installation

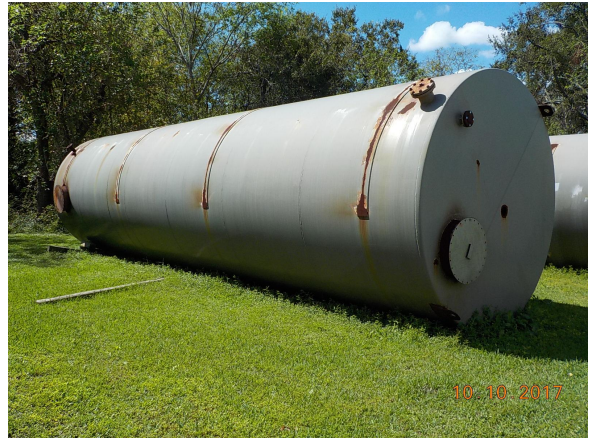
Photo 12, Tank 4 of 7 waiting installation

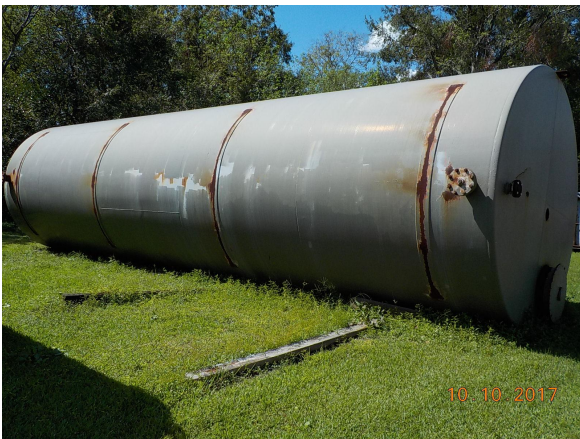
Photo 13, Tank 5 of 7 waiting installation

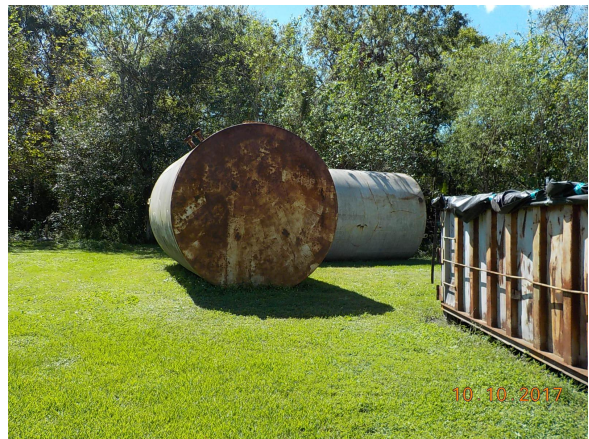
Photo 14, Tanks 6 and 7 of 7 waiting installation
