**Florida Department of  
Environmental Protection  
Hazardous Waste Inspection Report**

**Facility Name:** Lewis Environmental

**On-Site Inspection Start Date:** 10/17/2017

Routine Inspection for CESQG (<100 kg/month) facility

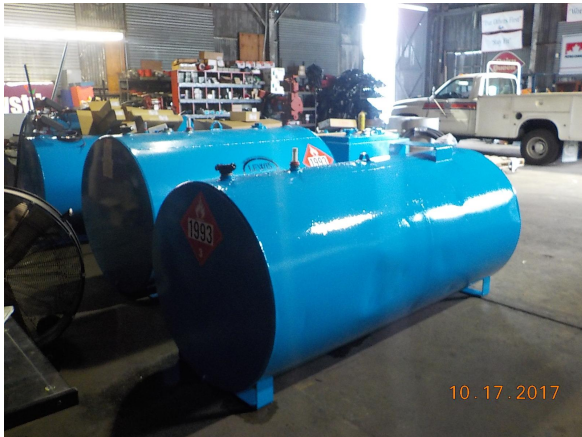
Photo 1 Maintenance Shop

At the Maintenance Shop, newly refurbished tanks are pressurized and quality control checked for function and condition (Photo 1). Mechanical pumps and minor equipment are maintained and repaired inside the Maintenance Shop.

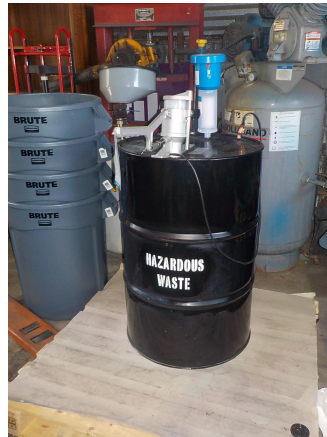
Photo 2 Aerosol Can Puncturing System

Mechanics use Pyroil™ Non-Chlorinated Brake Parts Cleaner occasionally on disposable rags. According to the Safety Data Sheet (SDS), Pyroil™ Non-Chlorinated Brake Parts Cleaner contains 30-50% solvent naphtha (petroleum) light aliphatic, 20-30% methanol, 20-30% acetone, 5-10% toluene, 5-10% carbon dioxide and 1-5% n-heptane. The flash point is 19.94 degrees Fahrenheit. Non-empty aerosol cans are D001 hazardous waste. Waste aerosol cans are collected in a container located inside the Maintenance Shop. Waste aerosol cans are then taken to a 55-gallon drum with an aerosol can puncturing system (Photo 2). Waste shop rags are managed as excluded solvent contaminated wipes. New and used lead acid batteries are also stored inside the Maintenance Shop (Photo 3).

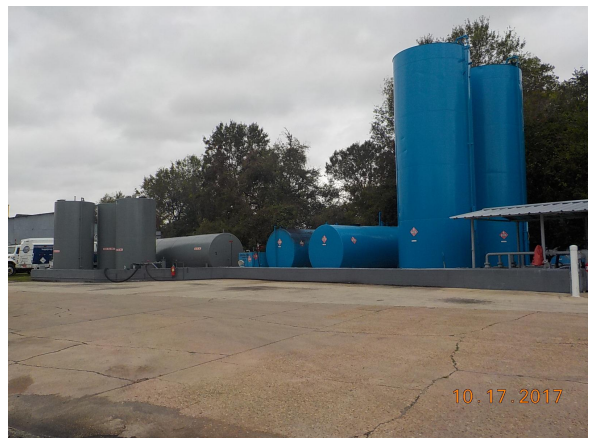
Photo 4 Tank Farm

The Tank Farm area (Photo 4) is divided into two sections, used oil and industrial waste water tanks (Photo 5) and product tanks (Photo 6). In the used oil tank area, there are two 6,000-gallon tanks and one 12,000-gallon tank for used oil (Photos 7-9) and one 6,000-gallon industrial waste water tank (Photo 10). These tanks were properly labeled and were located within secondary containment. The secondary containment had accumulated approximately a half inch of water from recent rain events. The accumulated rainwater had a visible sheen of oil on top (Photos 11 and 12). Mr. Stapp stated that the oily water inside the secondary containment is pumped out and transported to Liquid Environmental Solutions, LLC. for treatment.

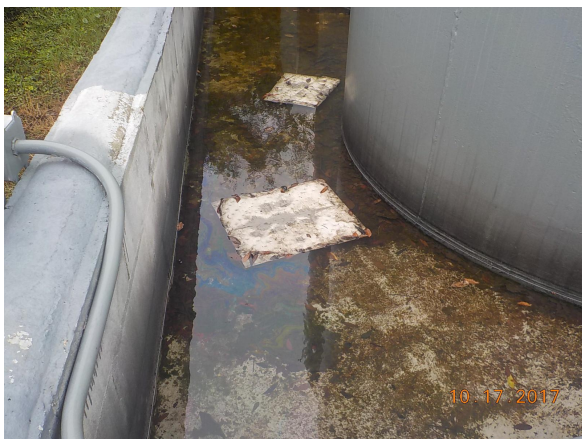
Photo 11 Oily Water Inside Secondary Containment Left Side

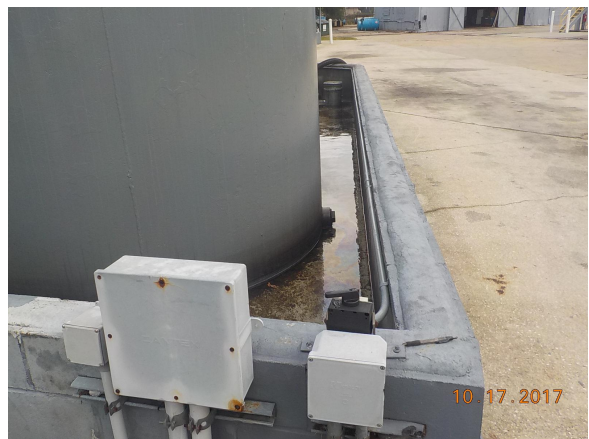
Photo 12 Oily Water Inside Secondary Containment Back

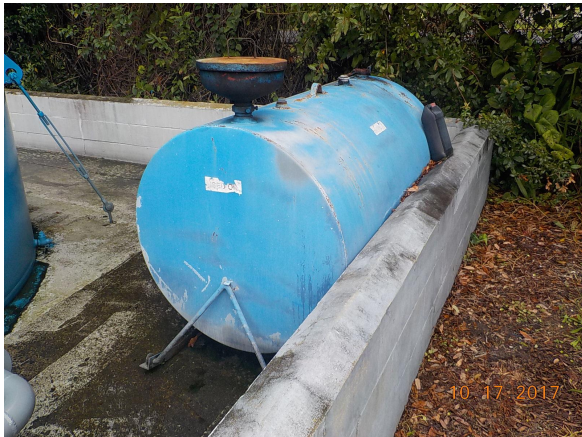
Photo 13 250-Gallon Used Oil Tank

Inside the containment area for the product tanks is one 250-gallon tank for PUOCC used oil (Photo 13). Mr. Stapp stated that this tank is used by customers that bring in small amounts of used oil. The tank was properly closed and labeled.

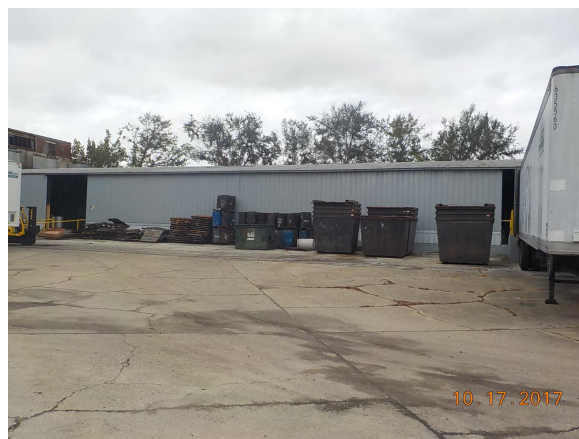
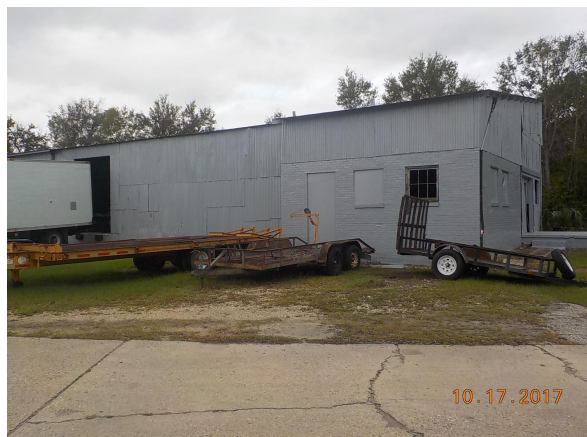
Product oil, lubricants, and supplies are stored in this warehouse for sale to customers (Photos 14-21). In one area of the warehouse (Photos 22 and 23), used antifreeze (Photo 24) and used oil filters (Photo 25) are off-loaded and stored. All containers observed were properly labeled. Used oil filters are removed from the 55-gallon drums upon arrival and placed onto a draining rack. Drained used oil from the used oil filters is collected into a 150-gallon used oil tank (Photo 26). Liquid used oil accumulating inside the bottom of the 55-gallon used oil filter drums is vacuumed out and pumped into the 150-gallon tank. Once drained, the used oil filters are placed back into 55-gallon drums for shipment off-site.

Photo 22 Off-Loading and Storage Area North End

Photo 23 Off-Loading and Storage Area South End

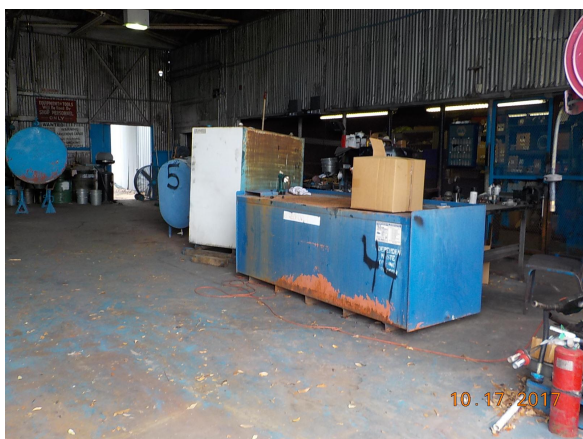
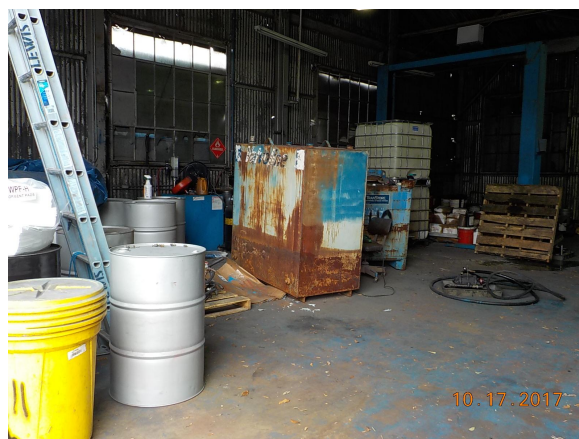
Inside the Tank Painting Area, new and old tanks are painted (Photos 27 and 28). Tanks are painted with Benjamin Moore, Super Spec HP Urethane Alkyd Gloss Enamel Deep Base - P22-3B (Chevron Blue) paint. According to the SDS, the Chevron Blue paint contains 30% hydrotreated heavy naphtha petroleum, 10% distillates petroleum hydrotreated light, 10% titanium dioxide, 5% kaolin, 5% stoddard solvent, 5% xylene,

0.5% ethyl benzene, 0.5% methyl ethyl ketoxime and 0.5% cobalt bis(2-ethylhexanoate). The flash point is 113 degrees Fahrenheit. Waste paint is a D001 hazardous waste. Containers holding paint are used until completely empty and discarded into the trash. Brushes used for painting are placed inside a small container and cleaned with mineral spirits. According to the SDS, 100% mineral spirits has a flash point of 108 degrees Fahrenheit. Waste mineral spirits are a D001 hazardous waste. This waste is poured into a 5-gallon satellite container. The container was properly closed and labeled. When full, the container is taken to the Duval county facility mentioned below. Waste paint brushes and rollers are non-hazardous, allowed to dry and then thrown into the trash. Mineral spirits on disposable rags are used for cleanup. These non-hazardous rags used for cleaning are then thrown into the trash.

Photo 27 Tank Painting Area Right Side

Photo 28 Tank Painting Area Left Side

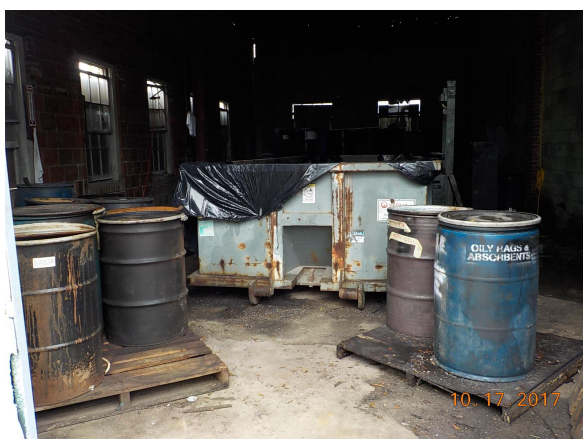
Photo 29 Non-Hazardous Roll-Off

-----  
The facility has a small building that contains one large roll-off (Photo 29). Non-hazardous waste such as oily absorbents, waste rags, used air filters and grease is placed into the roll-off (Photo 30). Once full, the roll-off is sent off-site for disposal.
