SUBJ: RCRA Compliance Evaluation Inspection
Safety-Kleen Systems, Inc. (Tampa)
EPA ID No: FLD 980 847 214

RCRA COMPLIANCE INSPECTION REPORT

Safety-Kleen Systems, Inc. (Safety-Kleen)
5309 24th Avenue S.
Tampa, Florida 33619-5368
Hillsborough County
EPA ID No.: FLD 980 847 271
Permit / Certification Number: 34744-HO -007
Date of Issue: February 21, 2012
Expiration Date: November 23, 2016
Latitude / Longitude: 27°55'33"N / 82°23'69"W
NAICS No.: 562111 – Hazardous Waste Treatment and Disposal
SIC No.: 4953 – Refuse System (Hazardous Waste Treatment and Disposal)

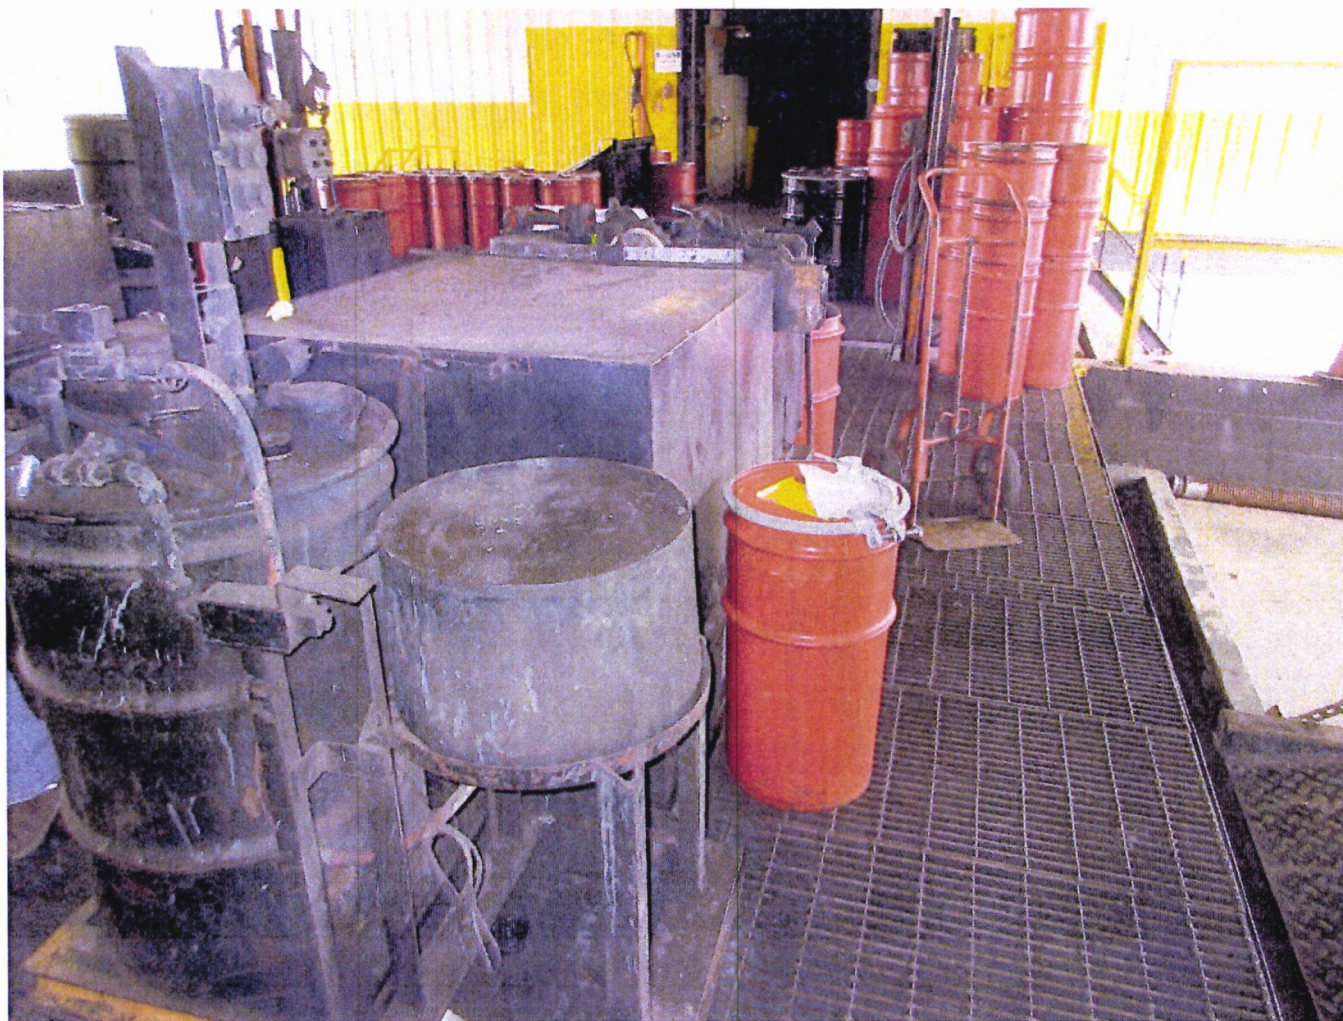
This area of the facility (Photo 1) is designated as a 10 day transfer area for incoming hazardous wastes. Various sizes and types of hazardous waste from incoming vehicles were observed in this area as they waiting on characterization test results before being placed into the permitted storage areas discussed below. One satellite accumulation container of gloves and hazardous containment equipment was observed in this area. The container was labeled with the words "Hazardous Waste" and closed at the time of the inspection.

The facility's dirty solvent reception basin was observed in this area as was the secondary containment area beneath the unit. No spills of hazardous waste were observed on the exterior of the unit or within the secondary containment area.

Photo 1 – Solvent recovery reception bin located on the facility's unloading dock.

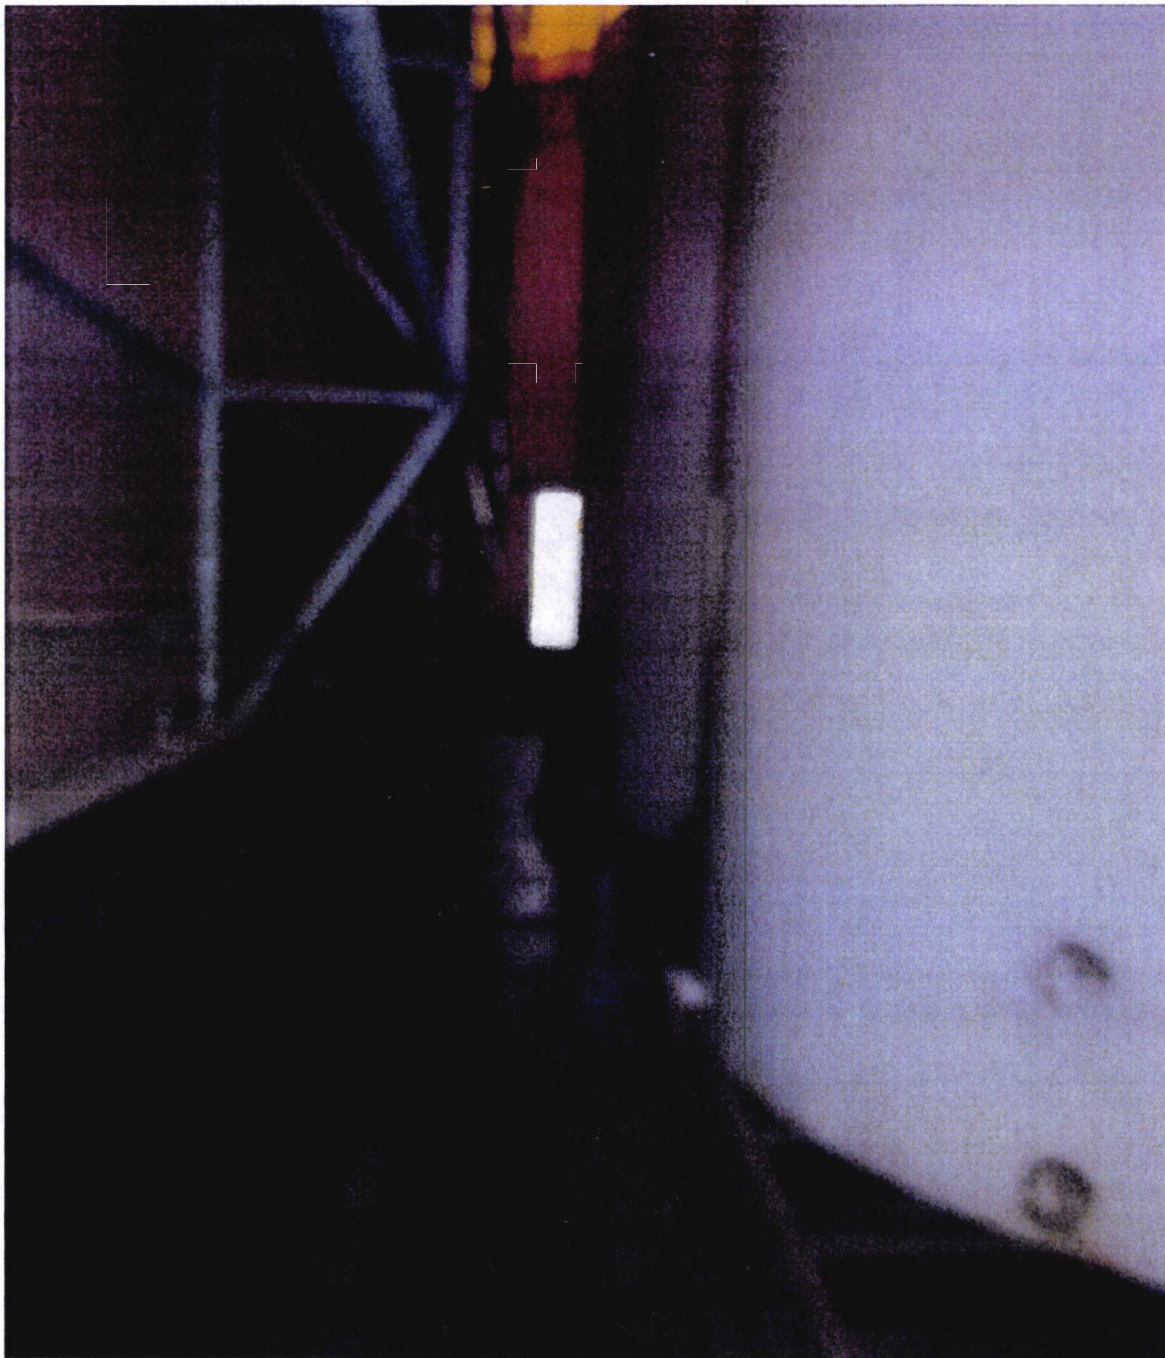
The facility operates a permitted hazardous waste storage tank with a volume of 15,000 gallons. The tank is used to store the facility's hazardous waste flammable solvent generated as part of the facility's recyclable solvent wash recovery program.

The tank is one of three tanks located within a tank farm (Photo 2) consisting of three 15,000 gallon tanks. Each of the tanks is located within a concrete secondary containment system capable of managing the contents of the 15,000 gallon tank. The tanks were labeled with the words "Hazardous Waste" and closed at the time of the inspection. All equipment associated with the 15,000 gallon hazardous waste tank were appropriately labeled with tags for the required air monitoring regulations. The pipe and equipment responsible for the transfer of the hazardous waste solvent from the loading dock to the storage tank (Photo 3) were properly marked.

Photo 2 – Hazardous waste tank storage area
