**Florida Department of  
Environmental Protection  
Hazardous Waste Inspection Report**

**Facility Name:** Heritage - Crystal Clean LLC

**On-Site Inspection Start Date:** 05/08/2018

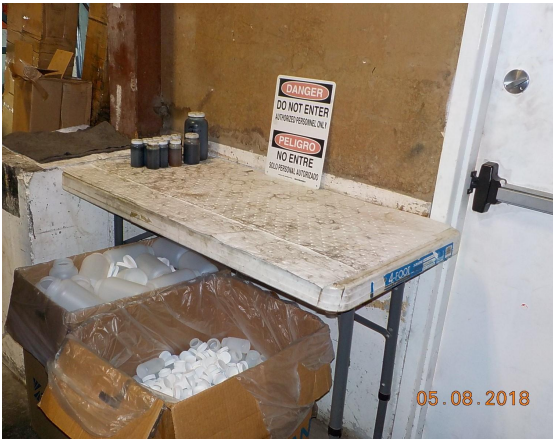
Photo 1

A used oil sample is collected from each customer and a batch sample is collected from the vacuum truck prior to transferring the used oil to Transflo. The samples are kept in the Main Warehouse (Photo 1), described below, for three months in case the receiving facility in Atlanta requests lab analysis. After three months, the used oil is emptied into one of two used oil containers located inside the Main Warehouse (Photo 2). When the containers are full, the used oil is pumped into the vacuum truck. Both used oil containers were closed and properly labeled.

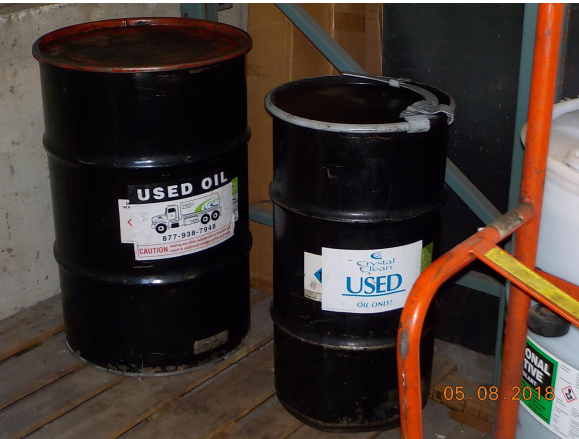
Photo 3

HCC generates a routine wastestream, "Branch Debris," during the transport and transfer of used oil. This wastestream includes solid wastes such as wipes, absorbents, PPE and similar items. HCC manages Branch Debris as non-hazardous waste, but it has not made a hazardous waste determination on this wastestream by having the waste analyzed for hazardous waste characteristics [40 CFR 262.11]. At the time of the inspection, two containers of Branch Debris were accumulating inside the Warehouse. Both containers were closed and labeled as non-hazardous waste. One of the containers was opened for inspection (Photo 3).

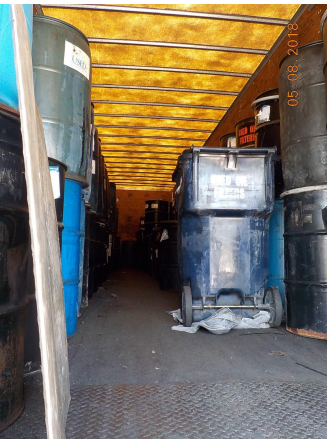
Photo 5

HCC transports hazardous waste in box trucks that return to the facility where the containers are transferred directly from the trucks into one of the semi-trailers located in the Waste Transfer Area described below. At least every ten days, a trailer with new products and supplies is brought into the facility, unhitched and then the trailer with the waste containers is attached to the truck cab and transported to HCC's facility in Atlanta. At the time of the inspection, the trailer contained approximately 20 drums of non-hazardous spent parts washer solvent (Photo 5). No hazardous waste was accumulating in the trailer.

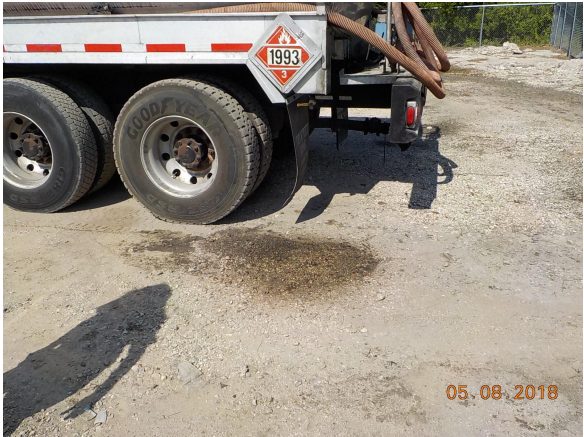
Photo 9

This parking area is located on the northside of the Main Warehouse and adjacent to the facility's northern property fence. The parking lot where the vacuum trucks are parked is unsealed asphalt, loose limerock and dirt. At the time of the inspection, there appeared to be several areas of what appeared to be used oil released in the vicinity of one of the vacuum trucks that had not been cleaned-up (Photos 6-8) [40 CFR 279.22(d)]. The northeast side of the parking lot is used for pump truck and box truck parking. One pump truck and one box truck were parked in the lot at the time of the inspection (Photo 9). All other vehicles were out of the yard for pick-ups or deliveries.

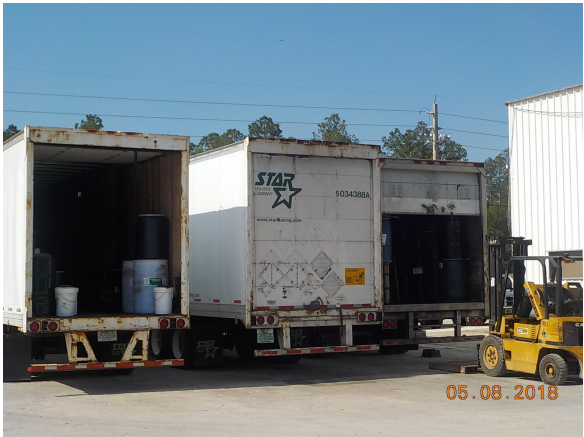
Used oil filters, hazardous waste, non-hazardous waste, universal waste and materials and supplies are transferred directly from incoming trucks into one of three unhitched semi-trailers parked on the east side of the Main Warehouse and southeast of the Truck Parking Lot described above (Photo 10). This area has an asphalt base that appears to be cracked in several areas adjacent to and under the semi-trailers.

The trailer on the left in Photo 10, and described above, is used to accumulate hazardous and non-hazardous wastes, universal waste and spent parts washer solvent. The trailer in the middle in Photo 10 is used to store new parts washer product and supplies (Photo 11). The trailer on the right in Photo 10, and described above, is used to accumulate used oil filters.

Type:	Violation
Rule:	62-710.850(5)(a)
Explanation:	The facility accumulated used oil filters in containers that were not stored on an oil-impermeable surface.
Corrective Action:	In order to return to compliance, the facility should store used oil filters in containers on an oil-impermeable surface.

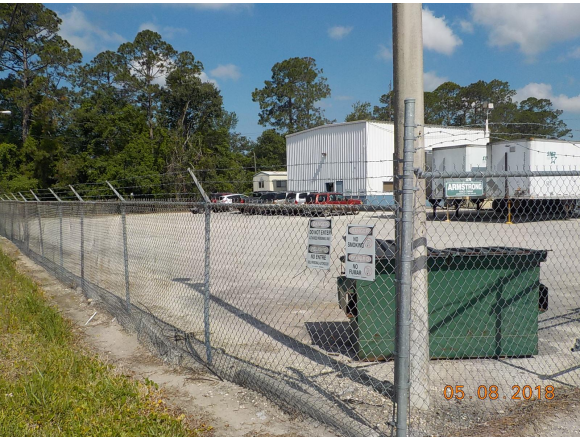
Photo 12

The facility is surrounded by a chain link fence topped with barbed wire. It appeared to be in good condition. The facility is accessed through a main entrance gate that is kept open during business hours when HCC employees are on-site. An exit gate is electronically controlled and motion-activated to open for trucks exiting the facility. Both gates are manually locked at night. At the time of inspection, the main gate was open for business, and the exit gate was closed. Adequate warning signage had been posted (Photo 12).
