Re: JEA Westside Service Center
EPA/DEP ID: FLD 981 027 279
Duval County – Hazardous Waste

**Florida Department of
Environmental Protection
Hazardous Waste Inspection Report**

Facility Name: JEA Westside Service Center

On-Site Inspection Start Date: 06/08/2018

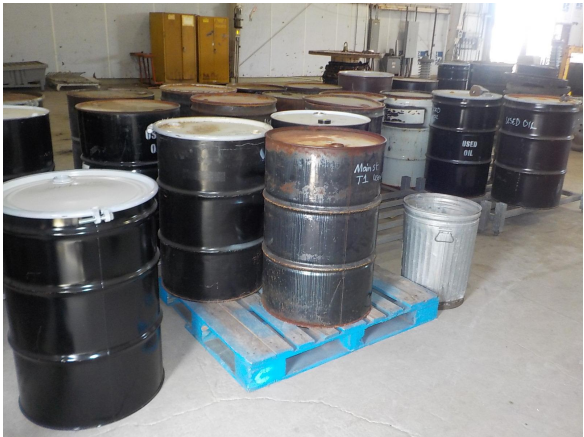
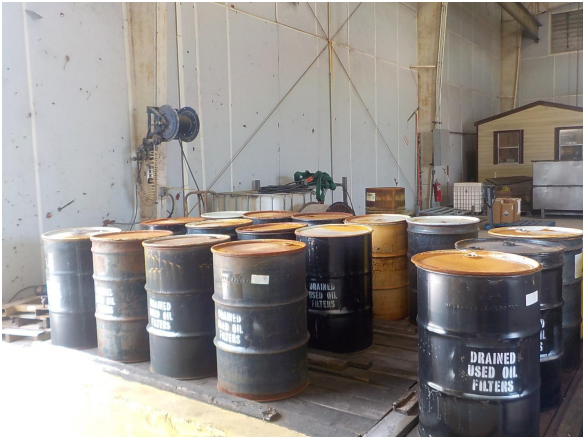
Photo 2

The facility also generates non-PCB used oil and used oil filters from maintenance of equipment at this and other JEA facilities. These wastes are transported back to this facility and stored in 55-gallon drums on the east side of the building. There were numerous drums of used oil and used oil filters accumulating at the time of the inspection (Photos 2 and 3), and all of the drums were properly labeled. The building provides secondary containment.

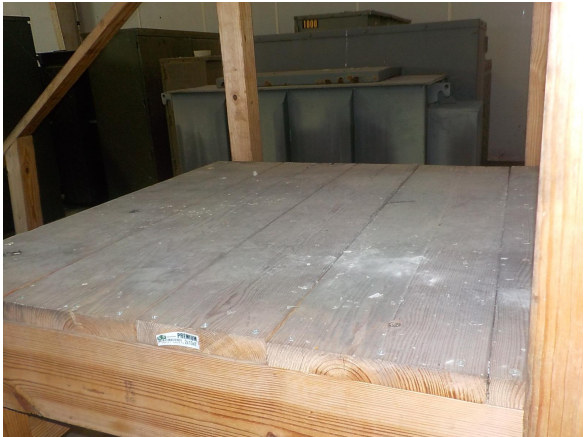
Photo 4

On the west side of the building is a bulb crusher that is used for spent fluorescent tubes and other types of used bulbs that are collected from the field. The crusher is attached to the top of a 55-gallon satellite accumulation drum. The bulb crusher and the drum were closed, and the drum was properly labeled. There are steps and a platform in front of the crusher for access to the top of the crusher where the bulbs are fed into the unit. Several pieces of broken bulbs were observed on the platform that the facility had not cleaned-up (Photo 4) [40 CFR 273.13(d)(2)]. Bulbs waiting to be crushed are contained in cardboard boxes or 55-gallon drums until they can be crushed. At the time of the inspection, there were five boxes and two 55-gallon drums of universal waste bulbs accumulating. The containers were closed and properly labeled and had been accumulating for less than one year.

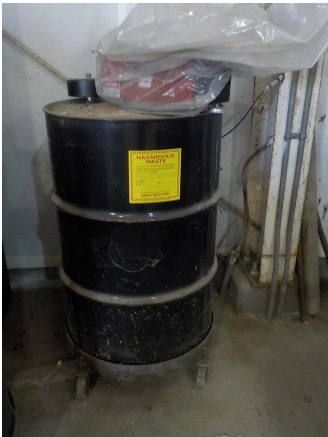
Photo 5

Adjacent to the bulb crusher is the facility's aerosol can puncturer that is attached to the top of a 55-gallon satellite accumulation drum (Photo 5). The drum was closed and properly labeled. Once punctured and drained, the empty cans are collected in an adjacent 55-gallon drum and recycled as scrap metal. The facility recently began generating this wastestream and had not yet accumulated enough waste to require disposal. Mr. Schumacher stated that a waste determination will be made for this wastestream prior to disposal.

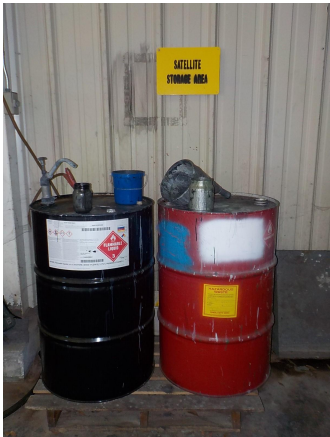
Photo 6

In this shop, transformers are dielectrically tested and minor surface repairs for corrosion prevention and paint touch-up are performed. A review of paint SDSs reveals no RCRA metals and flashpoints of <140°F. The facility cleans its paint guns with mineral spirits. Waste paint and mineral spirits from paint gun cleaning are placed into a 55-gallon satellite accumulation container. The satellite accumulation container was closed and

properly labeled (Photo 6). Waste paint and waste mineral spirits are managed as D001 hazardous waste liquids. The shop processes generate approximately two to three gallons of waste paint and mineral spirits per month. Solid wastes generated during this painting and cleaning process are non-hazardous, but the facility manages the paint related material waste as D001/F003/F005 hazardous waste. These solid wastes are placed into a dated accumulation container for D001/F003/F005 paint related material waste located in the <90-Day Hazardous Waste Accumulation Area (HWAA) described below.

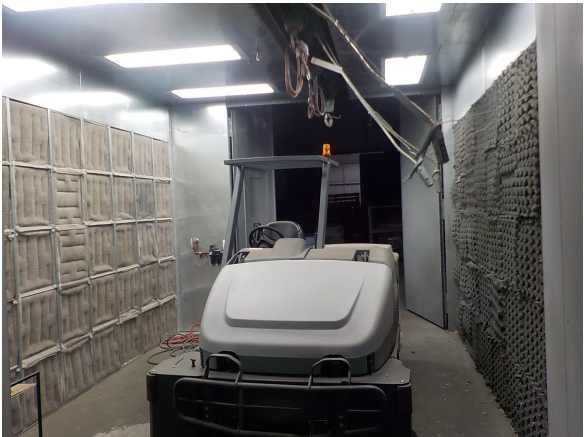
Photo 7

The facility has one walk-in paint booth (Photo 7) in this shop that is used for the transformers that require more than touch-up painting. Due to a recent process change related to the condition of transformers that are eligible to be returned to service, JEA is using the booth less frequently. The same type of paint is used in the paint booth as the light touch-up paint. The paint booth filters have not reached the end of their use and therefore have not required disposal. Mr. Schumacher stated that a waste determination will be made for this wastestream prior to disposal.
