MIAMI DADE COUNTY, FLORIDA
DEPARTMENT OF ENVIRONMENTAL RESOURCES MANAGEMENT
PRETREATMENT FACILITY INSPECTION REPORT

SOURCE NAME: N/A ADDRESS: Opa Locka PS#14
INSPECTOR: M Graham DATE: 11-2-18 TIME: 5:30-6:30pm
REASON: Complaint Request: XX Routine: Sample: Other:
TYPE: Prescheduled Unscheduled: XX Demand:

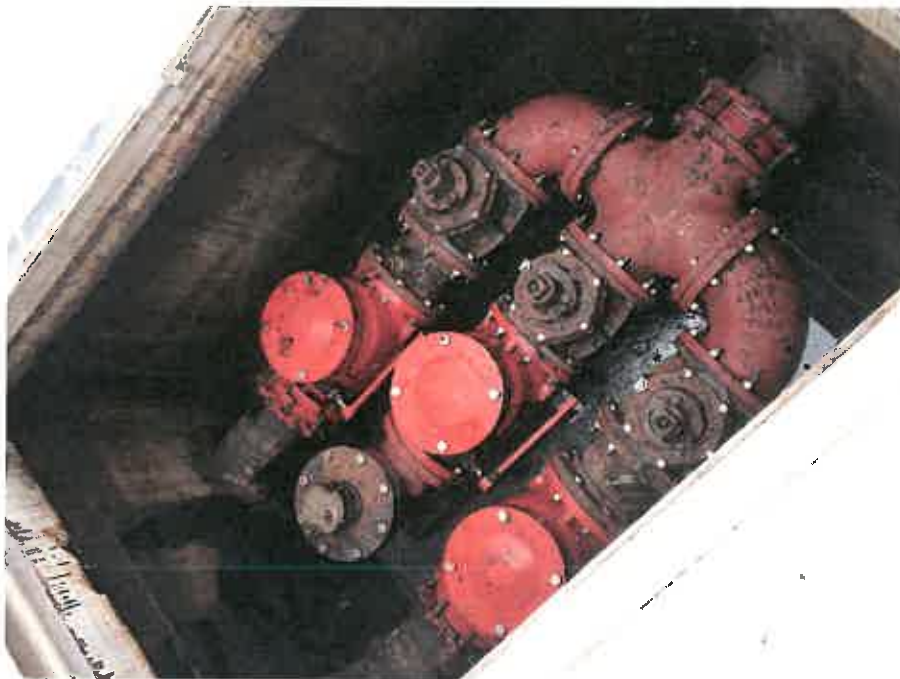
Photo #2 Valve pit adjacent to wet well after oil cleaned off by WP. Pit connected to wet well by an open overflow pipe.

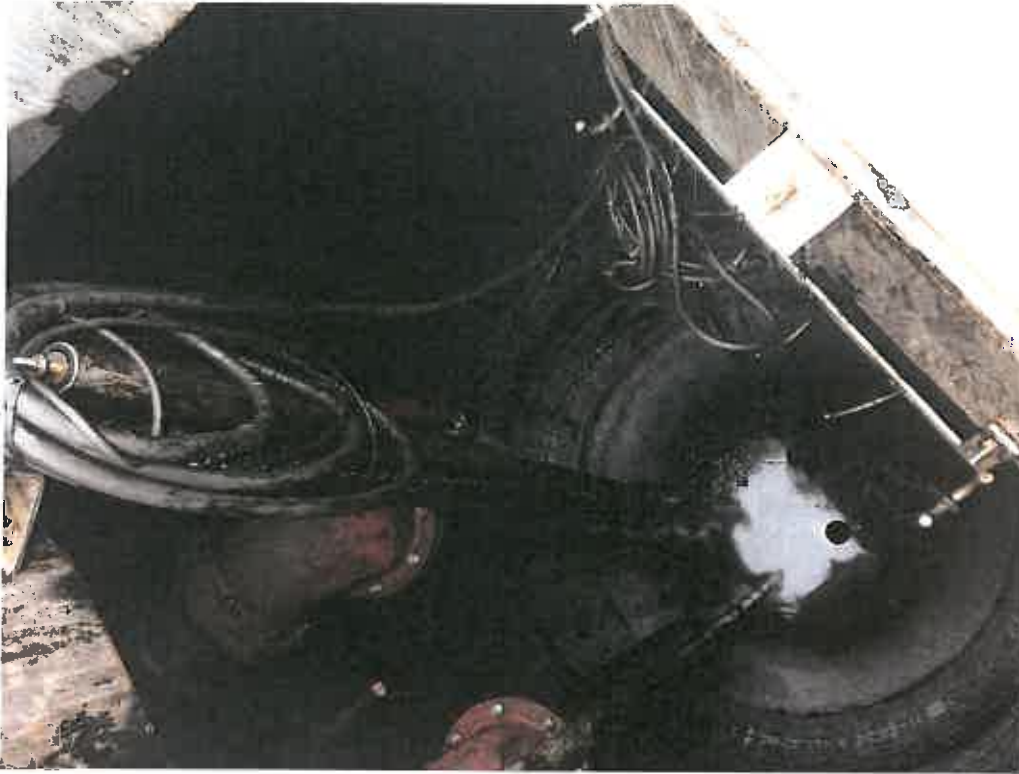
Photo #3 Wet well following pumping and attempt to pressure wash walls from the surface. Note heavy oil on cables and pipes.

The DERM contractor World Petroleum, Inc (WP) was called to Opa Locka PS 14 at approx 13200 NW 38 Ct to remove oil accumulated in the lift station at the request of the City of Opa Locka as reported by Myra Flagler and they arrived on site at 3:15PM. When I arrived on site WP had completed pressure cleaning a valve pit adjacent to the wet well which had been oiled by an overflow from the high oil level in the wet well and they were skimming oil from the top of water in the wet well itself. They had tried to pressure wash the oil off the walls of the wet well but the accumulated oil was too thick and the wet well was too deep at 15-20 ft to reach from the surface. WP staff said that the oil in question was so thick that it had to be identified as Bunker oil. There was no evidence of oil having overflowed the structure and the concrete surrounding the wet well was relatively clean. A large rainwater puddle was seen at the edge of the road just south of the lift station and no rainbow sheen was seen on the standing water. By 6:00pm the 3,000 gal WP vac truck was nearly full of oily water and discussions with DERM, Opa Locka, and WP resulted in a decision to return to the lift station on the following Monday morning with confined-space entry supplies such that a worker would be able to enter the lift station to degrease and pressure wash the walls of the structure at depth.

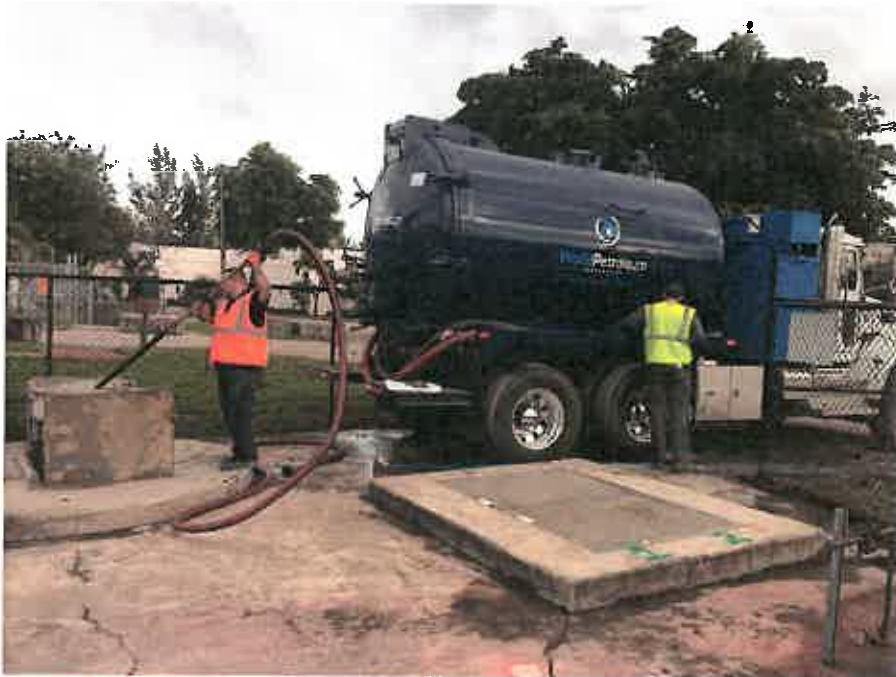
Photo #4 WP staff cleaning equipment just prior to leaving the site for the day. Valve pit shown in #2 is at right foreground with covers closed.
