Re: Ring Power Corporation – 4900 North Main St., Gainesville  
EPA/DEP ID: FLD 982 150 237  
**Alachua County – Hazardous Waste**

**Florida Department of  
Environmental Protection  
Hazardous Waste Inspection Report**

**Facility Name:** Ring Power Corp

**On-Site Inspection Start Date:** 11/01/2018

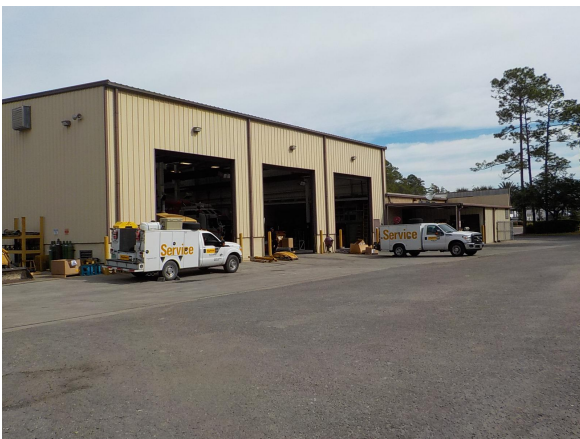
Photo 1

General maintenance is performed on a variety of vehicles in the 7-bay Service Shop (Photo 1). Used oil, used oil filters and used antifreeze are generated by the facility's operations. Used oil is drained into portable drain containers (Photo 2) and then pumped into a 1,000-gallon double-walled tank located outside (Photo 3). All of the used oil drain containers and the used oil tank were properly labeled. It is recommended that the label on the tank be re-stenciled, as it is beginning to fade. Used oil filters are drained into a portable drain container before being accumulated in a 330-gallon steel container (Photo 4). The container was in good condition, properly labeled and stored on an oil-impermeable surface. Used antifreeze is drained into portable drain containers and then transferred into a 250-gallon double-walled tank located outside (Photo 5). The tank was properly labeled.

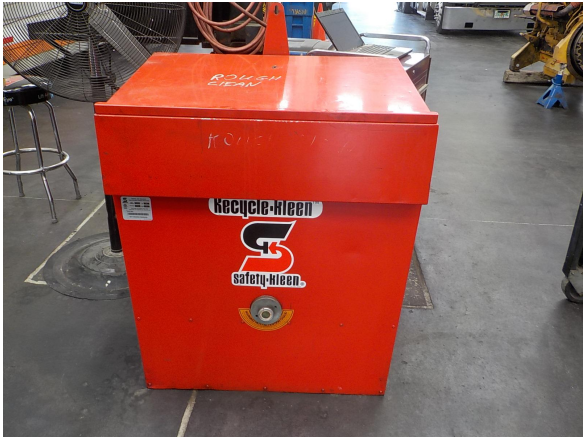
Photo 6

The facility operates two Safety-Kleen System One parts washers that use Safety-Kleen Premium Solvent (hydrotreated light petroleum distillates 100%; flash point 148°F) (Photo 6). The units distill spent solvent within the unit and pump clean solvent into the basin. The units are on a 16-week service with Safety-Kleen to add clean solvent as needed. The sludge is collected and disposed of as D006/D007/D008 hazardous waste as needed. The last shipment was in 2012 by Safety-Kleen (FLD980847214).

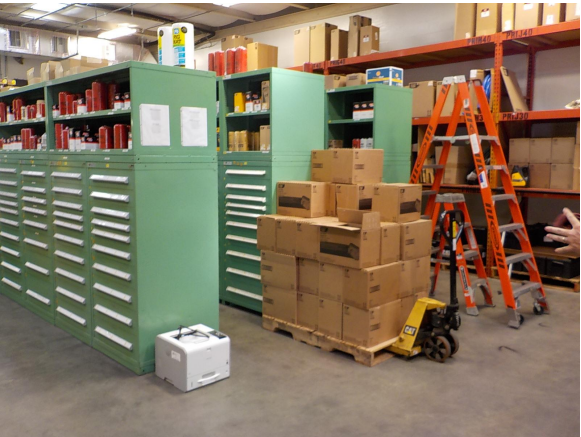
Photo 10

There is a Parts Warehouse (Photo 10) located adjacent to the Service Shop. Parts Warehouse operations generate Excluded Solvent Contaminated Wipes. There was one closed, properly labeled container for the accumulation of wipes observed. Spent lead acid batteries generated by maintenance operations are stored on a secondary containment pallet outside the parts warehouse (Photo 11). Batteries are sent back to Caterpillar for recycling by East Penn Manufacturing. Fluorescent bulbs are changed out and disposed of by the St. Augustine Ring Power facility. Electronic waste is also disposed of by the St. Augustine Ring Power facility.

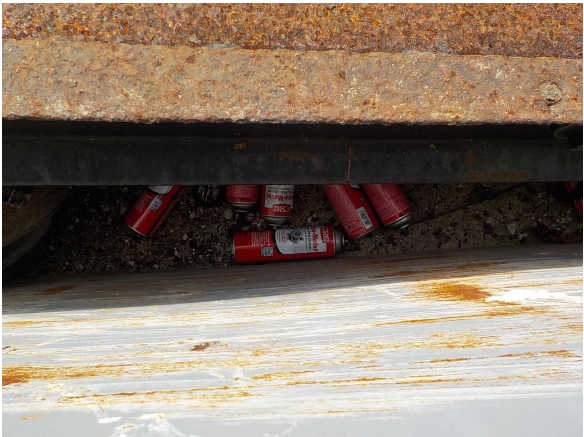
Photo 13

There were two dumpsters observed adjacent to the Wash Rack area. One dumpster contained several empty aerosol cans of Lectra-Motive Electric Parts Cleaner (Photo 13). The cans were punctured, but did not appear to have been punctured with the drum-top puncturing device. The cans were removed from the dumpster at the time of inspection. The facility is reminded that aerosol cans should be punctured with the designated puncturing device to ensure proper collection of the remaining product in the can in order for it to be managed as hazardous waste.
