SUBJ: RCRA Compliance Evaluation Inspection
Perma-Fix of Florida, Inc.: FLD980711071
RCRA/HSWA permit number: 17680-011-HO

RCRA Inspection Report

Perma-Fix of Florida, Inc.
1940 NW 67th Place
Gainesville, Florida 32653
Alachua County

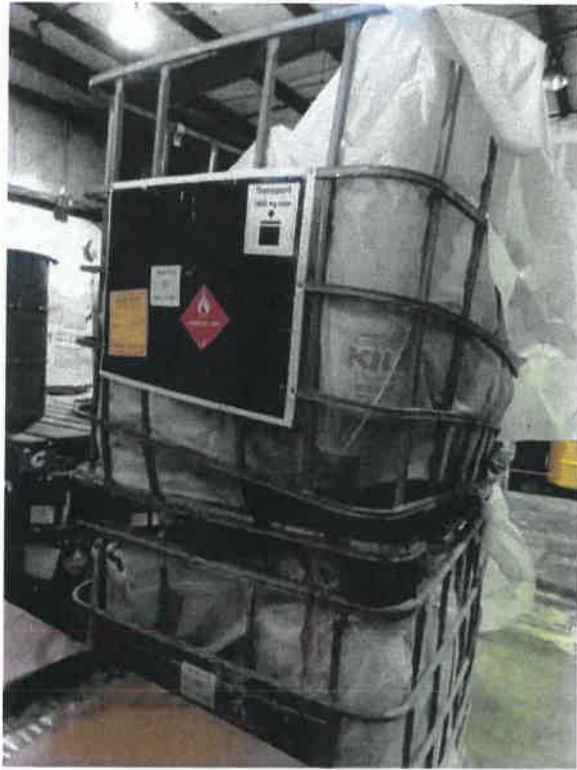
This storage area in the building is permitted to store up to 54,340 gallons of hazardous waste with a maximum container size of 718 gallons or B25 box. The area is under a roof on a curbed concrete pad. This area was within its permitted volume capacity and all containers had been accumulating for less than one year, as documented in the facility's electronic inventory system. At the time of the inspection, the inspection team noticed two pallets storing what appeared to be paint from household collection events. The plastic liner inside the tote was damaged and had the contents leaking outside the tote (See Figure 1).

Figure 1 - Leaking tote storing paint waste. Waste Storage Area. Photo taken 2/5/18

Pursuant to RCRA Permit 17680-011-HO, Part II Subpart B.2.1.- Container Storage Areas/Unit, the Permittee is allowed to store the wastes listed in Attachment A of this permit only in the Processing and Storage Building (PSB), Treatment and Operations Building (TOB), and in the Liquid Scintillation Vial (LSV) Processing and Waste Storage Warehouse. Containers must conform to D.O.T. requirements. If a container holding hazardous waste is not in good condition, or begins to leak, the waste shall be transferred to another container that is in good condition [40 C.F.R. § 264.171] or it will be over-packed. Containers shall be kept closed, except when adding or removing waste and be handled in a manner that will not allow the containers to rupture or leak [40 C.F.R. § 264.173].

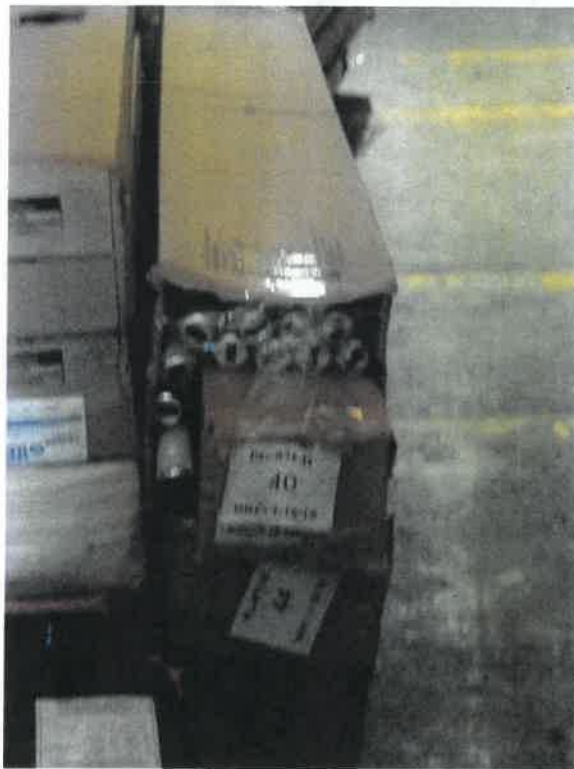
In addition, the inspection team found a box of universal waste lamp that was not closed (See Figure 2). As well, some boxes were not labeled with the words "Universal Waste-Lamp(s)," or "Waste Lamp(s)," or "Used Lamps."

Figure 2 - Open box of universal waste lamps. Waste Storage Area. Photo taken on 2/5/18

Pursuant Fla. Admin. Code Ann. r. 62-737.400(5) [40 C.F.R. § 273.13(d)], a SQHUW must manage universal waste lamps in a way that prevents releases of any universal waste or component of a universal waste to the environment.

Pursuant to Fla. Admin. Code Ann. r. 62-737.400(5)(b)1. [40 C.F.R. § 273.14(e)], a SQHUW must label or mark each lamp or container of lamps clearly with one of the following phrases: "Universal Waste-Lamp(s)," or "Waste Lamp(s)," or "Used Lamps."

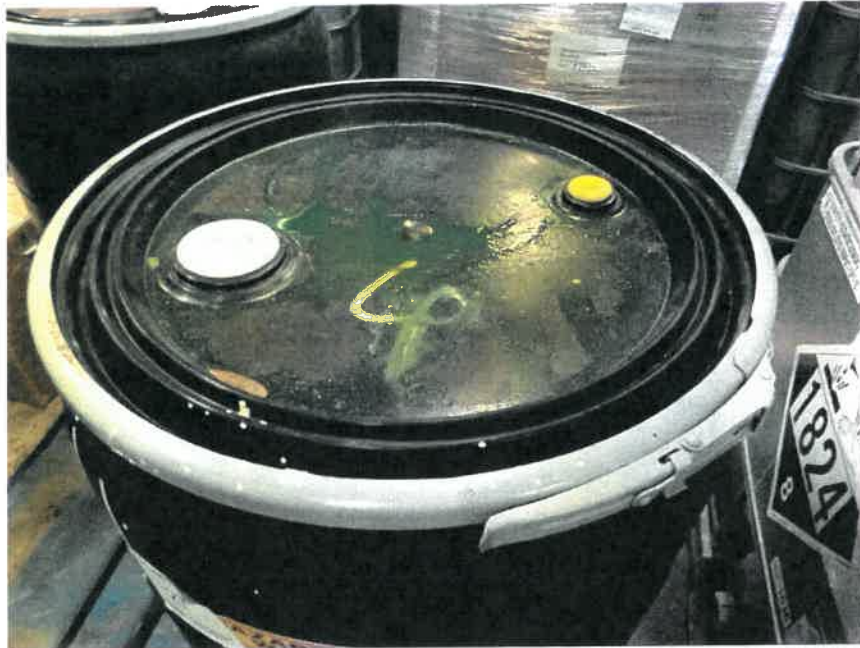
Three 55-gallon drums were located in this 90-day storage area. The hazardous waste comes from the SAA containers inside the lab. The drums were stored on pallets, were closed, labeled and dated (oldest 11/29/17). At the time of the inspection, the inspection team noticed residue on top of the lid of the 55-gallon drum storing sulfuric acid (See Figure 3). The facility personnel removed the residue and properly containerized the waste debris before the inspectors left the area.

Figure 3 - 55-gallon drum with waste residue on top. Drum located at the TOB. Photo taken on 2/5/18

Pursuant to Fla. Admin. Code Ann. r. 62-730.160(1) [40 C.F.R. § 262.34(a)(1)(i) (2016)], which incorporates Fla. Admin. Code Ann. r. 62-730.180(2) [40 C.F.R. § 265.171], and is a condition of the LQG Permit Exemption, if a container holding hazardous waste is not in good condition, or if it begins to leak, the generator must transfer the hazardous waste from this container to a container that is in good condition, or manage the waste in some other way that complies with the requirements.
